# LORETO COLLEGE, MANCHESTER

CONDITION SURVEY REPORT  
APRIL 2023

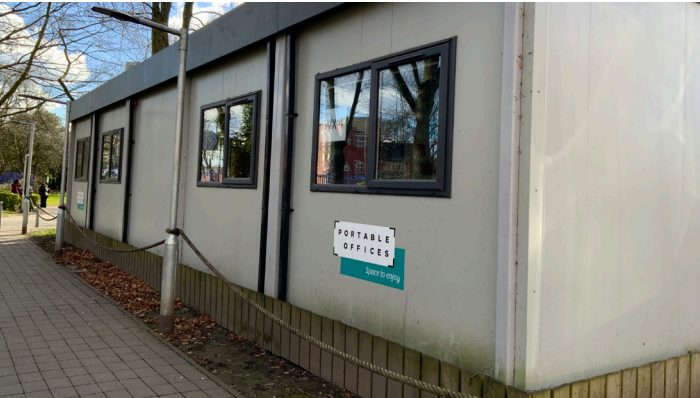
Unit A - East Elevation

From observing the units, the only signs of age or wear on the exterior of the buildings are mild amounts of moss/algae build-up towards the foundations on units A and B. This should not be seen as an ongoing maintenance issue as it can be quickly resolved by cleaning. The walls are in a good condition overall.

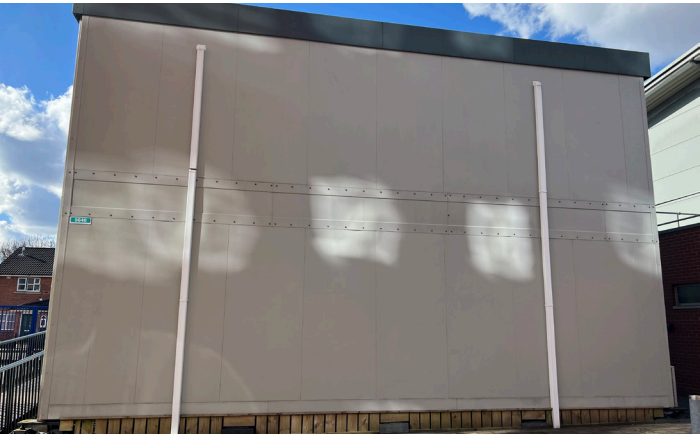
Unit C - East Elevation

The elevations are buttermilk in colour to the body with vertical timber plinths. The classrooms also have anthracite windows and external doors. The following images illustrate the current conditions of the external walls of the temporary buildings, which are all in a good state of repair.

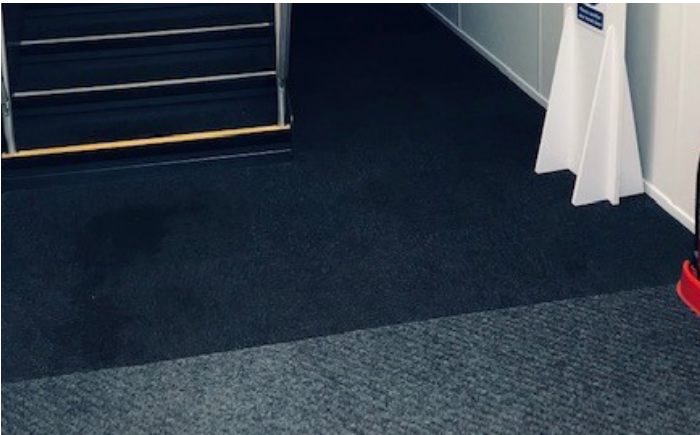
Unit C - Entrance Lobby Floor Covering

The general condition of these floors are good, with little evidence of wear. The image below from Unit C shows arguably the area with the heaviest foot traffic, as this area leads to four classrooms. The following images show that the floor coverings are still in good condition.

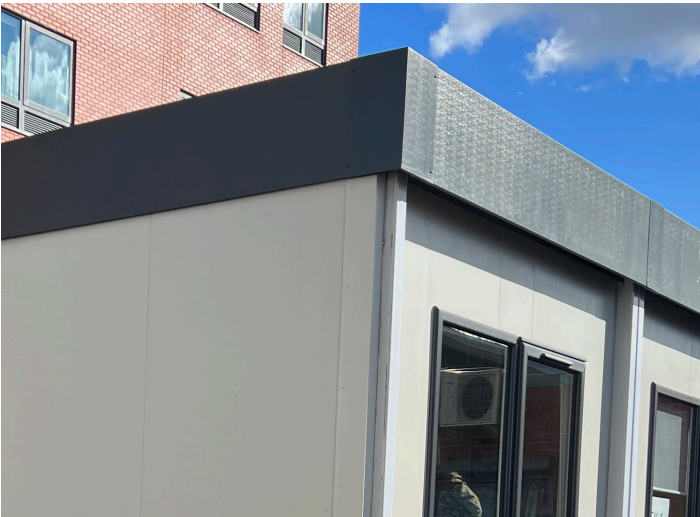
Unit D - Fascia Condition

The roof is a mono-pitch roof finished with firestone fire-rated EPDM black roof membrane. It was not possible to inspect the condition of the roof of each unit in person, however the fascias were in good condition, as seen in the photographs below. Any maintenance required to the roofs has been undertaken by Portable Offices Ltd.

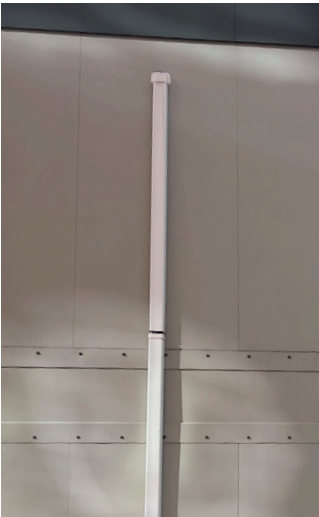
Unit C - Downspout Conditions

Plastic rainwater goods appear to one elevation per unit. Each module will have its own rainwater gutter and downspout. The below photographs illustrate the overall, good condition of the downspouts observed on all units. They have all been reported as working and show no sign of leaking or staining.

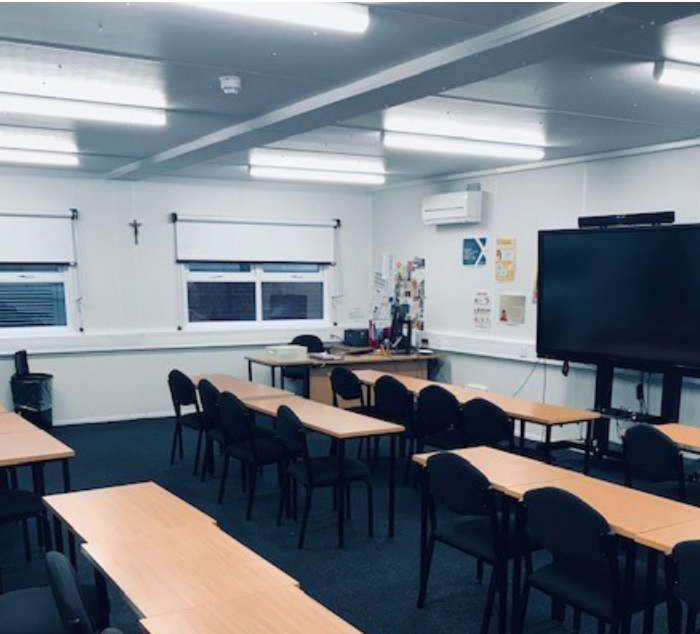
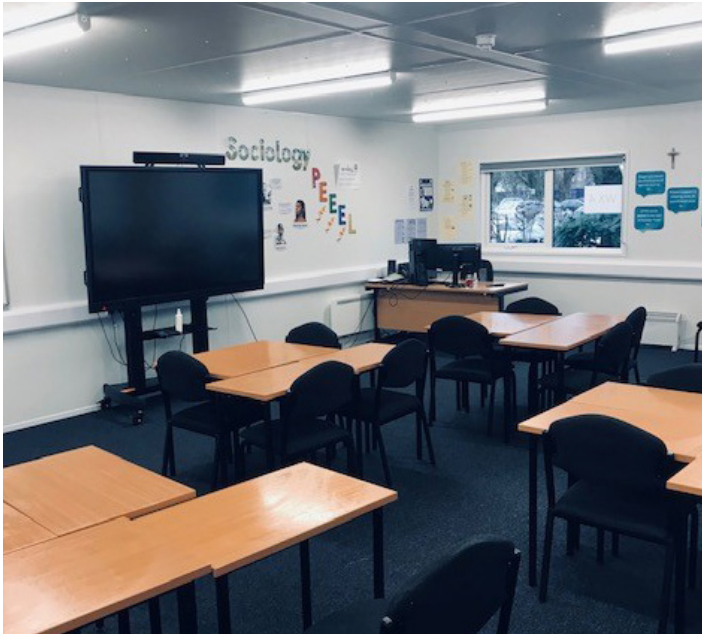
The internal walls and ceilings are in good condition. The college have confirmed that no maintenance to the walls have been undertaken. The ceilings have undergone maintenance where required due to small leaks, and this was undertaken by Portable Offices Ltd. The following photographs are representations of all temporary classrooms.

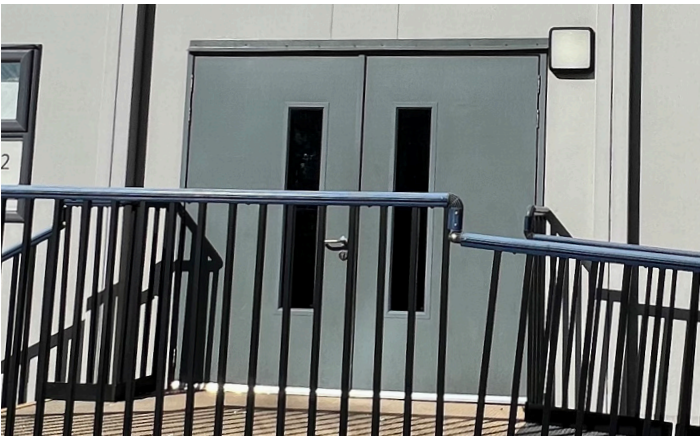
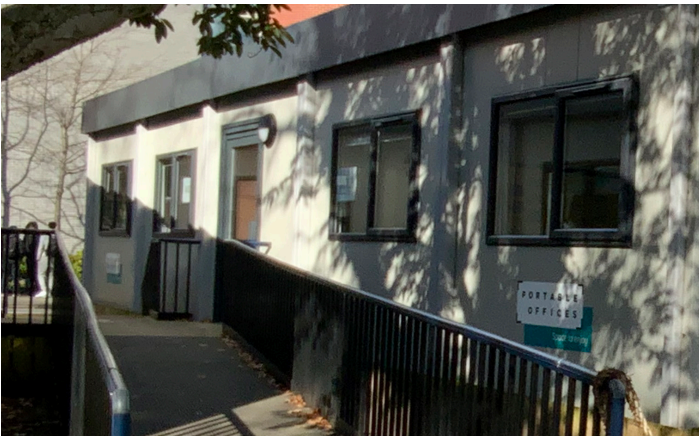
The following image shows the good general condition of the doors across all units. The college have confirmed that all doors are working properly and have required no maintenance whilst on site. None of the windows or vision panels show any evidence of condensation or need of maintenance. All seals are intact and they appear to be in good condition.

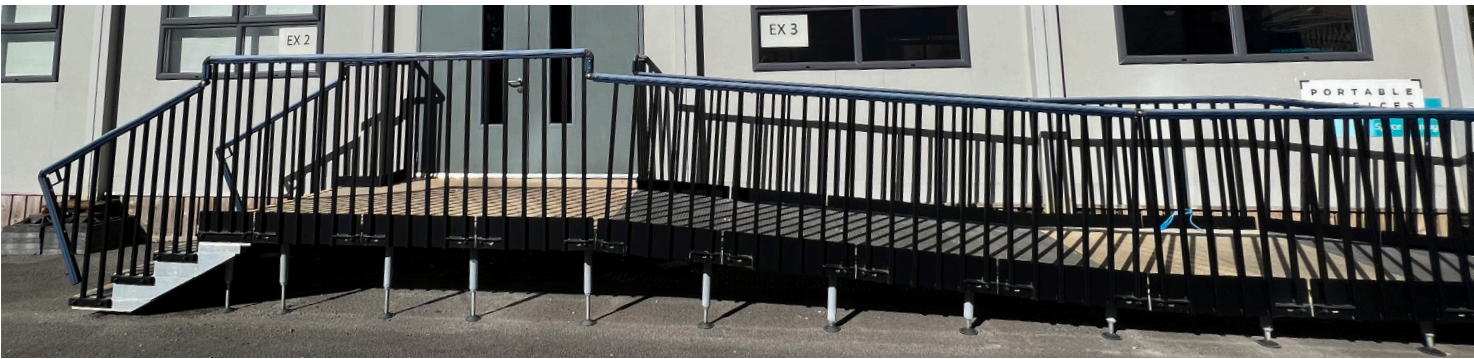
Unit C - Access Ramp

All units have steel, wheelchair accessible ramps, which are in good condition, demonstrated by the photograph below. All balustrades are secure and have not required any maintenance whilst on site.
