# GEOSHIELD Verification Report

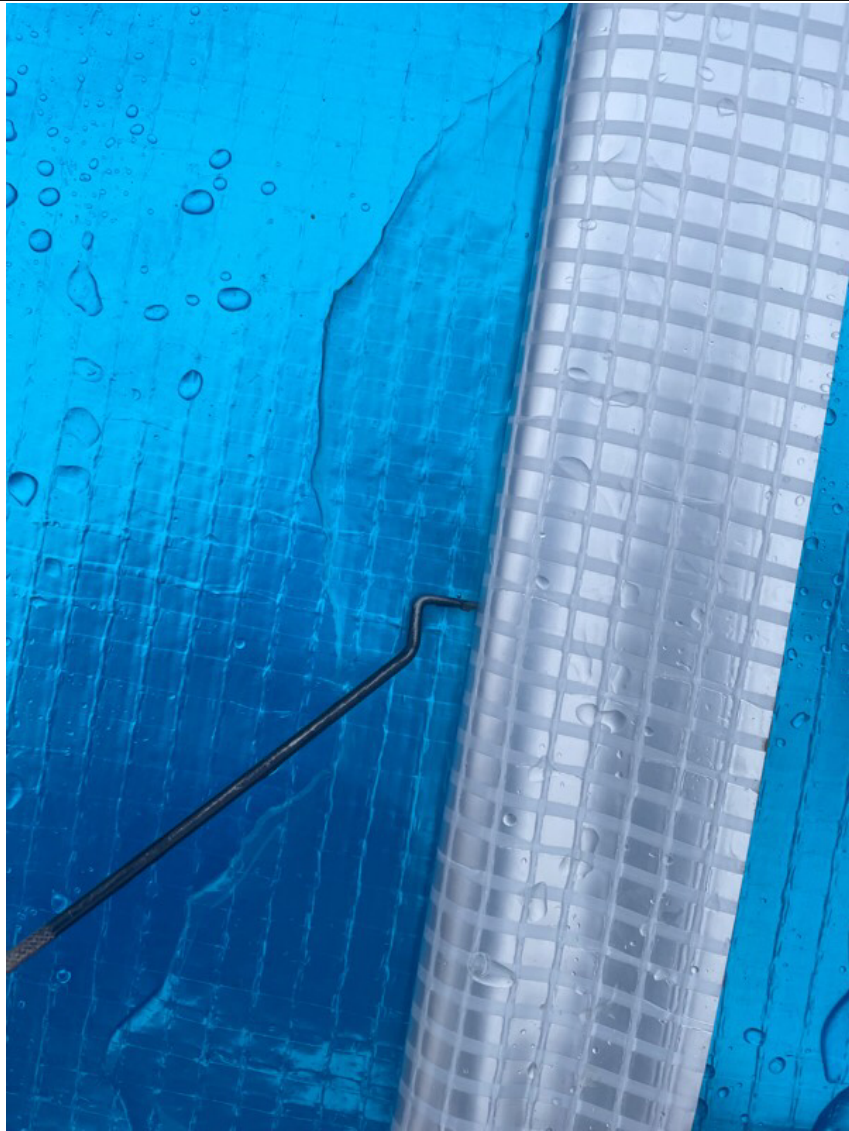
## VERIFICATION ITEM TWO

The above photograph demonstrates a mechanical point stress test also known as a pick and probe test being carried out to a sealed lap joint.

Only 3 minor faults were identified during this testing procedure which were

remediated on site. Lap joints tested and verified in accordance with CIRIA 735.

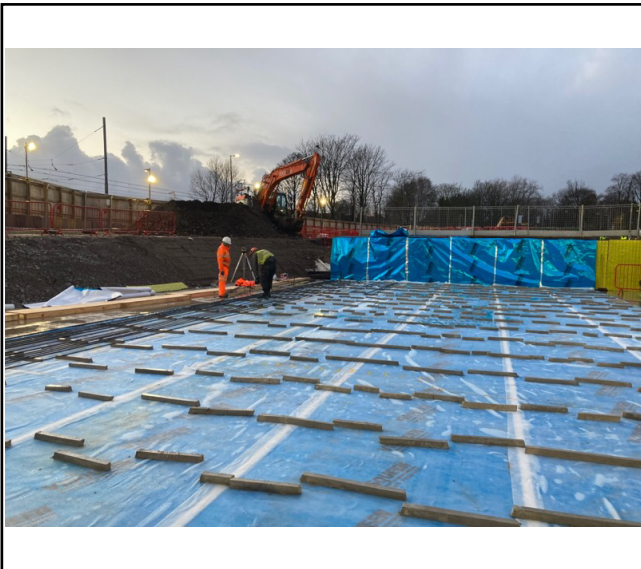
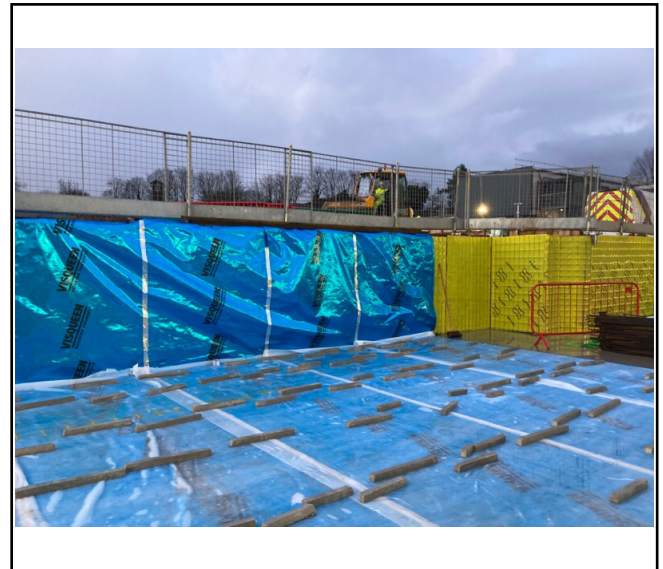
LOCATION/GRID LINE: Pour one - Basement slab.

The application of Treadguard 300 has provided adequate protection upon the gas membrane. The above photos also show clay bar spacers in place which will minimise direct contact between the steel bars and Visqueen standard gas barrier.

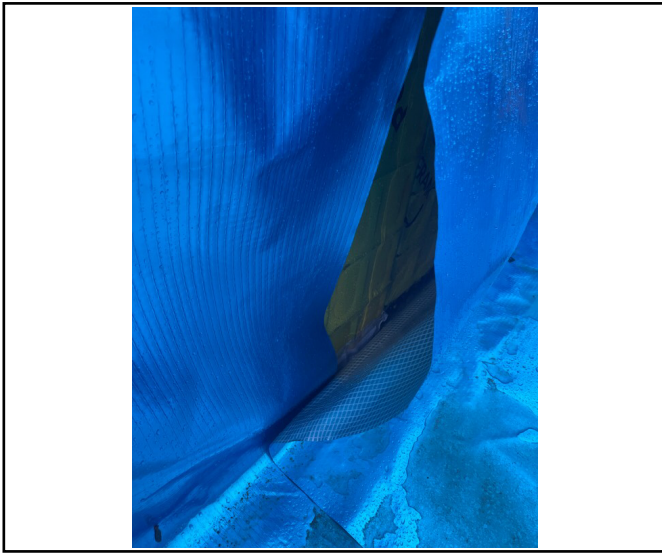
Lap joint required sealing further up

the sheet piled wall.

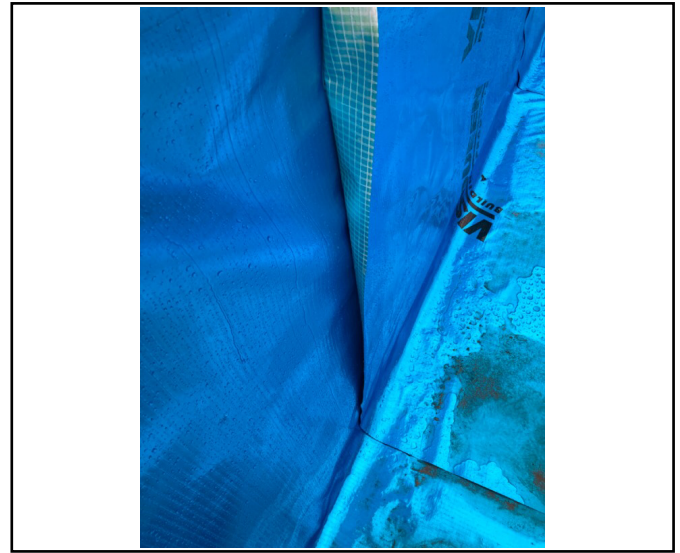
Lap joint sealed in excess of 650mm

up the sheet piled wall.

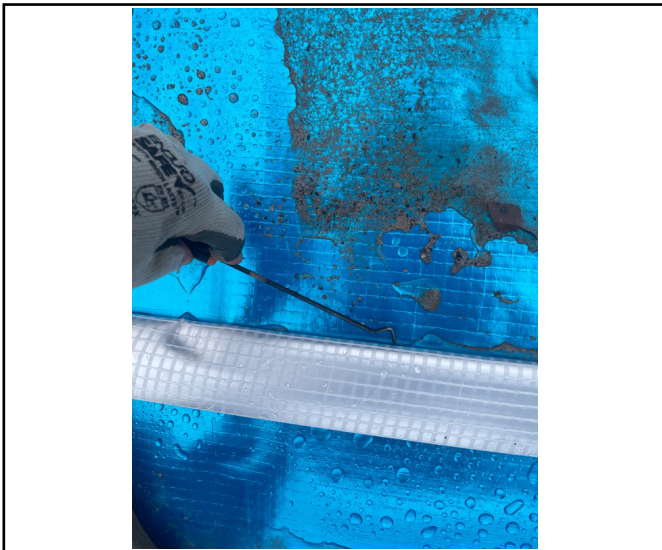
Pick and probe testing to a sealed lap

joint prior to lap tape installation.
