# Demolition Asbestos Survey Report

x2 Garages at St Edward's R.C. Parish Hall,  
Thurloe Street, Rusholme, Manchester, M14 5SG

| <b>Job Reference:</b> | JPR/AR/3666. | |

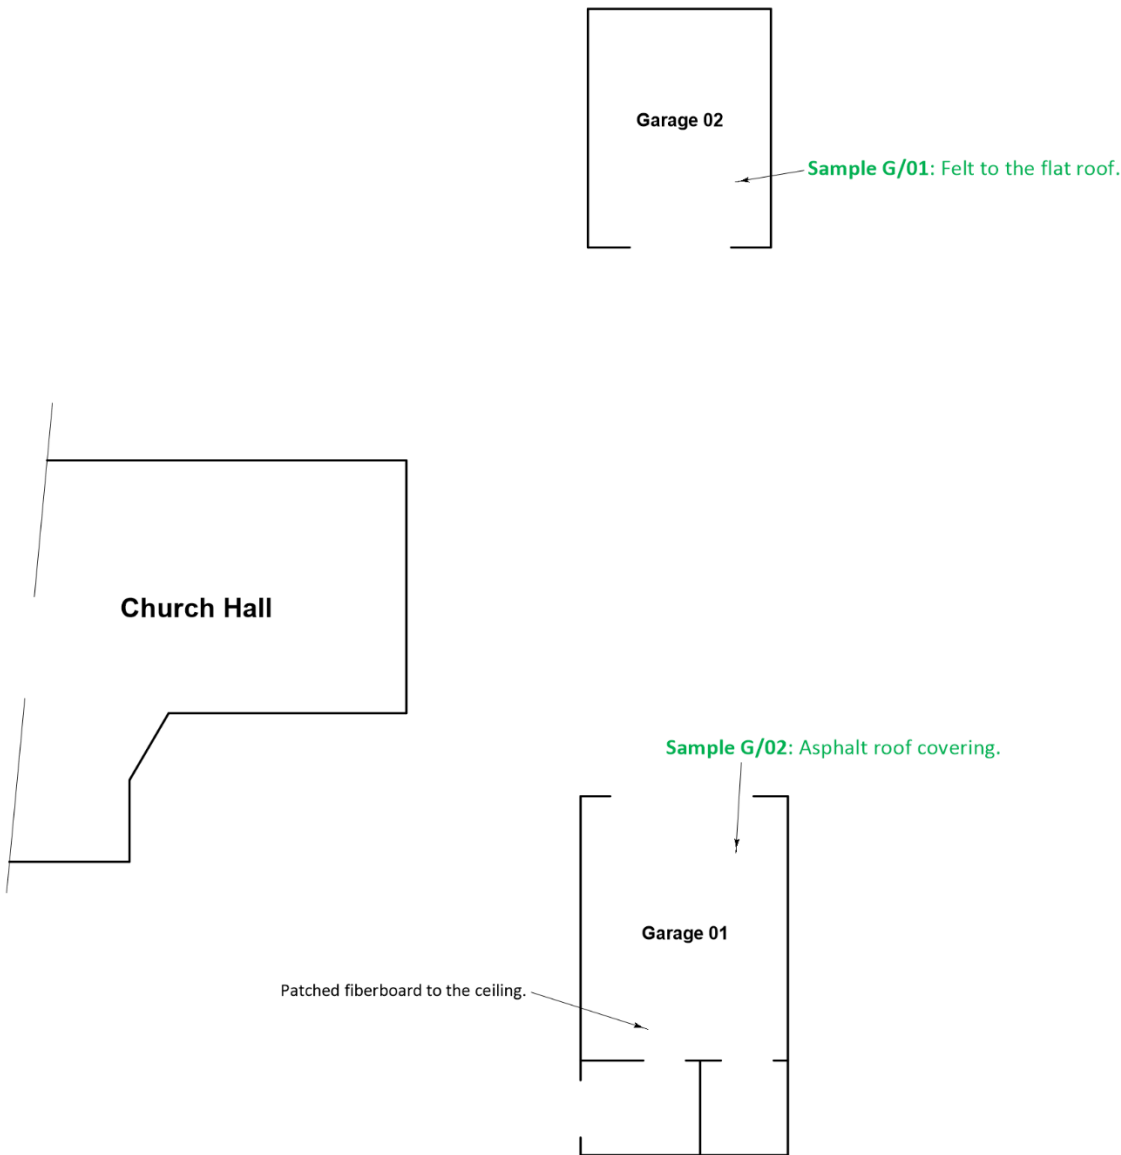
Section 04: Survey diagram (If applicable):

No asbestos materials were detected

Scope of works: Demolition survey of x2 garages.
