Heritage defect repair specification and methodology

123-125, Liverpool Road,  
Manchester M3 4JN

Prepared for: Artal

Date: 07 March 2023

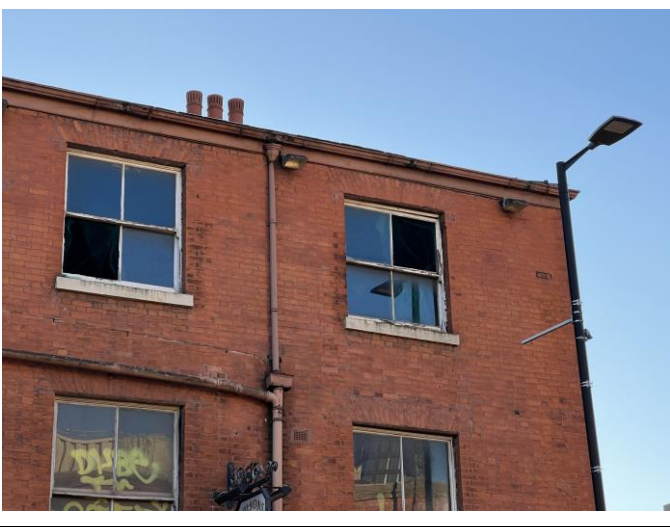
| 2. | View of the existing windows and gutters. | |

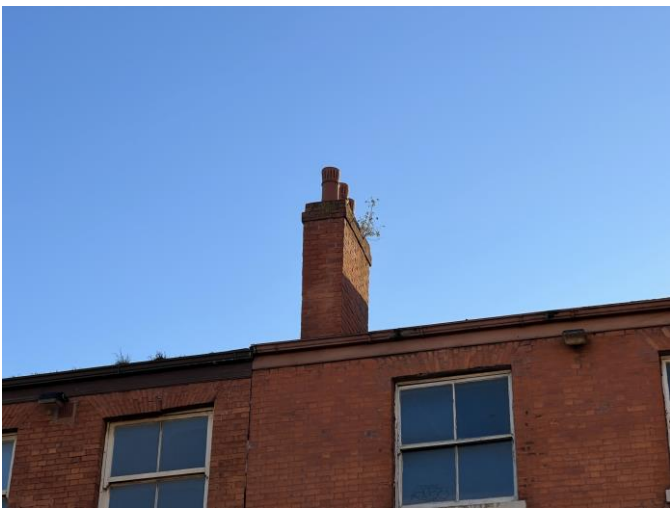
| Item | Location | Element | Description of area | Repair method |
|---|---|---|---|---|
| 5. | Façade | Brickwork | Isolated sections of missing expansion joints. | See Appendix A – A7 |
| 9. | Roof | Chimney & Flaunching | Buddleia growth is present to the central chimney, including isolated cracked and degraded mortar joints. | See Appendix A – A5 & A10 |

| 3. | View of buddleia to the central chimney and typical view of missing expansion joint. | |

| Item | Repair description |
|---|---|
| A7 – Replacement of expansion joint. | <p><u>Preparation</u></p> <ol style="list-style-type: none"> <li>1. The cut fillets to brickwork which lack expansion joints should be thoroughly cleaned, leaving free from dirt or any obstruction.</li> <li>2. Carefully install a foam expansion joint filler ahead of application of mastic sealant.</li> </ol> <p><u>Application</u></p> <ol style="list-style-type: none"> <li>1. Carefully fill the joint with a high-quality polyurethane sealant, such as 'Soudaflex PU sealant', or similar approved as per the manufacturer's instructions, creating a clean and tidy joint which can be cut out and reversed if required.</li> </ol> |

| Item | Repair description |
|---|---|
| A10 – Removal of vegetation to the chimney and repairs to flaunching. | <p><u>Preparatory works</u></p> <ol style="list-style-type: none"> <li>Using a safe access platform, cut back branches and remove roots by hand only, taking care to keep disruption to the surrounding surfaces to an absolute minimum.</li> </ol> <p><u>Application of Herbicide</u></p> <ol style="list-style-type: none"> <li>Using an appropriate herbicide, treat remaining roots and areas if they cannot be suitably removed.</li> </ol> <p><u>Finishing</u></p> <ol style="list-style-type: none"> <li>Following removal of vegetation, allow to repoint any mortar joints that have been removed in coincidence, using the mortar specification as detailed in A5.</li> <li>Following removal of the vegetation, should flaunching be defective, loose or cracked, the heritage surveyor is to inspect and provide a suitable, sensitive method for replacement.</li> </ol> |

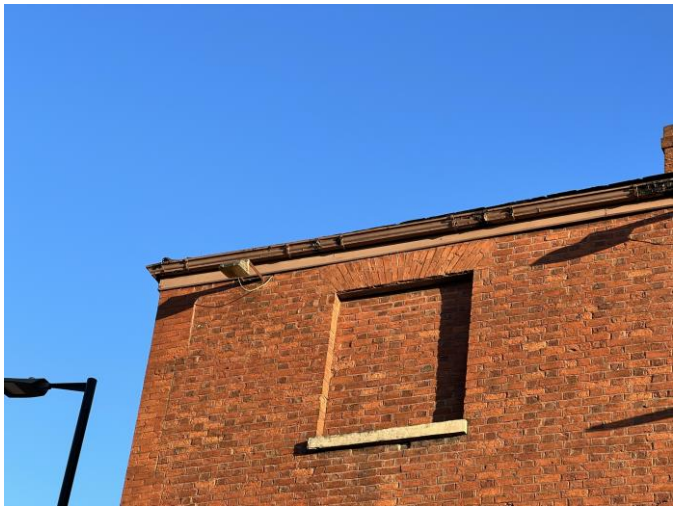
| 5. | View of the bricked-up window. | |

| Item | Repair description |
|---|---|
| A11 – Removal of brickwork to bricked up window. | <p><u>Preparation</u></p> <ol style="list-style-type: none"> <li>Using a safe access platform, allow to carefully remove bricks blocking the existing window up <b>only</b> using a plugging chisel or similar approved. The use of power tools is not permitted to remove bricks.</li> </ol> <p><u>Replacement bricks</u></p> <ol style="list-style-type: none"> <li>Once the bricks have been removed, repair methodology A6 should be followed when replacing broken toothed bricks, to ensure the same specification and matching bricks are sourced.</li> </ol> <p><u>Installation of new glazing</u></p> <ol style="list-style-type: none"> <li>Carefully install new bespoke glazing panel to opening, as per architects and manufacturers specification.</li> </ol> |

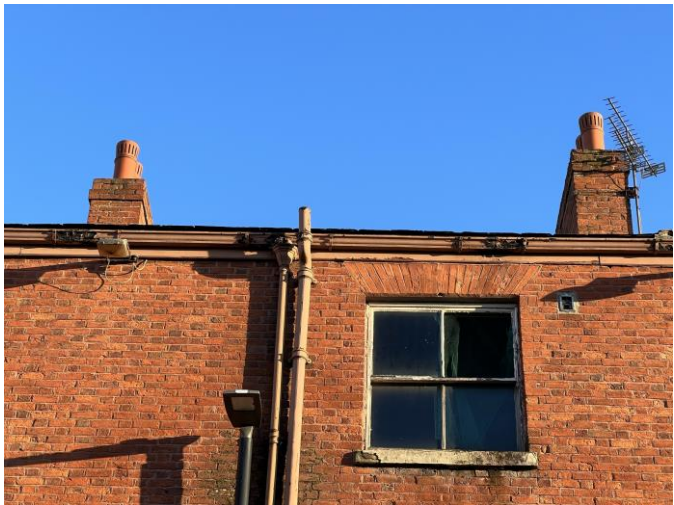
| 6. | View of the guttering to the right side elevation. | |

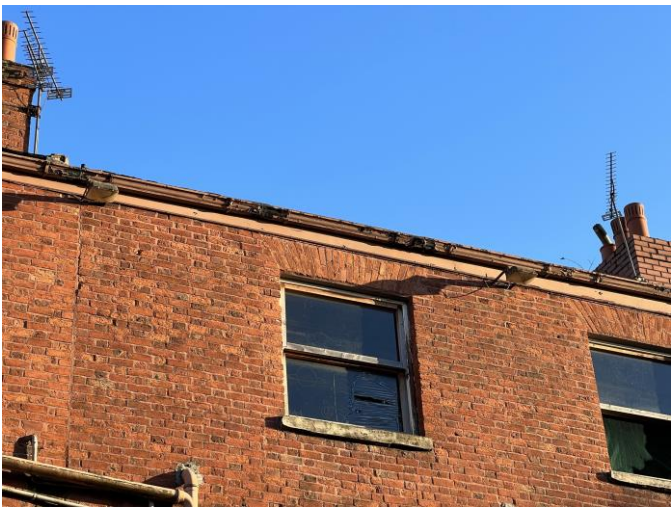
| 7. | View of the guttering to the right side elevation. | A photograph showing the upper part of a red brick building. A dark gutter runs along the roofline. A window is visible on the right side of the frame. The sky is clear blue. |

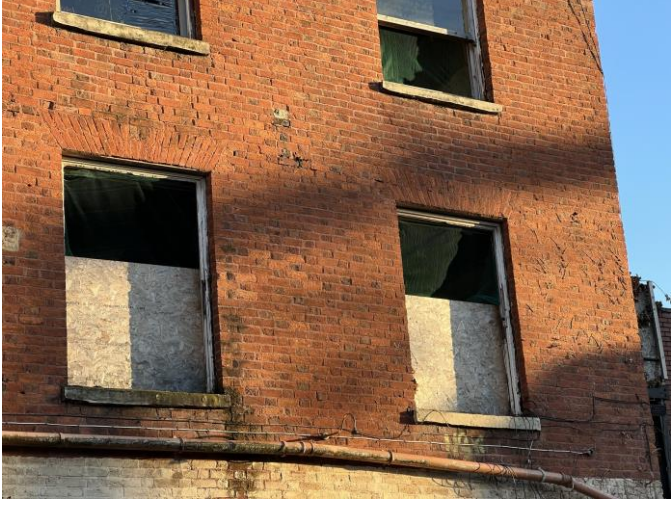
| Item | Location | Element | Description of area | Repair method |
|---|---|---|---|---|
| 21. | Façade | Brickwork | There are sections of loose, cracked and defective mortar joints. | See Appendix A – A5 |
| 22. | Façade | Brickwork | Isolated sections of spalling brickwork (highlighted in yellow on the plans). | See Appendix A – A6 |

| 8. | View of degraded mortar and spalling bricks to the right side elevation. | A close-up photograph of a red brick wall. The mortar joints are crumbling and the bricks are spalling. Two windows are visible, one of which is boarded up with a piece of plywood. |

| Item | Repair description |
|---|---|
| A5 - Isolated pointing repairs to external elevations | <p><u>Preparation</u></p> <ol style="list-style-type: none"> <li>Where any re-pointing works are to be carried out, a sample should be taken of the area by an appointed reputable mortar analysis consultant, to ensure a like for like match of the aggregate and mortar contents.</li> <li>Re-pointing where specified, loose and defective mortar joints shall be raked out/carefully chiselled using a plugging chisel, square to a depth of not less than 15mm, to give an effective key. Extra care shall be taken where mortar is strong and well adhered. On no account shall angle grinders or other power tools be used during the removal process.</li> </ol> <p><u>Mortar mix and method of application</u></p> <ol style="list-style-type: none"> <li>Pre-wet the affected surface, ensuring the area is damp, but not saturated, prior to commencement.</li> <li>Starting from top to bottom, the filling of the joints shall be pressed well in to ensure maximum penetration, compaction and bond to the original bed. At the same time, it shall be kept well within the confines of the joint and never allowed to spread over the face of the brickwork.</li> <li>The mortar mix for re-bedding or repointing to comprise of Natural Hydraulic Lime (NHL) 3.5 with a well graded, washed sharp sand in a 3:1 mix, to comply with BS EN 13139. The sand used must be the sand as identified in the mortar analysis and mortar 'biscuits' should be prepared for the satisfaction of the Conservation Officer.</li> <li>Should a colour match be required for aesthetic purposes, a crushed matching brick can be incorporated within the mix in small quantities.</li> <li>The masonry wall should be covered in hessian sheets at the end of each day to protect from the elements and prevent shrinkage. At the start of each working day, fresh pointing from the previous day should be wetted with a light spray.</li> </ol> <p><u>Finishing</u></p> <ol style="list-style-type: none"> <li>Using a stipple brush or a stiff bristled brush, tamp the mortar joint to ensure good compaction, cohesion and to bring through the aggregate, as the mortar begins to 'firm up' to prevent wet mortar smearing on adjacent brickwork.</li> </ol> |
| A6 – Isolated brick repairs. | <p>To areas of defective and missing brickwork, matching bricks should be sought and approved by the Conservation Officer or of the local authority, Heritage Surveyor. Each brick is to be assessed and marked to determine which ones are beyond repair, prior to works commencing with a heritage surveyor. No power tools are permitted to remove affected bricks.</p> <ol style="list-style-type: none"> <li>Once the replacement bricks have been sourced and approved, the bricks should be bedded using an NHL 3.5, mixed with a well graded, washed sharp sand in a 3:1 mix, to comply with BS EN 13139, to include crushed matching brick dust to achieve a colour match with adjacent mortar joints, allowing to always follow the plumb of the wall.</li> <li>Once the mortar has gone off, a stipple brush should be used to brush back the aggregate on the mortar joint.</li> <li>The masonry wall should be covered in hessian sheets at the end of each day to protect from the elements and prevent shrinkage. At the start of each working day, fresh pointing from the previous day should be wetted with a light spray.</li> </ol> |

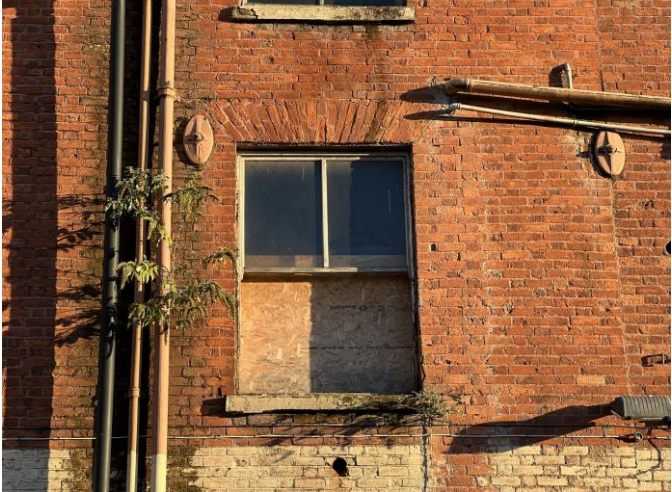
| Item | Location | Element | Description of area | Repair method |
|---|---|---|---|---|
| 23. | Façade | Brickwork | Isolated sections of penetrated brickwork requiring replacement, including making good following removal of vents, etc. | See Appendix A – A6 |

| 9. | View of penetration to the brickwork and existing windows/mortar joints. | A photograph of a red brick wall with a window. There is a visible penetration in the brickwork above the window. A vertical pipe runs down the left side of the wall. The mortar joints are crumbling. |

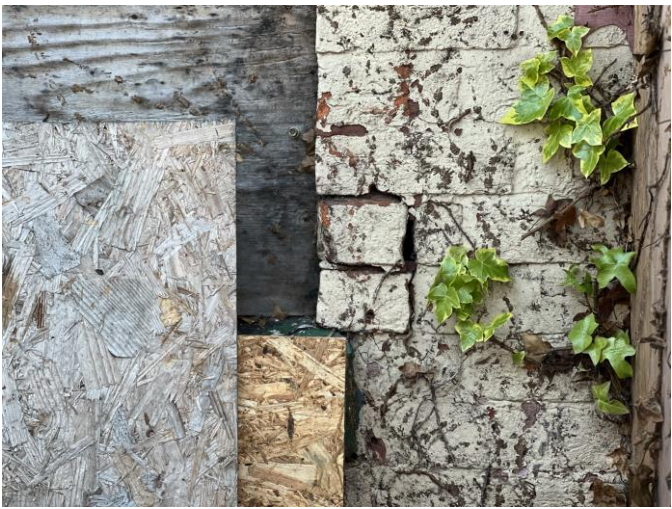
| 10. | View of dislodged bricks adjacent to a window. | |

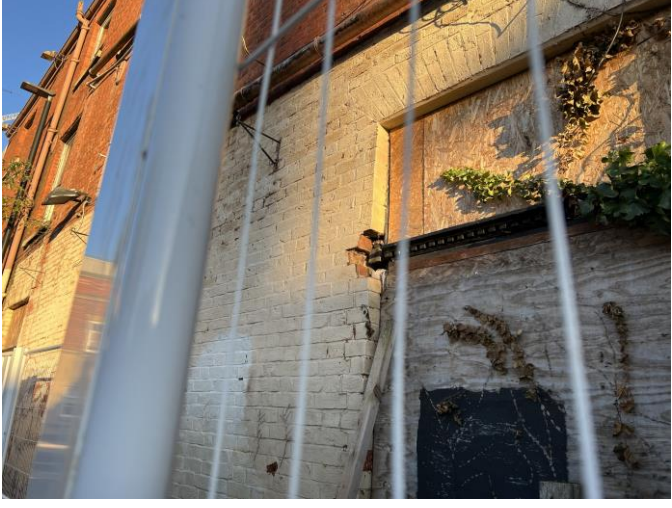
| 11. | View of dislodged bricks adjacent to a window. | |

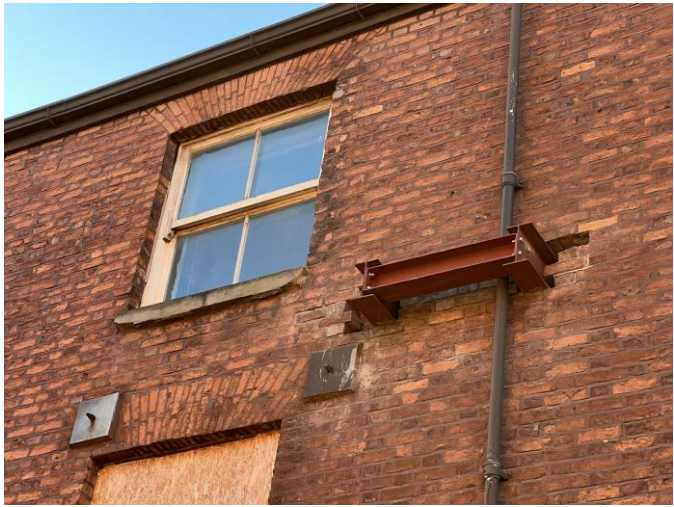
| Item | Location | Element | Description of area | Repair method |
|---|---|---|---|---|
| 34. | Façade | Sandstone cills. | There are isolated cills which would benefit from a small indent (dutchman's repair), to prevent further degradation. | See Appendix A – A9 |

| 13. | View of penetration accommodating structural steel and deteriorated cill. | |

| Item | Repair description |
|---|---|
| A9 – Dutchman indent repairs to stone | <p>Note: All workmanship to be carried out in accordance with BS 8221-2:2000. <b>Allow approximately 10m2 to undertake sufficient indent repairs.</b></p> <p><u>Preparation</u></p> <ol style="list-style-type: none"> <li>1. Identify the type of stone that is to be repaired and provide an appropriate sample for approval of the Heritage Surveyor and Conservation Officer.</li> <li>2. Identify the unit of stonework to be repaired, giving an identification mark and producing a template and working drawing, for approval of the heritage surveyor and Conservation Officer.</li> <li>3. If repairing stone, identify the natural bed, ensuring it is vertical and at right angles to the wall face (joint bedded).</li> </ol> <p><u>Preparation of Stone Unit</u></p> <ol style="list-style-type: none"> <li>1. Using hand tools only, work the exposed stone and joint faces of each replacement stone to a square and true surface, working the face to a true architectural profile compatible with adjacent existing work, forming out of solid stone and avoiding mitred joints.</li> </ol> <p><u>Preparation to existing stone unit</u></p> <ol style="list-style-type: none"> <li>1. Using the approved template and identification marks, using hand tools, carefully cut out defective stone until structurally sound material is reached and an adequate bond can be achieved, leaving cavities cut square and taking great care to avoid damage to retained faces and arrises.</li> <li>2. Wash down cavities and arrises using low pressure water to leave clean.</li> </ol> <p><u>Laying stone indents</u></p> <ol style="list-style-type: none"> <li>1. Lay the new solid stone indent piece on a full even bed of mortar, joints are to be kept as fine as possible, commensurate with forming sound joints using stone adhesive for tacking purposes.</li> <li>2. Mortar mix is to be the same as specified within 'A5 - Isolated pointing repairs to external elevations'.</li> <li>3. Stone adhesive should not be used in a continuous film, as to not impair the water circuitry of the stone.</li> </ol> |

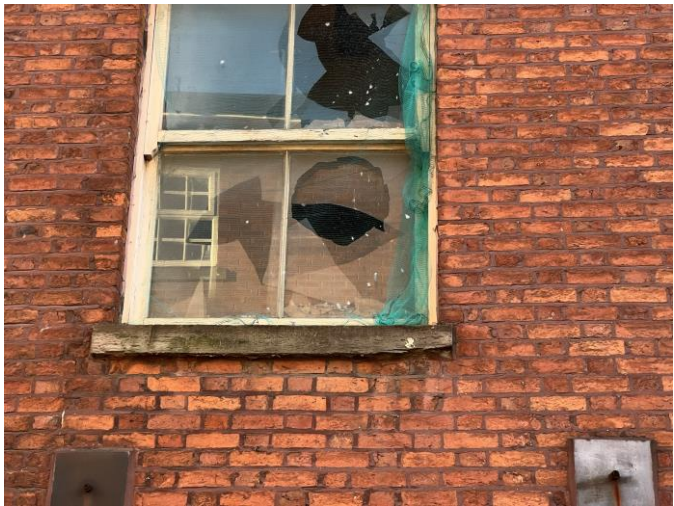
| 14. | View of deteriorated cill. | |

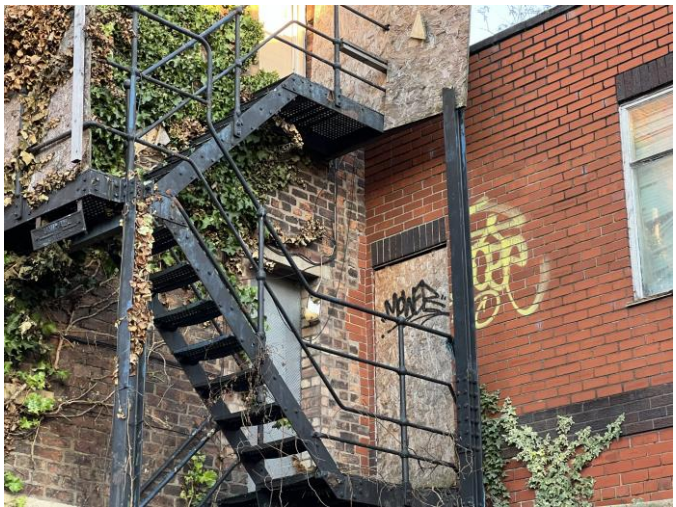
| 16. | View of ivy and toothed in brickwork. | |
