# Blackley Fire Station, Blackley

## Phase 1 Geo-Environmental Investigation

For: Greater Manchester Combined Authority (GMCA)

Ref: 3866b-01  
Job: 3866b  
Rev: A  
By: LM

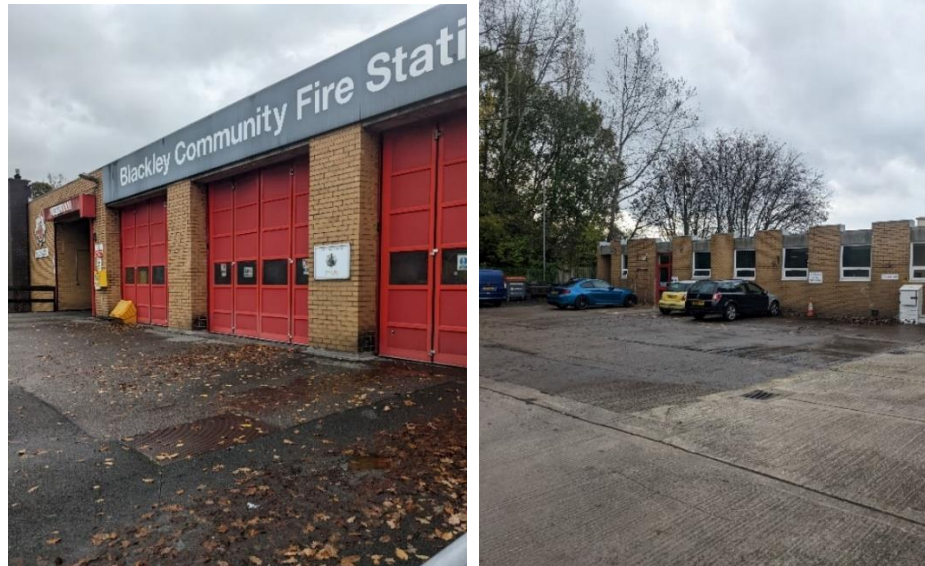
The site currently comprises a fire station with various facilities, including crew accommodation, offices, appliance storage and car parking. The fire station is a single storey masonry building with a basement across the majority of the site. The basement was inaccessible during the walkover survey thus its extent could not be clarified. The ground underfoot was noted to be hardstanding, with some grassed areas along the eastern and southern site boundaries.

Figure 2: Photographs of the outer site section looking towards the north (left) and inside (right) section, facing south-west.

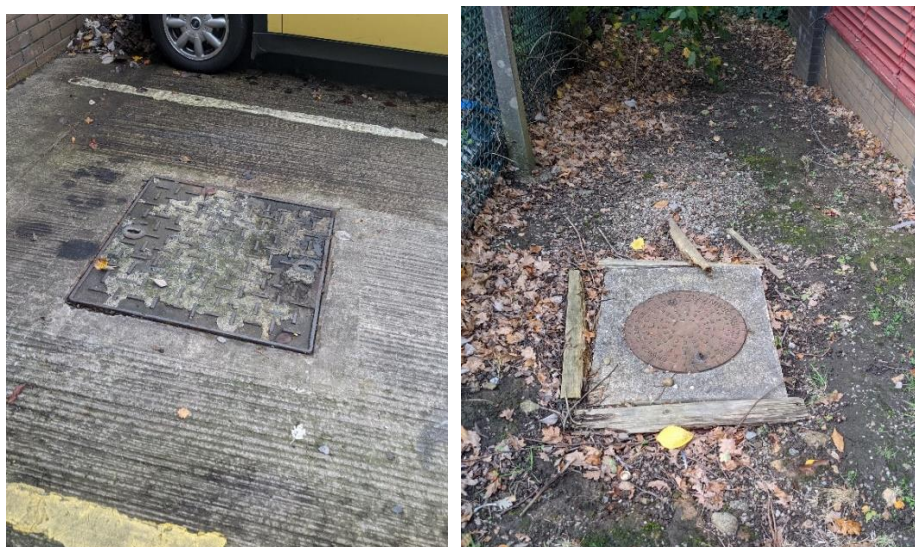
Services were noted to be present across the site, including numerous manholes enabling access to water networks. A sub-station for electric installations was noted in the southern site section along the southern station wall.

Figure 3: Photograph showing the service access points for water across the site, in the central site section (left) and along the southern boundary (right), with the electricity sub-station visible above the manhole (red).

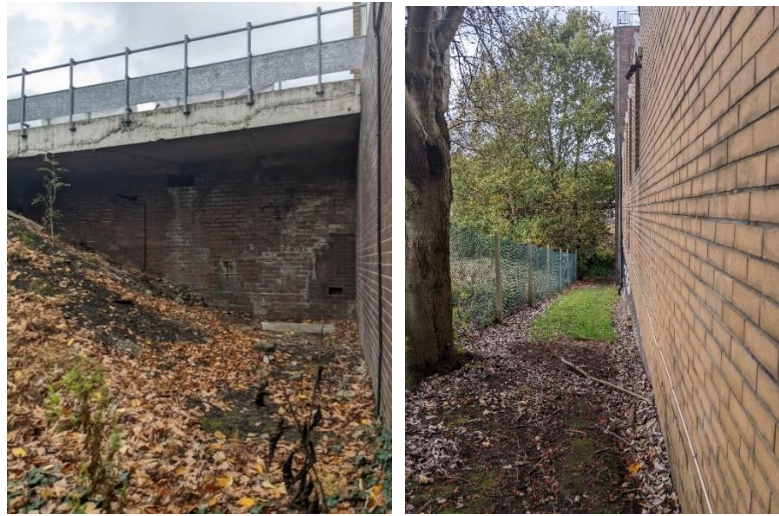
Relatively steep slopes were noted during the site walkover along the northern, western and eastern site boundaries, with these being steep downward slopes of the approximate gradients of 1:1 to 1:2.5 from 79.70m AOD to 77.10m AOD, and a very gentle upward slope along the eastern site boundary, with a gradient of approx. 1:3 from 81.00m AOD to 85.00m AOD. The slopes appear to be predating the construction of the fire station and are anticipated to be associated with the construction of Rochdale Road to the west.

Figure 4: Photographs showing the steep western slope along the western site boundary with the basement wall, looking north, with a pedestrian bridge across the slope (left) and a gentle slope along the southern site boundary, looking west (right).

| <b>Slope Stability</b> | Steep slopes are present along site boundaries. The slopes are most prominent along the western site boundary, possibly associated with the construction of Rochdale Road. The slope gradients are between 1:1 and 1:2.1 (approx. 2.00 - 2.60m tall) in the western site section, and 1:3.1 (approx. 4m tall) along the eastern boundary, where they become gentler. | A relatively rapid outward and downward movement of a mass of rock or soil on a slope due to the force of gravity. Typically slope instability is caused by either a decrease in soil strength or an increase in shear stress. Numerous factors are involved but usually loading on or at the crest of the slope, increasing the amount of water entering the slope or cutting at the toe of the slope cause failure. Damage by landslide can occur through the removal of supporting ground from under structures, externals or services or by the movement of material onto property. | <b>Moderate to High</b> |

- 5.8 Due to the presence of established trees along site boundaries and the presence of cohesive deposits, an arboricultural survey is recommended.
- 5.9 It is recommended that a slope stability assessment is undertaken along the site boundaries to ensure safety for the site redevelopment following demolition.

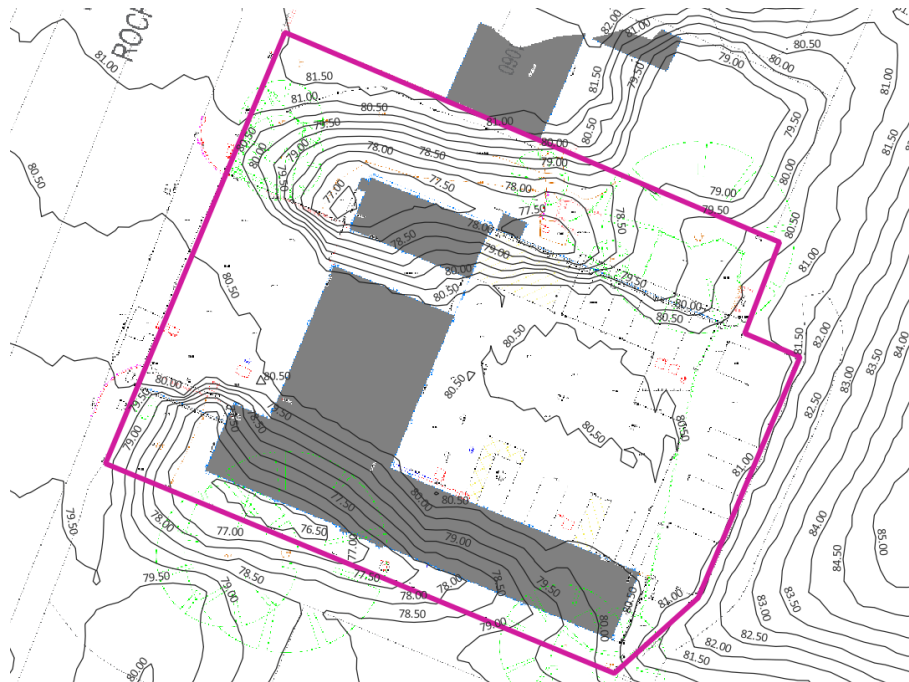
Figure 5: Extract of LiDAR imagery with the steep 1:1 and 1:2.1 slopes along the western site boundary to the east of Rochdale Road, as well as gentle 1:3.1 slopes along the eastern boundary.

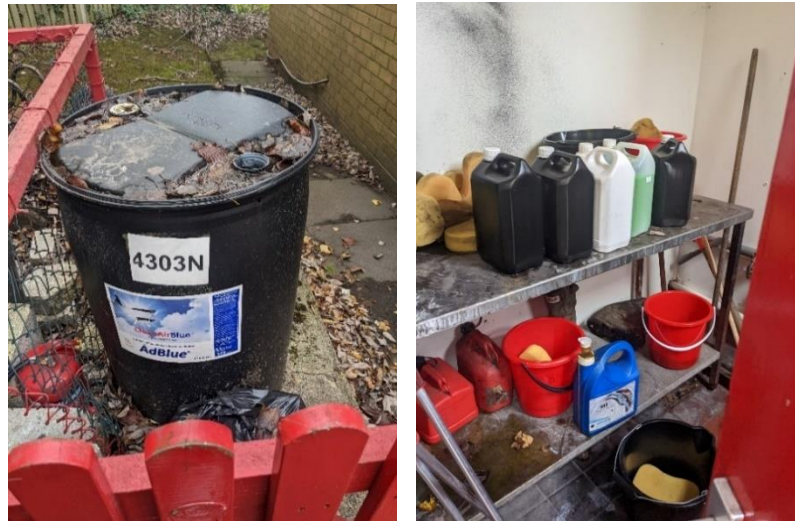
No evidence of contamination (i.e. spillages or leakages) were identified, however, potential contaminative sources have been noted on-site, with AdBlue drums and cleaning supplies noted during the site walkover in the central site section. A training yard is present in the north-eastern site corner, where disused vehicles are used for firefighter training, potentially being a source of contamination on-site.

Figure 6: Photographs showing AdBlue drum (left) and a storage room containing various cleaning supplies (right), found in the central site section.

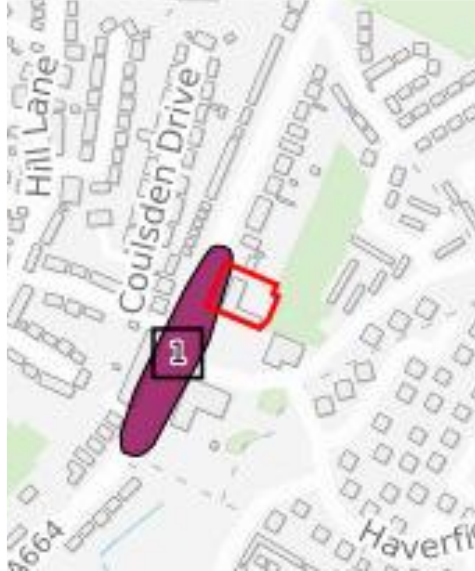
The BGS geological maps record Made Ground along the western boundary (dark purple on the below extract), anticipated to be associated with the construction of the Rochdale Road to the west of the site and possible on-site level adjustments.

Figure 9: Extract showing the location of the Made Ground (Dark purple).

| Factors | Remarks | Considerations | Risk |
|---|---|---|---|
| <b>On-Site Made Ground</b> | Widespread Made Ground is anticipated on-site, as well as the nearby BGS records noting an area of Made Ground off-site. Deep Made Ground is possible along the western site boundary associated with the construction of Rochdale Road. | Made Ground may settle variably, have highly inconsistent bearing capacity and may suffer significant movements that may be problematic for foundations, externals and infrastructure elements without treatment. The presence of Made Ground may be problematic for foundations as there may be loose / soft spots within the Made Ground and it may not be suitable to utilise traditional foundations. | <b>Low to Moderate</b> |
