Gazetteer  
November 2004

## **GAZETTEER**

### **Victoria Baths**

## Listed Building Description

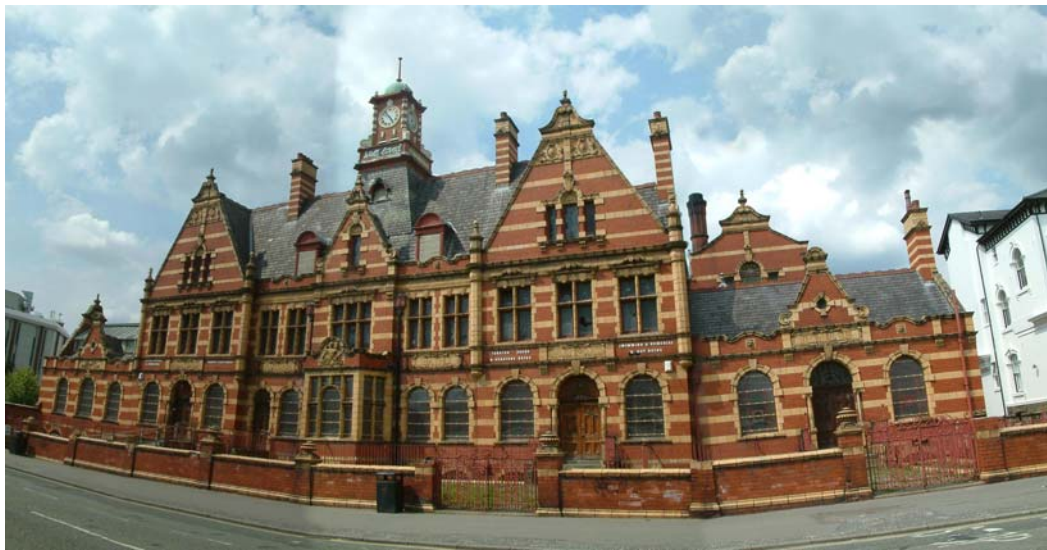
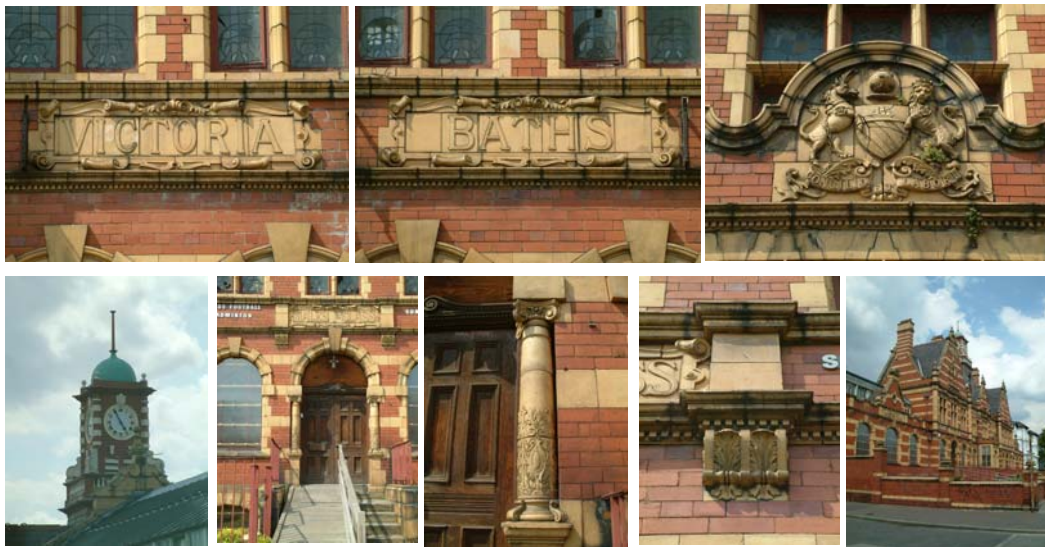
**GAZETTEER NO: EX1**

The condition survey has identified a series of problems with the roof, walls and foundations of this element.

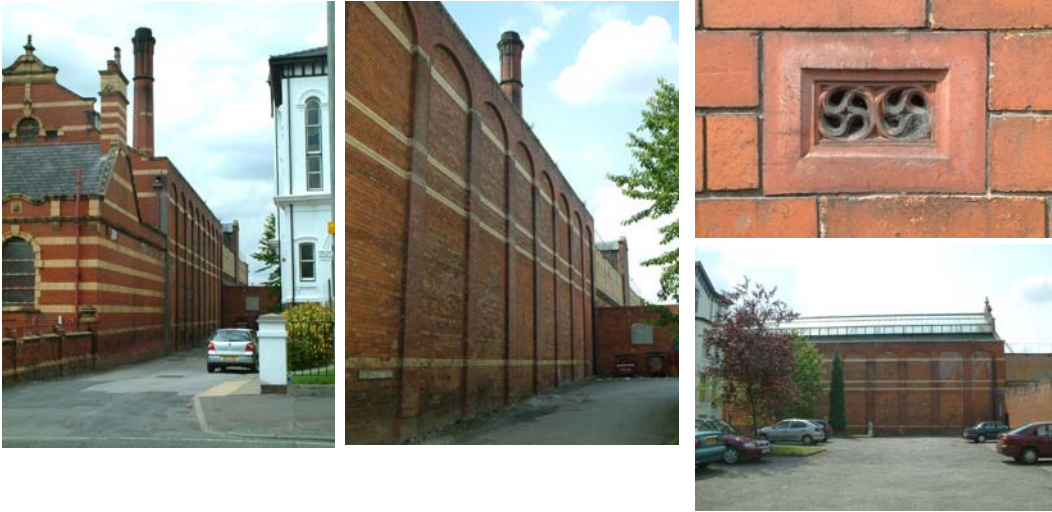
| <p><b>Vulnerability:</b><br/> The condition survey identifies problems with steelwork to the pool halls, settlement to the SE corner and rainwater failures amongst other defects.</p> | |

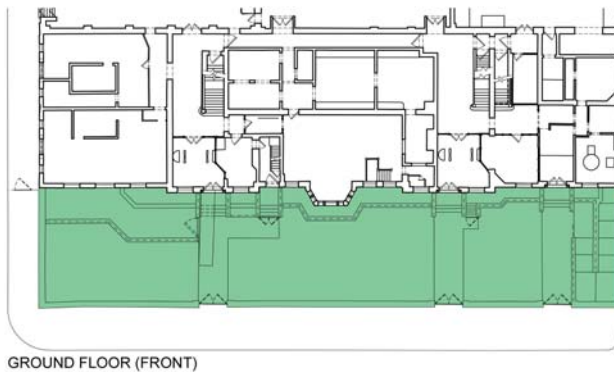
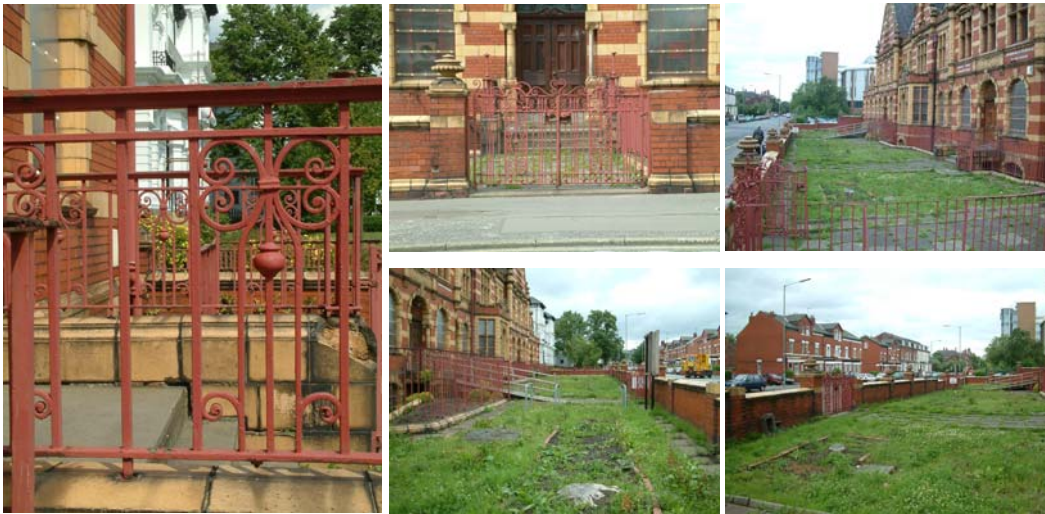
**GAZETTEER NO: EX5**

The walls, copings, gate piers and caps, gates and railings are all in very poor condition.

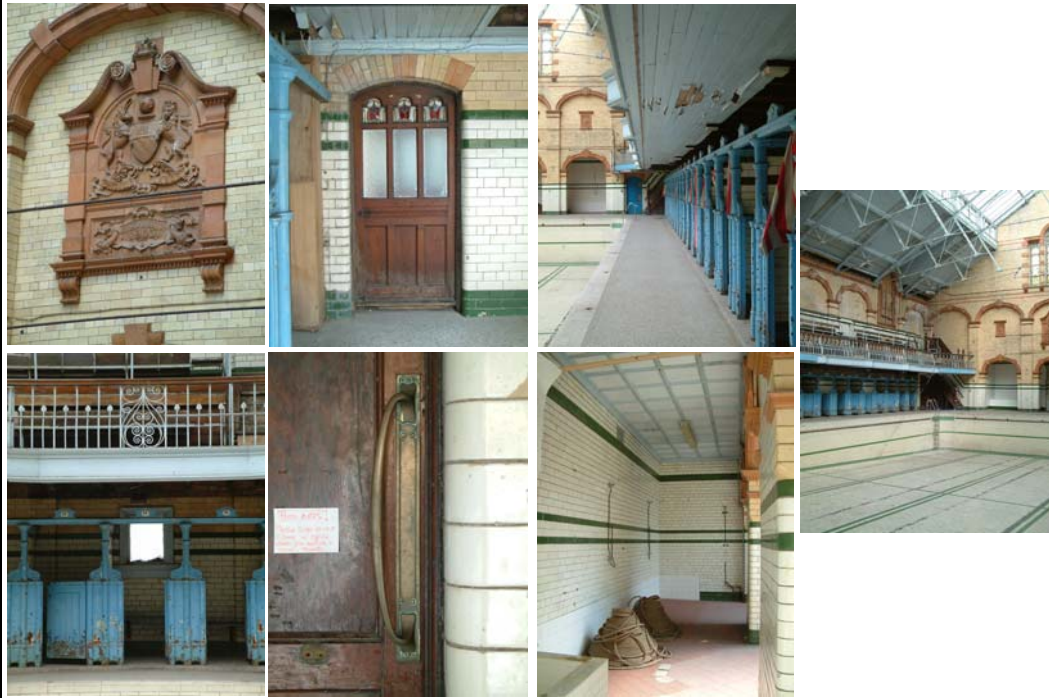
**GAZETTEER NO: G4**

The future of this magnificent pool hall is unclear. It is faced with structural defects, maintenance problems and the difficulty of upgrading the facility to contemporary standards.

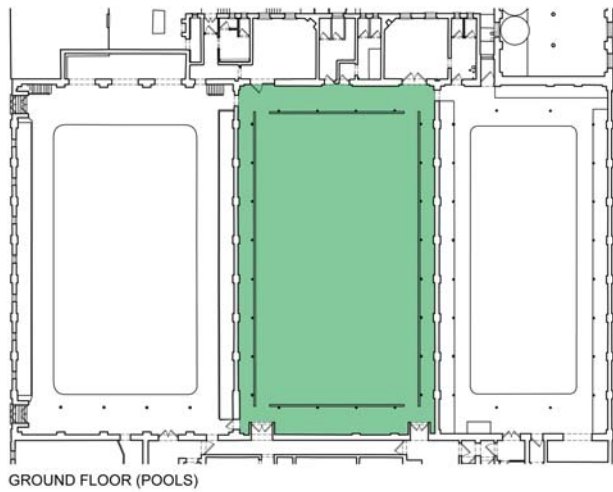
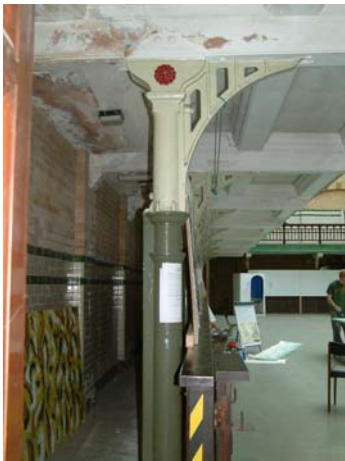
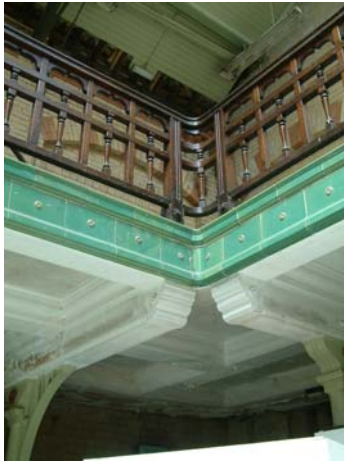
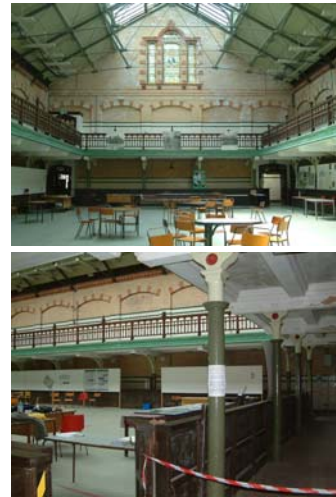
**GAZETTEER NO: G10**

The appropriate reuse for this large open volume is difficult to determine. This, with the condition of the structure makes this hall one of the most threatened spaces.

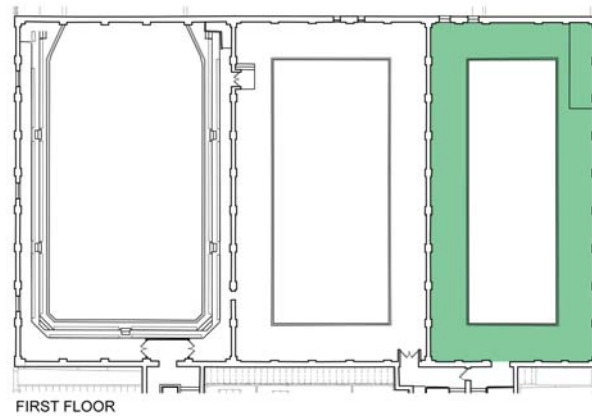
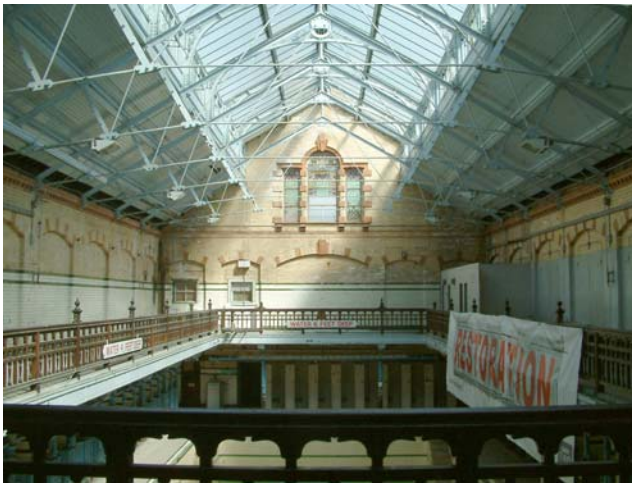
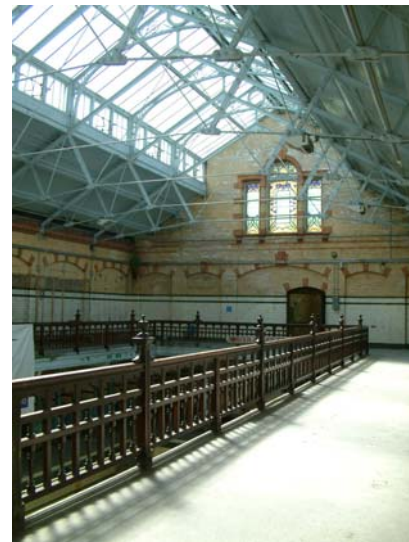
**GAZETTEER NO: G15**

This pool is the most complete of the three pool halls. It is also the most threatened given its remoteness from the Turkish Baths. The gallery is structurally failing and will require removal. Reconstruction is possible.

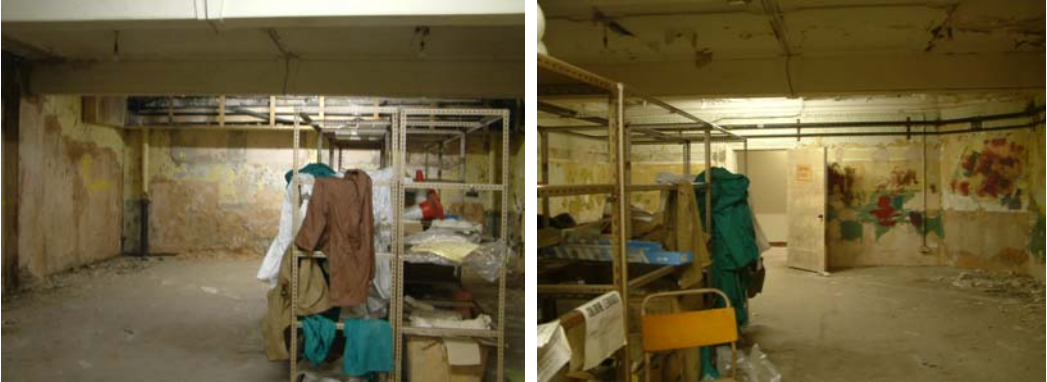
| <p><b>Vulnerability:</b><br/>Low – The wood block floor is susceptible to moisture.</p> | |

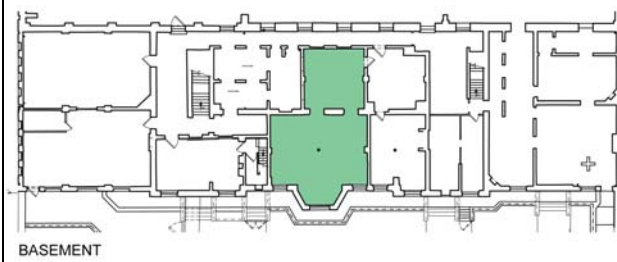
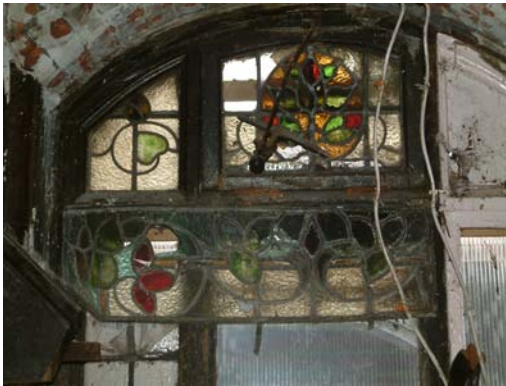
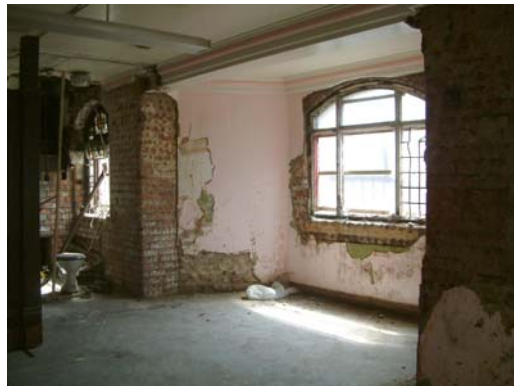
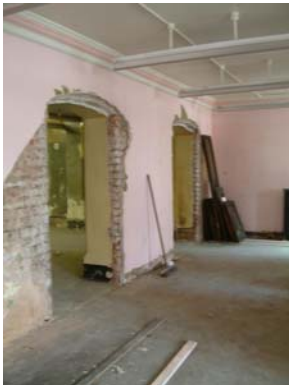
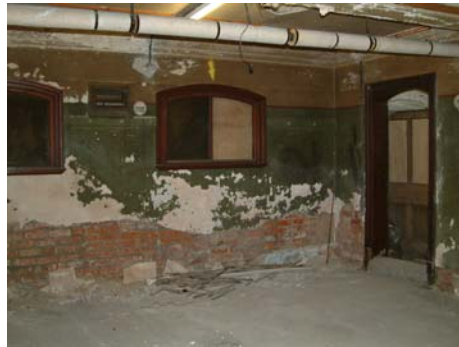
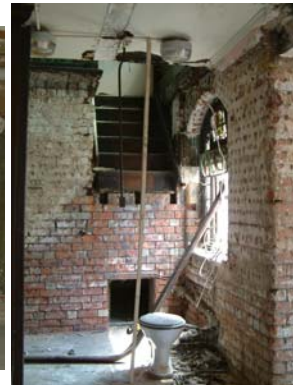
**GAZETTEER NO: B9**

The timber fixtures and fittings suffered from dry rot but are now away from the damp masonry. This is an important part of the Turkish Baths.
