job title Abraham Moss Leisure Centre

job no. 1620005164

| purpose SITE VISIT TO INSPECT GAS MEMBRANE INSTALLATION | |

## Verification Report

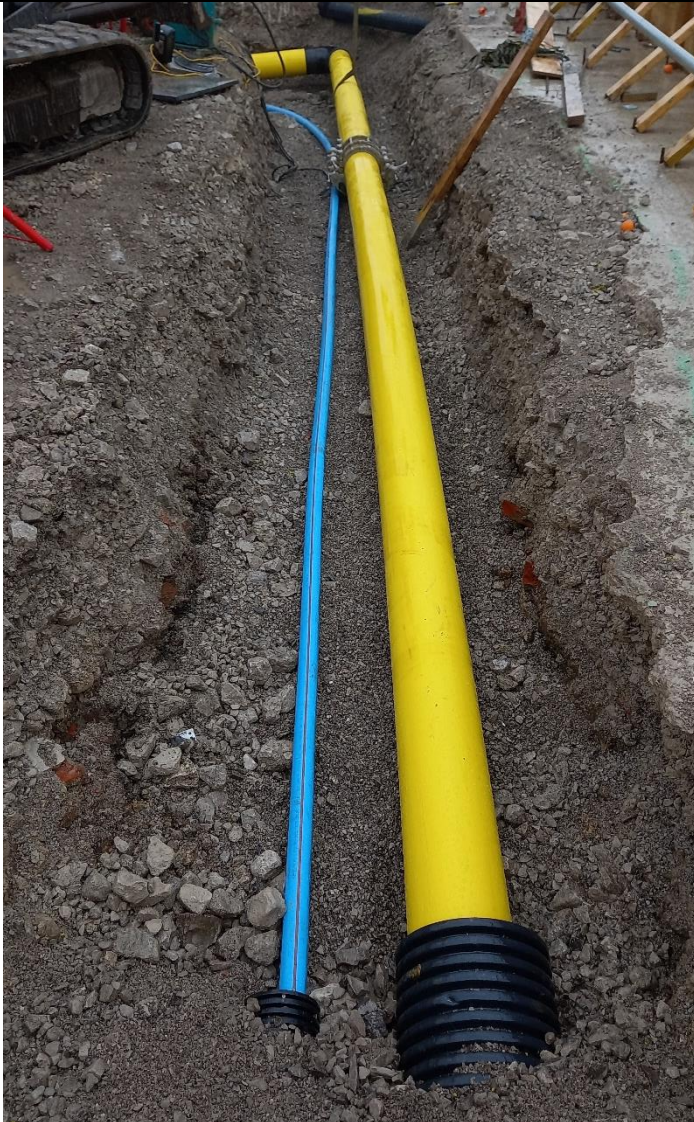
*Photograph of the water barrier pipe crossing the site with the building footprint on the right. The route is roughly crossing the site in a north-easterly direction.*

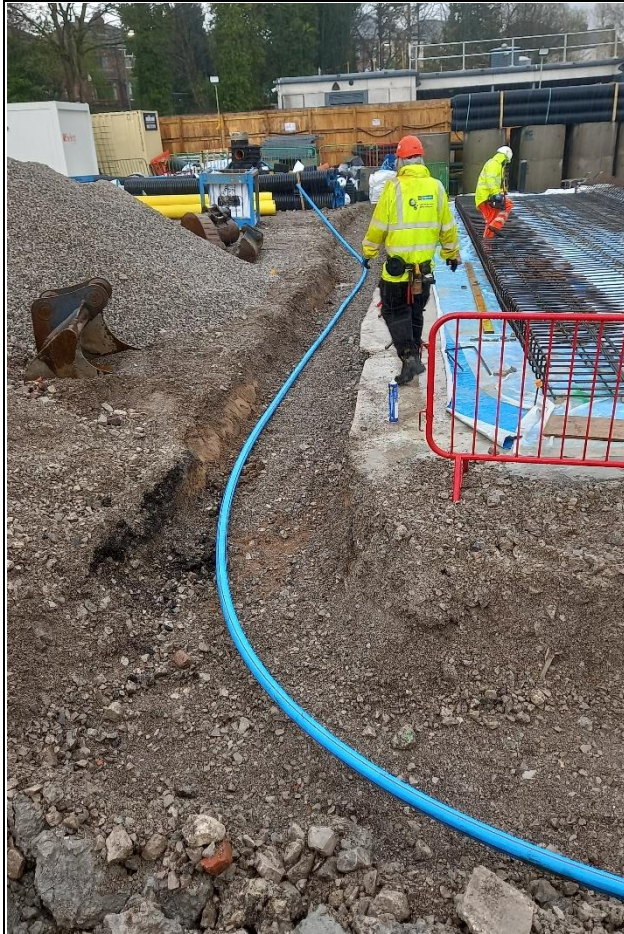
*Photograph showing the proposed route for the water barrier pipe, which is adjacent to the building footprint (on the right). The photograph is taken facing the north-east.*

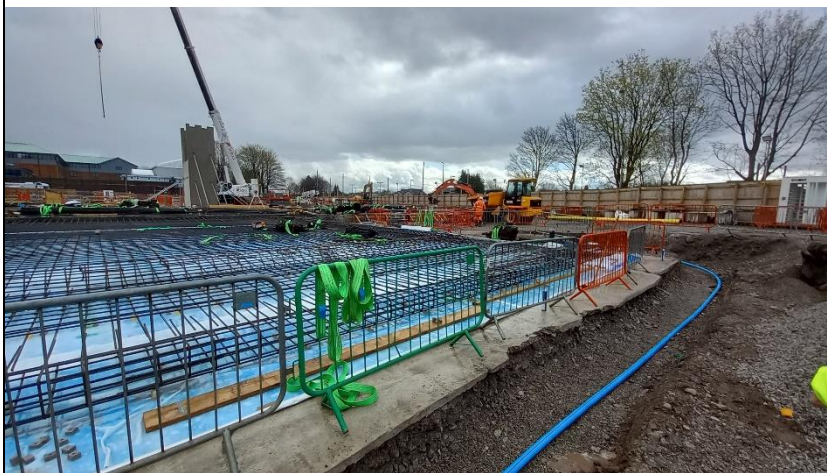
*Photograph of the water pipe route facing the south. Building footprint is visible on the left.*

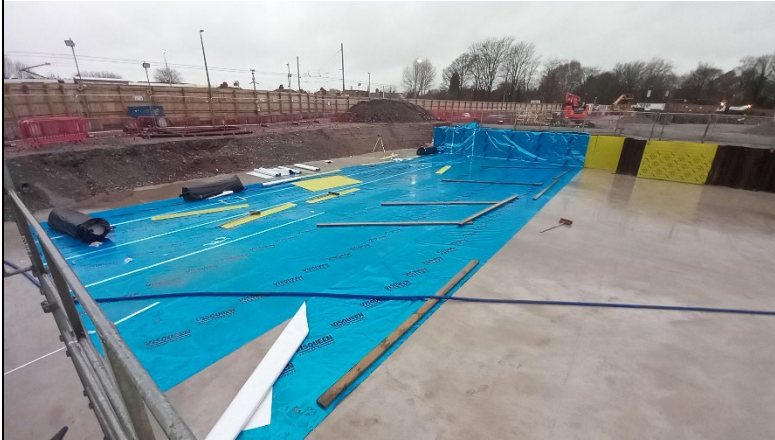
*Photograph showing the area with Visqueen Gas Barrier membrane requiring resealing due to the weather. Photograph taken of the Basement Area, facing the west.*

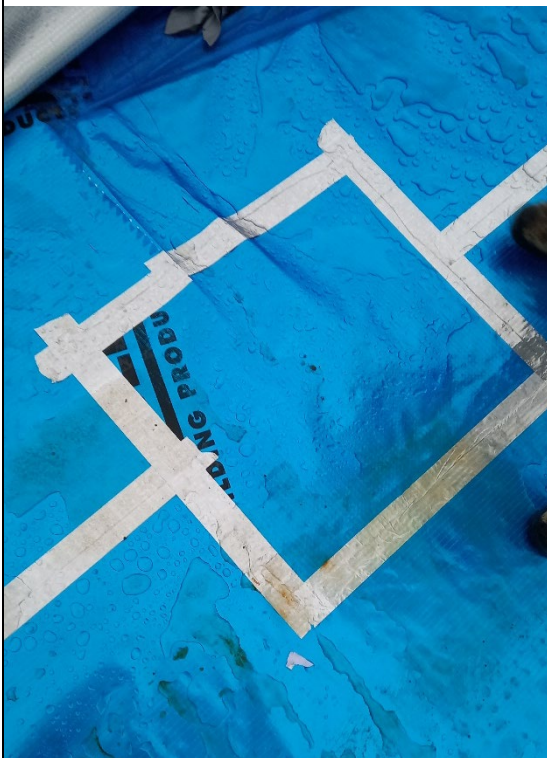
*Photograph showing the area of repair of the membrane within the Basement Area.*

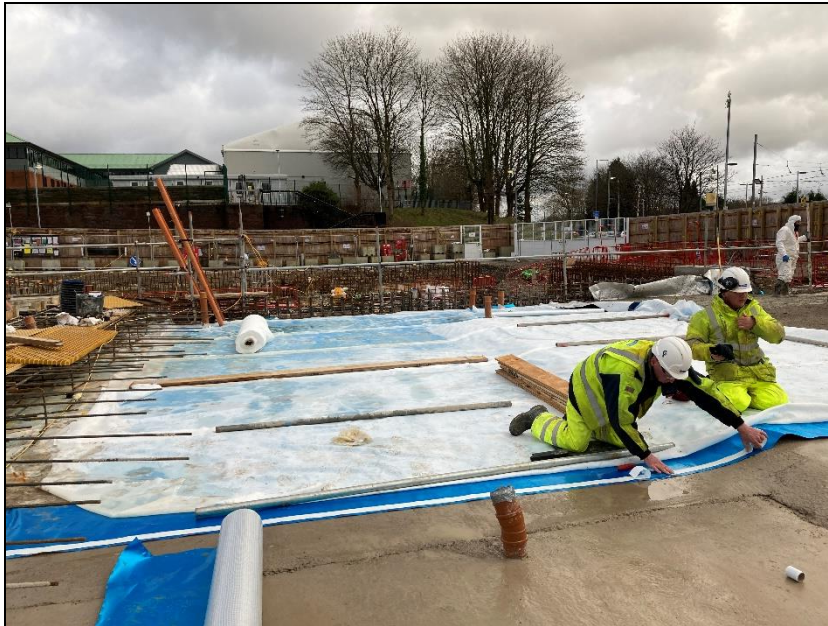
Photograph showing the area with Visqueen Gas Barrier membrane in process of installation in the central upper raft area of the site (dated 14<sup>th</sup> February 2022), prior to Ramboll site attendance. Photograph taken facing south-east.

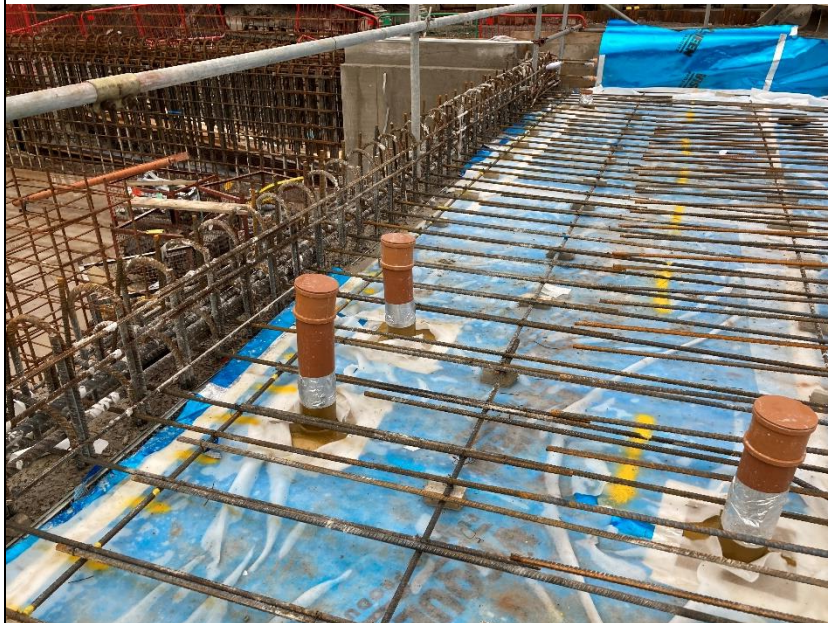
Photograph of a service pipe entry seals around the service ducts in the upper raft area. These were further sealed with GR foil lap tape

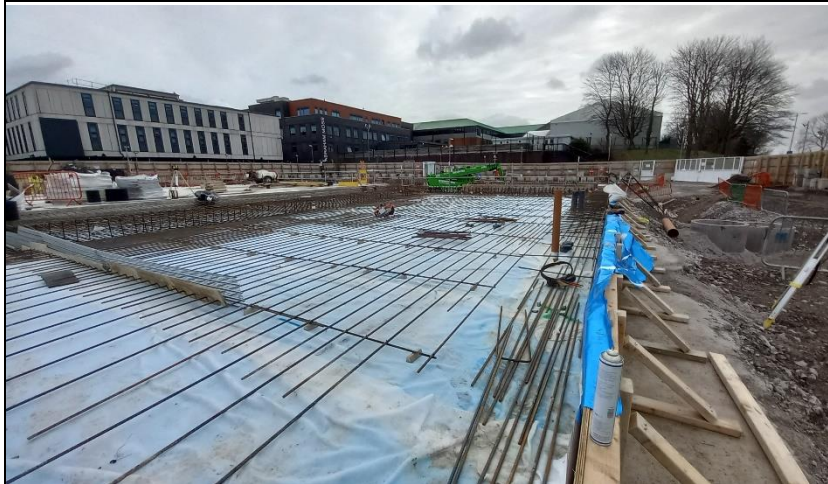
Photograph of the completed membrane installation, awaiting the concrete pour in the upper raft area. Photograph taken facing the east.

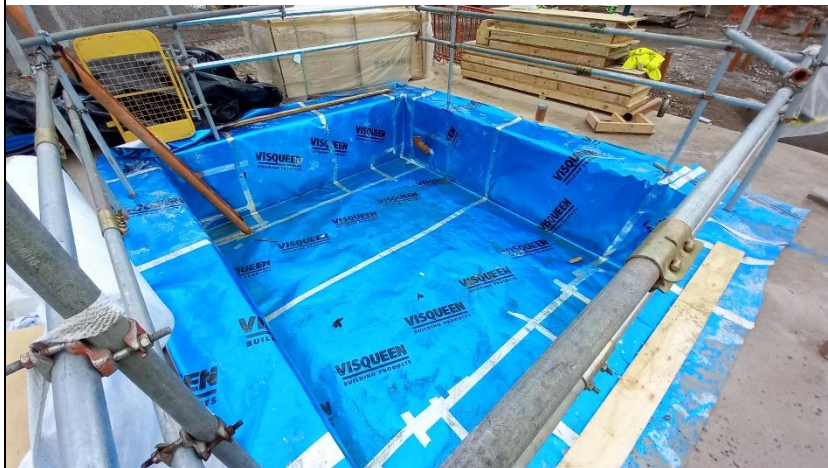
Photograph of the elevator shaft area lined and sealed with the Visqueen membrane. A service penetration at the top of the image is still requiring sealing.

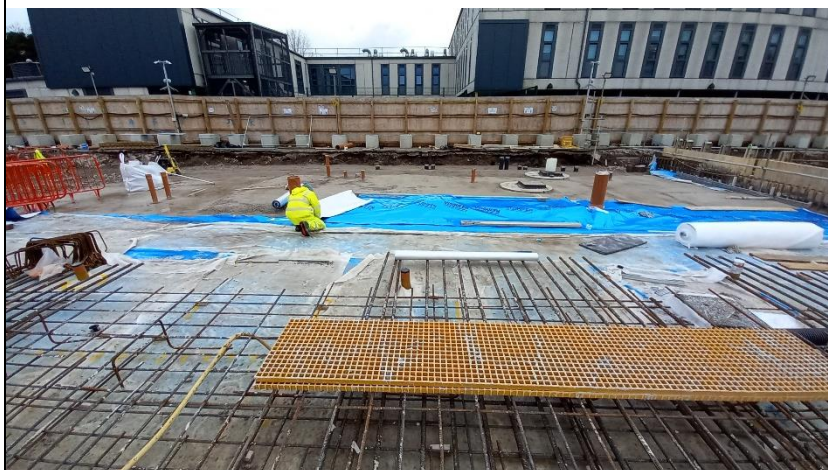
Photograph of the membrane installation underway towards the north-eastern site boundary. The membrane is laid down in strips. Photograph taken facing the north-east.

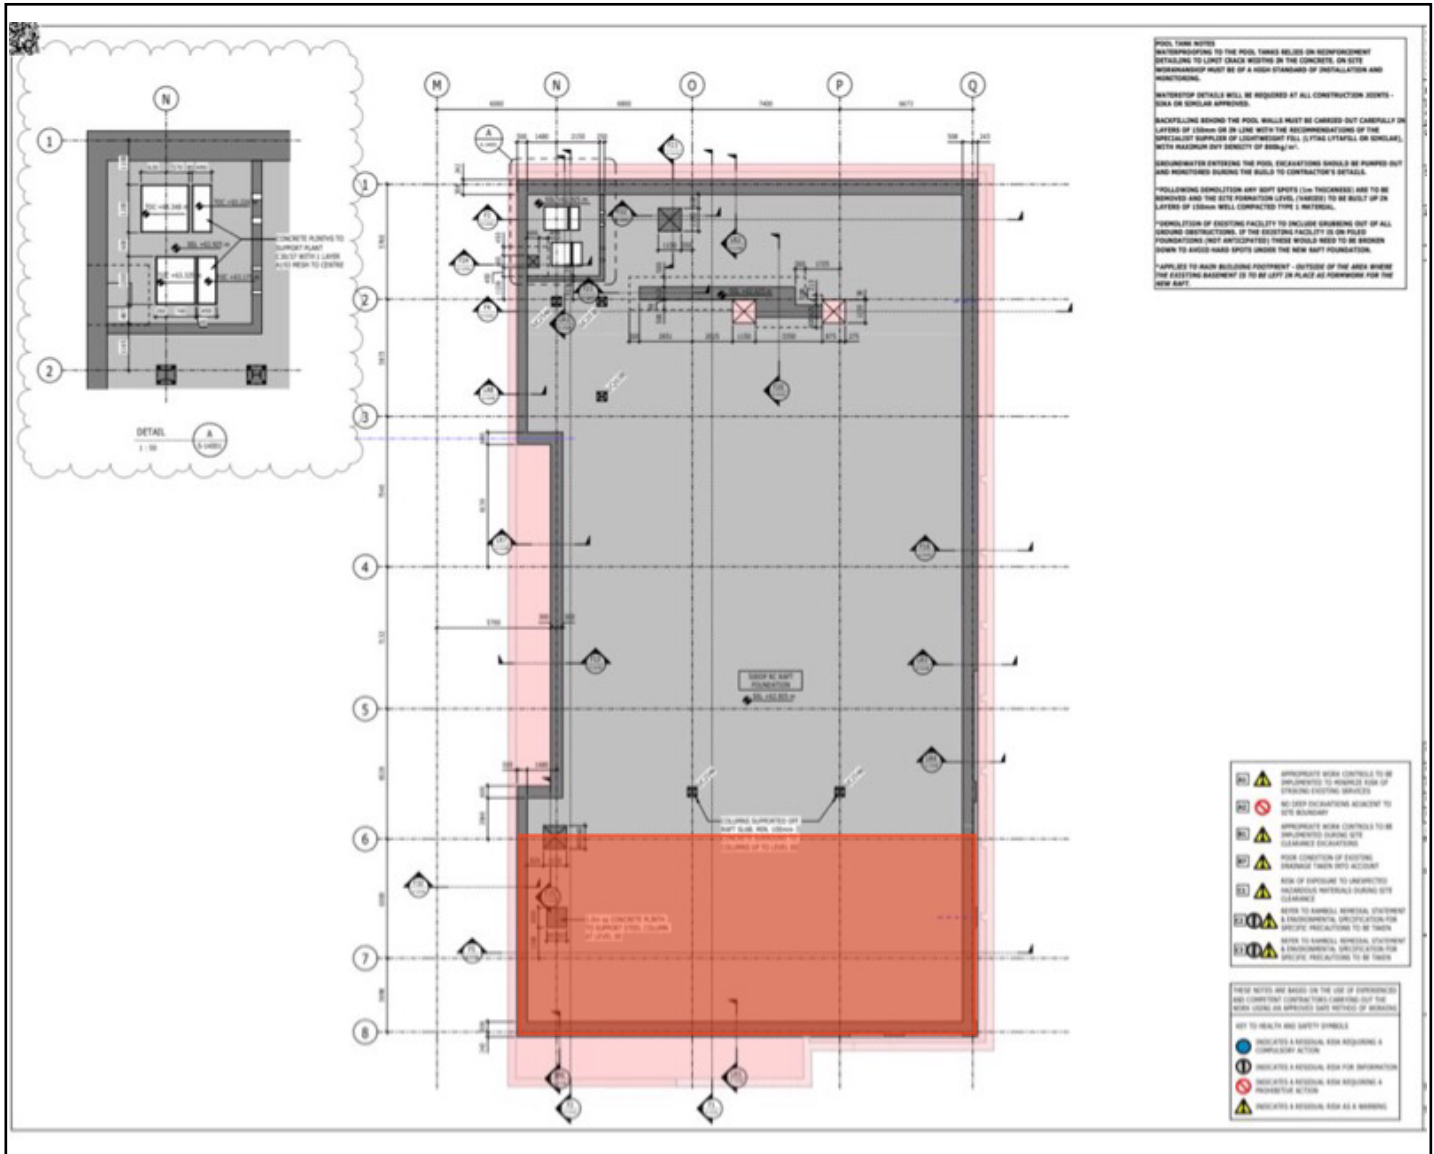
Grid lines 6-8/(M/N)-Q

The area highlighted red above is where verification took place during this visit.

Pour one within the basement slab.

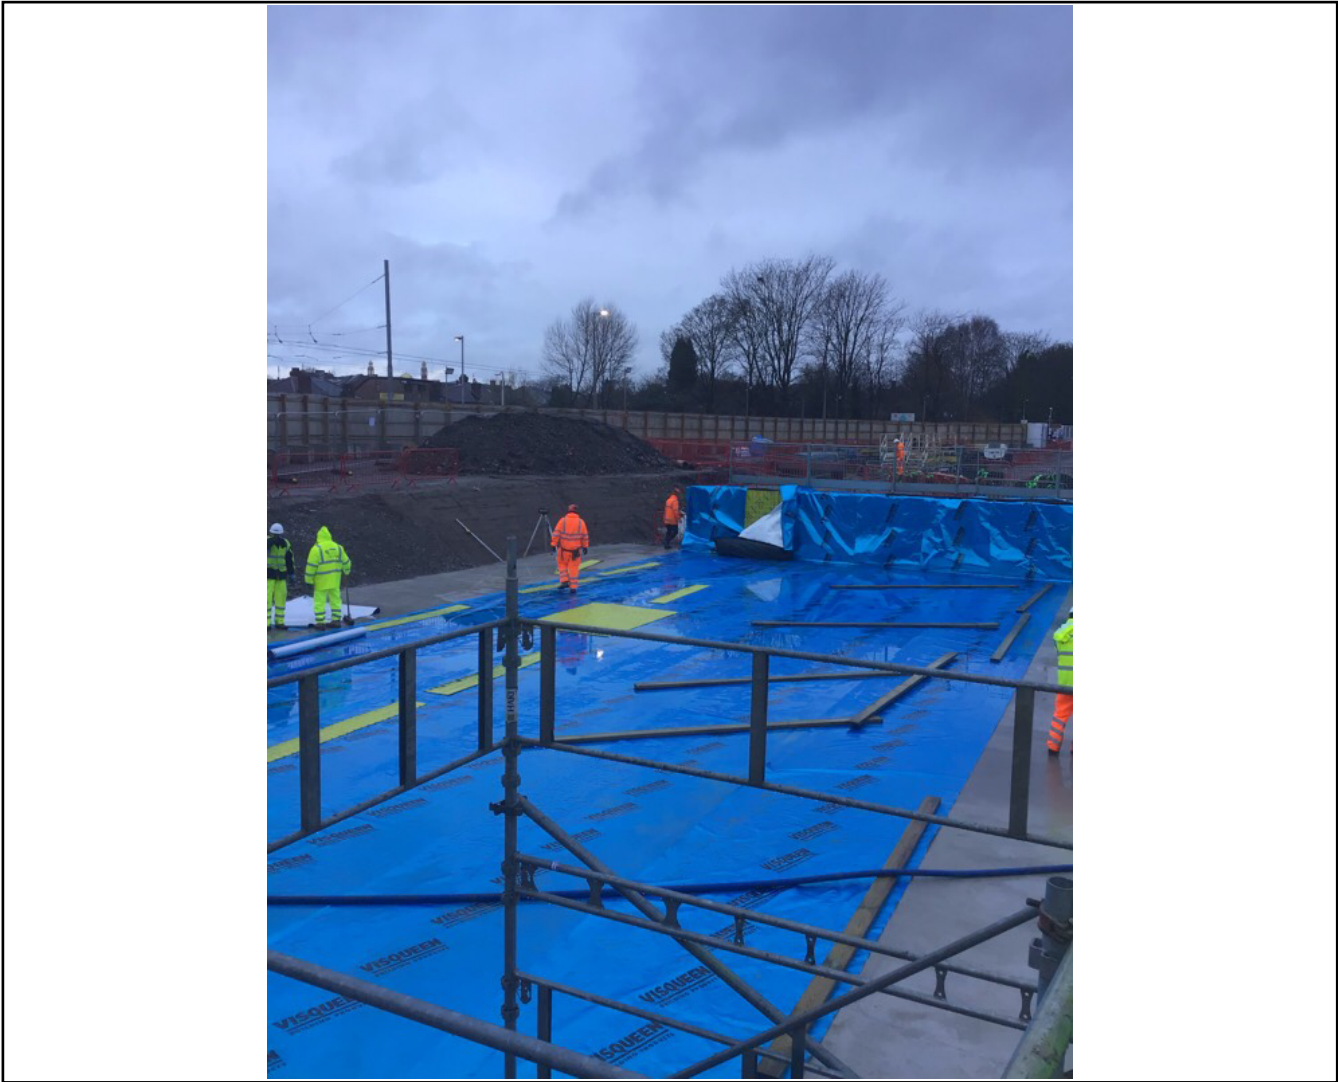
Overview photograph of the area verified during this visit.

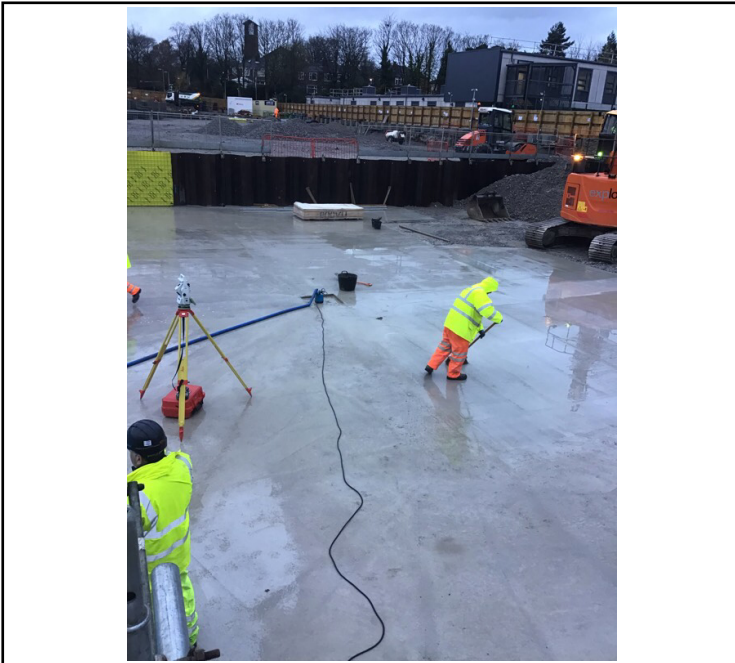
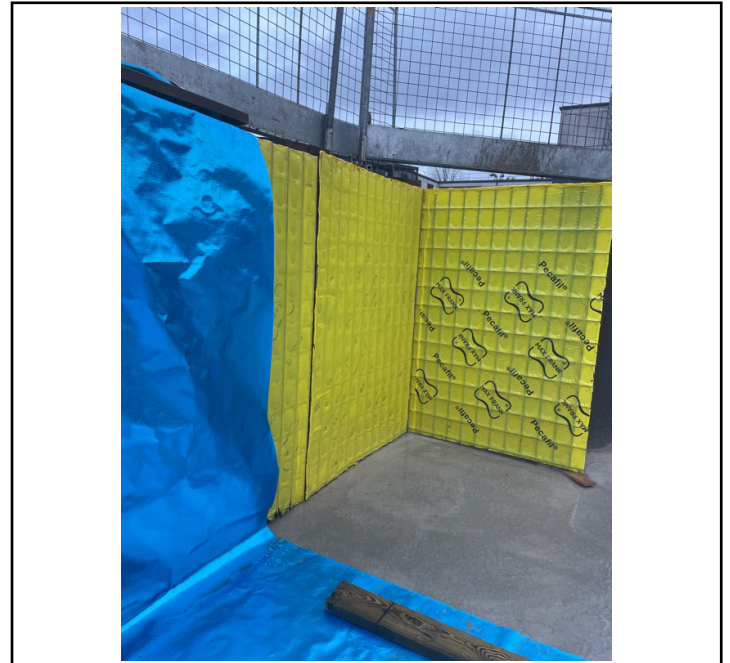
LOCATION/GRID LINE: Basement slab.

The below photographs display the preparation to the areas requiring gas membrane installation. The photograph on the left shows the smooth concrete blinded surface being swept clear of surface water prior to gas membrane application. The photograph on the right

right shows the sheet piles that have received pecafile sheets which has achieved a flat surface for the Visqueen standard gas barrier to be returned up and over the wall.

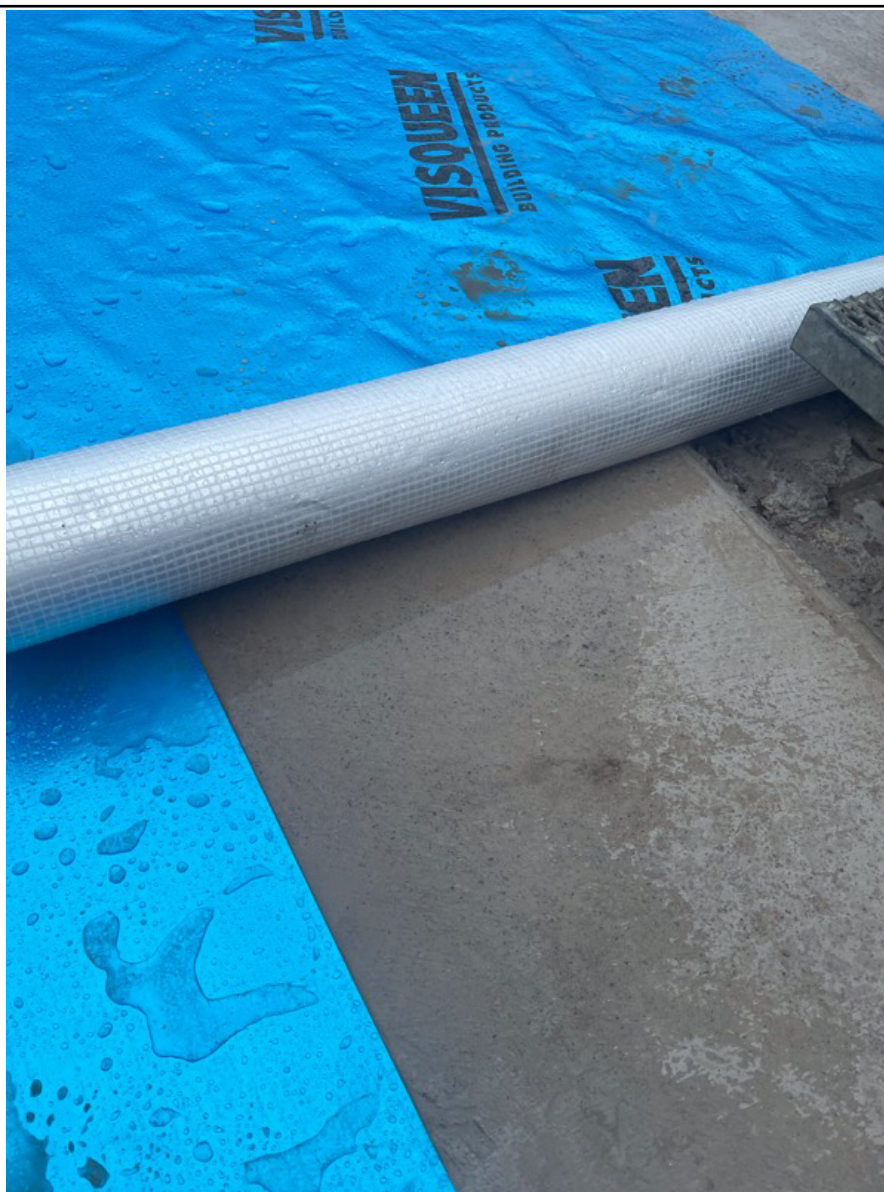
The above photograph displays the smooth concrete blinded surface the Visqueen standard gas barrier has been installed upon. The surfaces have been swept clear of any debris which cause potential damages from beneath the membrane and swept clear of surface water so lap joints can be successfully sealed, adhering the sheets together.

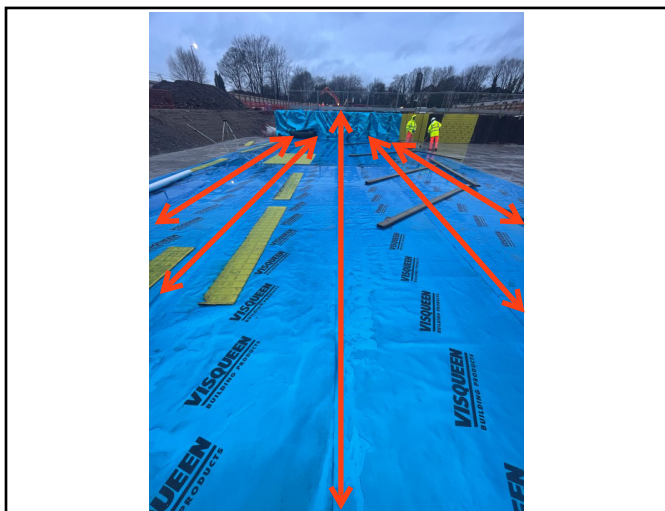
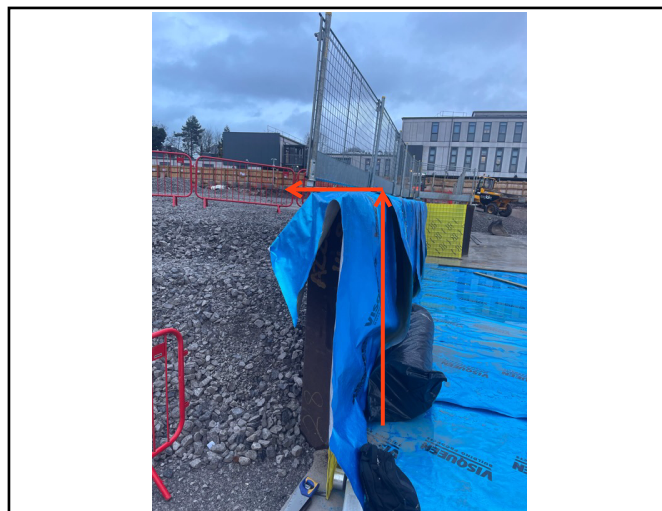
LOCATION/GRID LINE: Pour one - Basement slab.

The installation of Visqueen gas barrier has been installed across pour one within the basement slab. The annotations on the left highlight the successfully adhered lap joints within this installation prior to application of the single side foil lap tape.

All lap joints have been successfully sealed in accordance to manufactures specification. Visqueen ultimate double sided jointing tape has been applied between each overlap & sheet(s) of gas membrane. The photograph on the right shows the membrane applied up the peca-filled sheet piles with an overhang in excess of 150mm returning into the ground floor area so that adequate overlaps and joints can be achieved for future works.

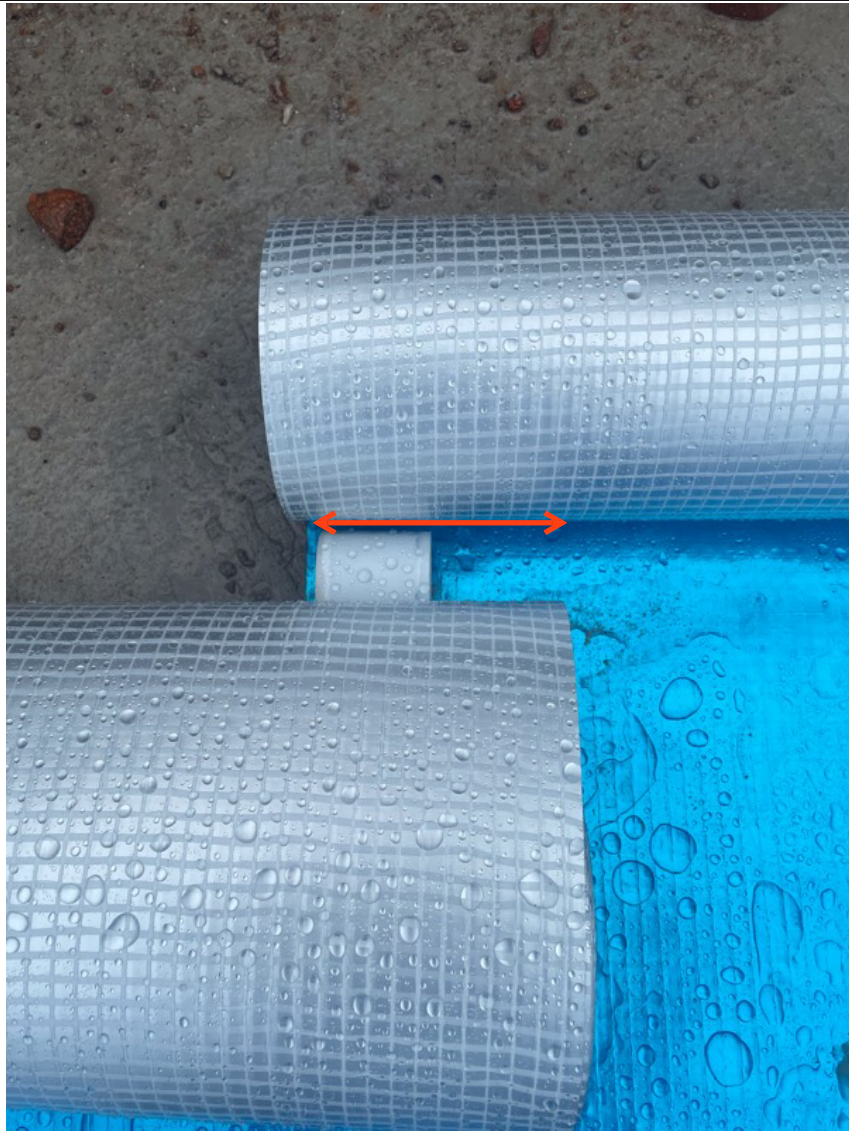
The above photograph displays a sufficient 150mm overlap in place between two sheets of Visqueen standard gas barrier membrane. Conforming to manufactures specification prior to adhering the two sheets together using VisqueenPro double-sided joint tape.
