## Arboricultural Report for

### Mortgage & Insurance

10 Malvern Grove  
Manchester  
M20 1HT

| REPORT DATE: | 20/09/2022 |

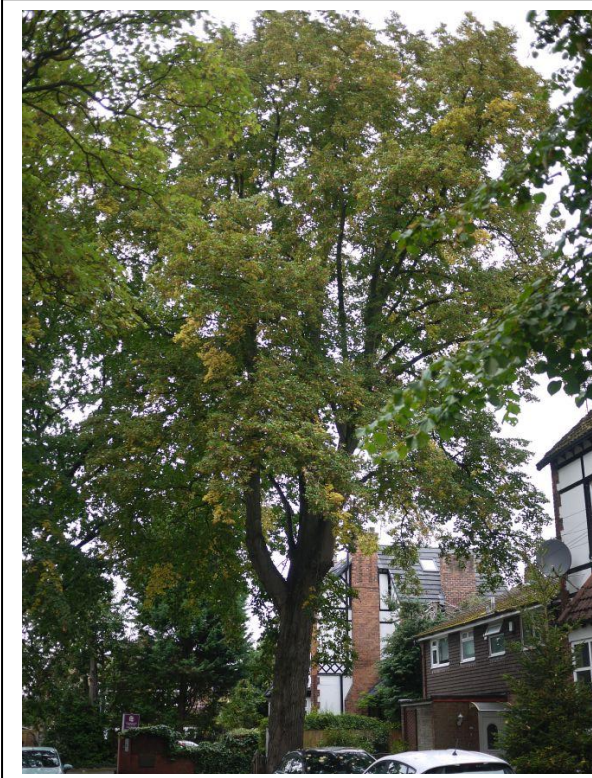
| Age Range | | Y - Young SM – Semi-mature EM - Early Mature M - Mature | | | | | | |
|---|---|---|---|---|---|---|---|---|
| T1 | Lime | 22 | 900* | 14 | 7.4 | Good | Mature | Local Authority |
| Observations & Management History | | No recent management noted. | | | | | | |

View of T1

| Age Range | | Y - Young SM – Semi-mature EM - Early Mature M - Mature | | | | | | |
|---|---|---|---|---|---|---|---|---|
| Recommendation | | Local Authority owned tree, beyond the control of the subject property | | | | | | |

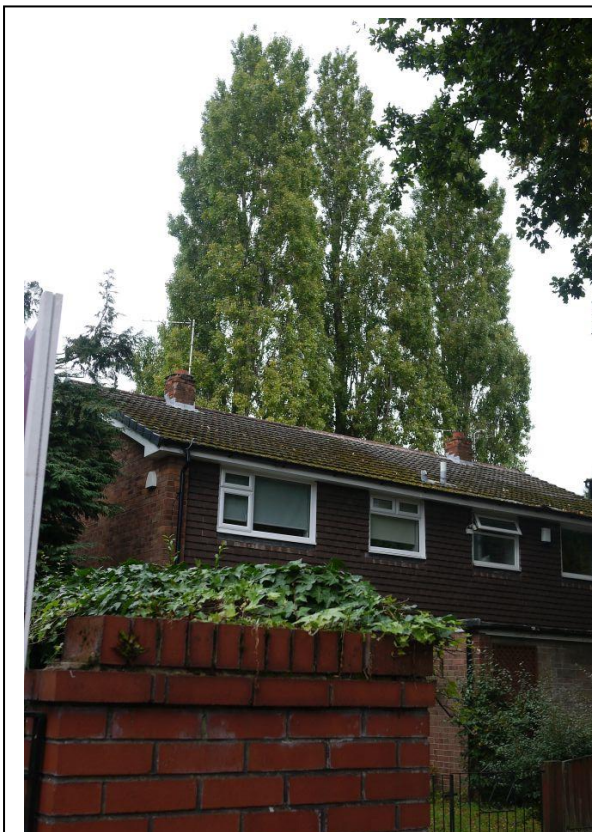
| Age Range | | Y - Young SM – Semi-mature EM - Early Mature M - Mature | | | | | | |
|---|---|---|---|---|---|---|---|---|
| T2 | Lombardy Poplar | 25 * | 1200 * | 8 | 7.5 | Good | Mature | Third Party |
| Observations & Management History | | No recent management noted. | | | | | | |
| T3 | Lombardy Poplar | 25 * | 1000 * | 7 | 8 | Good | Mature | Third Party |
| T4 | Lombardy Poplar | 25 * | 1000 * | 7 | 10 | Good | Mature | Third Party |

View of T2 – T4 from Malvern Grove

| Age Range | | Y - Young SM – Semi-mature EM - Early Mature M - Mature | | | | | | |
|---|---|---|---|---|---|---|---|---|
| Recommendation | | Third Party owned trees, beyond the control of the subject property | | | | | | |

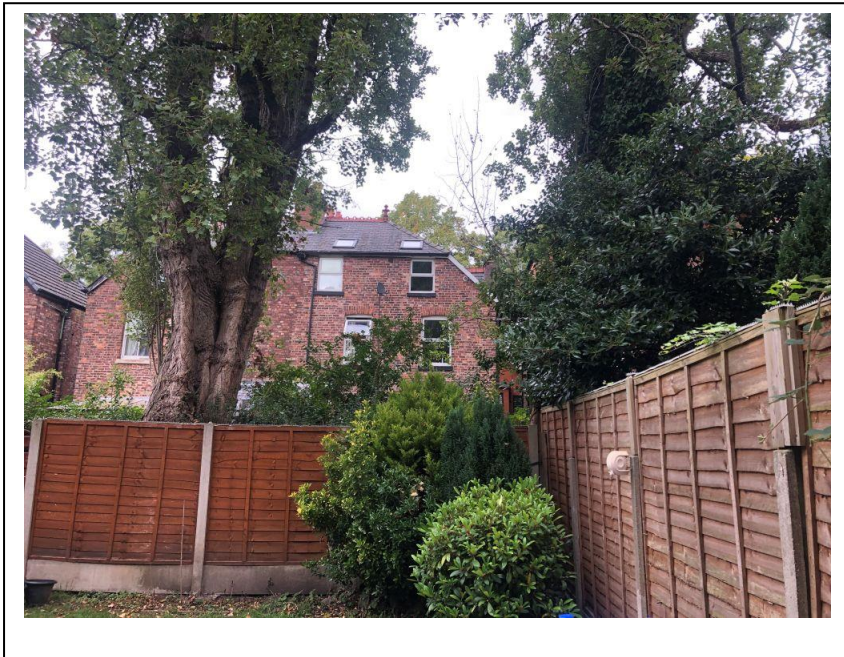
| Tree No. | Species | Height (m) | Dia. (mm) | Approx. Crown Spread (m) | Dist. to structure (m) | Condition | Age Range | Ownership |
|---|---|---|---|---|---|---|---|---|
| TG1 | Mixed coniferous group | 2 * | 50* | 3 | 6 | Poor | Young | Subject Property |
| Observations & Management History | | No recent management noted. | | | | | | |

View of T2 and TG1 from rear garden.

| Tree No. | Species | Height (m) | Dia. (mm) | Approx. Crown Spread (m) | Dist. to structure (m) | Condition | Age Range | Ownership |
|---|---|---|---|---|---|---|---|---|
| Recommendation | | Maintain close to existing dimensions by regular pruning | | | | | | |

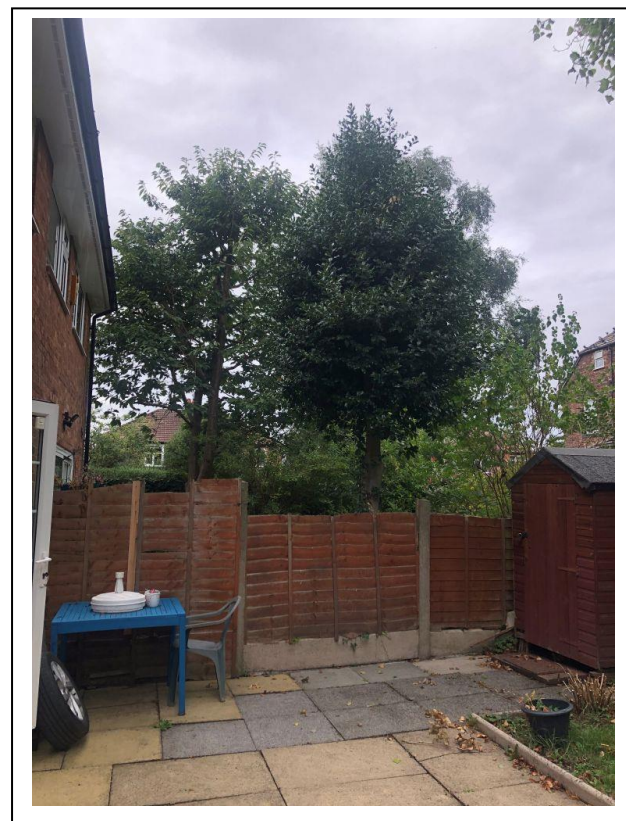
| Age Range | | Y - Young SM – Semi-mature EM - Early Mature M - Mature | | | | | | |
|---|---|---|---|---|---|---|---|---|
| T5 | Holly | 5 * | 200 * | 3 | 4 | Good | Semi-Mature | Third Party |
| Observations & Management History | | Recently reduced/pruned. | | | | | | |

| Tree No. | Species | Height (m) | Dia. (mm) | Approx. Crown Spread (m) | Dist. to structure (m) | Condition | Age Range | Ownership |
|---|---|---|---|---|---|---|---|---|
| T6 | Cherry | 6 * | 300 Ms * | 8 | 8 | Good | Semi-Mature | Third Party |
| Observations & Management History | | Recently reduced/pruned. | | | | | | |

View of T6 and T5

| Age Range | | Y - Young SM – Semi-mature EM - Early Mature M - Mature | | | | | | |
|---|---|---|---|---|---|---|---|---|
| Recommendation | | Third Party owned trees, beyond the control of the subject property | | | | | | |

| Tree No. | Species | Height (m) | Dia. (mm) | Approx. Crown Spread (m) | Dist. to structure (m) | Condition | Age Range | Ownership |
|---|---|---|---|---|---|---|---|---|
| Recommendation | | Third Party owned trees, beyond the control of the subject property | | | | | | |

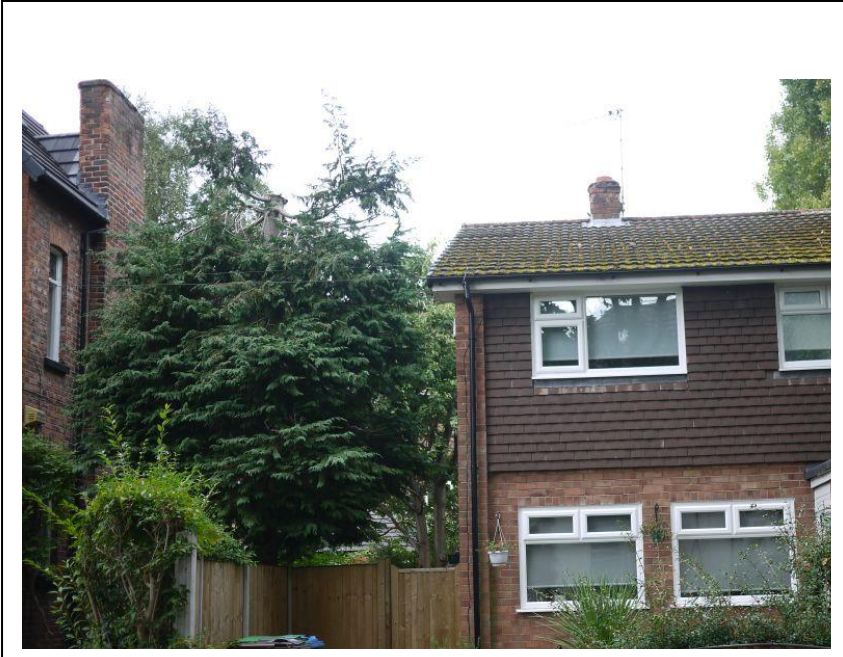
| Tree No. | Species | Height (m) | Dia. (mm) | Approx. Crown Spread (m) | Dist. to structure (m) | Condition | Age Range | Ownership |
|---|---|---|---|---|---|---|---|---|
| T7 | Cypress | 7 * | 300 * | 7 | 10 | Good | Semi-Mature | Third Party |
| Observations & Management History | | Recently reduced/pruned. | | | | | | |

View of T7

| Tree No. | Species | Height (m) | Dia. (mm) | Approx. Crown Spread (m) | Dist. to structure (m) | Condition | Age Range | Ownership |
|---|---|---|---|---|---|---|---|---|
| Recommendation | | Third Party owned trees, beyond the control of the subject property | | | | | | |
