Thermal Imaging

**Project: Moss-side Millenium Powerhouse, Manchester**

**Build IR Ref No: 10156-1**

Build IR have been appointed to carry out a thermographic survey of the entire building, to investigate the thermal performance and identify areas of heat loss.

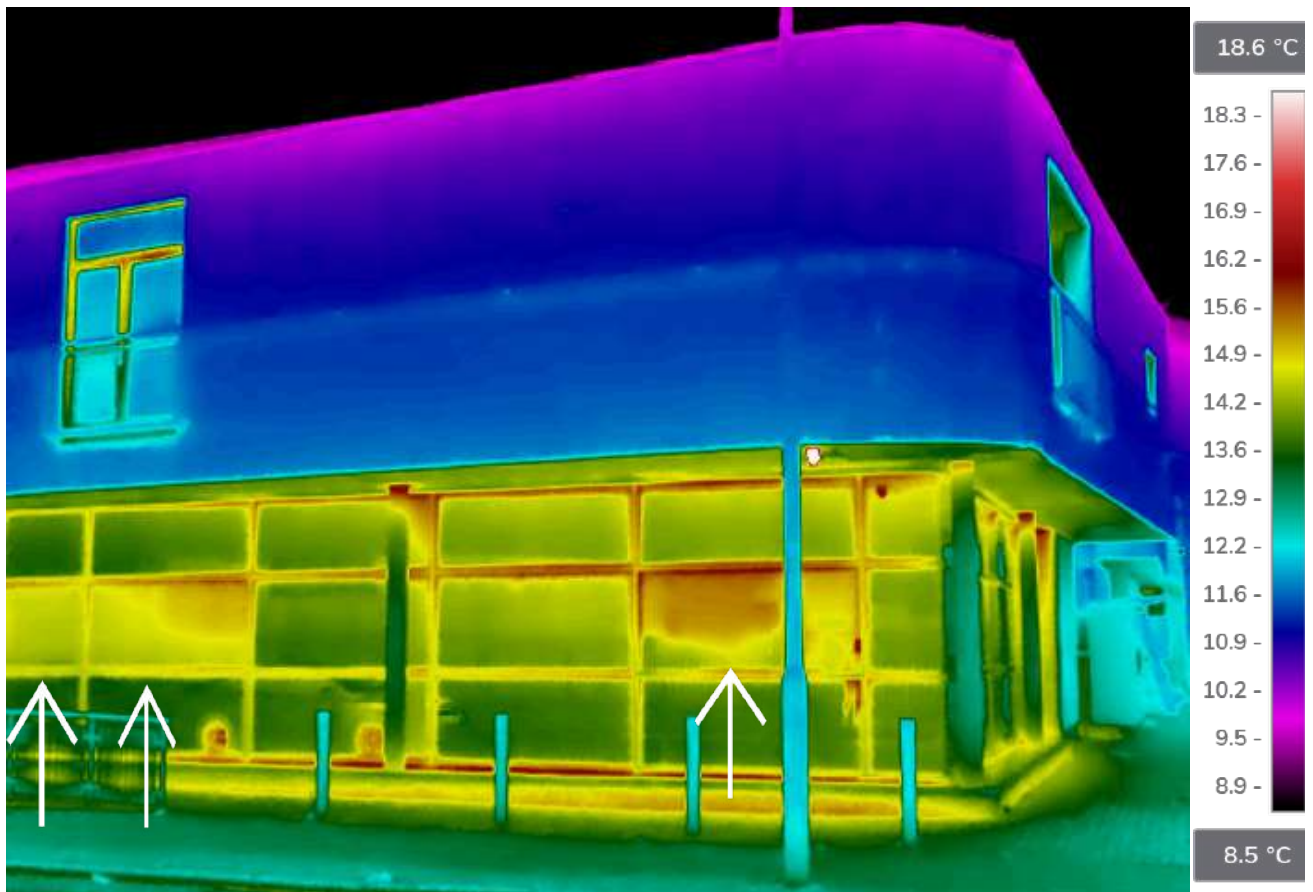
| Image number | 1 |

Insulated render to 1st floor showing good temperature consistency indicating good thermal performance.

White arrows indicate glazing panes showing increased heat loss. This continues along the elevation, and can be seen on internal images for the Library area.

Increased heat loss noted along edge of ground floor slab - potential thermal bridging.

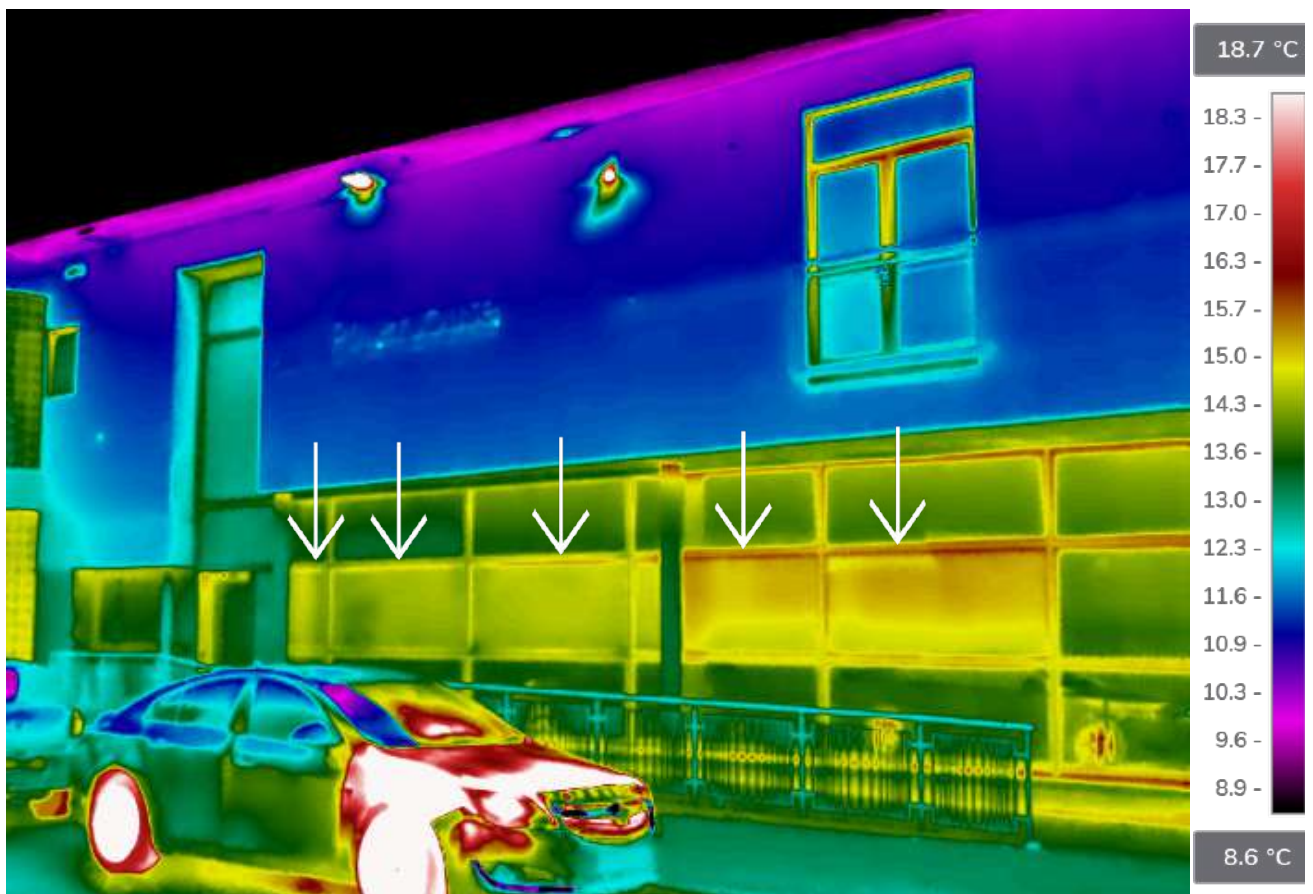
| File information | |
|---|---|
| Image number | 2 |

Thermal performance same as image 1.

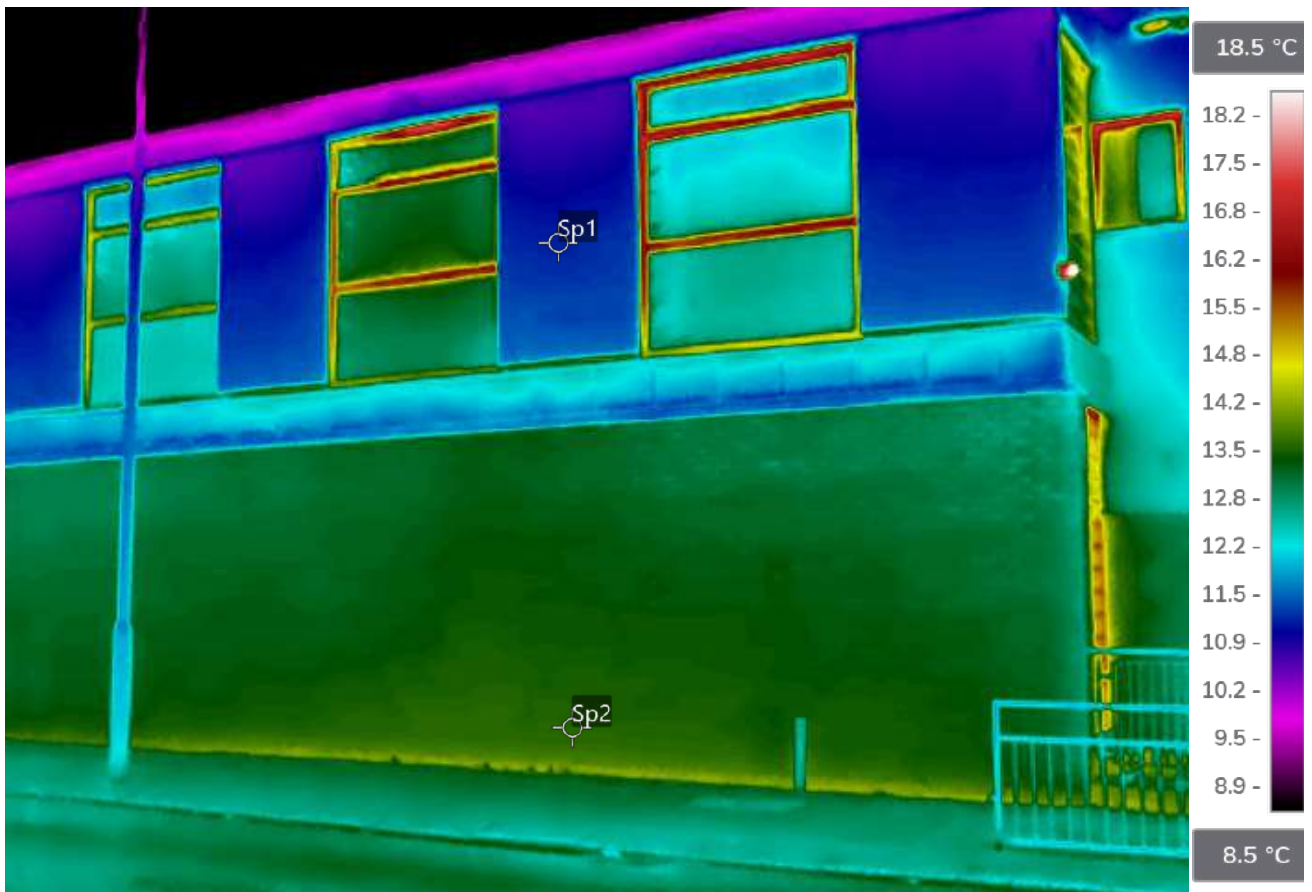
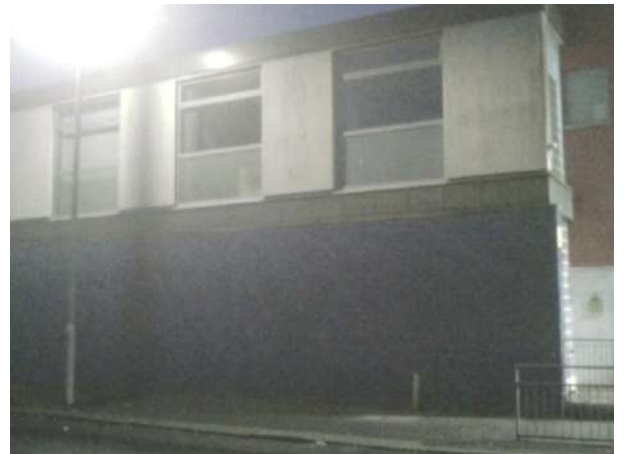
| File information | | Measurements | |
|---|---|---|---|
| Image number | 5 | | |

Sp1 + 2 included to show difference in heat loss between construction types - cavity wall showing some increased heat loss (cause unknown).

Glazing frames showing poor thermal resistance

Insulated render performing well.

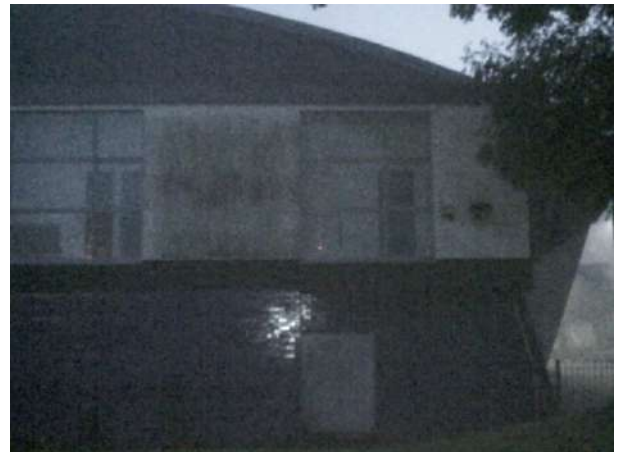
| File information | |
|---|---|
| Image number | 11 |

High level - air leakage at cladding wall junction with roof (generic of this detail).

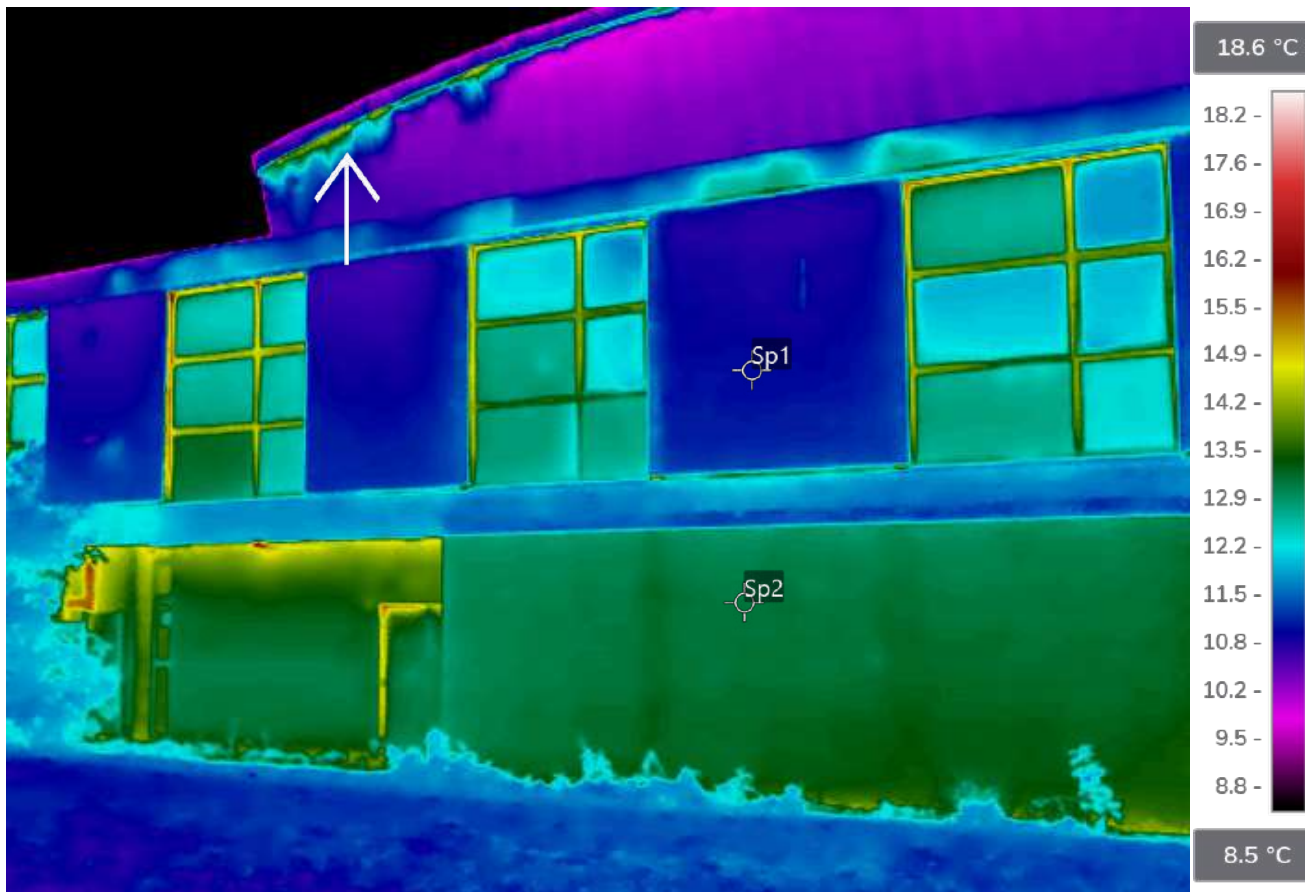
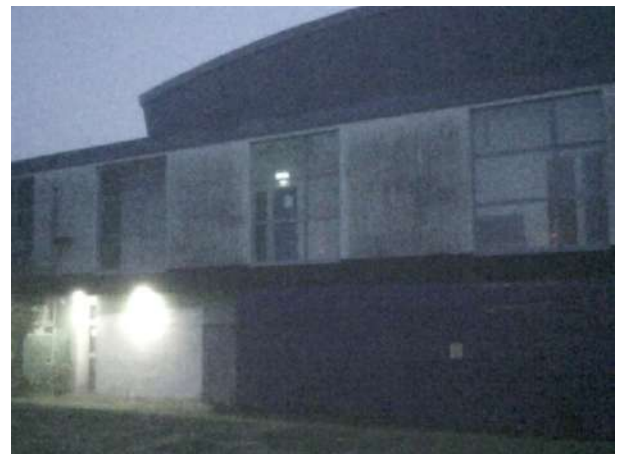
| File information | | Measurements | |
|---|---|---|---|
| Image number | 12 | | |

Continuation of air leakage at cladding roof / wall junction.

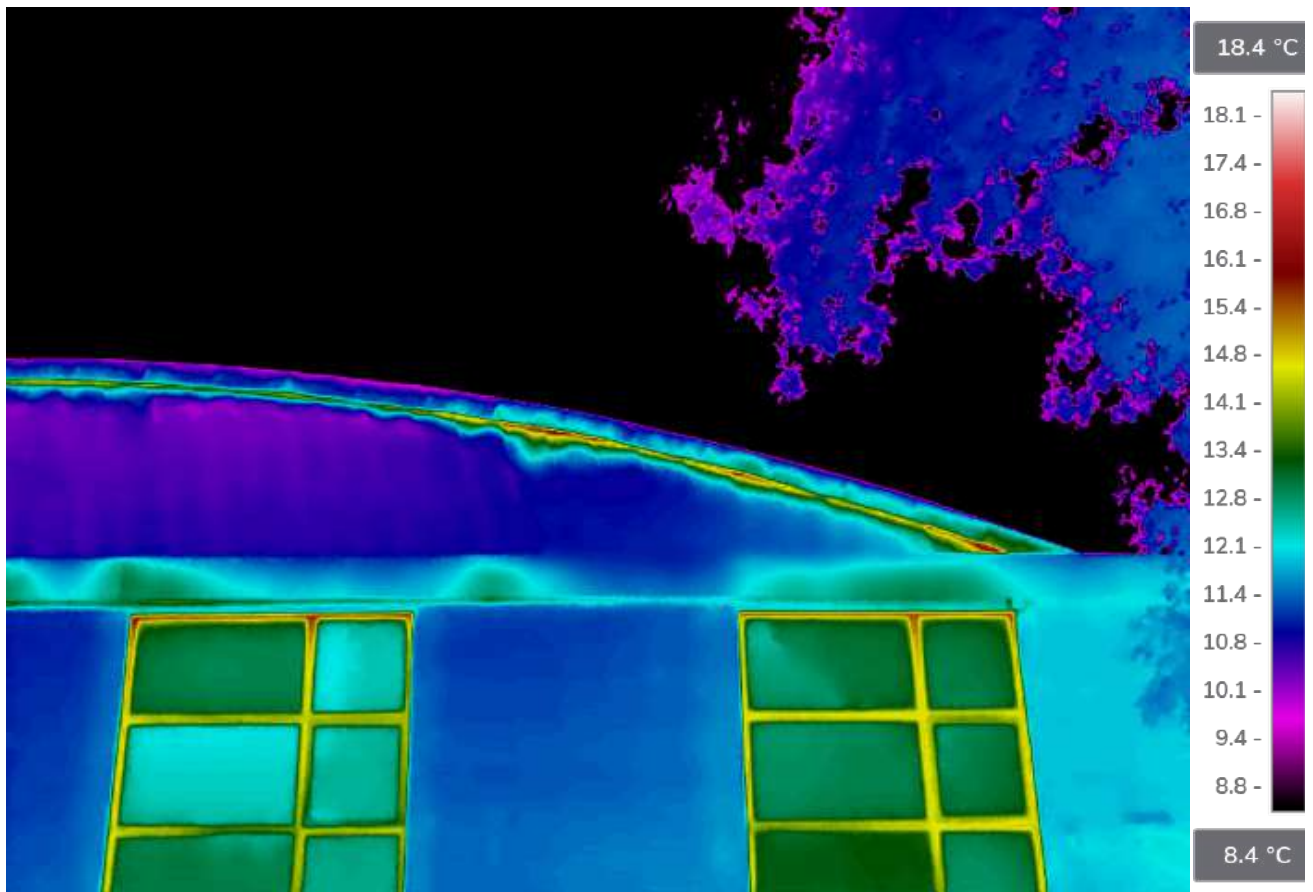
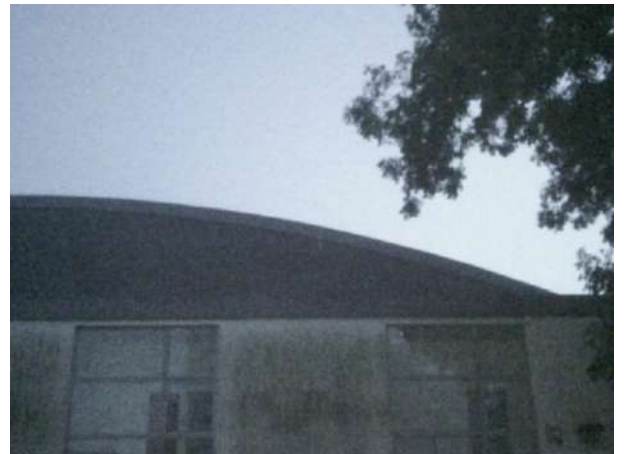
| Image number | 13 |

Close up of air leakage noted high level.

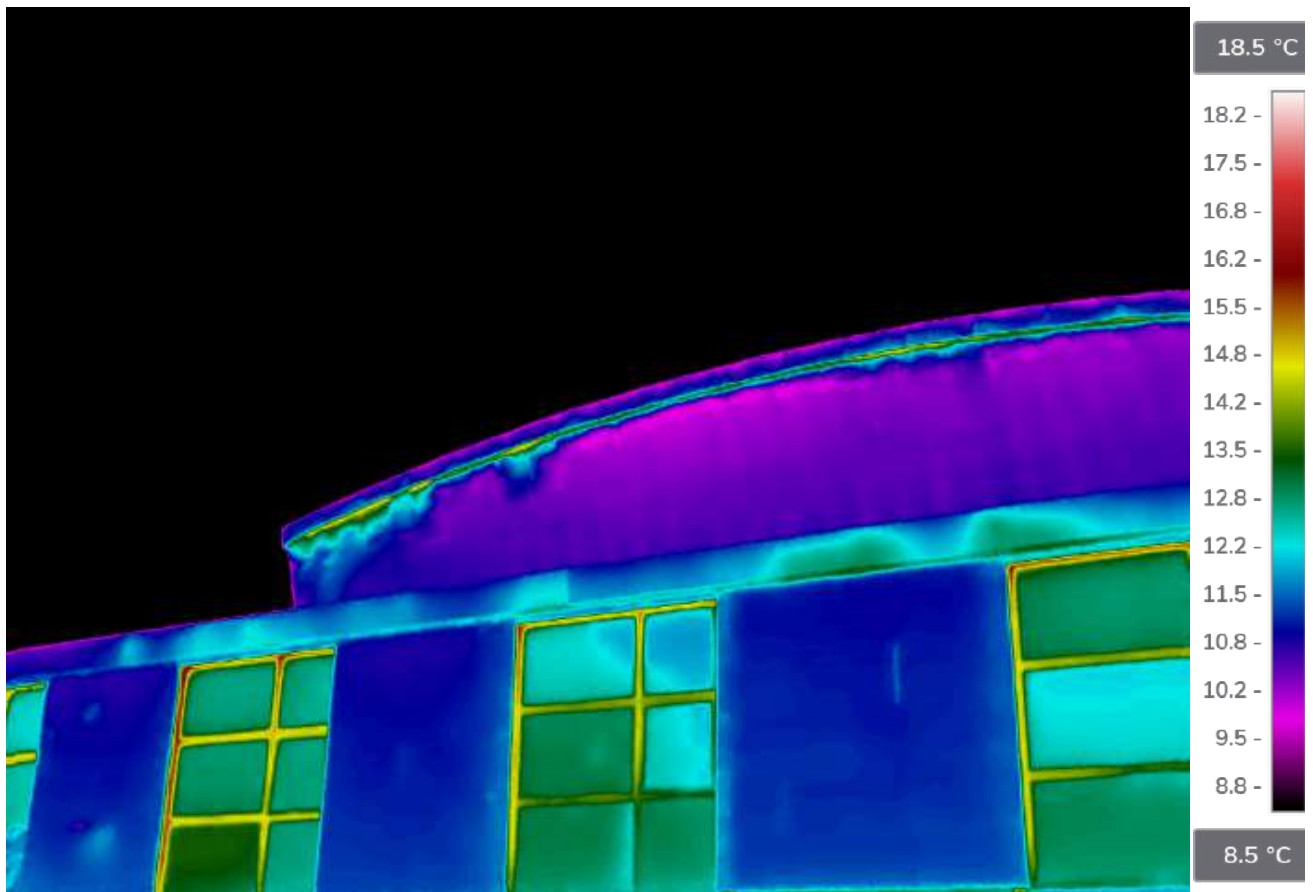
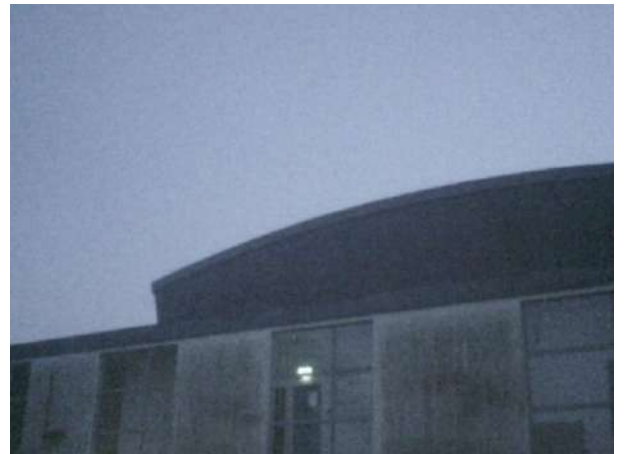
| Image number | 14 |

Close up of air leakage high level.

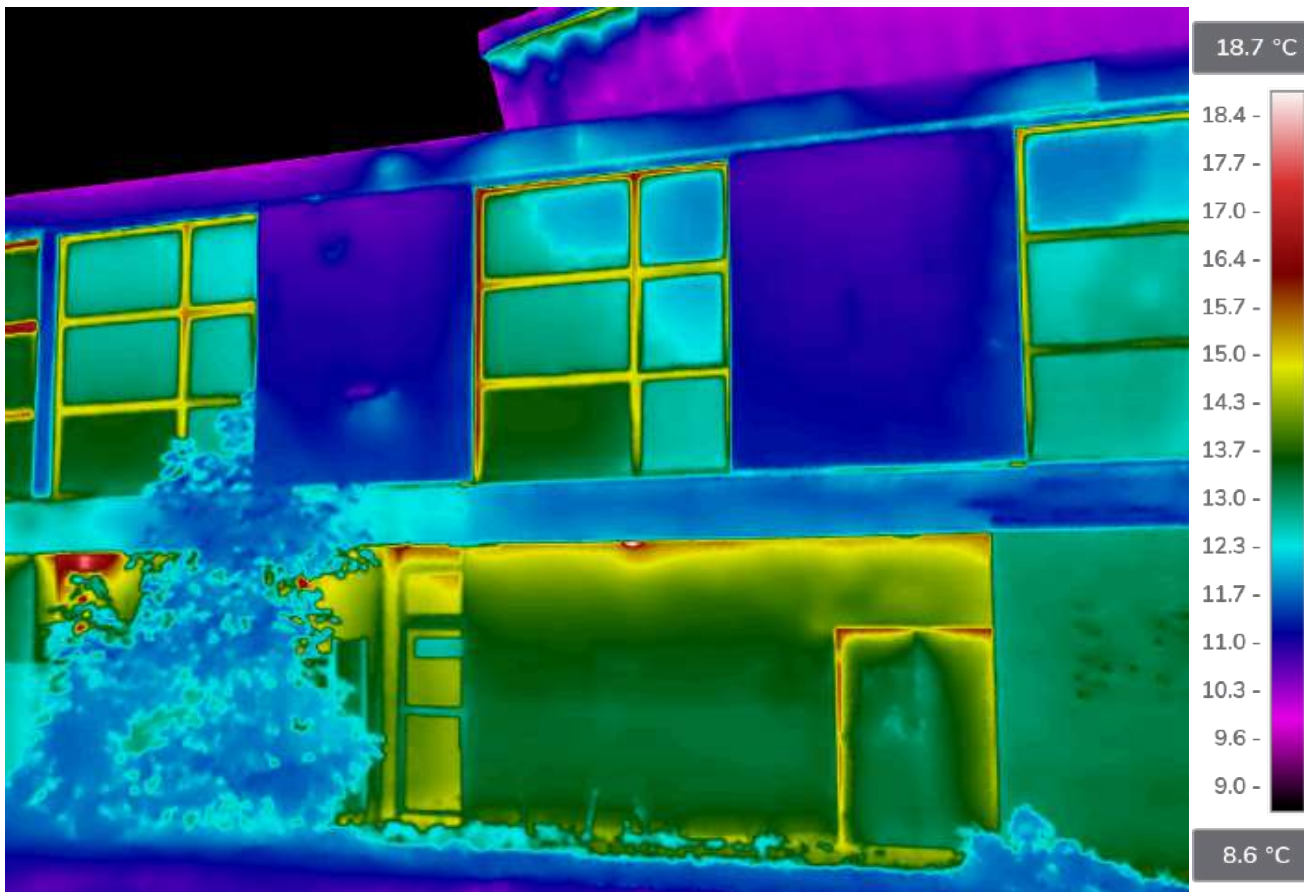
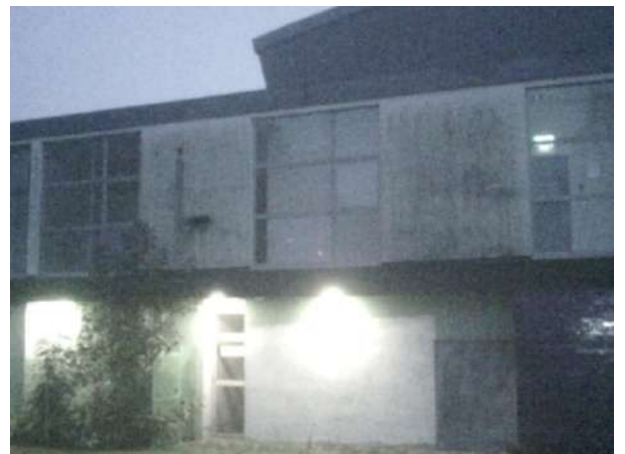
| File information | |
|---|---|
| Image number | 15 |

Increased heat loss under soffit noted generically along this elevation.

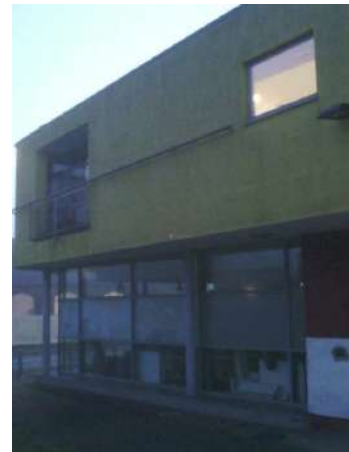
| File information | | Measurements |
|---|---|---|
| Image number | 24 | |

Thermal performance of ground floor same as noted in image 1.

Heat loss noted by arrow is from open window.

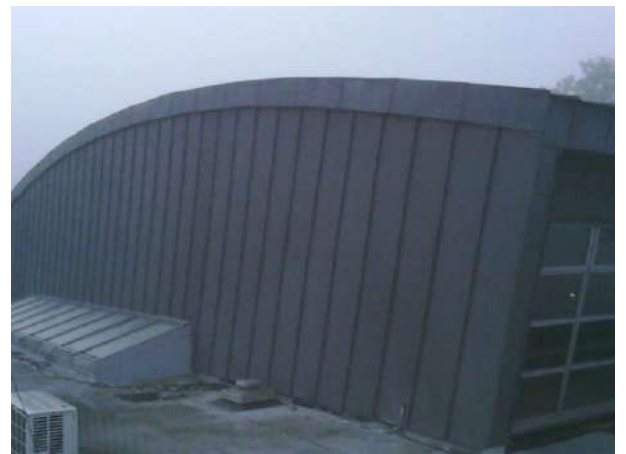
| File information | | Measurements |
|---|---|---|
| Image number | 33 | |

Air leakage noted to flashing along entire elevation at roof / wall junction.

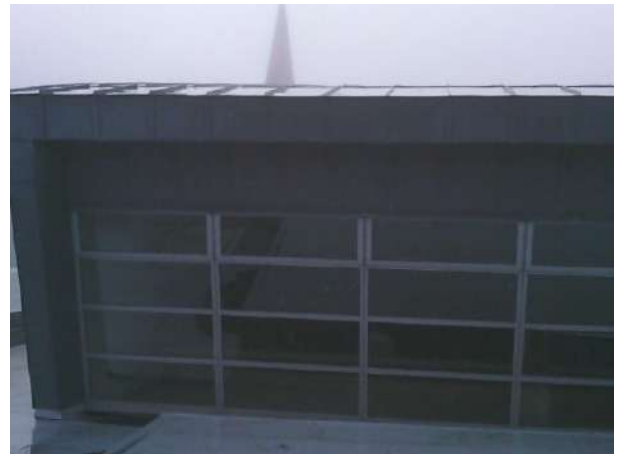
| File information | | Measurements |
|---|---|---|
| Image number | 38 | |

Arrows indicate area of air leakage to cladding.

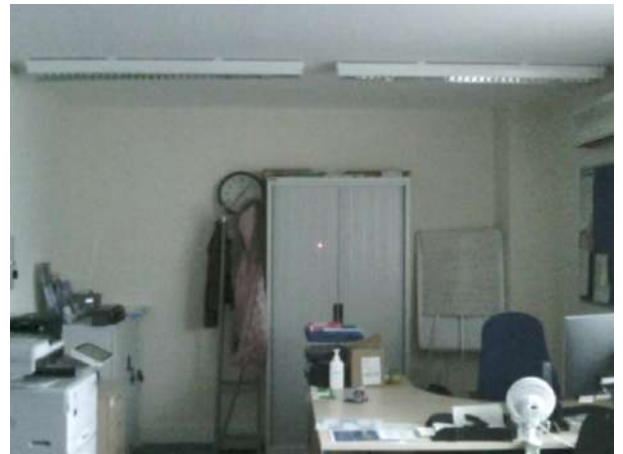
| File information | |
|---|---|
| Image number | 45 |

Air infiltration noted behind drylining.

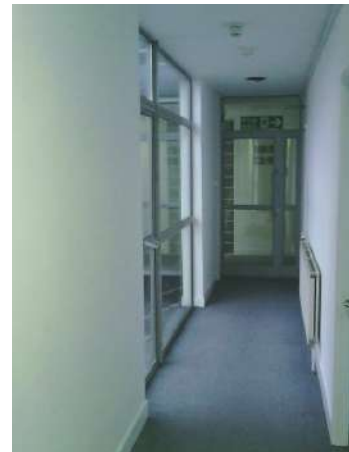
| File information | |
|---|---|
| Image number | 48 |

| Comments |
|---|
| Air infiltration noted under and around poorly sealed glazing frames. |

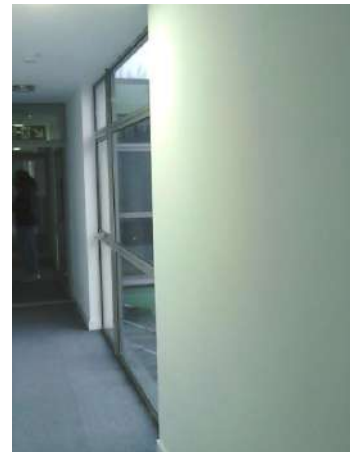
| File information | |
|---|---|
| Image number | 49 |

| Comments |
|---|
| Air infiltration noted under and around poorly sealed glazing frames. |

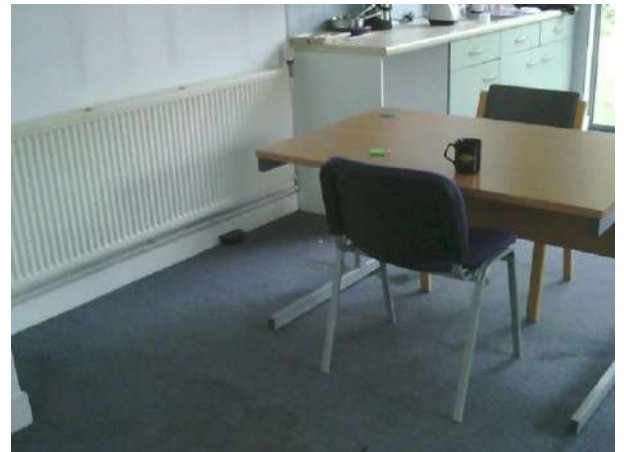
| File information | |
|---|---|
| Image number | 50 |

No thermal separation between conditioned space and Plant room.

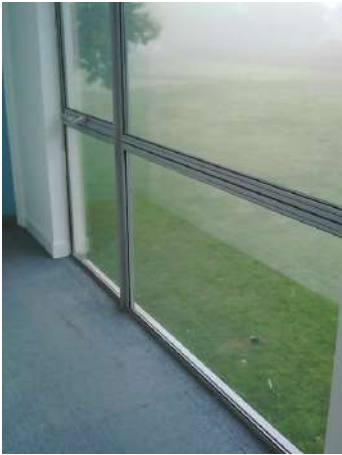
| File information | |
|---|---|
| Image number | 55 |

| Comments |
|---|
| Glazing performing poorly and cold air noted tracking in below frames. |

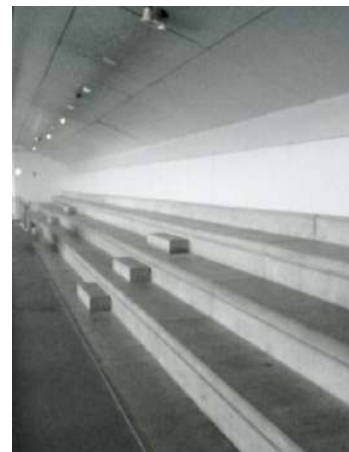
| File information | |
|---|---|
| Image number | 56 |

| Comments |
|---|
| Cold noted to concrete seating area from louved store rooms below. |
| Cold also noted tracking behind dry lining and above ceiling tiles - possibly related to cold air ingress - intrusive investigation recommended. |

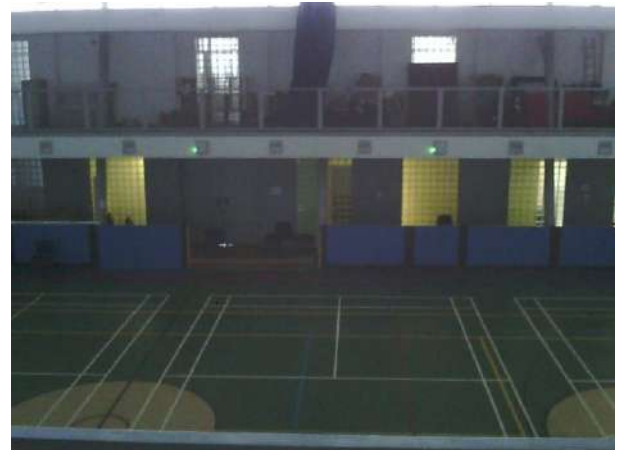
| File information | |
|---|---|
| Image number | 58 |

At time of survey - only 1 underfloor heating loop working.

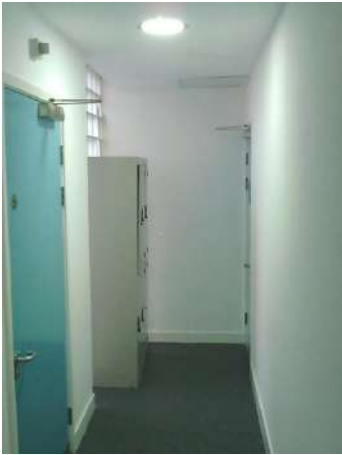
| Comments |
|---|
| Cold noted to end of corridor due to lower thermal performance of glass blocks. |

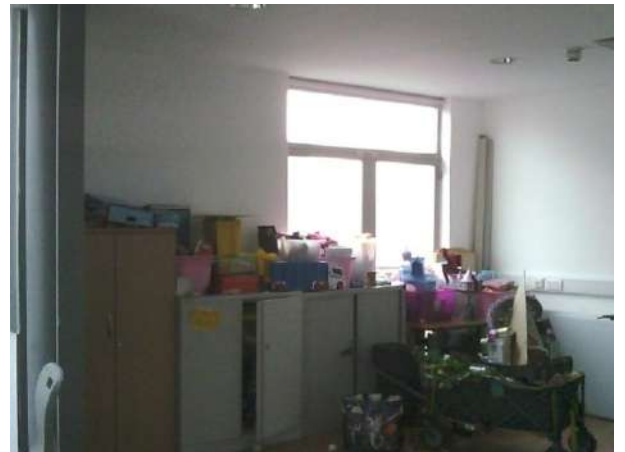
| File information | | Measurements | |
|---|---|---|---|
| Image number | 71 | | |

Unknown cold ingress high level - possible air infiltration.

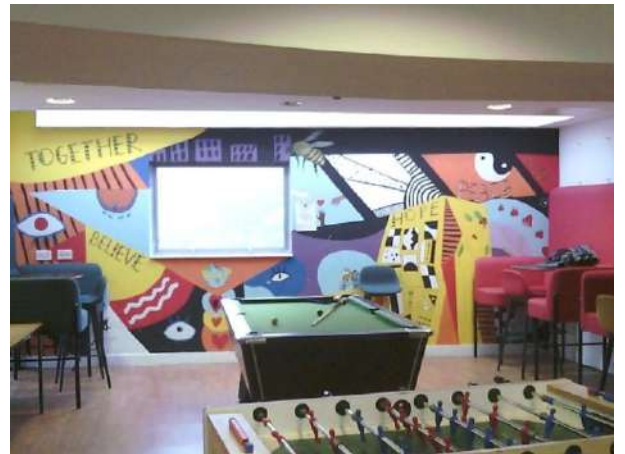
| File information | | Measurements |
|---|---|---|
| Image number | 72 | |

Cold noted behind dry lining from rooflight area, around window, and left side of image (glass blocks).

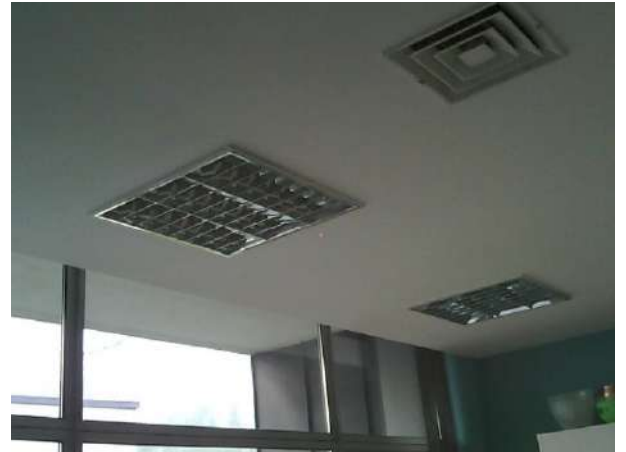
| File information | | Measurements |
|---|---|---|
| Image number | 74 | |

Likely cold air noted tracking above plasterboard ceiling.

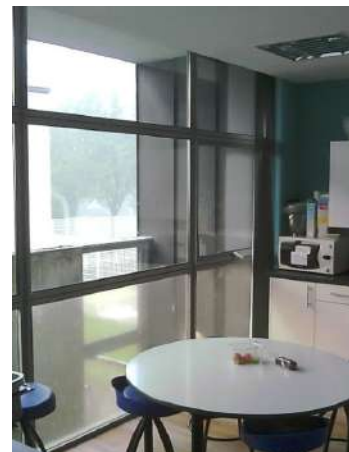
| File information | |
|---|---|
| Image number | 75 |

Glazing and frames performing poorly including seals to opening windows.

Air infiltration noted behind dry lining.

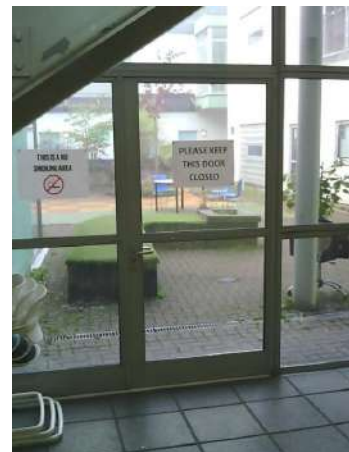
| File information | |
|---|---|
| Image number | 77 |

Air infiltration noted around external door.

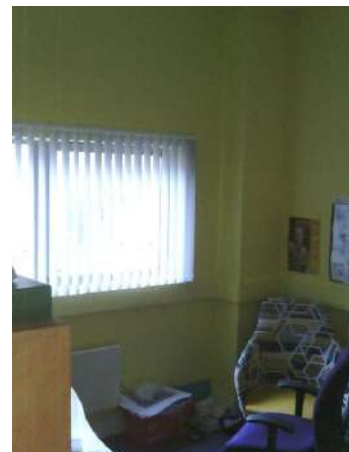
| File information | |
|---|---|
| Image number | 80 |

Air infiltration behind dry lining.

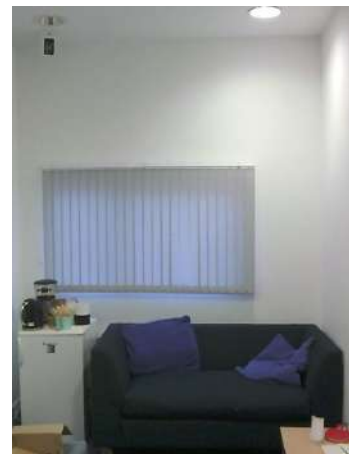
| File information | |
|---|---|
| Image number | 81 |

Air infiltration behind dry lining.

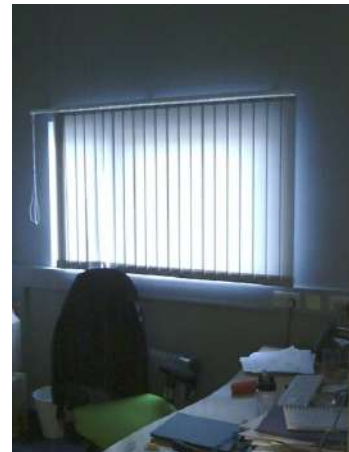
| File information | |
|---|---|
| Image number | 82 |

Arrow highlights air infiltration through open trickle vent.

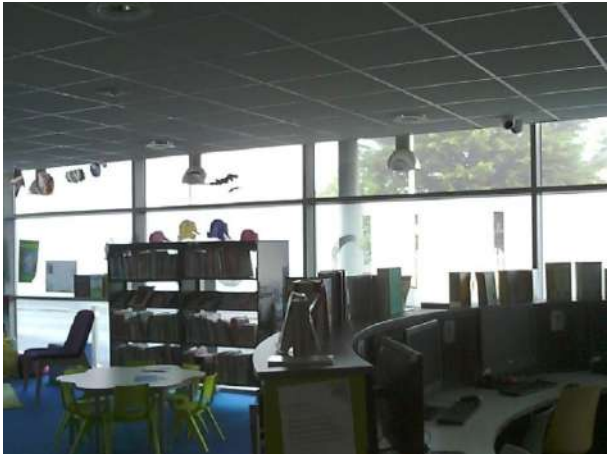
| File information | | Measurements | |
|---|---|---|---|
| Image number | 86 | | |

SP1 + 2 included to highlight difference in glazing performance as noted externally.

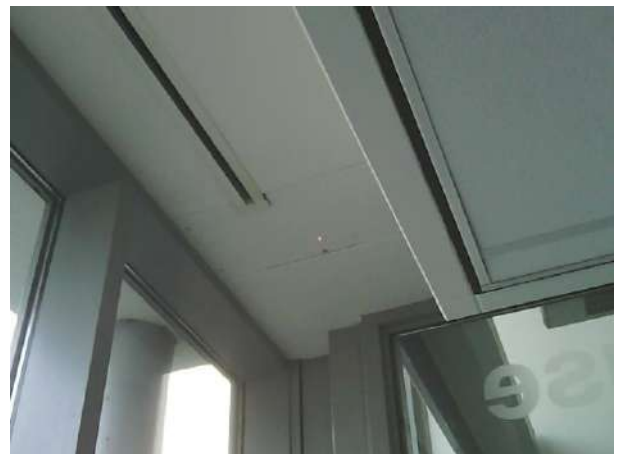
| Image number | 88 |

Possible air infiltration above ceiling.

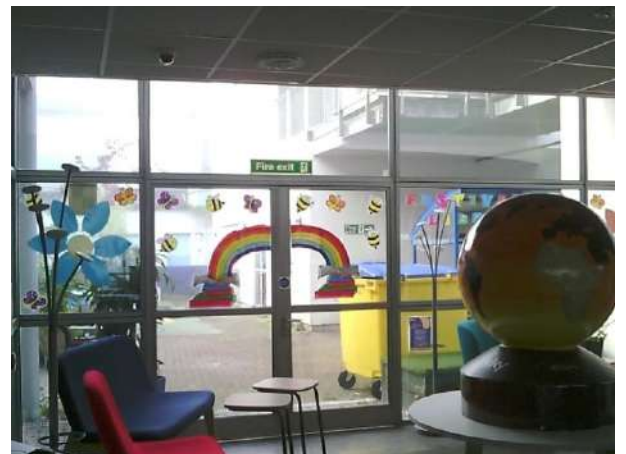
| File information | |
|---|---|
| Image number | 90 |

Poorly performing glazing and frames, and air infiltration around poorly fitting door.

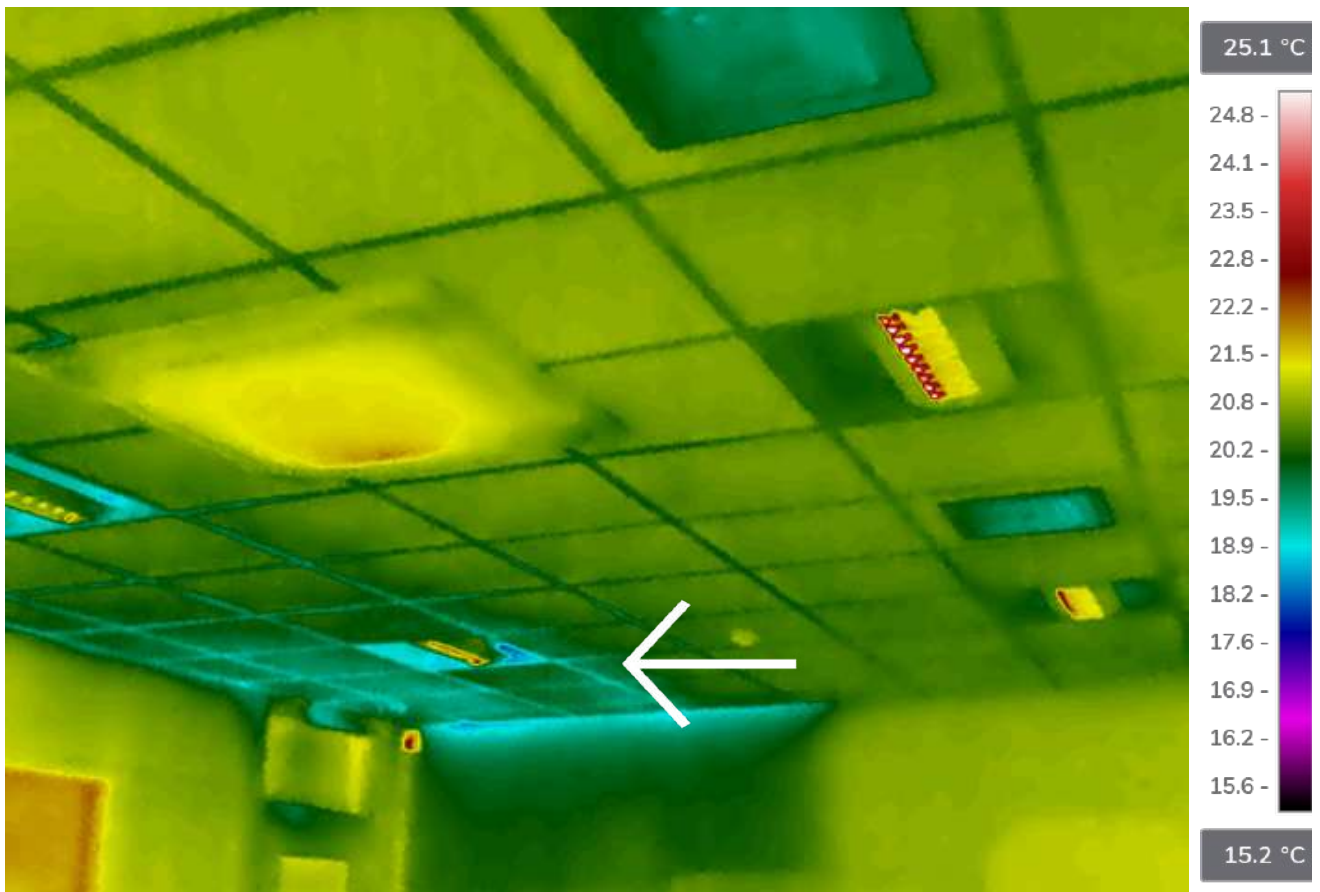
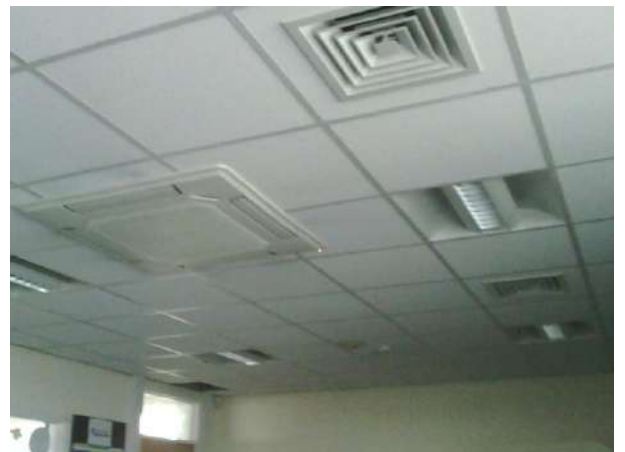
| File information | | Measurements |
|---|---|---|
| Image number | 91 | |

Air infiltration above ceiling. Linked to image 93.

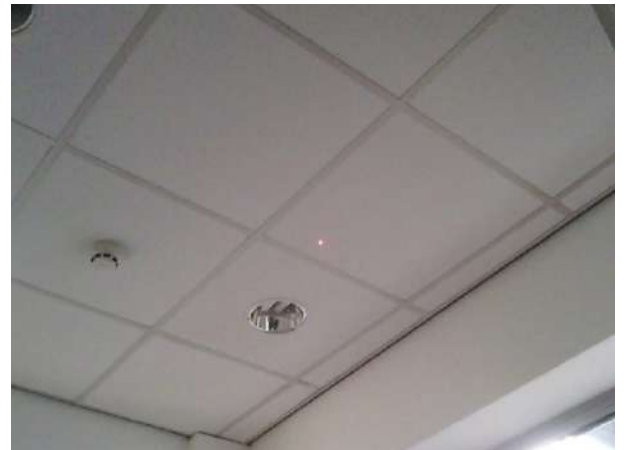
| File information | |
|---|---|
| Image number | 93 |

Excessive air infiltration above ceiling - source is open louvre on external wall.

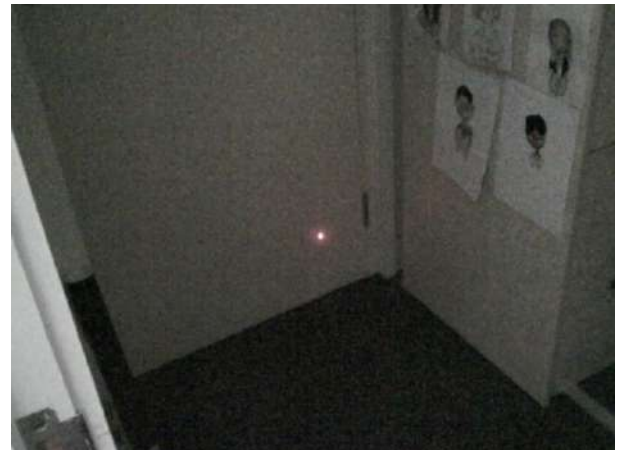
| File information | |
|---|---|
| Image number | 94 |

Air infiltration under external door.

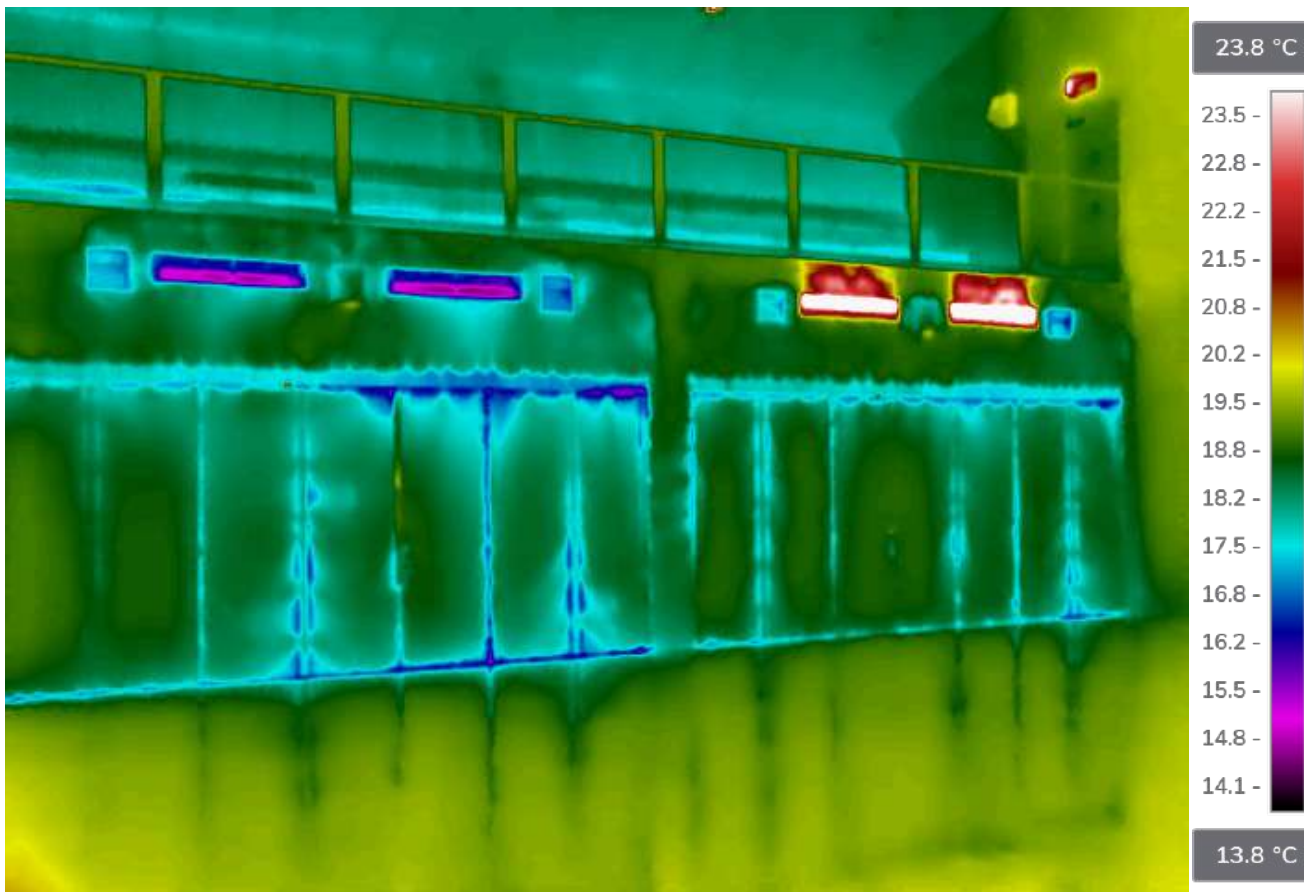
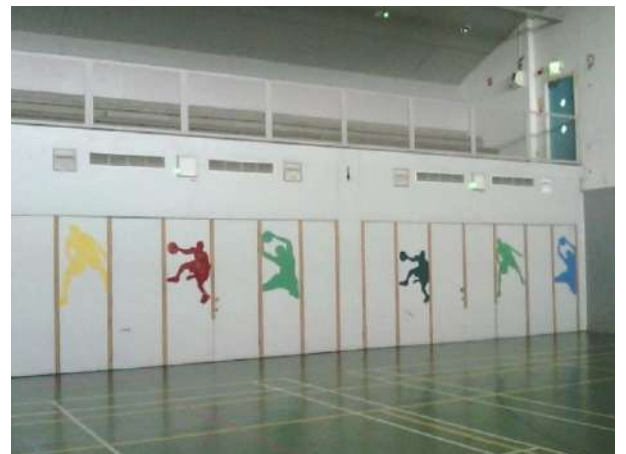
| File information | |
|---|---|
| Image number | 95 |

Air infiltration from louvred store rooms.

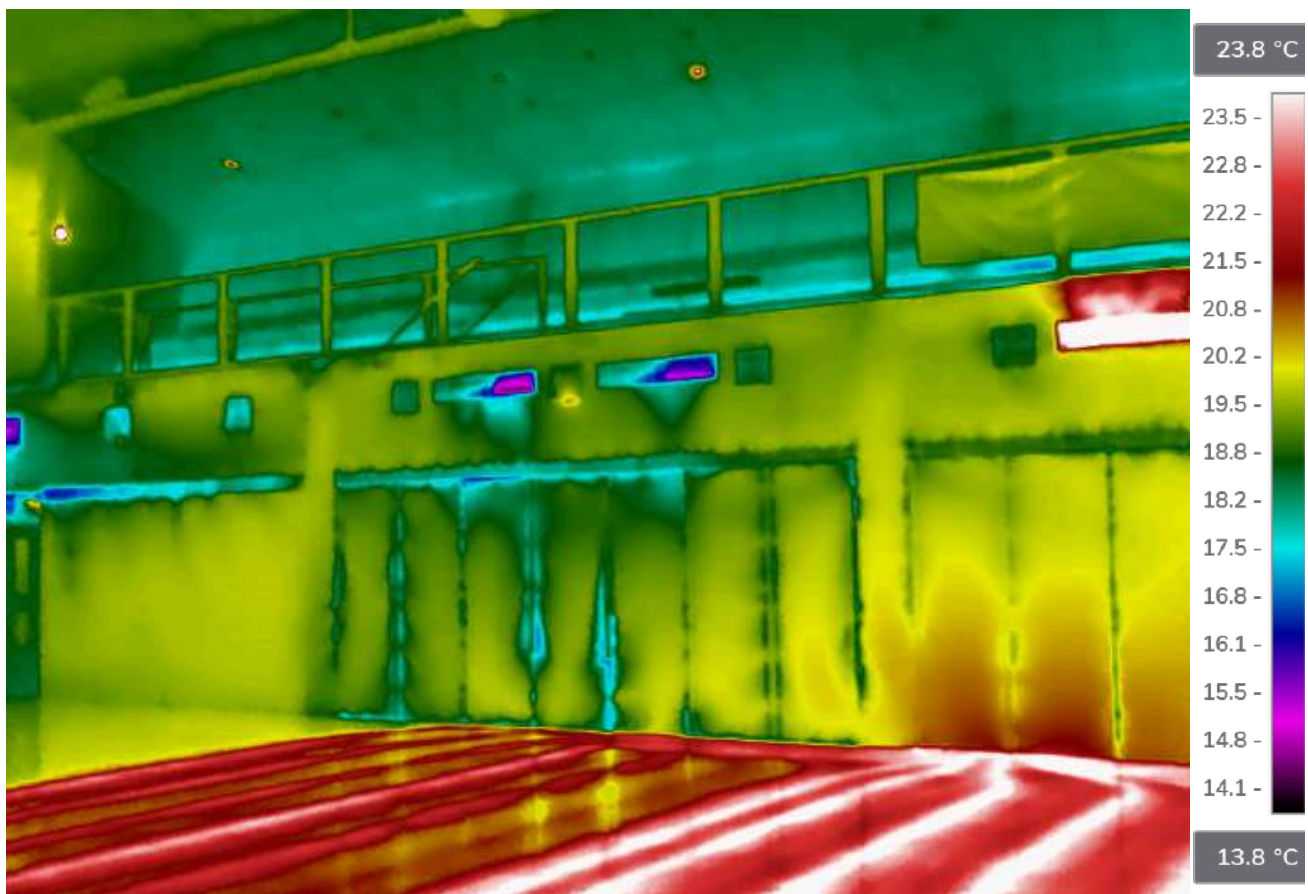
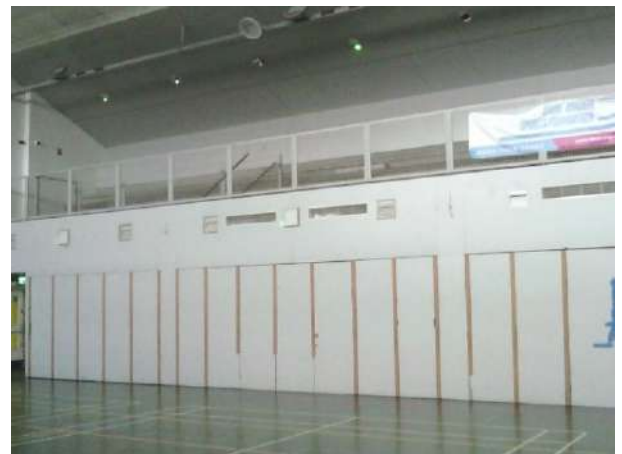
| Image number | 96 |

Air infiltration from louvred store room.

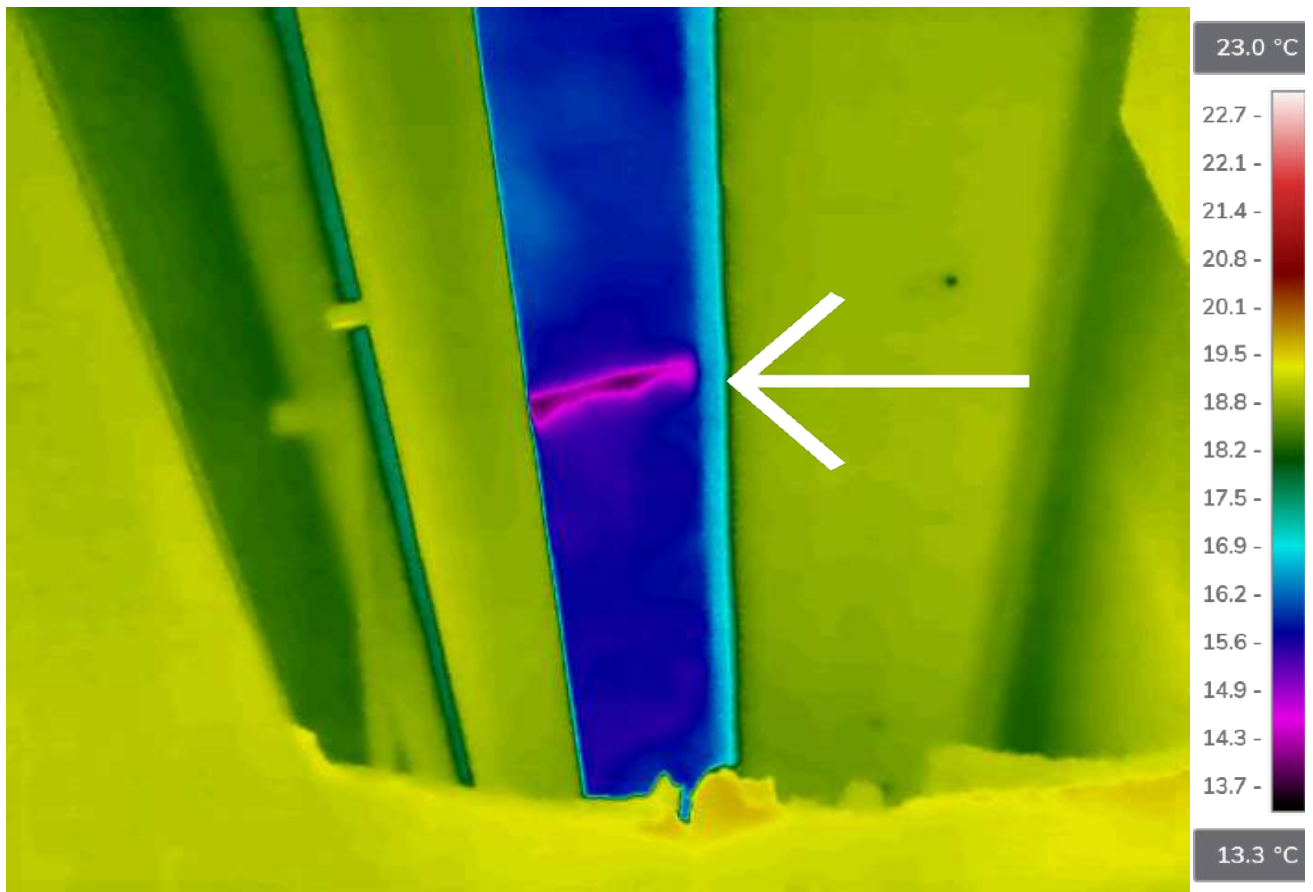
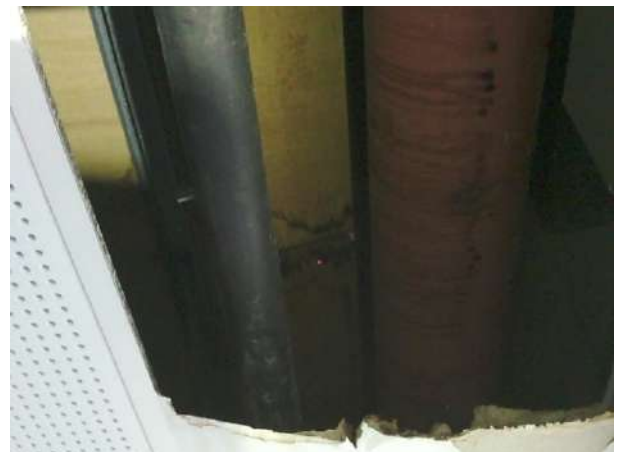
| File information | |
|---|---|
| Image number | 106 |

Uninsulated gutter and water leaks to gutter.

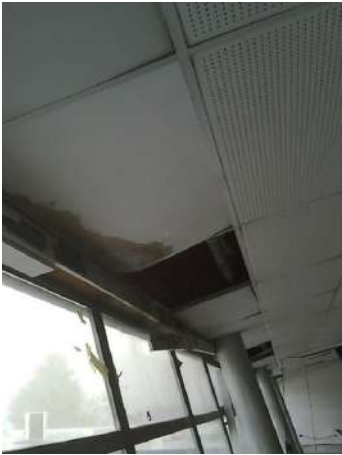
| File information | |
|---|---|
| Image number | 107 |

| Comments |
|---|
| Water leaks noted. |

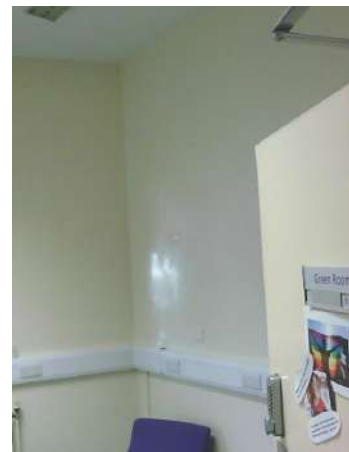
| File information | |
|---|---|
| Image number | 114 |

No thermal separation between Plant room and conditioned space.
