Thermal Imaging

**Project: Moss-side Millenium Powerhouse, Manchester**

**Build IR Ref No: 10156-1**

Build IR have been appointed to carry out a thermographic survey of the entire building, to investigate the thermal performance and identify areas of heat loss.

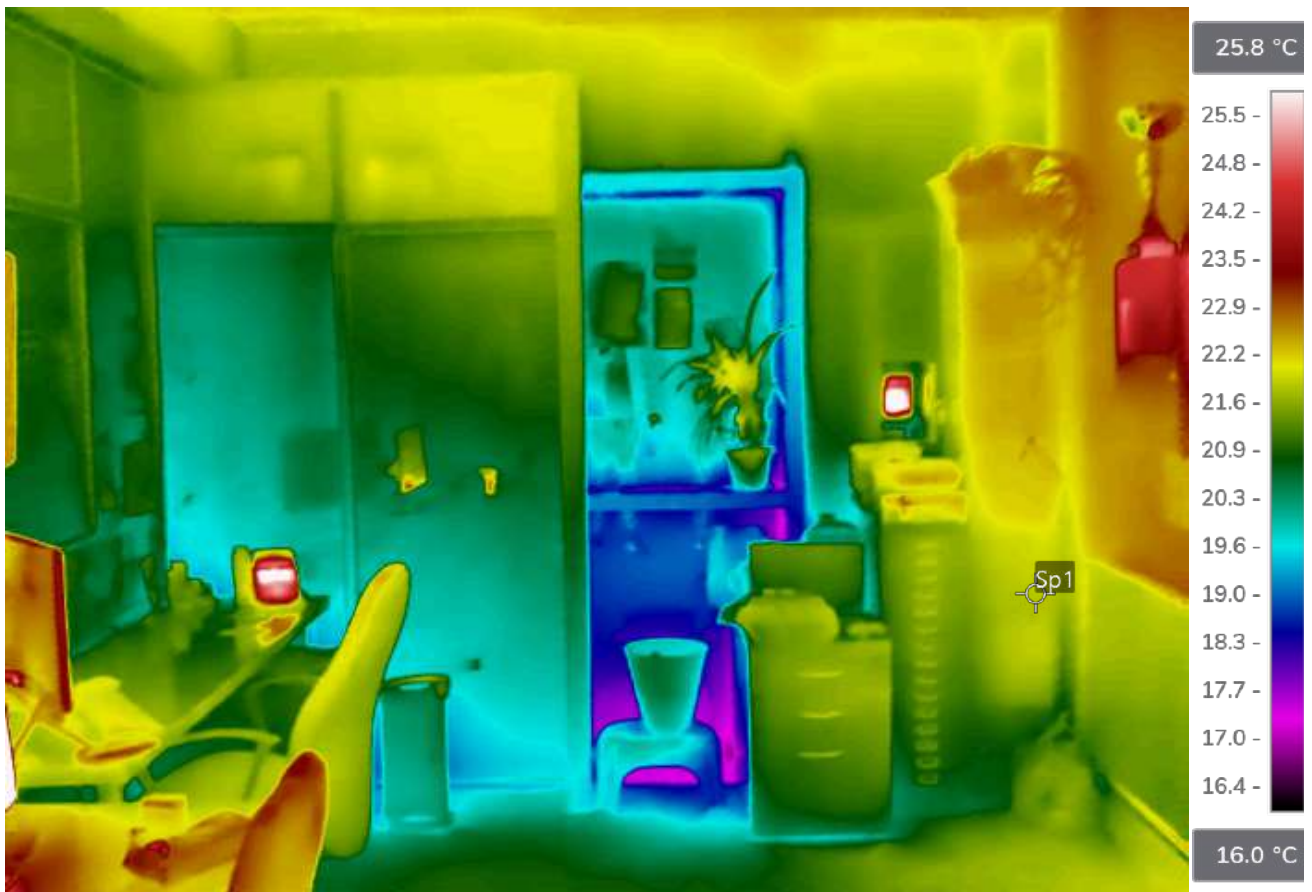
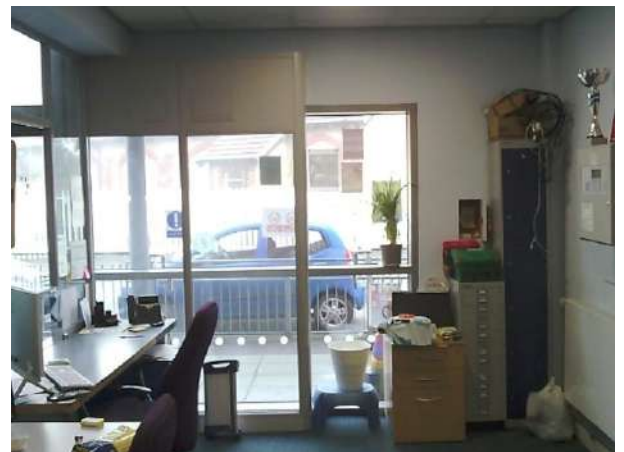
| File information | | Measurements | |
|---|---|---|---|
| Image number | 118 | | |

Cold noted low level - possibly from junction with external door.
