# DAYTIME BAT SURVEY

7 RAINFORTH STREET,  
MANCHESTER

NOVEMBER 2022

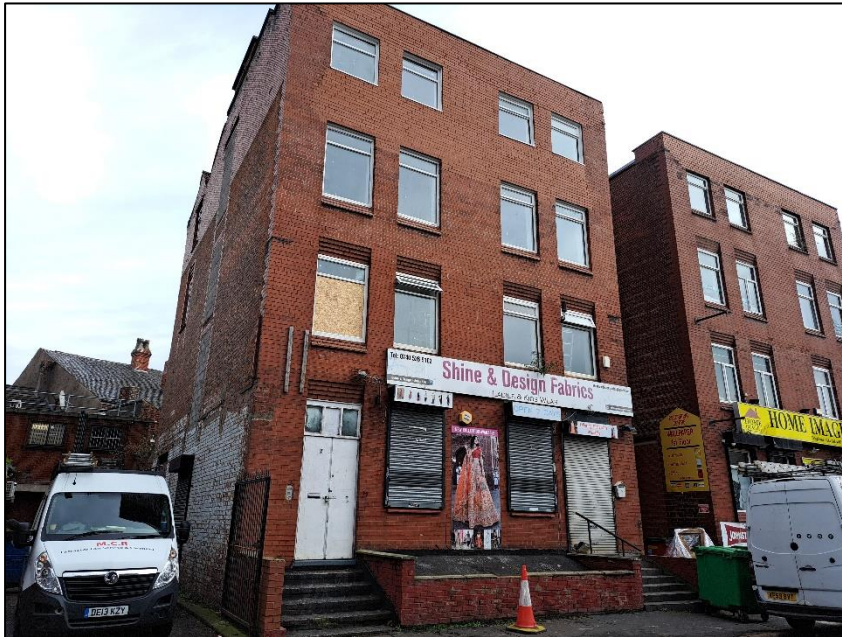
*Photograph 1 showing*

- 3.1 The building is constructed from brick and has a pitched, tiled roof. The external brickwork is complete and intact on the front elevation, with no significantly damaged bricks or recessed mortar. The window frames are flush to the surrounding masonry (see Photograph 1). The brick lintels are complete and intact.

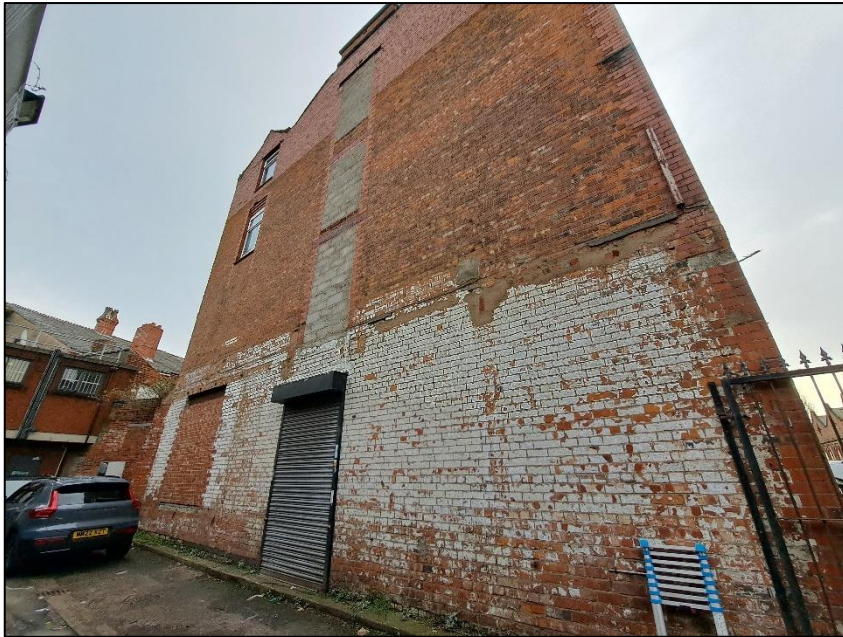
- 3.2 The brickwork on the rear elevation is partially damaged in places (see Photographs 2 and 3), though none of the damaged bricks present cavities suitable for bats to roost within. Vegetation is penetrating parts of the external brickwork. Rainwater is also affecting the brickwork.

*Photograph 2 showing the north elevation*

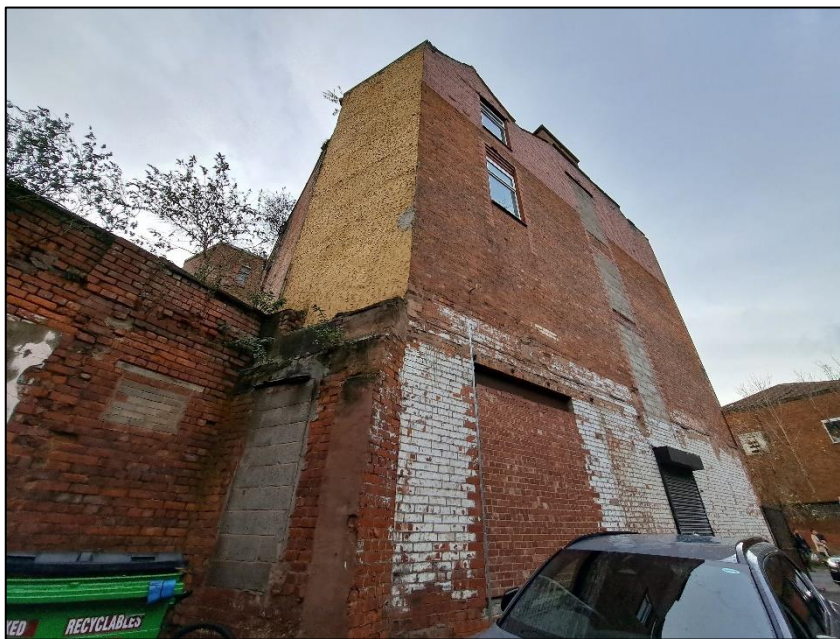
*Photograph 3 showing the rear (east) elevation*

- 3.3 The roof is not fully visible from the ground. Several tiles are damaged at the roof edges. The upper brick courses are intact. One elevation has a cement render (see Photograph 3), which is complete and offers no gaps or cracks for bats to exploit.

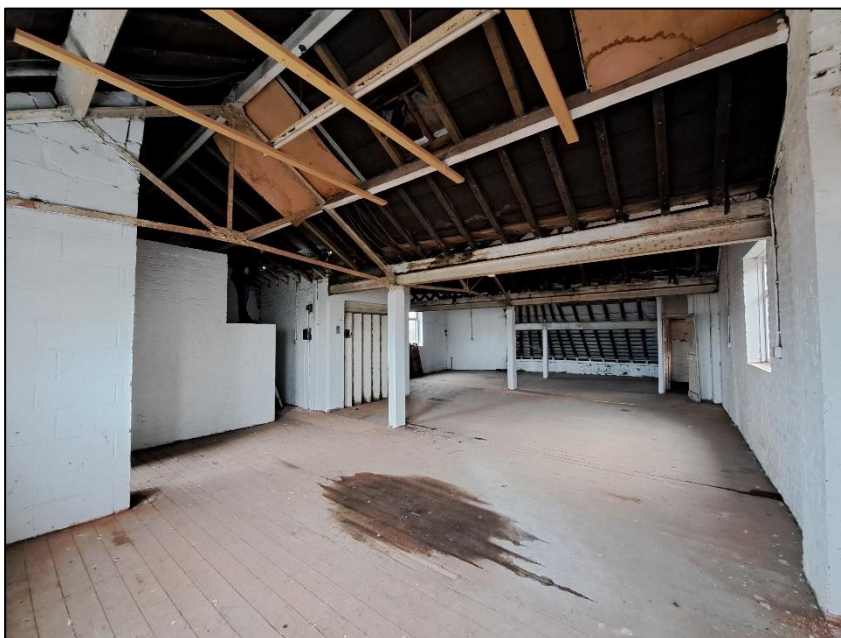
- 3.5 The interior space on the upper most floor has several windows and is well lit. The space is open to the roof with no separate roof void (see Photograph 4) and is draughty, cold, and considerably damp. The roof is supported by a metal frame that has some superficial rust, and wooden beams that have rotted in places (see Photograph 5). Some beams have been replaced to maintain the structure (see Photograph 4). These features are complete without gaps or cracks for bats to exploit.

*Photograph 4 showing the uppermost floor of the property*

- 3.6 The roof lining is visible and not well sealed (see Photograph 6), wind was blowing through some of the particularly exposed areas. Several gaps and holes were identified in the roof and tiles are visible from the interior (see Photograph 7). The space is damp and there are obvious signs of leaking from the roof (see Photograph 4).

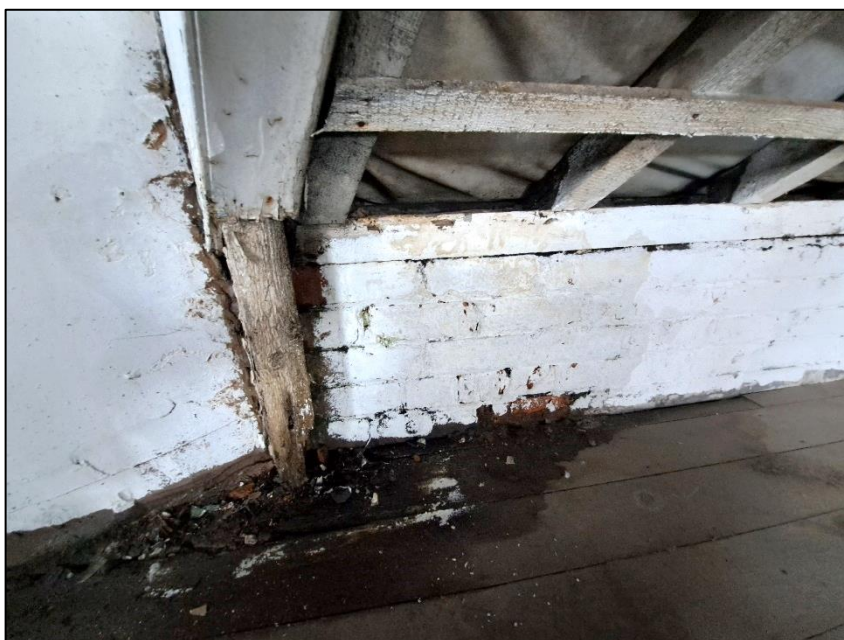
*Photograph 5 showing an area of wood rot*

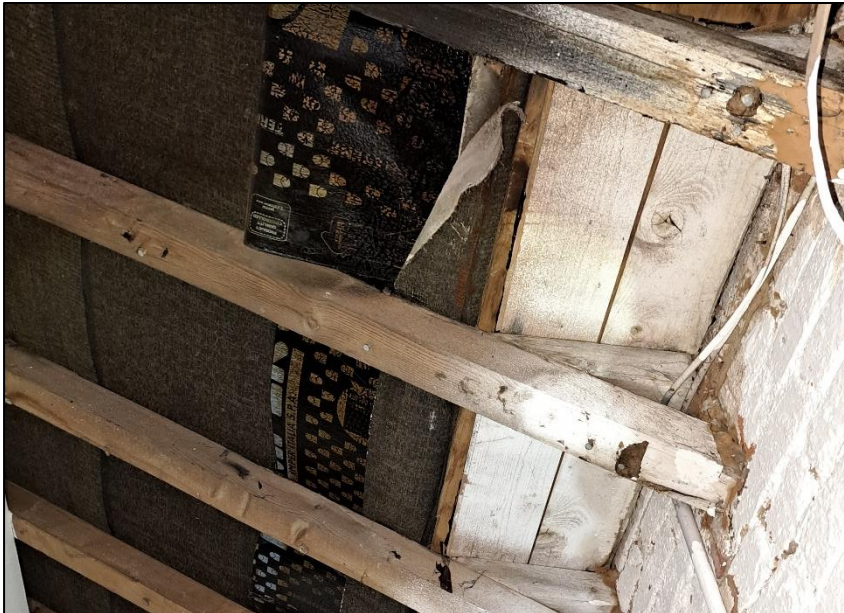
*Photograph 6 showing an area of exposed roof lining*

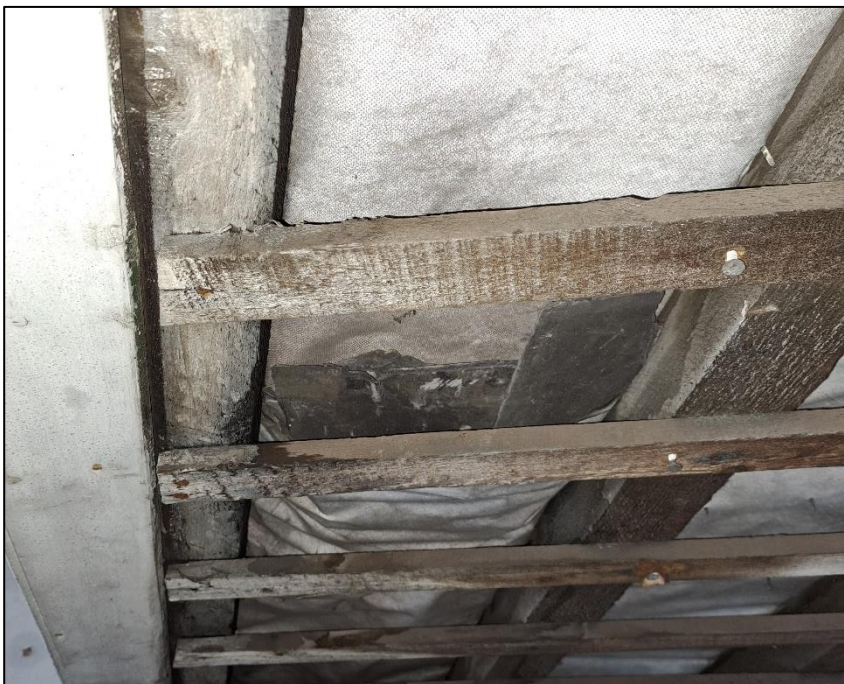
*Photograph 7 showing exposed slate tiles*

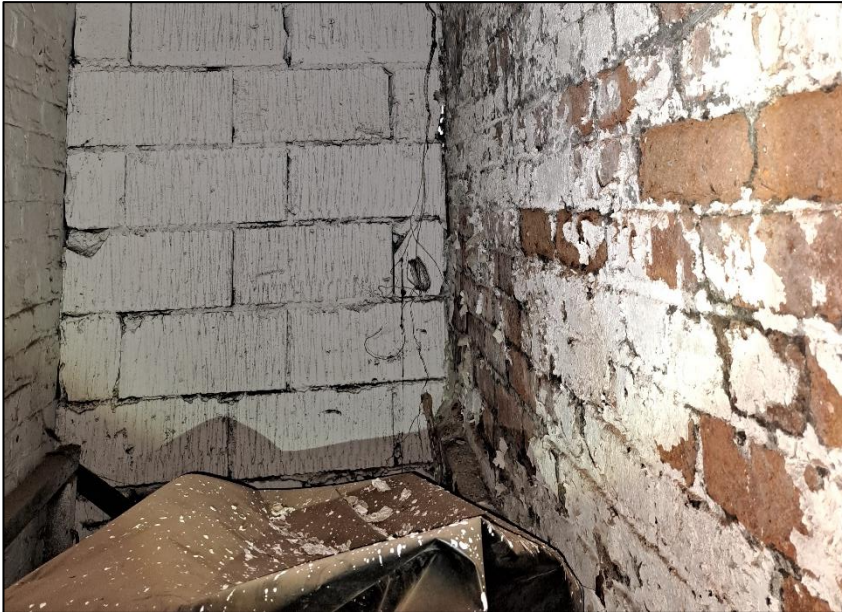
- 3.7 The internal brickwork is largely complete and intact (see Photograph 7). There are no gaps in the mortar for bats to exploit. There are, however, gaps at the corners that lead directly to the exterior (see Photograph 8). These are large enough for bats to access the space.

*Photograph 7 showing the condition of the internal brickwork*

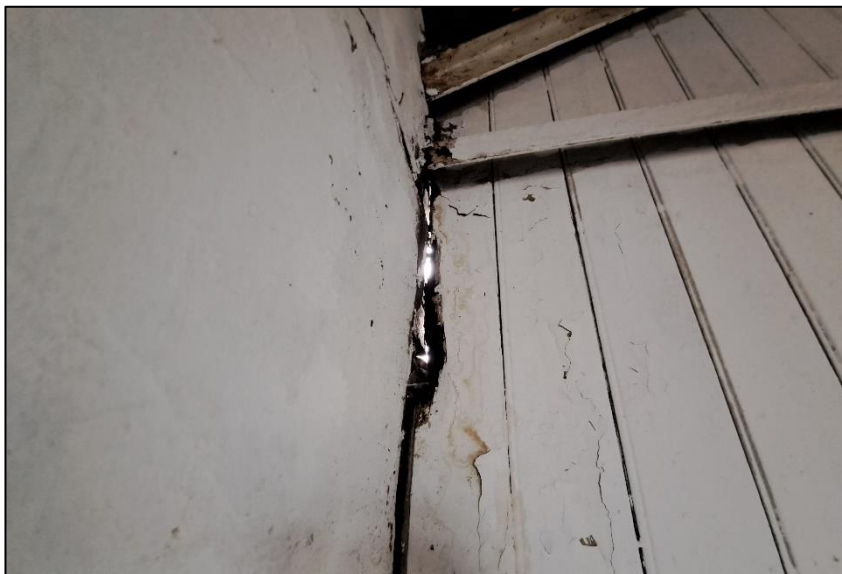
*Photograph 8 showing one of the gaps in the corner of the uppermost floor*

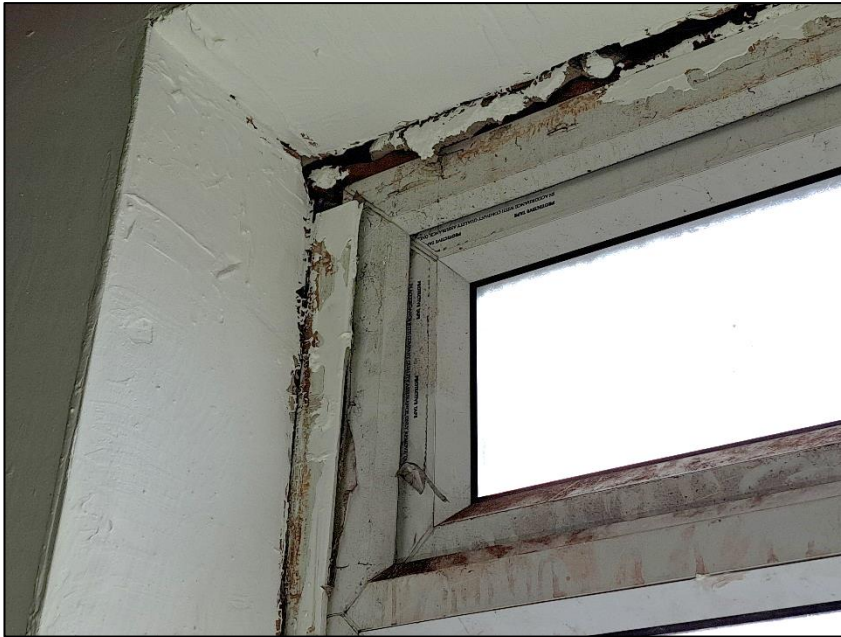
- 3.8 The windows are uPVC and are well sealed. There is damage above one window where the wall is coming away from the window frame (see Photograph 9). This, however, does not offer any suitable crevices for bats. There is space where a skylight has been boarded up. This is leaking and there is a significant damp patch beneath the feature.

*Photograph 9 showing damage above one of the windows*

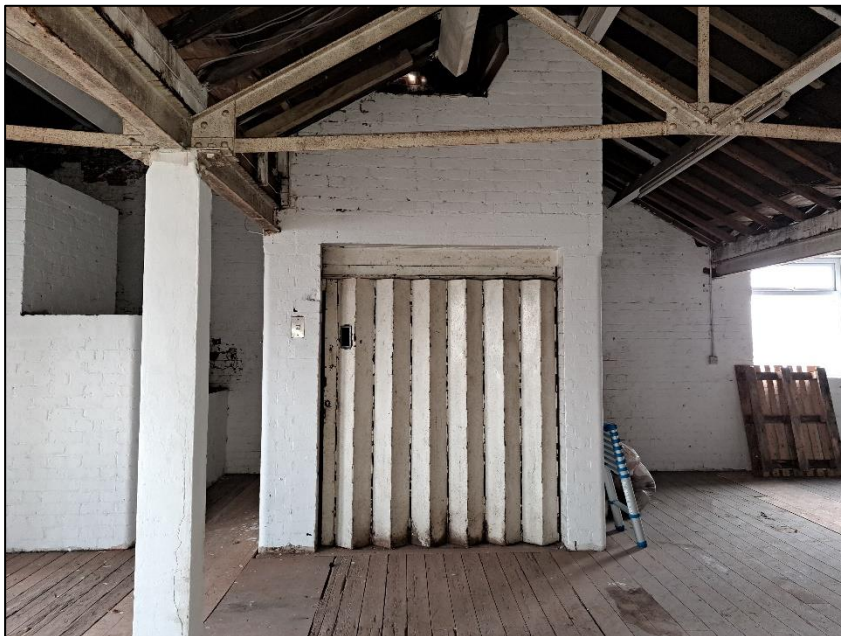
- 3.9 There is a void above the lift shaft that offers access to/ from the exterior, daylight is visible where bricks are missing (see Photograph 10). This space has many cobwebs, and no signs of bats were identified.

*Photograph 10 showing the void and daylight above the lift shaft*

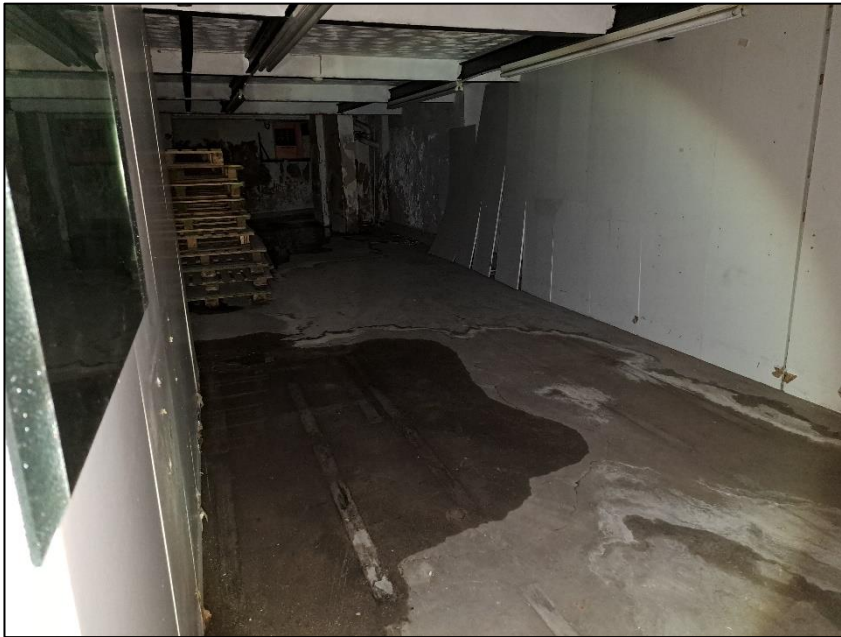
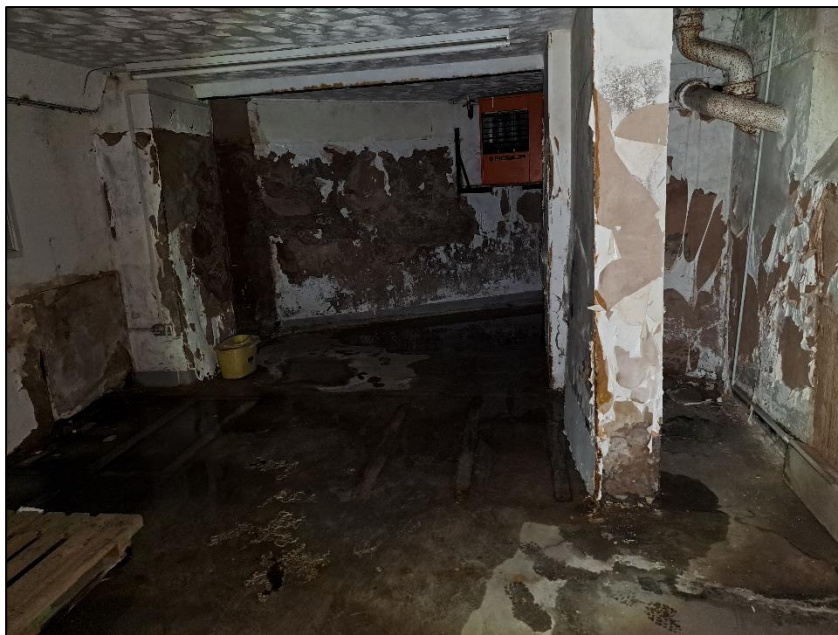
- 3.11 The property has an extensive cellar space. These areas are damp with mould and fungi on the walls and large puddles on the floor (see Photographs 11 & 12). The space is derelict, and no access points or evidence of bats was identified.

*Photograph 11 showing one of the basement rooms*

*Photograph 12 showing one of the basement rooms*
