## PRELIMINARY DAMP AND TIMBER CONDITION

51-53 RICHMOND STREET, MANCHESTER

JOB NO. 213-41

12 SEPTEMBER 2022

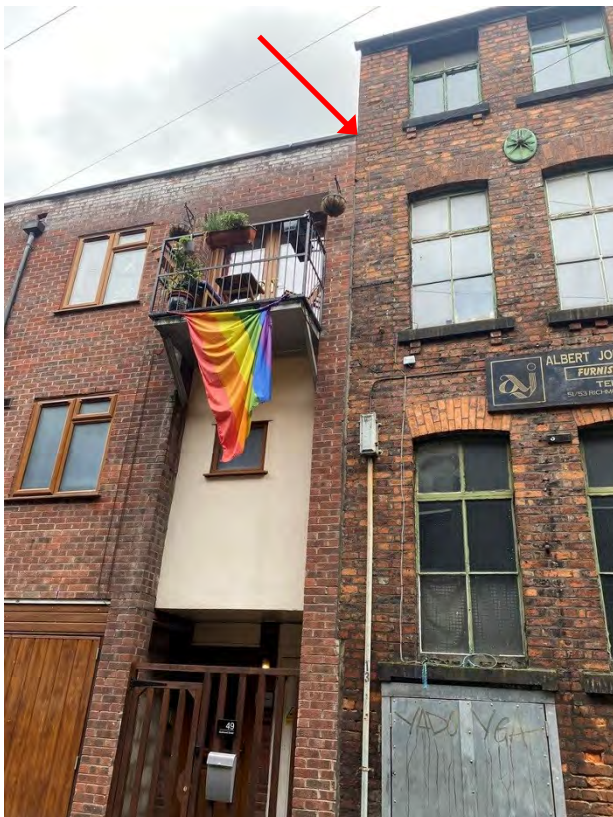
**Fig 2:**

North-west elevation; showing a mastic joint at the abutment with the neighbouring flats. This joint and the lead flashing (at roof level) may be vulnerable to water penetration

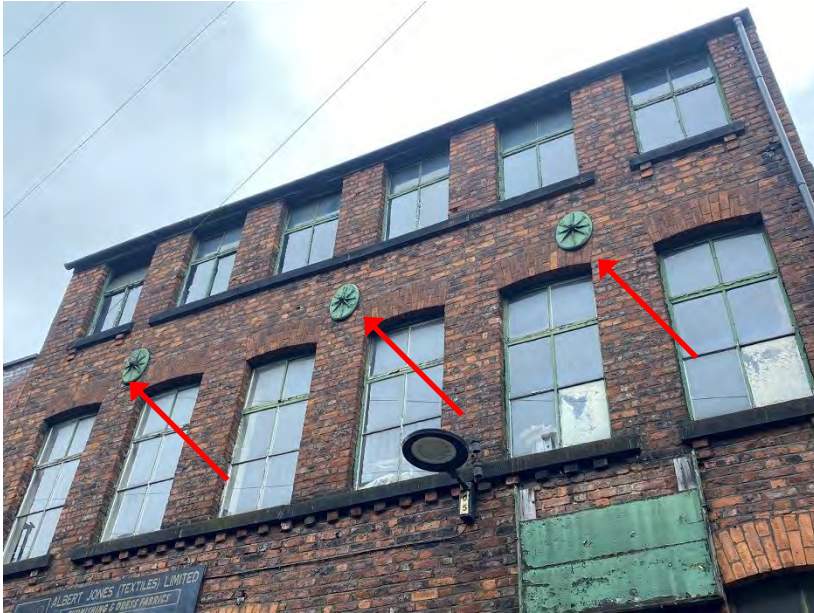
**Fig 3:**

North-west elevation; showing patress plates which correspond with tie-bars in the Second floor

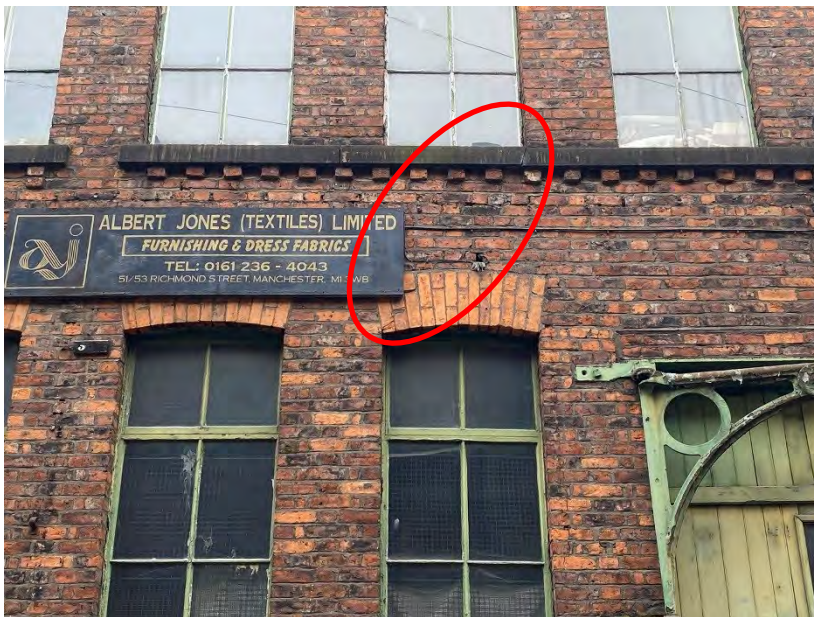
**Fig 4:**

North-west elevation; showing location of step cracking which has extended through the brickwork and projecting stone sill

*Allow for a detailed inspection of the external masonry and render. It may be possible to carefully remove the existing cementitious repointing mortar without causing damage to the brickwork. Future repointing should be undertaken using a suitably specified lime mortar where required. The Structural Engineer should assess the significance of the step cracking and condition of the pattress plate/tie rod installation*

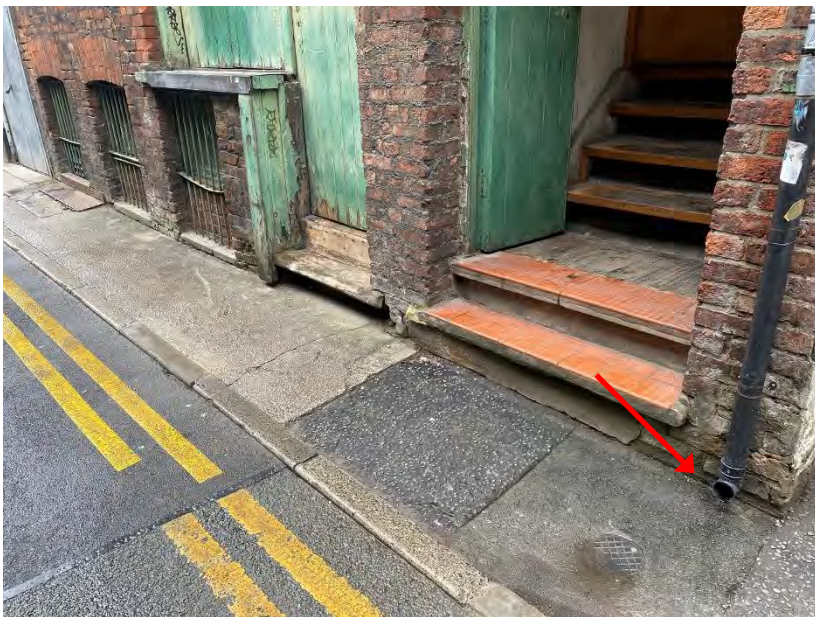
**Fig 6:**

- 2 Rainwater drainage: The pitches were served by uPVC eaves gutters with downpipes located towards the south-west gable. The downpipe to the front elevation discharged via a shoe directly onto the footpath of Richmond Street and gradually drained into a surface drain in the road. The downpipe to the rear elevation discharged directly into the alleyway. There was no evidence of significant defect in the rainwater drainage to the front elevation. However, the rear gutter was inadequately sloped and was overflowing at its centre and in the east corner. The eaves gutter to the neighbouring flats (no's 43-49) was also blocked with debris causing it to overflow onto the east corner of the no. 51-53. These defects in the gutters appeared to be a longstanding issue and resultant water penetration was providing the conditions for damp and timber decay internally

North-west elevation; showing the rainwater downpipe which discharged directly onto the footpath

*Rainwater drainage goods should be serviced as soon as possible. The neighbouring property should also be informed of the defects in their rainwater drainage goods, and this should be rectified. Upon refurbishment it would be advantageous for the downpipes to discharge directly into drainage gullies rather than onto the ground*

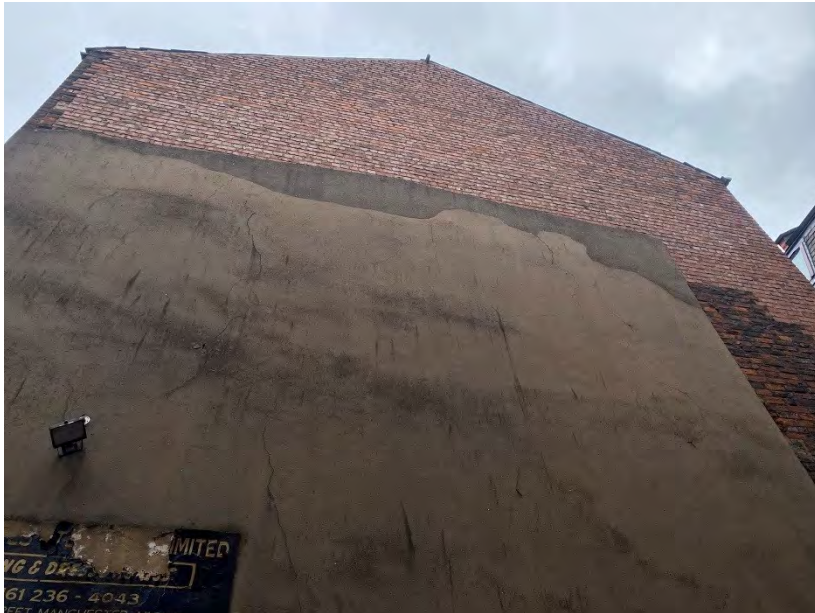
**Fig 7:**

South-west elevation; showing rebuilt section of gable. This is believed to be a response to WW2 bomb damage. There was widespread cracking through the cementitious render which was probably associated with initial shrinkage

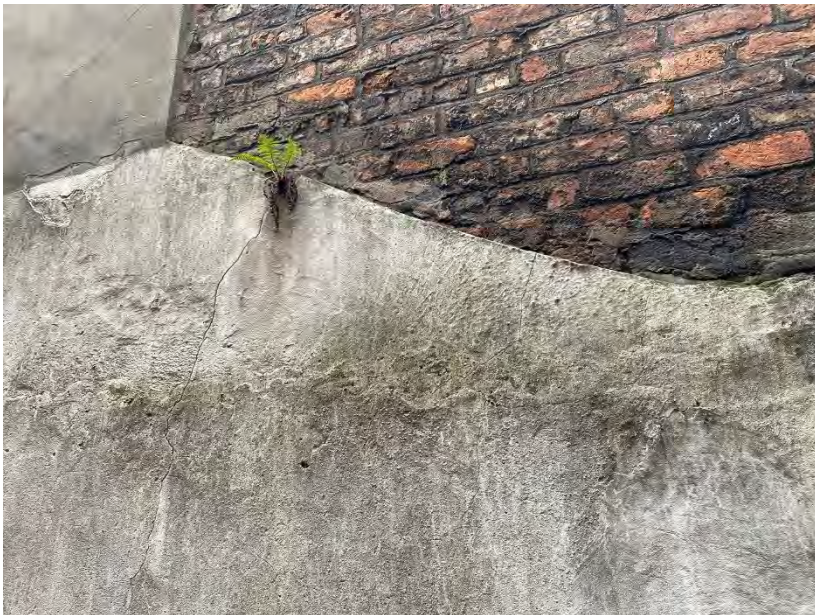
**Fig 8:**

South-west elevation; showing fern growth corresponding with cracking in the cementitious render. Plant growth was indicative of damp conditions within this area of the masonry

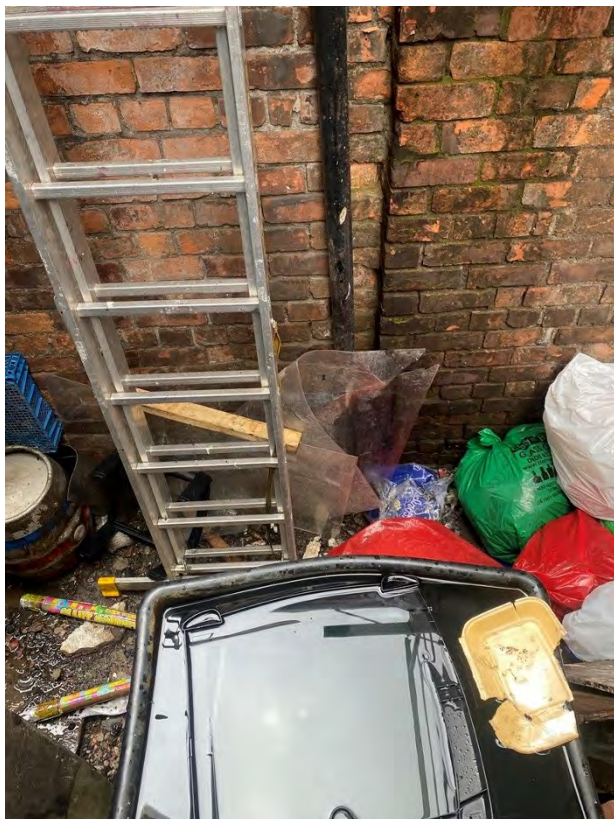
**Fig 10:**

Alleyway; showing a large plastic container filled with water blocking access through the gate. The alleyway was also filled with stored items and general waste

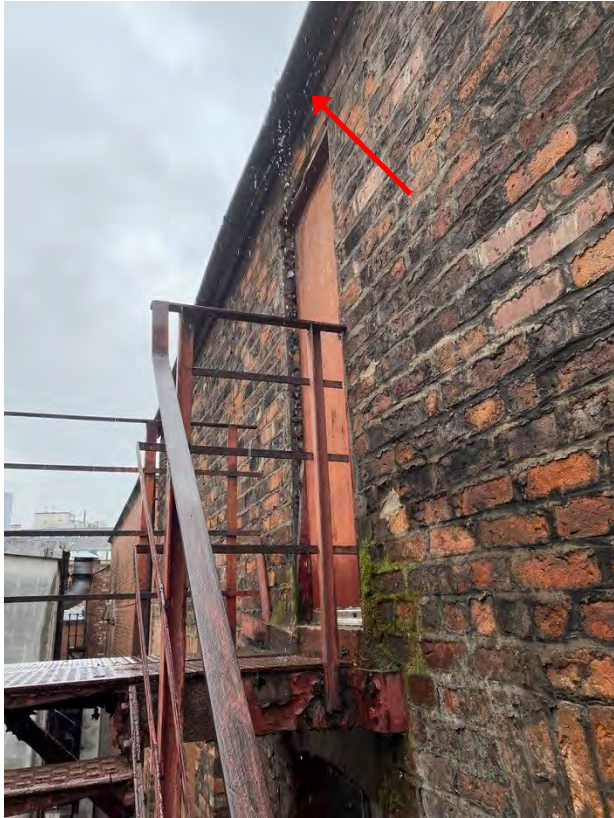
**Fig 11:**

South-east elevation; showing eaves gutter overflowing towards the centre of the rear elevation. This was providing the conditions for damp and timber decay in the internal timber structures

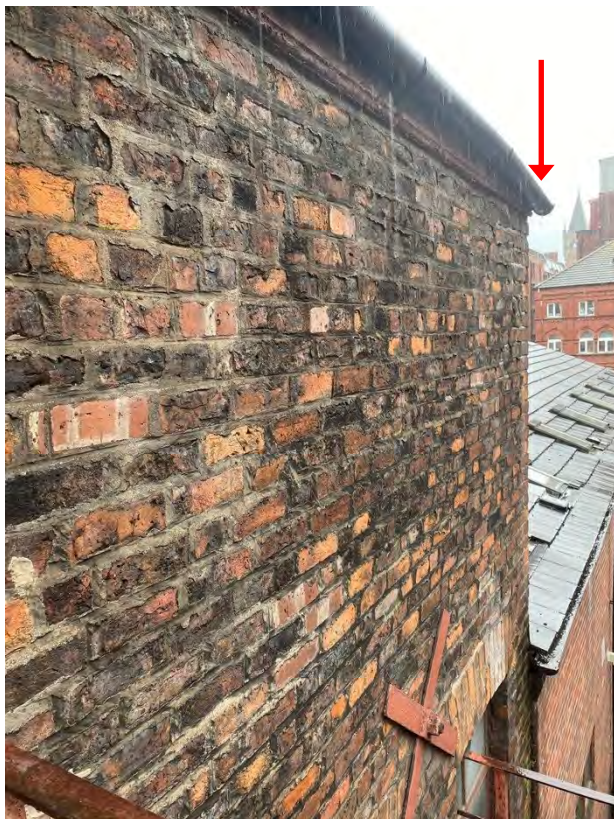
**Fig 12:**

South-east elevation; showing a low point in the east corner of the eaves gutter that was allowing rainwater to discharge against the building

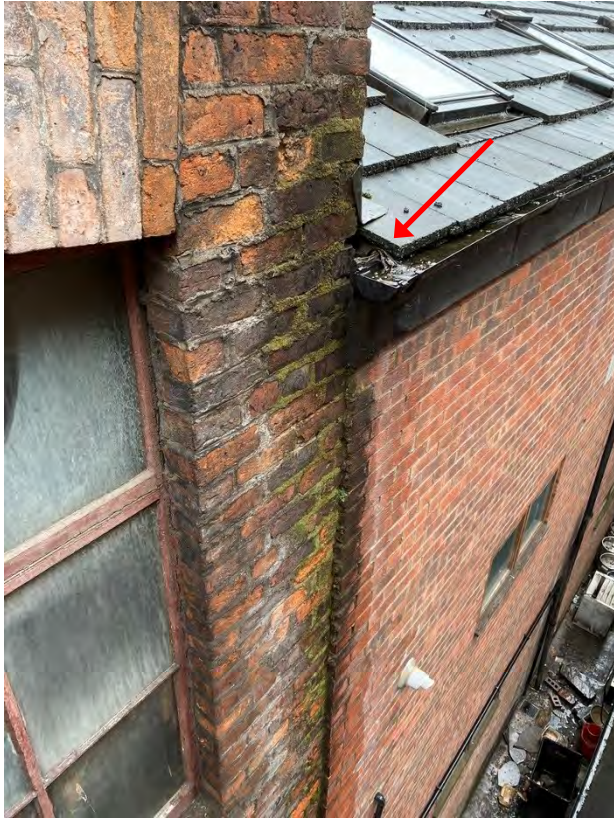
**Fig 13:**

South-east elevation; showing a blockage in the neighbouring eaves gutter providing an additional source of moisture to the east corner of the building

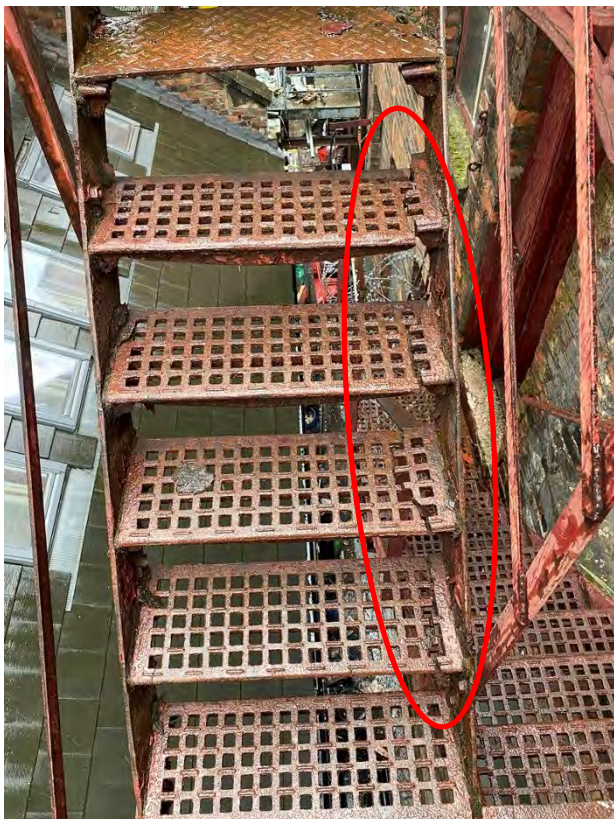
**Fig 14:**

South-east elevation; showing cracks through the fire exit stair treads

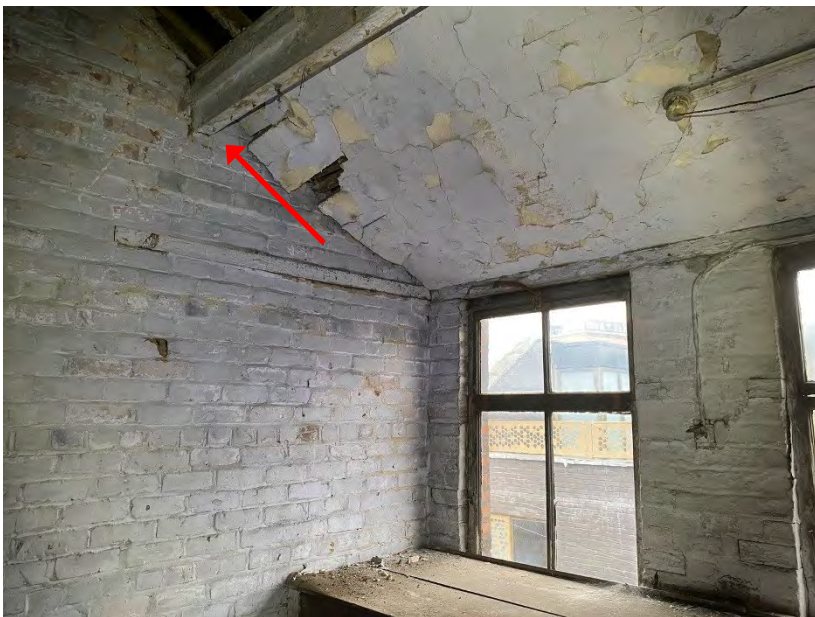
**Fig 16:**

Second floor; showing the bearing end of the lower purlin which was tested by decay detection drilling and deep moisture probing. No decay was detected but the purlin was damp

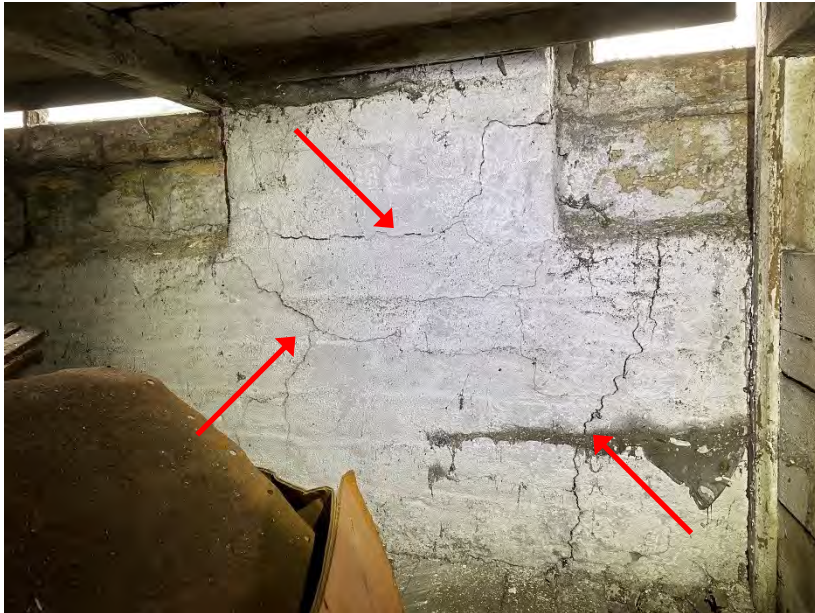
**Fig 17:**

Second floor; showing cracking through the brickwork directly over the location of the patrix plate and tie bar passing through the floor

*Structural Engineer to inspect and assess the significance of the cracking in the brickwork*

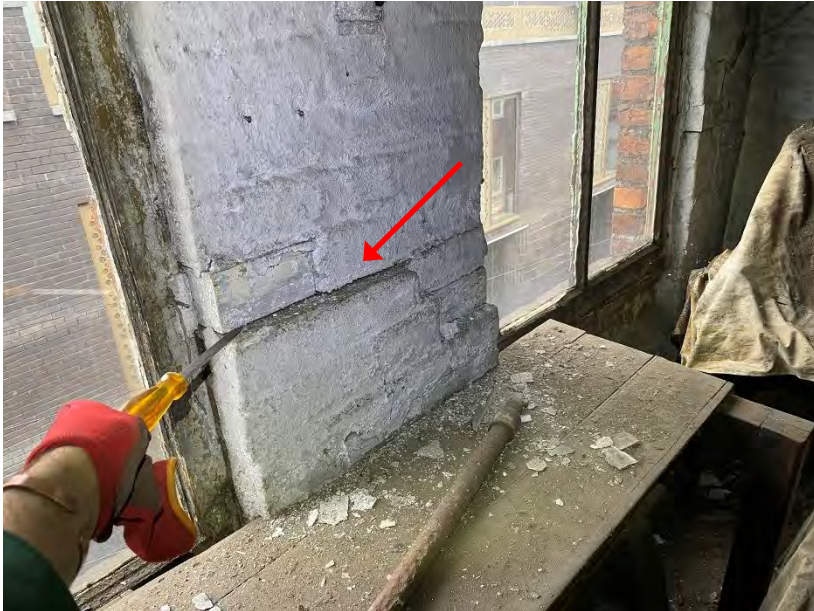
**Fig 19:**

Second floor; showing cracking through the brick pier between the windows. Brickwork and a timber block were loose

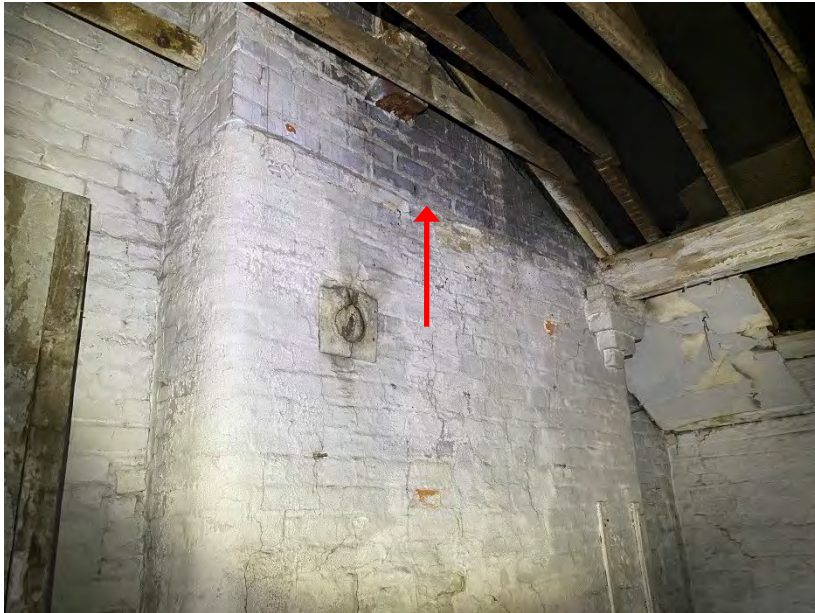
**Fig 21:**

Second floor; showing rebuilding of the upper portion of the chimneystack. This appears to date from WW2 bomb damage

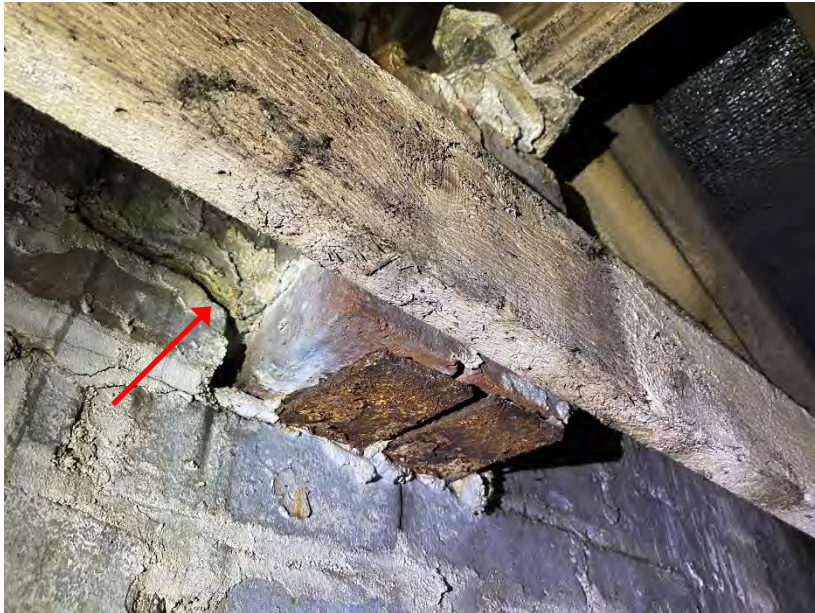
**Fig 23:**

Second floor; showing step cracking through the gable brickwork caused by corrosion of metal beneath the purlin brick corbel

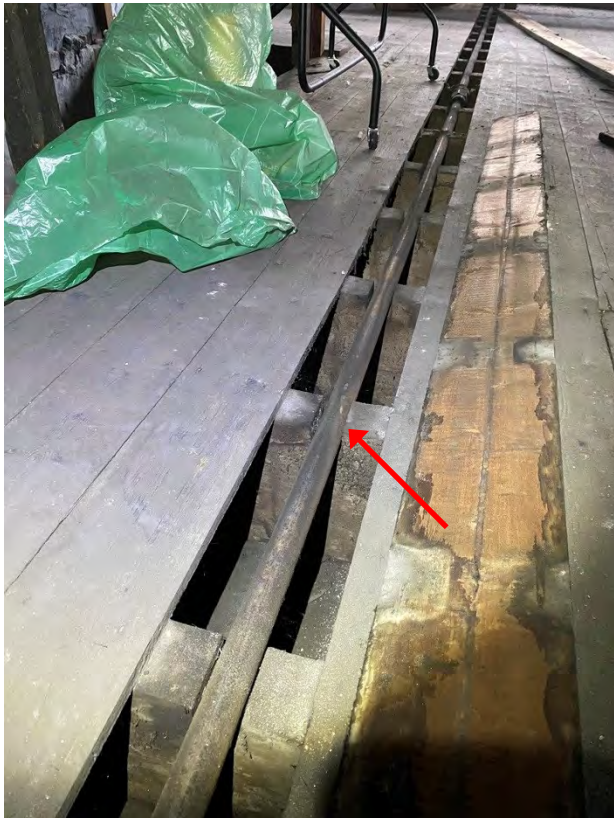
**Fig 31:**

Second floor; showing exposure of one of the three lateral restraint tie bars. Note that the upper section of the joists had been notched to accommodate the tie bar

*No timber decay related repairs identified at this time. Structural Engineer to inspect and assess the performance of the lateral restrain tie bars*

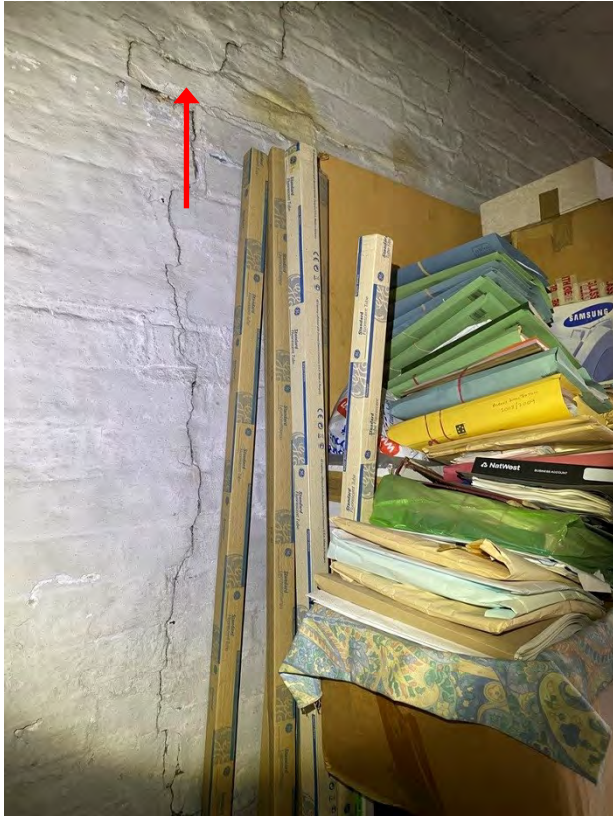
**Fig 37:**

- 3 Walls: There was vertical cracking at either end of the south-west gable wall

First floor; showing vertical cracking within the south-west gable wall. This appeared to correlate with the location of a former doorway. Note that the brickwork was spanned by a redundant timber lintel

*Structural Engineer to inspect and assess the significance of the cracking in the brickwork*

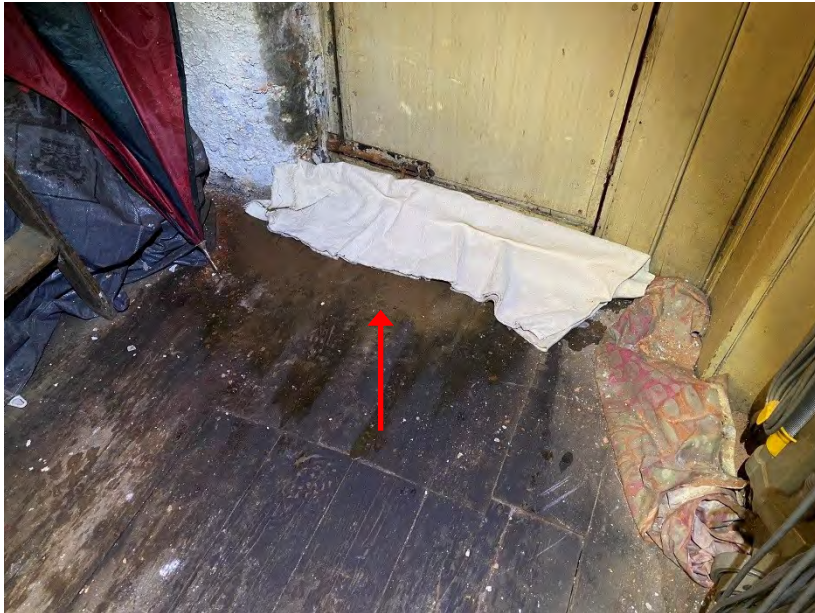
**Fig 41:**

First floor; showing water penetration where rainwater from the leaking gutter was splashing off the emergency exit door threshold. Floorboards were damp and vulnerable to decay but no significant decay had yet occurred

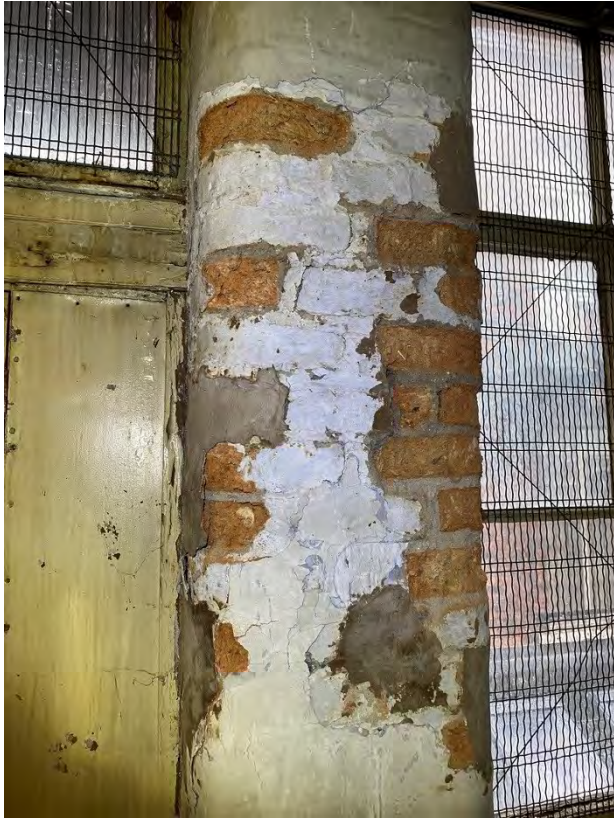
**Fig 43:**

First floor; showing spalling of the brickwork pier caused by inappropriate repointing of damp brickwork using a cement mortar. The brickwork was now dry and this is a historical intervention

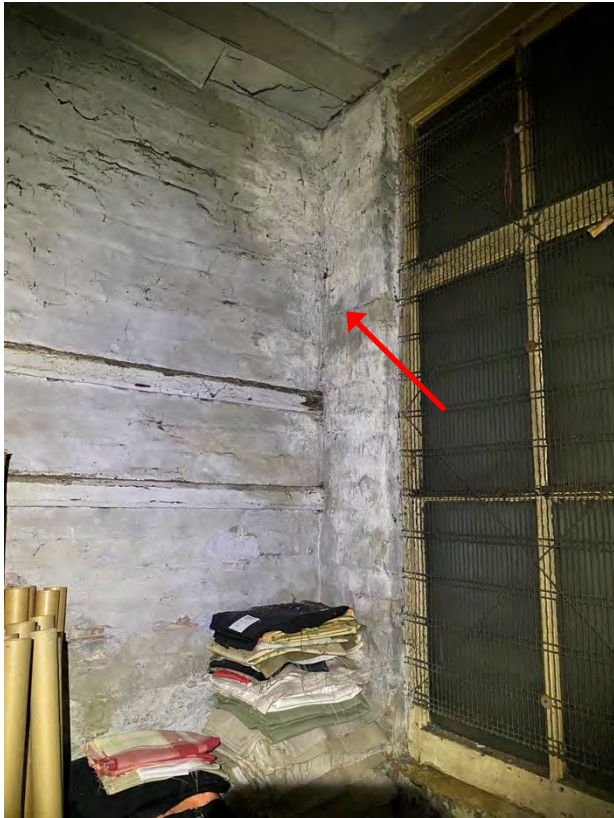
**Fig 51:**

Ground floor; showing staining associated with water penetration from the neighbours defective gutter (see Fig 12-13). Timbers were vulnerable to damp and decay in this location

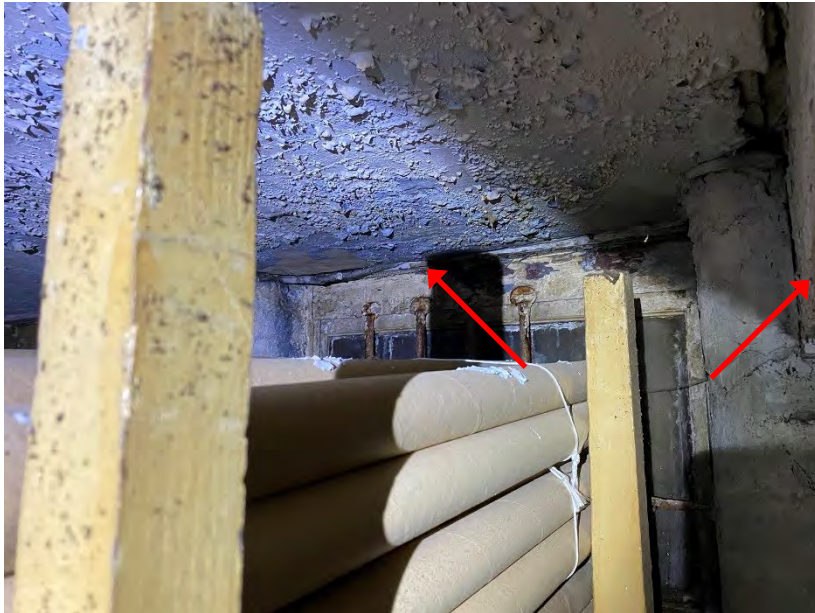
**Fig 53:**

- 2 Lintels: All window openings were spanned by softwood timber lintels internally. The lintel immediately adjacent to the damp floor beam was damp and vulnerable to decay. Access was generally impeded by shelving and stored items at this level

Ground floor; showing the timber lintel which was probably damp. However, there was no visual evidence of fungal decay. The south-east bearing end of the central floor beam was damp but no significant decay had yet occurred

*No timber decay related repairs identified at this time. However, whilst water penetration continues, and residual moisture remains in the structure the lintel was vulnerable to decay. The extent of decay can be confirmed by H+R following purchase*

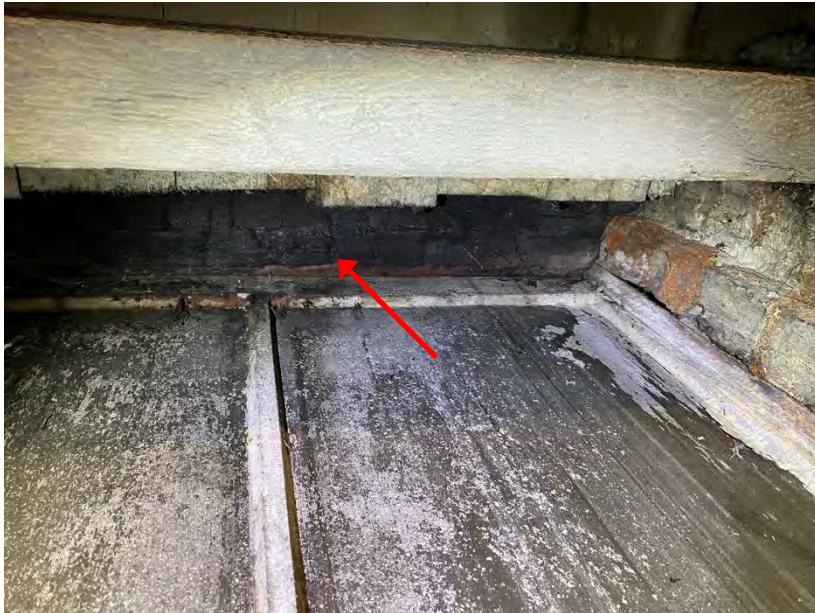
**Fig 59:**

- 2 Lintels: All window openings were spanned by softwood timber lintels internally. All lintels to the south-east elevation were particularly vulnerable to damp and timber decay caused by the defective rainwater drainage. However, the lintels were inaccessible for tactile assessment as the floor height restricted access but there was visible surface charring to the timbers related to the historical fire

Lower ground floor; showing charring to the inner timber lintel caused by fire damage

*Allow for detailed assessment of the significance of charring. Whilst water penetration continues, and residual moisture remains in the structure the lintels were vulnerable to decay. The extent of decay can be confirmed by H+R following purchase. Allow for replacement of decayed lintels with concrete as specified by a Structural Engineer*

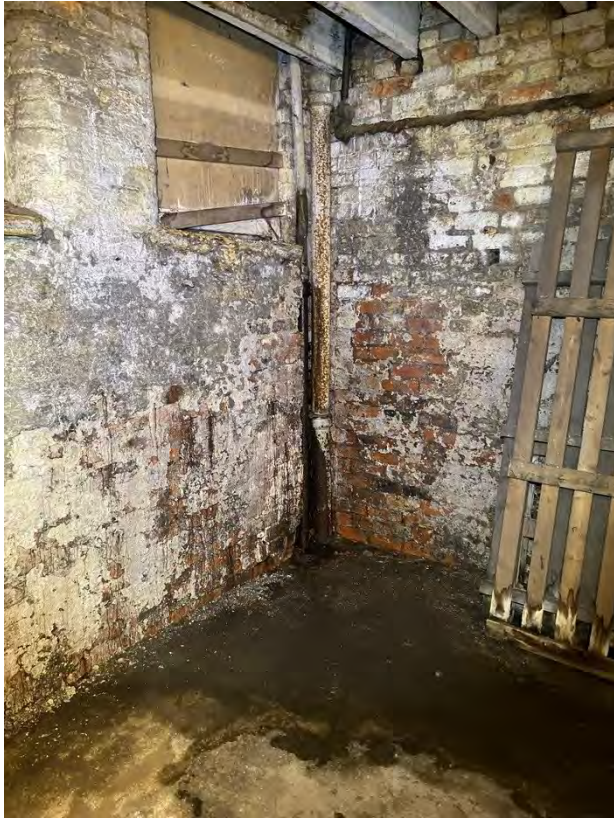
**Fig 61:**

- 4 Drainage: The downpipe to the rear elevation entered the building and discharged into a drain in the lower ground floor. The soil vent pipe also appeared to be blocked and leaking sewage into the lower ground floor

Lower ground floor; showing leakage of the downpipe and soil vent pipe in the south corner. Water gradually drained towards a drain in the centre of the basement floor

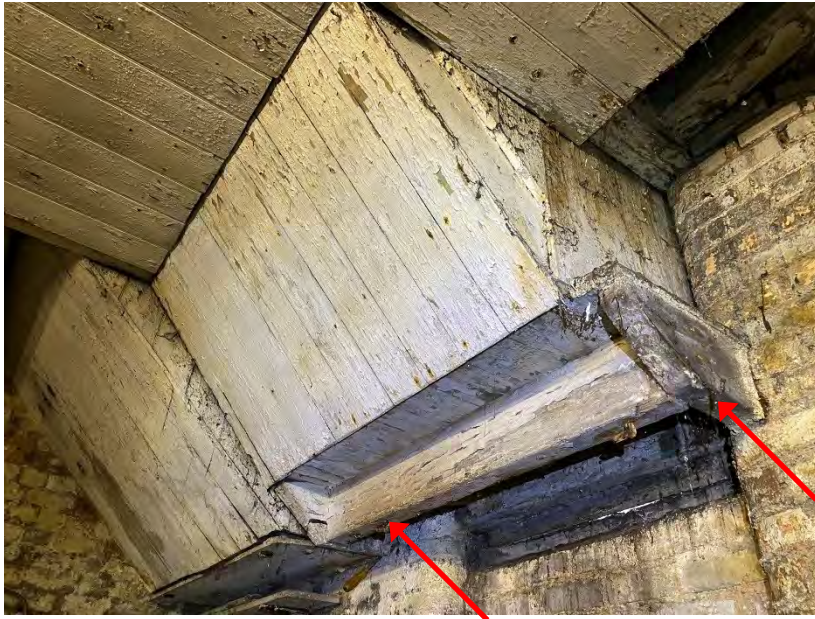
**Fig 65:**

- 1 Staircase: The bearing end of the staircase landing joists were damp and partially decayed by wood-boring weevil. The timbers were prone to damp as they were practically level with the external ground level

Lower ground floor; showing the base of the staircases where they were supported in the masonry. The timber joists were damp and partially decayed by wood-boring weevil

*Allow for repairs to the decayed landing joists. Ideally, the timbers should be removed from the damp wall and re-supported on non-timber hangers/corbels so that no timbers are in direct contact with the damp masonry*

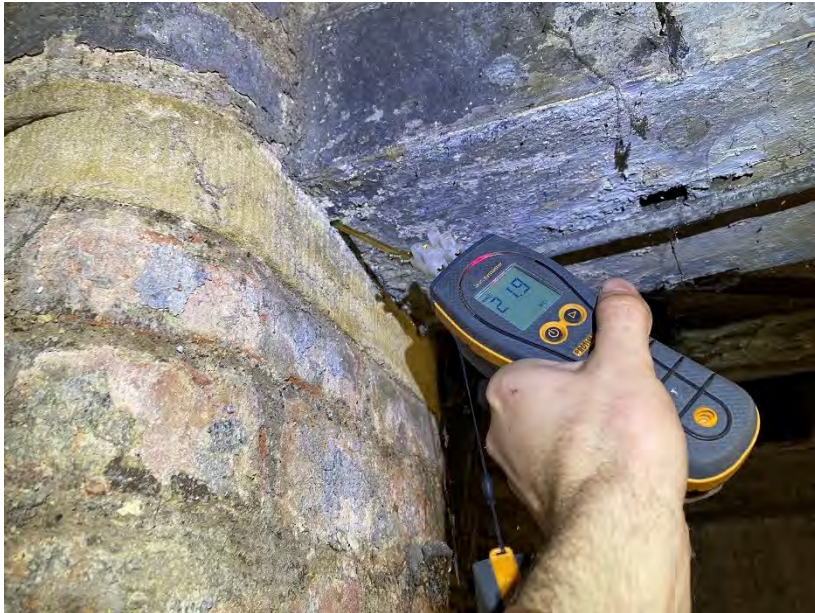
**Fig 67:**

Lower ground floor; showing deep moisture probing of the north-west bearing end of the central floor beam. The beam was damp but no significant decay was detected

*No timber decay related repairs identified at this time. However, whilst water penetration continues, and residual moisture remains in the structure the bearing ends of floor timbers are vulnerable to decay. The extent of decay can be confirmed by H+R following purchase. However, at this stage, allow for repairs to the bearing end of the floor beam, say 5 no. joists and 4m<sup>2</sup> of floorboards*
