**Re: London Road Fire Station - Coronas Court - update Rot Inspection**

**SURVEY REPORT**  
**TIMBER INSPECTION**

**Coronas Court Update**  
**London Road Fire Station**  
**Manchester**

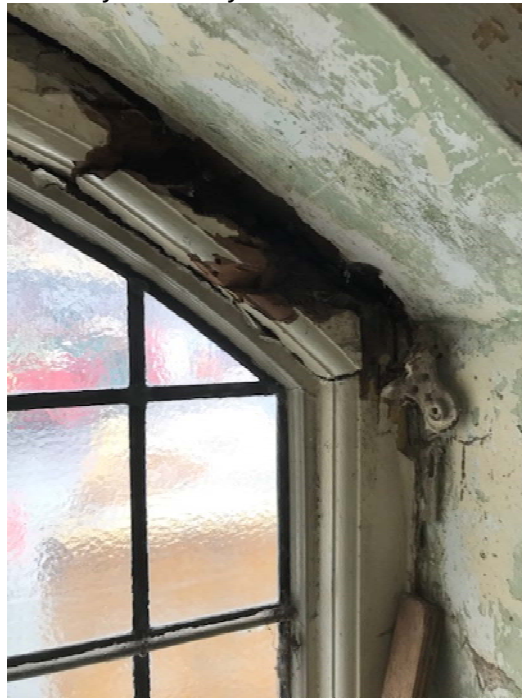
| ROOM NO | TIMBER ELEMENT | CONDITION |
|---|---|---|
| | Window joinery; cill & casement | Curved frame decayed – dry rot; requires bespoke repair, plaster strip and masonry treatment |

Dry rot decay to window Frame

| Area of Issue | Work | Cost |
|---|---|---|
| Room 7; Window joinery; dry rot to frame | strip out localised area around windows back to brickwork and treat masonry (surface spray) inc.<br><br>Window splice repair to curved frame (bespoke) | £350<br><br>By main Contractor |

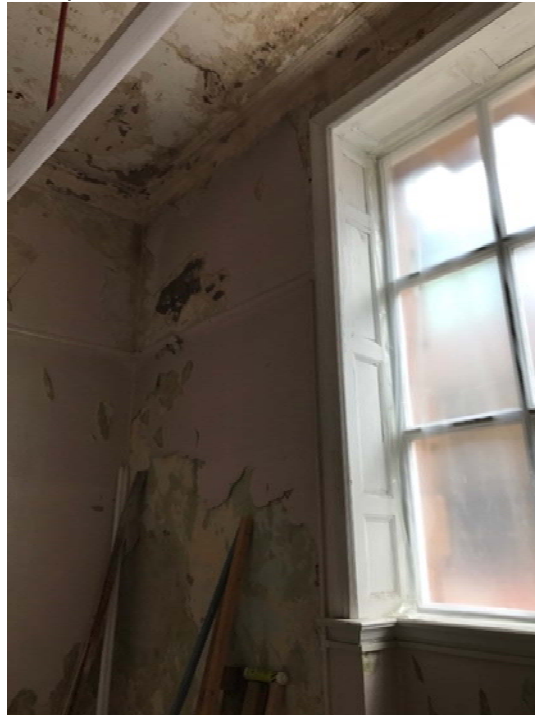
Residual dampness to wall and soffit around window reveals

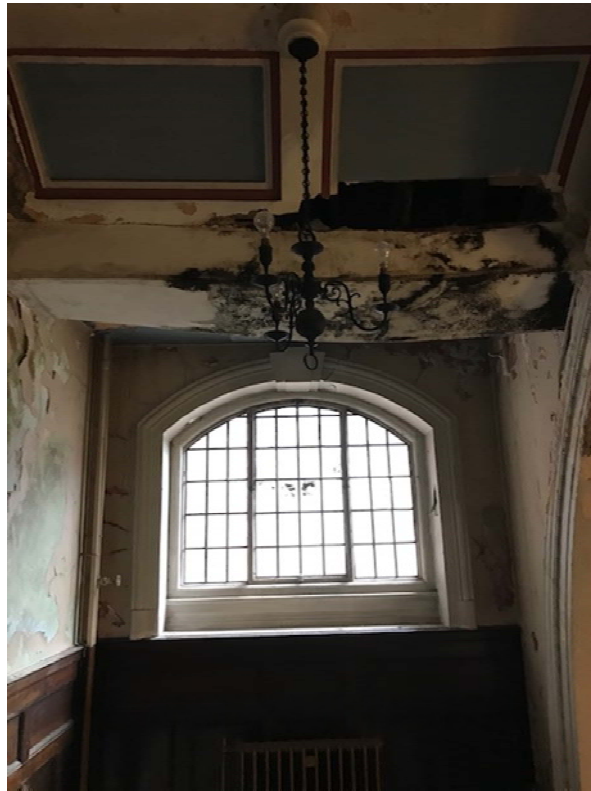
2.5 The main notable difference since the original reports is where ingress has since caused the soffit to collapse over the courtroom balcony (dry rot is present) and the rooms behind the courtroom below the entrance road in the courtyard are particularly damp and all nearby finishing timber has deteriorated.

| ROOM NO | TIMBER ELEMENT | CONDITION |
|---|---|---|
| | Area of ingress over soffit | <p>Dry rot decay visible to soffit; full access and investigation required; <b>allow prov. sum repairs:</b></p> <ul style="list-style-type: none"> <li>- Bearer beam; approx. 3m; replace</li> <li>- Ceiling joists; approx. 8no.; replace 1.5m</li> <li>- Vertical posts/straps; replace approx. 3no.</li> <li>- Patruss timber forming curve to soffit; approx. 8no.</li> <li>- Loft hatch trimmers + Architraves</li> <li>- Upper purlins – allow x2</li> <li>- Unknown repairs</li> <li>- Masonrty treatment</li> <li>- Timber treatment locally</li> </ul> <p>Other; ornate plaster damaged with salts noted; residua dampness</p> |

Soffit Collaspse around beam; dry rot

| Area of Issue | Work | Cost |
|---|---|---|
| Room 6; Ingress over soffit;<br>dry rot and ceiling collapse<br>present | Prov. Sums<br>Bearer beam; approx. 3m;<br>replace<br><br>Ceiling joists; approx. 8no.;<br>replace 1.5m<br><br>Vertical posts/straps; replace<br>approx. 3no.<br><br>Patruss timber forming curve<br>to soffit; approx. 8no. (repair)<br><br>Loft hatch trimmers +<br>Architraves<br><br>Upper purlins - allow x2<br><br>Unknown repairs<br><br>Strip plaster/Masonry<br>treatment inc.<br><br>Timber treatment locally | £150 Scaff<br>£550<br><br>£600<br><br>£225<br><br>£1500<br><br>£350<br><br>£2000<br><br>£2000<br><br>£1000<br><br>Inc. |

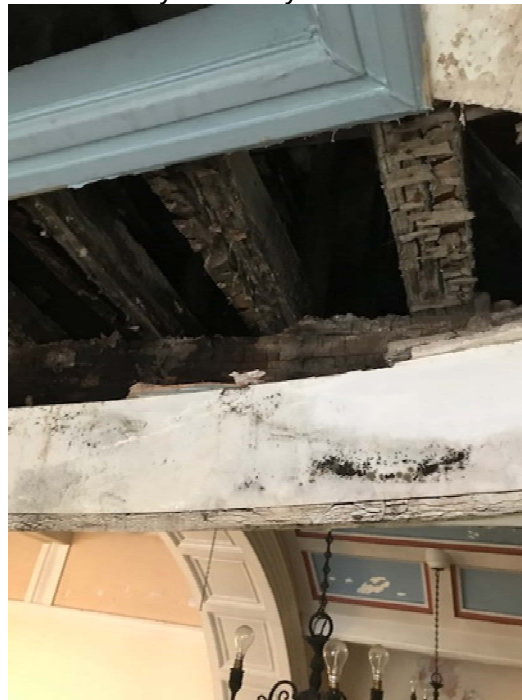
Dry rot decay to soffit

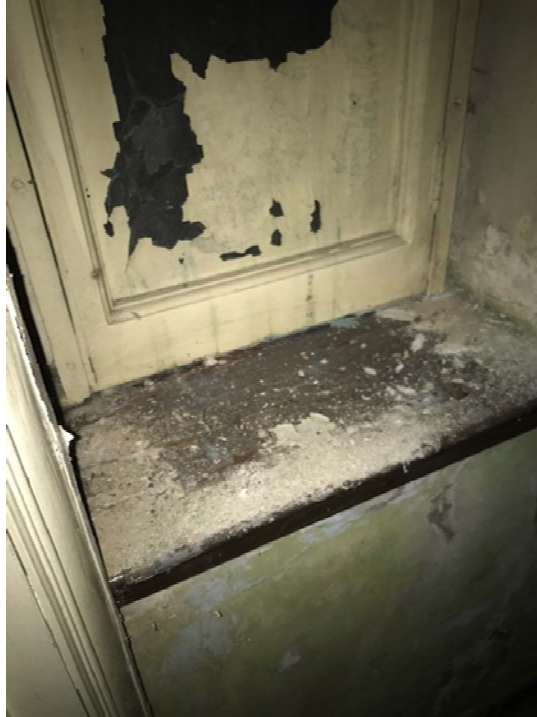
| | Window joinery in toilet cubicle | <b>Dry rot to soffit of reveal (lath &amp; plaster on battens); strip out and masonry treatment - Lower WC</b><br><b>Dry rot to cill of window; strip out and masonry treatment - Upper WC</b> |

Dry rot decay to cill in WC

| Area of Issue | Work | Cost |
|---|---|---|
| Room 5; Window joinery in<br>toilet cubicle; Dry rot to soffit<br>of reveal (lath & plaster on<br>battens); Dry rot to cill of<br>window | strip out localised area around<br>windows back to brickwork and<br>treat masonry (surface spray)<br>upper and lower WC<br><br>Reinstatement/plaster/window<br>joinery | £200 strip<br><br>Inc.<br>Treatment<br><br>By Main<br>Contractor |

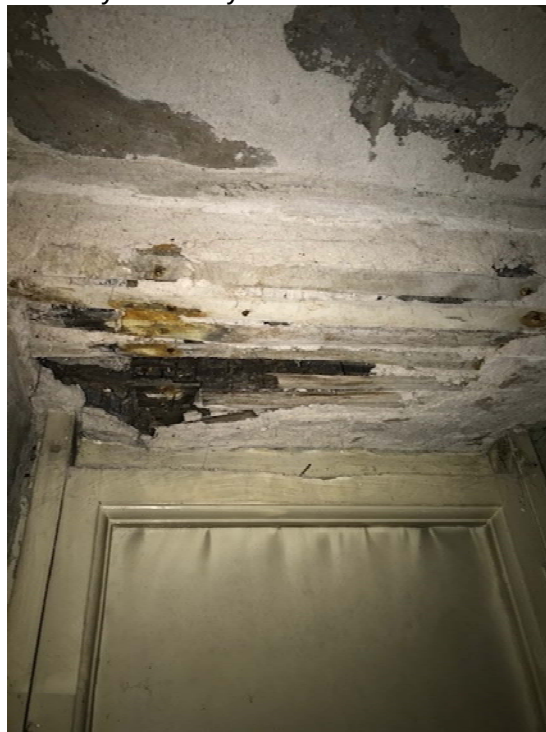
Dry rot decay to reveal soffit in WC

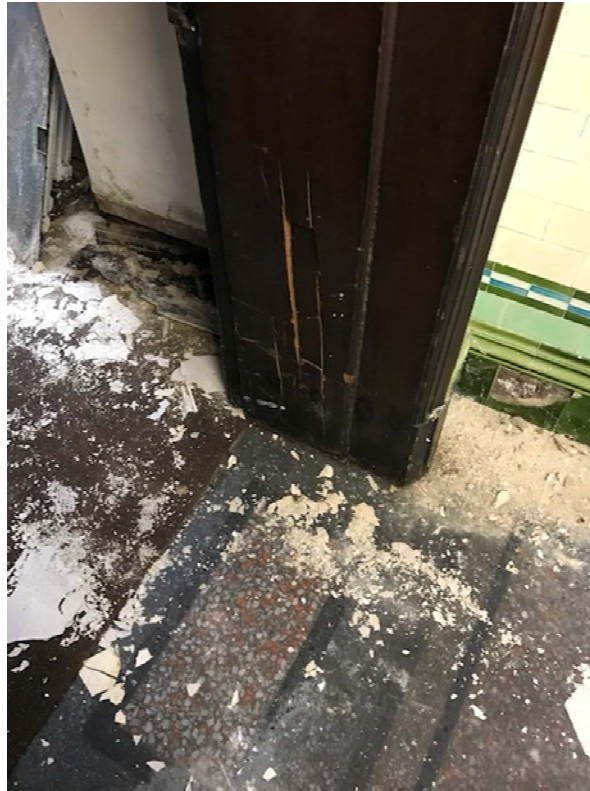
Dry rot decay to door jamb reveal

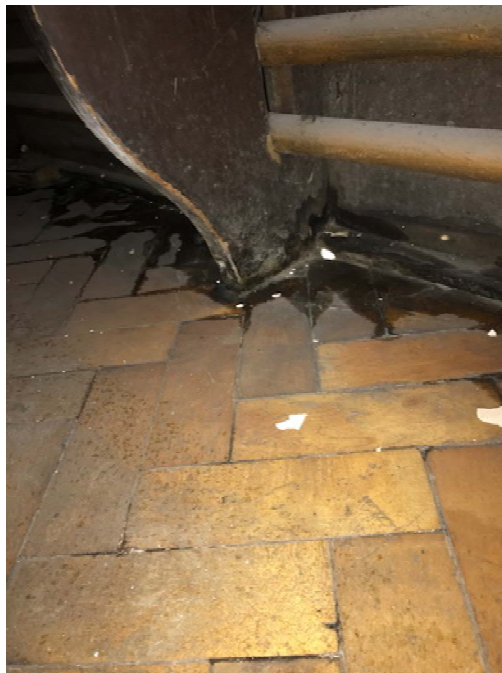
| ROOM NO | TIMBER ELEMENT | CONDITION |
|---|---|---|
| | Parquet Floor | No signs of visible rot; just some visible wetting below balcony wall |

Visible wetting to Parquet in Courtroom
