**Condition Report and Repair Schedule**  
27-33 King Street West, The Carriage Works and Warehouse

This Condition Report and Repair Schedule has been produced on behalf of Property Alliance Group to accompany the Planning and Listed Building Consent application for the redevelopment of 27-33 King Street West, The Carriage Works and Warehouse.

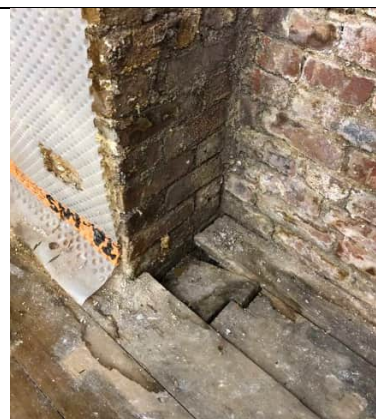
X28

| Item | Concrete infill |

| Specification | n/a |

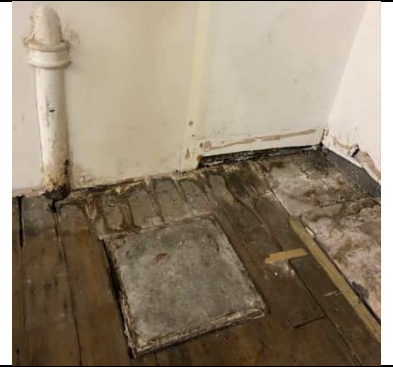
X29

| Item | Fire Hearth |

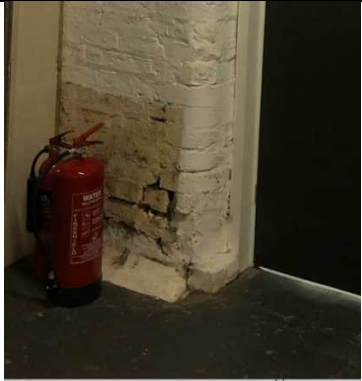
G04

| Item | Missing mortar | |
| Description | Mortar has been dislodged, loose and eroded. | |
| Condition | 02 | |

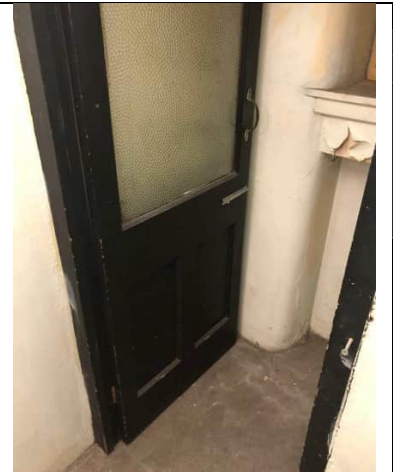
G15

| Item | Feature - Timber door |

| Specification | (DOR-001) – Repair / Refurbish door |

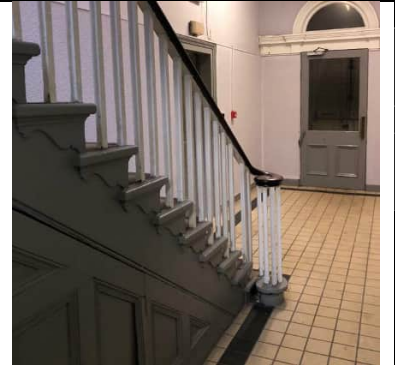
G18

| Item | Feature – Wall vent grille |

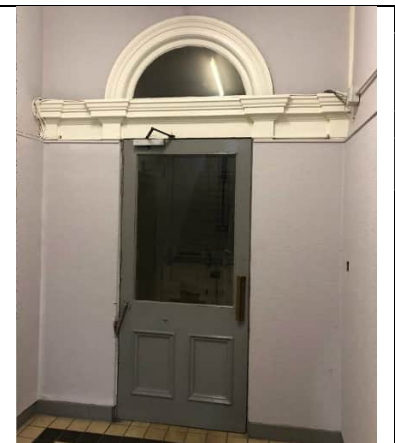
G20

| Item | Tiled floor |

| Specification | (REM-100) – Remove tiled flooring |

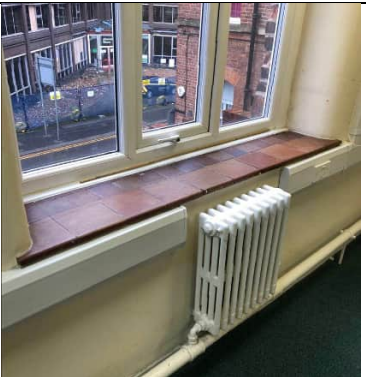
1.01

| Item | Tiled window cills | |
| Description | Tiles laid to all window cills, some being cut to radiused jambs<br>Unlikely original. | |
| Condition | 01 | |

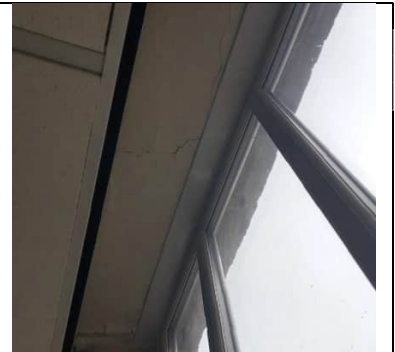
1.03

| Item | Tiled window cills |

| Specification | n/a |

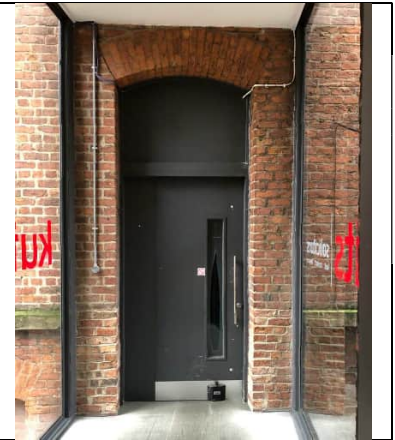
1.05

| Item | Reinstate window, brickwork and cill |

| Specification | <b>(MAS-001)</b> Masonry repair<br><b>(MAS-002)</b> Masonry repointing<br><b>(MAS-003)</b> New masonry<br><b>(WIN-100)</b> Replacement Window |

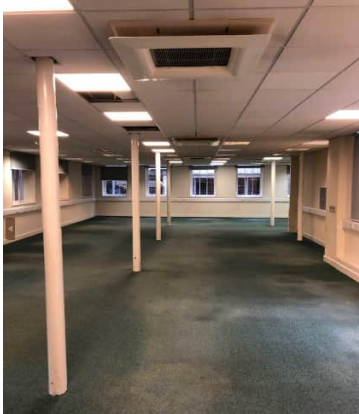
1.06

| Item | Feature - Columns | |
| Description | Original cast iron structural columns, assumed to have profiled heads above ceiling with supporting timber beams and joists. | |
| Condition | 01 | |

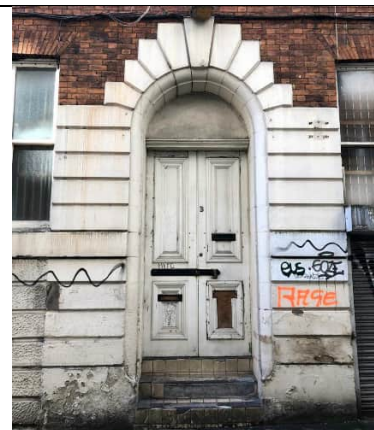
E  
111

| Item | Masonry pointing |

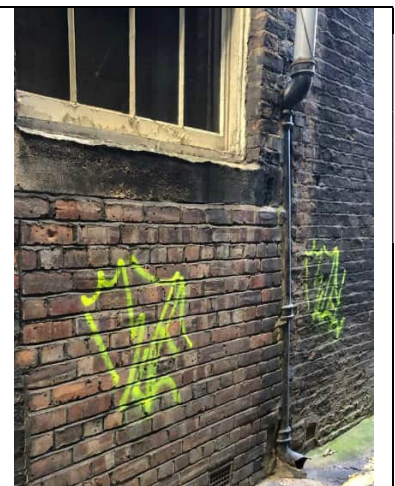
E  
202

| Item | Stone cill spalling |

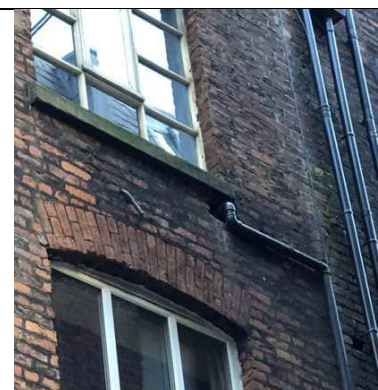
E  
214

| Item | Rainwater pipes upvc / Iron |

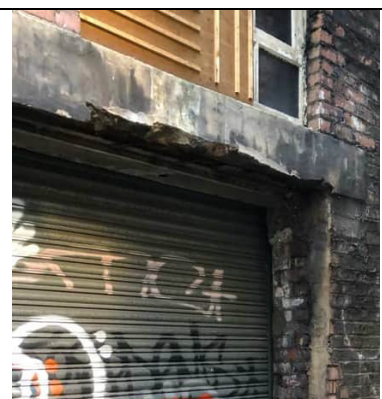
E  
218

| Item | Vegetation |

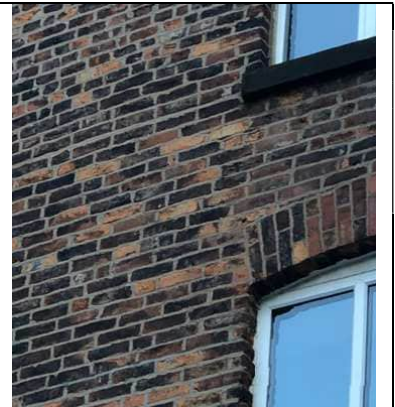
E  
301

| Item | Façade mounted fixture |

| Specification | (REM-100) Remove fixture<br>(MAS-001) Masonry repair<br>(MAS-002) Masonry repointing |

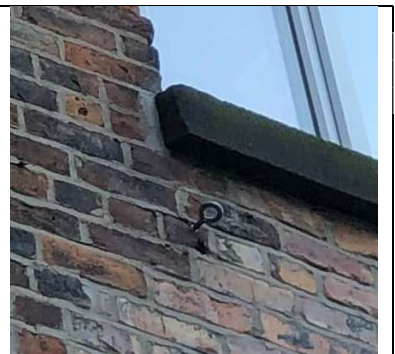
E  
302

| Item | Poor quality brick infill |

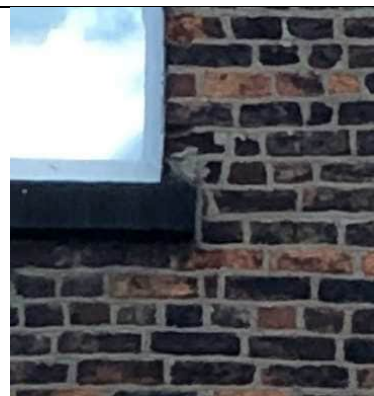
E  
305

| Item | Damage to external stone cill |

| Specification | <b>(MAS-001)</b> Masonry repair |

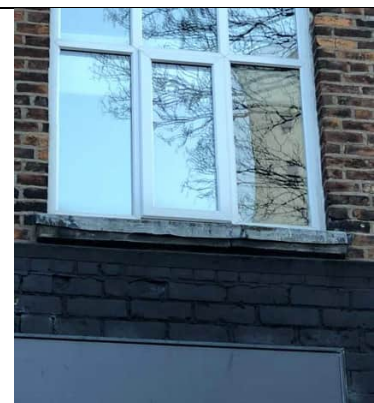
E  
307

| Item | Damage to external stone cill |

| Specification | (MAS-001) Masonry repair |

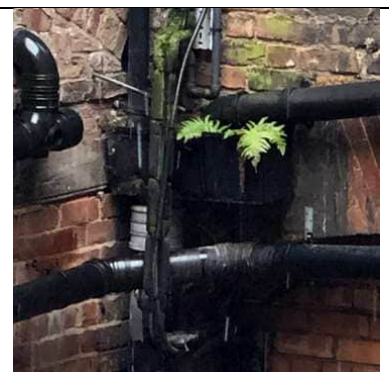
E  
504

| Item | Service penetrations |

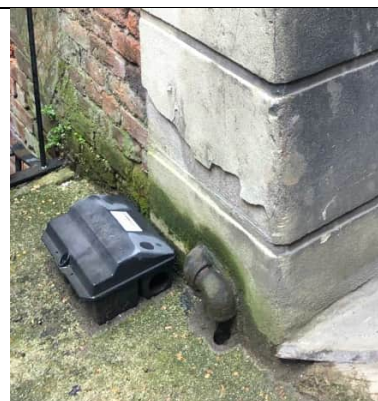
E  
705

| Item | Render to stonework |

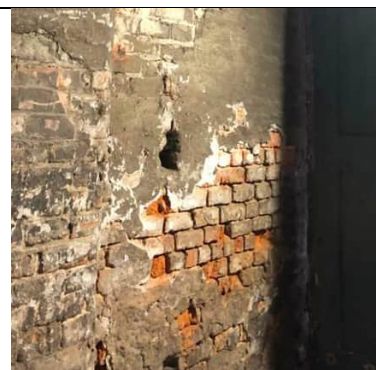
E  
709

| Item | Exposed structure |

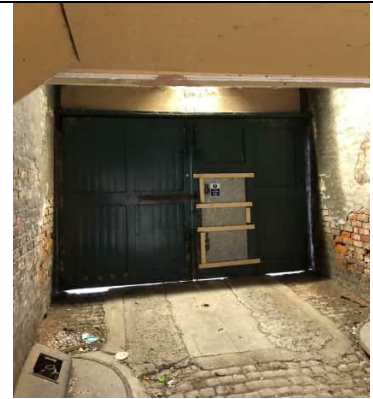
G24

| Item | Feature - Iron kerb |

| Specification | (CLN-001) – Cleaning<br>(REM-100) – Remove concrete (note below) |
