## Freetrade Exchange Paint Analysis

### Report on Findings Report No HPMFT01

ISSUE 01– 16/01/2023

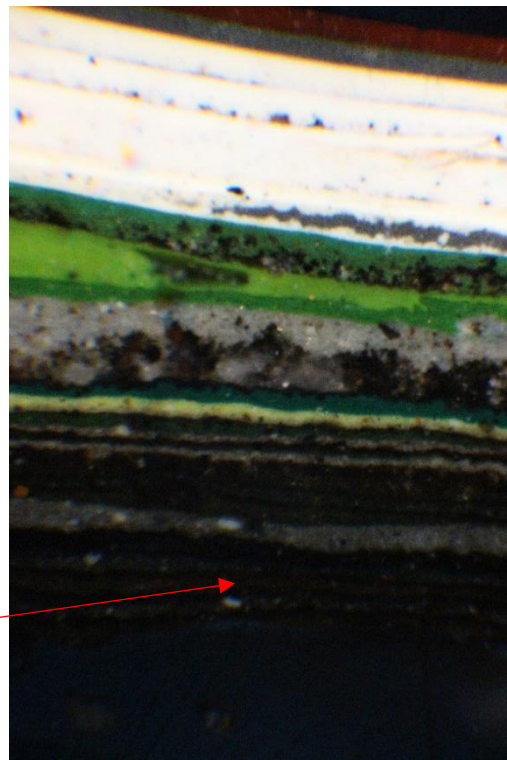
Extract from sample 5 analysis – showing the 31 separate paint layers applied to the timber windows.

Earliest paint coatings – dark green oil paint (lead based) which had a matt finish.

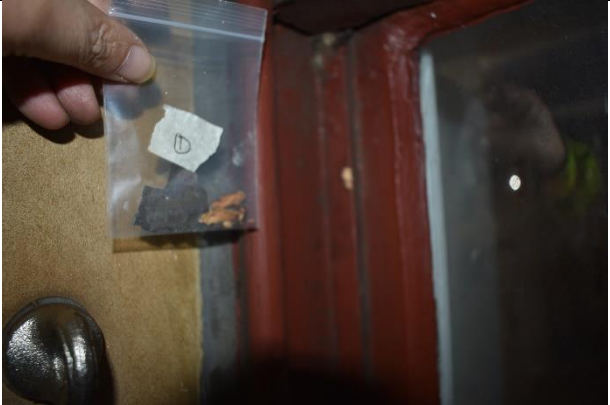
| Sample Ref: 01 – (Window) | Location: Freetrade Exchange |
|---|---|
| <p>Paint sample removed from:</p> <p>Location: 01 – First Floor Window – South Elevation</p> <p>A total of 13 separate paint layers were found.</p> | |

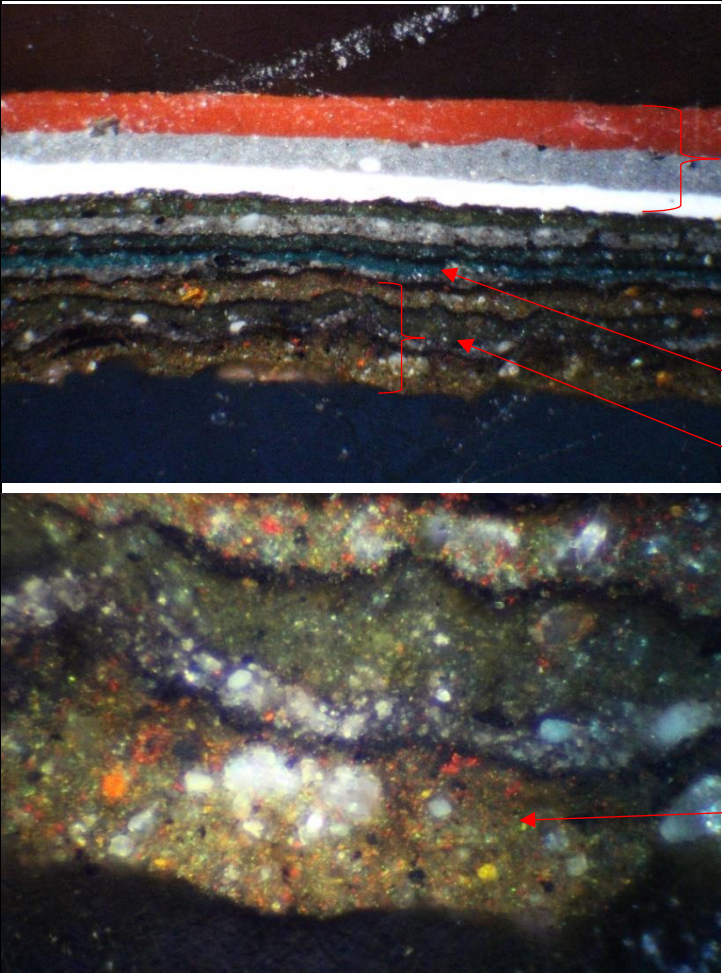
| Sample Ref: 01 – (Window) | Location: Freetrade Exchange |
|---|---|
| | <p>X50 –</p> <p>Current dark red colour scheme (Red alkyd paint with grey intermediate coating and white primer layer).</p> <p>3 separate green oil paints over grey intermediate coats.</p> <p>Single blue paint colour.</p> <p>3 No green oil paints (earliest paint coatings).</p><br><p>X400 -</p> <p>Earliest paint layers.</p> <p>Earliest paint scheme – green oil paint with considerable dirt on the surface of the paint.</p> |

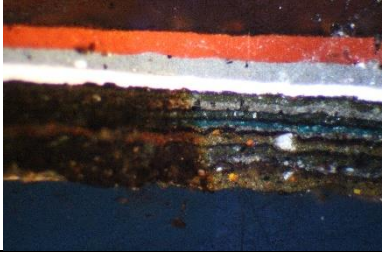
| Sample Ref: 01 – (Window) | Location: Freetrade Exchange |
|---|---|
| <p>Early schemes tested for lead</p> <p>Yes – evidence of white and red lead present.</p> | |

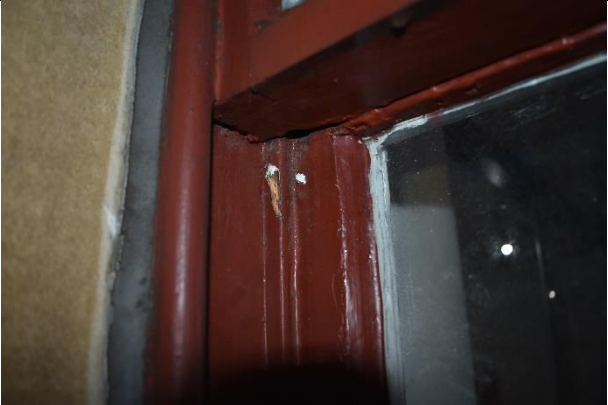
| Sample Ref: 02 – (Window) | Location: FreeTrade Exchange |
|---|---|
| <p>Paint sample removed from:</p> <p>Location: 02 – Second Floor Window – East Elevation</p> <p>A total of 11 separate paint layers were found.</p> | |

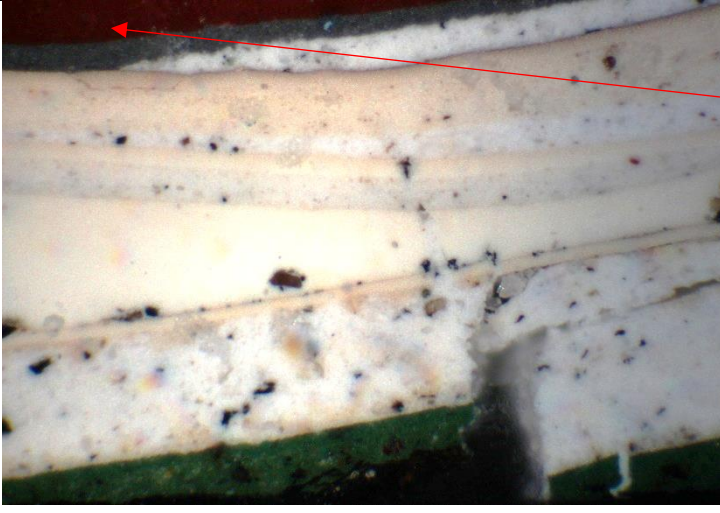
| Sample Ref: 02 – (Window) | Location: FreeTrade Exchange |
|---|---|
| | <p>X50 –<br/>Current dark red colour scheme (Red alkyd paint with grey intermediate coating and white primer layer).</p> <p>4No separate Titanium white paint coatings over white intermediate coatings.</p> <p>2No green oil paints (earliest paint coatings).</p> |

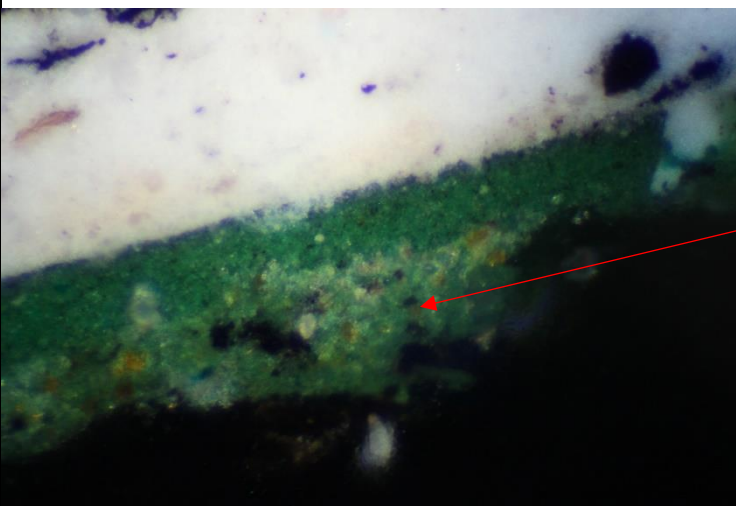
| Sample Ref: 02 – (Window) | Location: FreeTrade Exchange |
|---|---|
| | <p>X400 –<br/>Earliest paint layers.</p> <p>Earliest paint layer present – green oil paint. Earliest paint layers are missing in sample. (Window fully abraded prior to application of green layers).</p> |

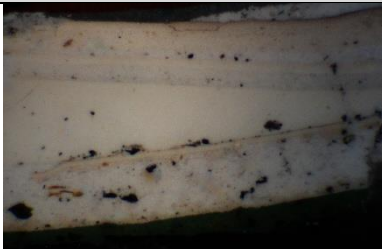
| Sample Ref: 02 – (Window) | Location: FreeTrade Exchange |
|---|---|
| <p>Early schemes tested for lead</p> <p>Yes – no evidence of lead paints.</p> | |

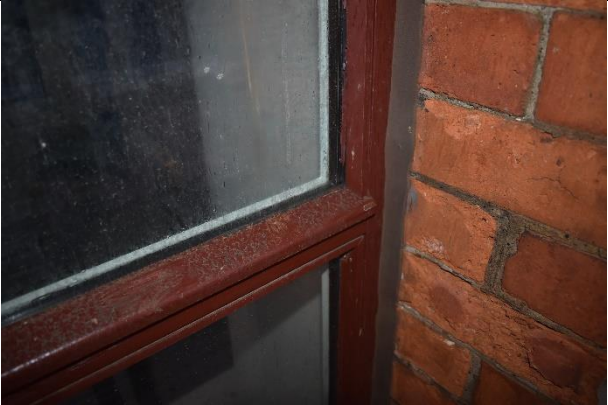
| Sample Ref: 03 – (Window) | Location: Freetrade Exchange |
|---|---|
| <p>Paint sample removed from:</p> <p>Location: 03 – Third Floor Window – North Elevation</p> <p>A total of 3 separate paint layers were found.</p> | |

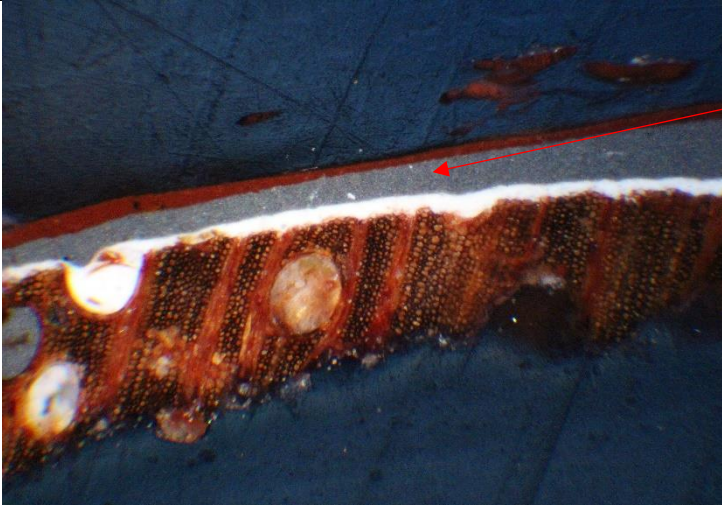
| Sample Ref: 03 – (Window) | Location: Freetrade Exchange |
|---|---|
| | <p>X50 –<br/>Current dark red colour scheme<br/>(Red alkyd paint with grey intermediate coating and white primer layer).</p> <p>(Windows are modern replacements – only one paint scheme applied since installation).</p> |

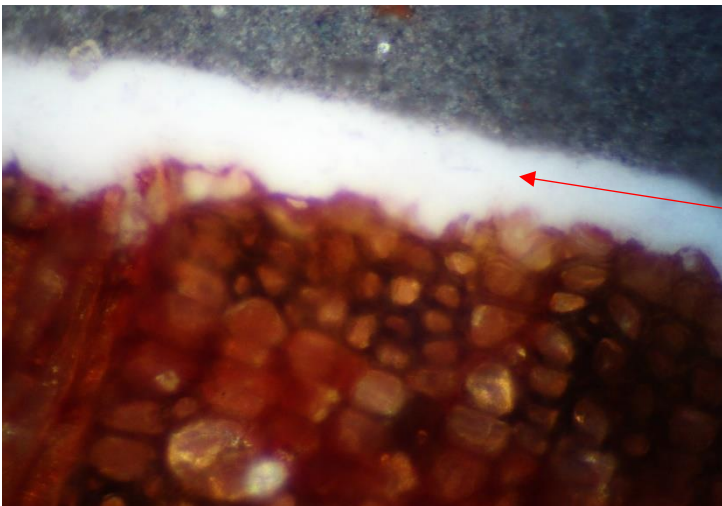
| Sample Ref: 03 – (Window) | Location: Freetrade Exchange |
|---|---|
| | <p>X400 –<br/>Earliest paint layers.</p> <p>Earliest paint layer present – white primer.</p> <p>Hardwood timber window.</p> |

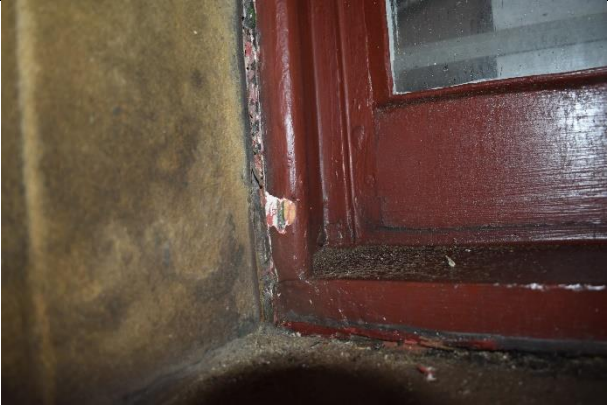
| Sample Ref: 04 – (Window) | Location: Freetrade Exchange |
|---|---|
| <p>Paint sample removed from:</p> <p>Location: 04 – Fourth Floor Window – East Elevation</p> <p>A total of 20 separate paint layers were found.</p> | |

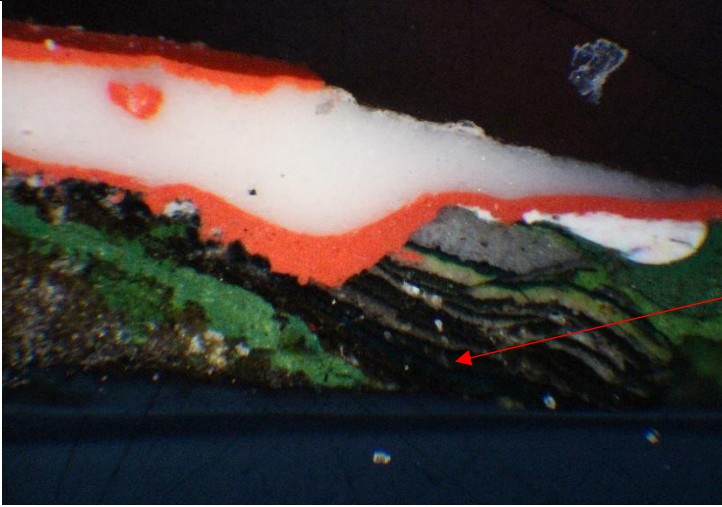
| Sample Ref: 04 – (Window) | Location: Freetrade Exchange |
|---|---|
| | <p>X50 –<br/>Current dark red colour scheme<br/>(Red alkyd paint with red intermediate coating and white primer layer).</p> <p>Earliest paint layers (over later green paint layer due to (partial detachment))</p> |

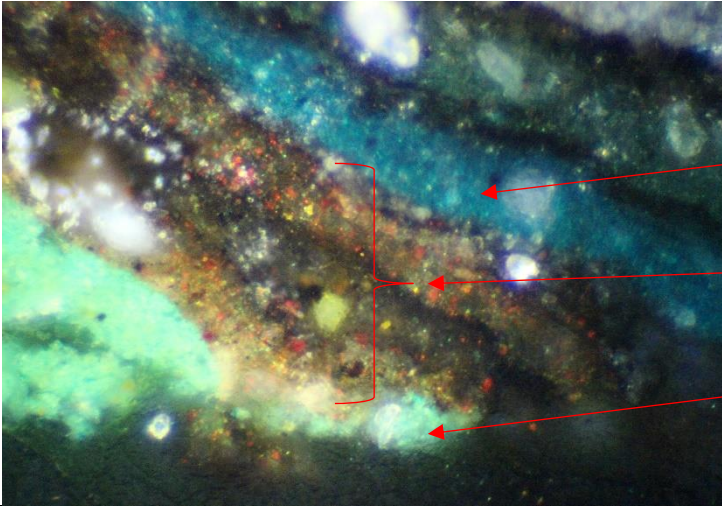
| Sample Ref: 04 – (Window) | Location: Freetrade Exchange |
|---|---|
| | <p>X400 -<br/>Earliest paint layers.</p> <p>Single blue paint layer.</p> <p>Earliest paint layers present – 3No green oil paint layers.</p> <p>Later modern green alkyd paint.</p> |

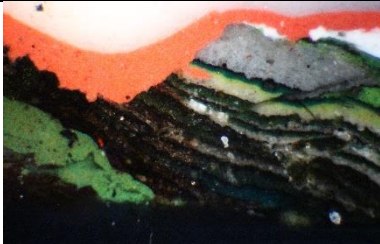
| Sample Ref: 04 – (Window) | Location: Freetrade Exchange |
|---|---|
| <p>Early schemes tested for lead</p> <p>Yes – Evidence of white and red lead pigments.</p> | |

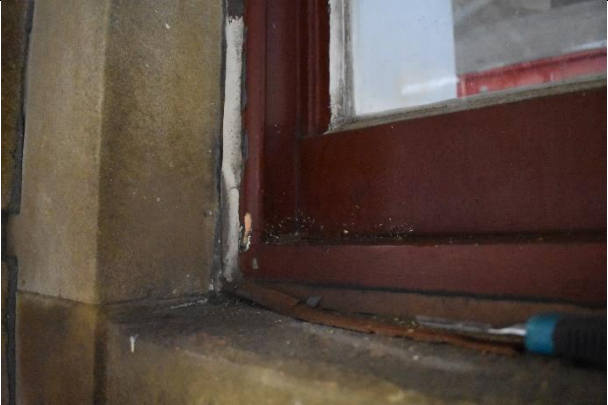
| Sample Ref: 05 – (Window) | Location: FreeTrade Exchange |
|---|---|
| <p>Paint sample removed from:</p> <p>Location: 05 – Ground Floor Window – East Elevation</p> <p>A total of 31 separate paint layers were found.</p> | |

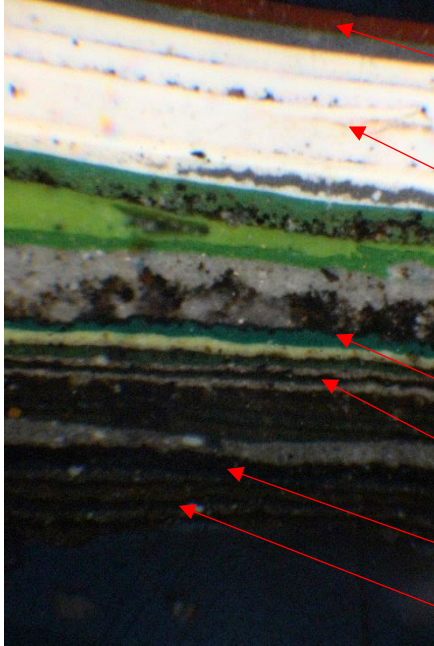
| Sample Ref: 05 – (Window) | Location: FreeTrade Exchange |
|---|---|
| | <p>X50 –<br/>Current dark red colour scheme (Red alkyd paint with grey intermediate coating and white primer layer).</p> <p>4x Modern Titanium white gloss alkyd paints with white intermediate coatings.</p> <p>3No green alkyd paints over grey intermediate coating.</p> <p>Blue / green gloss over yellow intermediate coating.</p> <p>4No green oil paints over grey intermediate coatings.</p> <p>Single blue oil paint.</p> <p>3No green oil paints</p> <p>X100 -<br/>Earliest paint layers.</p> |

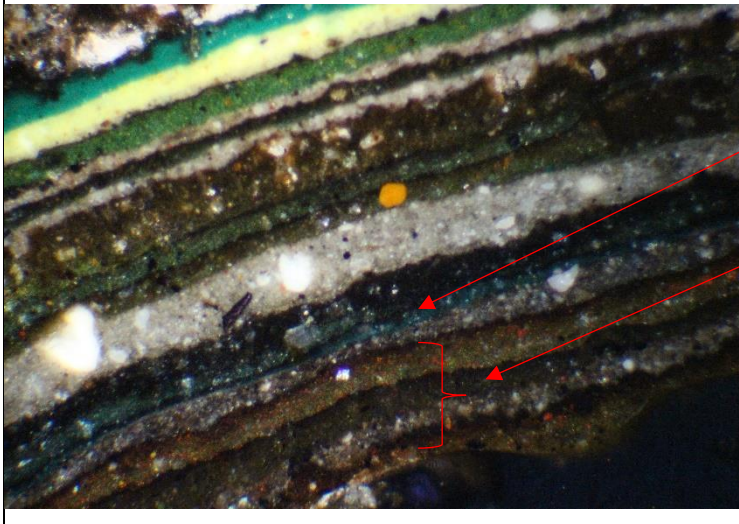
| Sample Ref: 05 – (Window) | Location: FreeTrade Exchange |
|---|---|
| | <p>Single blue paint layer.</p> <p>Earliest paint layers present – 3No green oil paint layers.</p> |

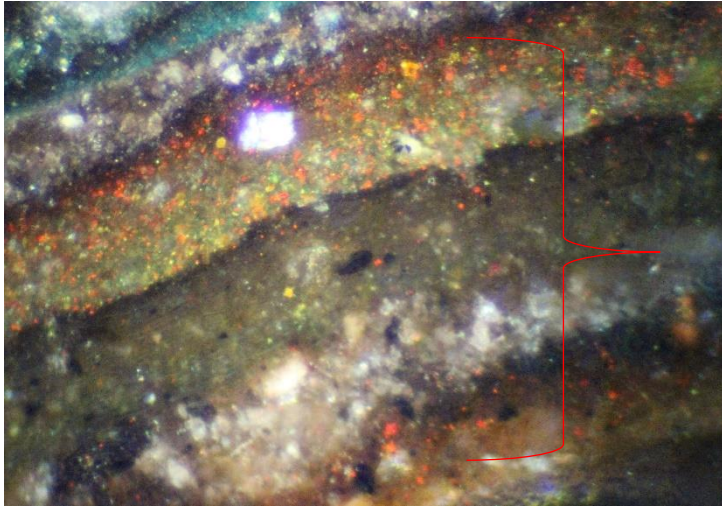
X400 – Earliest layers

Dirt on surface of paint.

3No green oil paint layers.

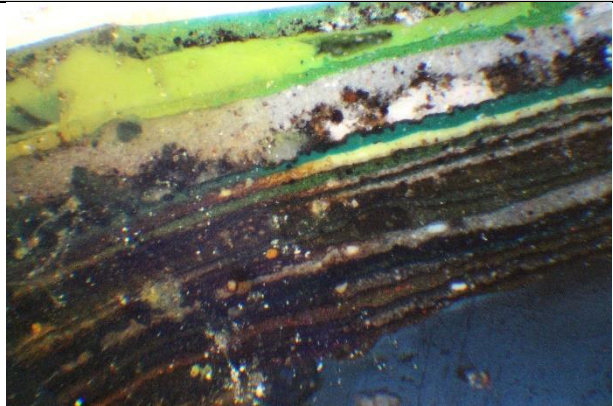
Early schemes tested for lead

Yes – Evidence of white and red lead pigments.

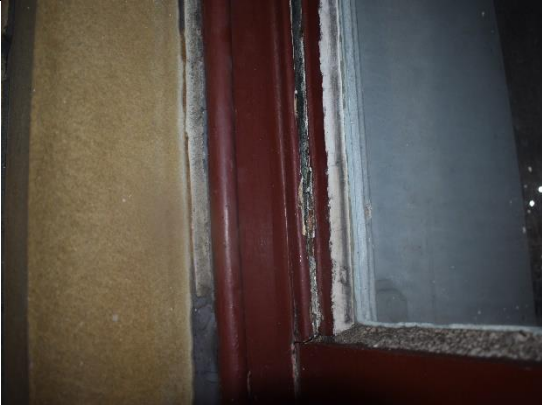
| Sample Ref: 06 – (Window) | Location: Freetrade Exchange |
|---|---|
| <p>Paint sample removed from:</p> <p>Location: 06 – Ground Floor Window – East Elevation</p> <p>A total of 31 separate paint layers were found.</p> | |

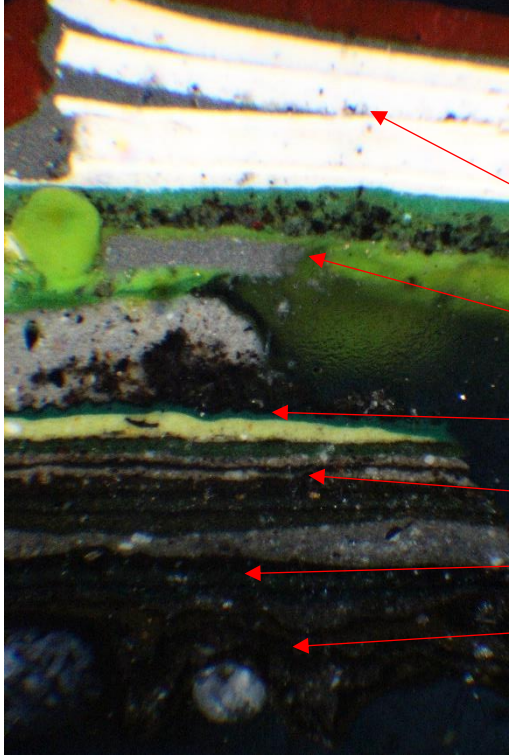
| Sample Ref: 06 – (Window) | Location: Freetrade Exchange |
|---|---|
| | <p>X50 –</p> <p>Current dark red colour scheme (Red alkyd paint with grey intermediate coating and white primer layer).</p> <p>4x Modern Titanium white gloss alkyd paints with white intermediate coatings.</p> <p>3No green alkyd paints over grey intermediate coating.</p> <p>Blue / green gloss over yellow intermediate coating.</p> <p>4No green oil paints over grey intermediate coatings.</p> <p>Single blue oil paint.</p> <p>3No green oil paints</p> |

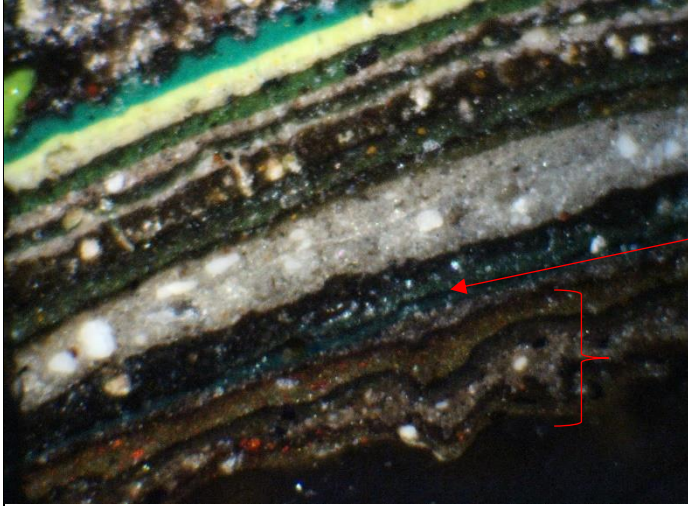
| Sample Ref: 06 – (Window) | Location: Freetrade Exchange |
|---|---|
| | <p>X100 –</p> <p>Earliest paint layers.</p> <p>Single blue paint layer.</p> <p>Earliest paint layers present – 3No green oil paint layers.</p> |

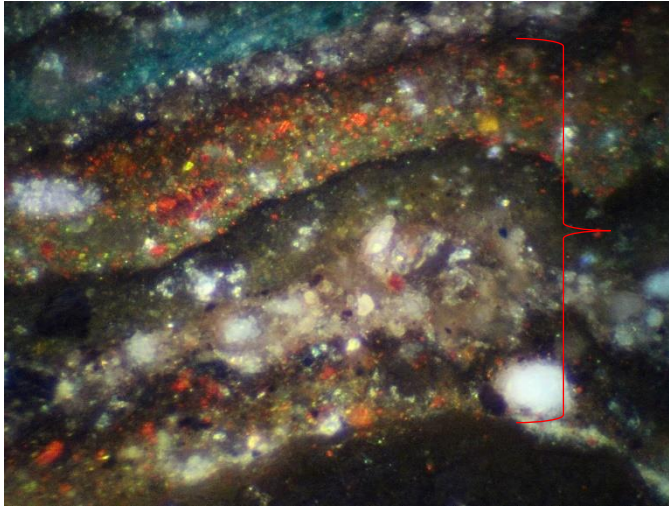
X400 – Earliest paint layers.

3No green oil paints (with grey intermediate coatings).

Note: Dirt layers on surface of pint.

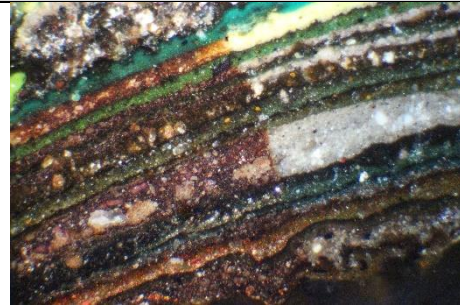
Early schemes tested for lead

Yes – Evidence of white and red lead pigments.
