project: bridgewater house  
dwg no: 304  
dwg title: GF ceilings & cornice  
scale: 1:100 @ A1

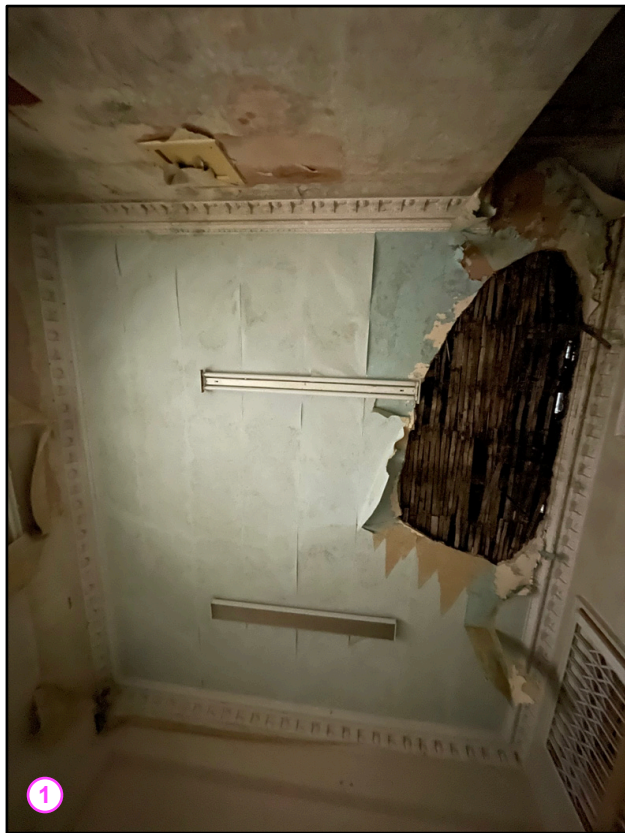
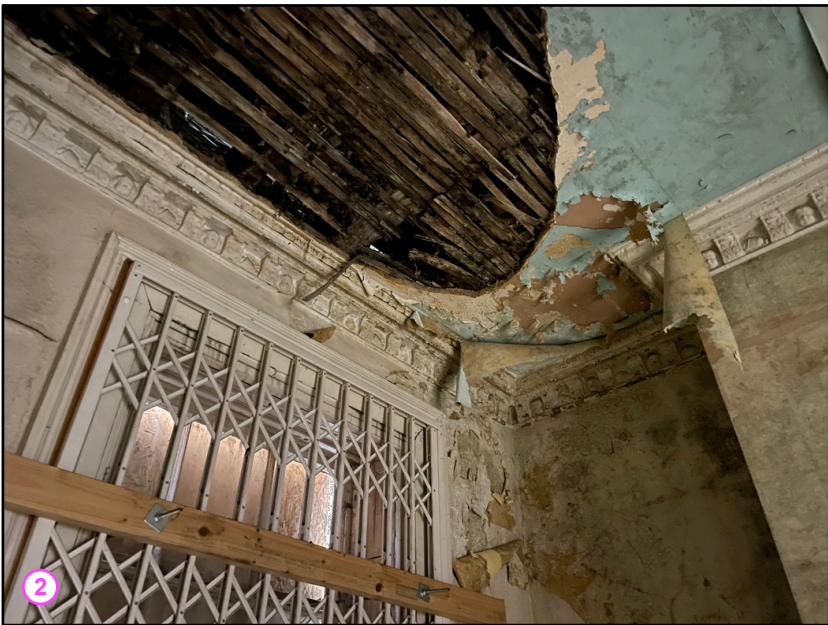
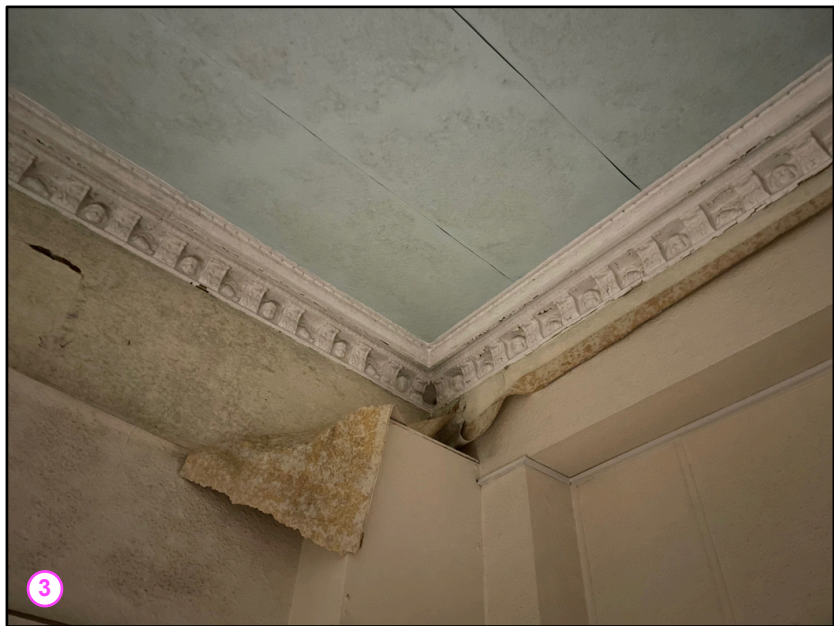
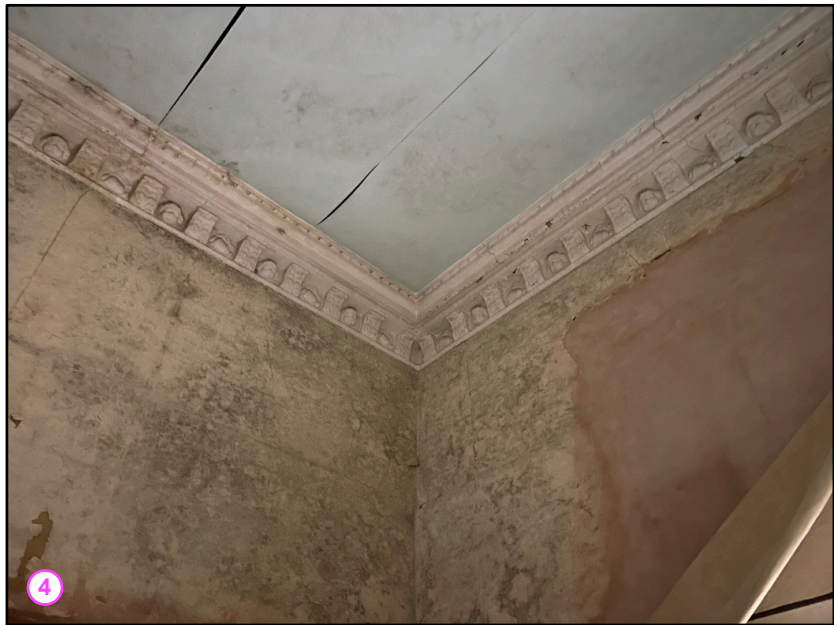
ROOM G.12

- Cornice all around as noted on the plan
- Partially collapsed ceiling as noted on the plan
- Water damage to cornice

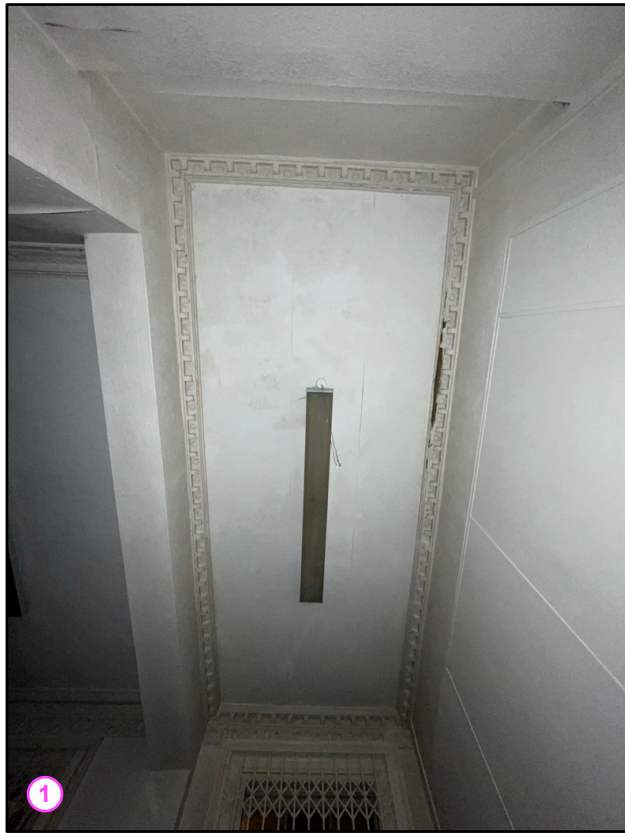
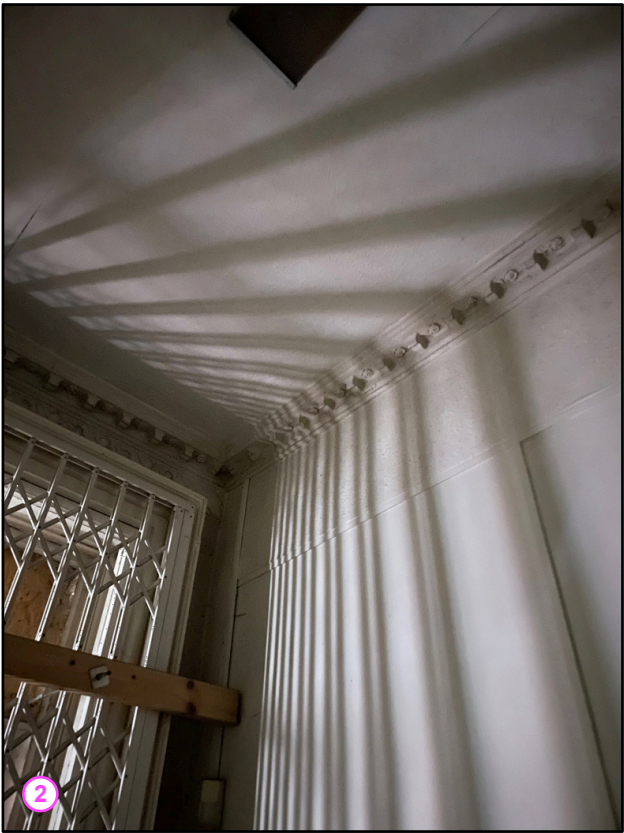
ROOM G.13

- Cornice all around as noted on the plan
- Ceiling in relatively good condition

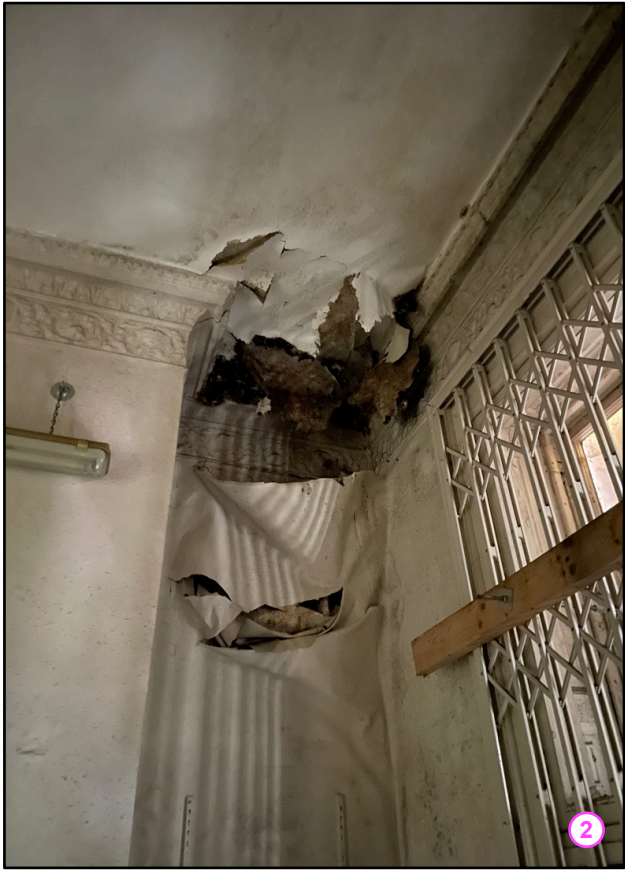
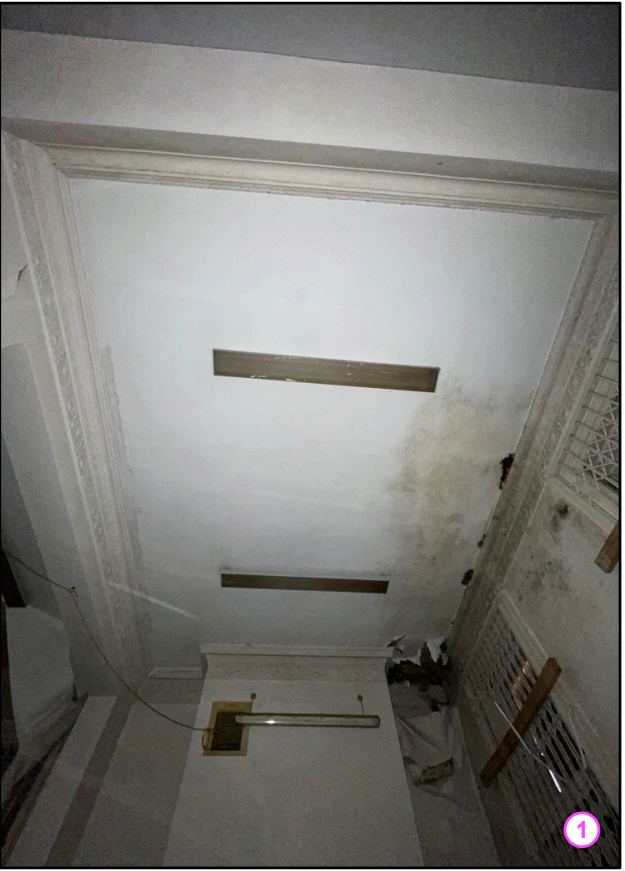
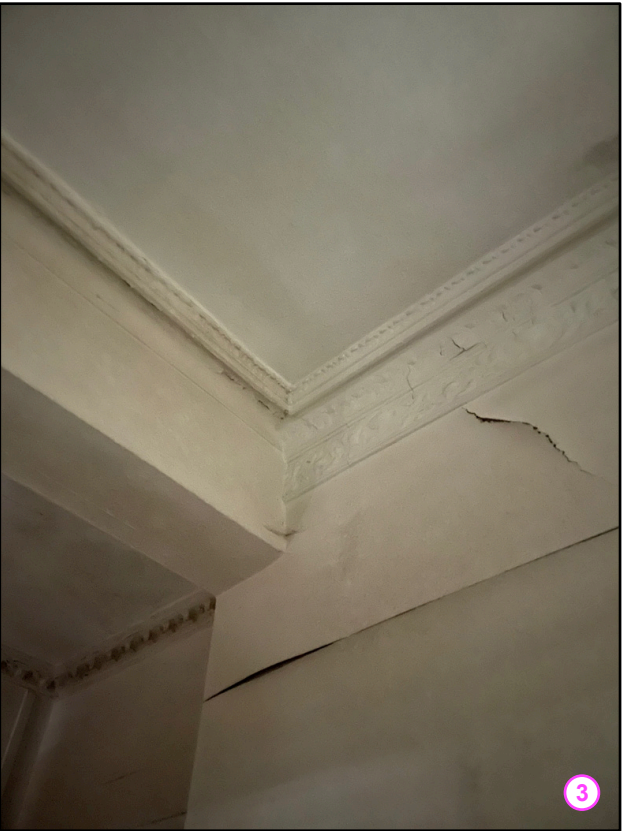
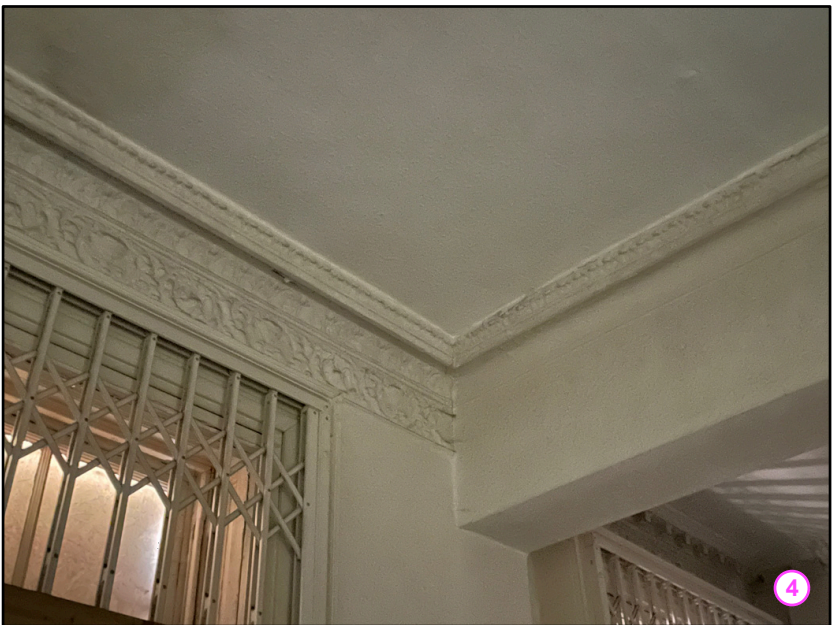
ROOM G.14

- Cornice all around as noted on the plan
- Partially (water) damaged ceiling as noted on the plan

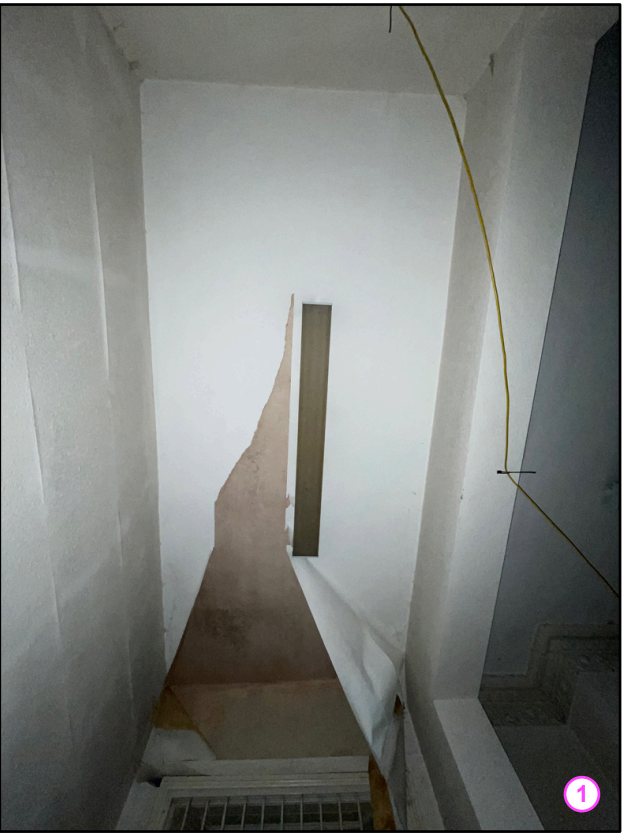
ROOM G.15

- No cornice
- Plasterboard ceiling in relatively good condition

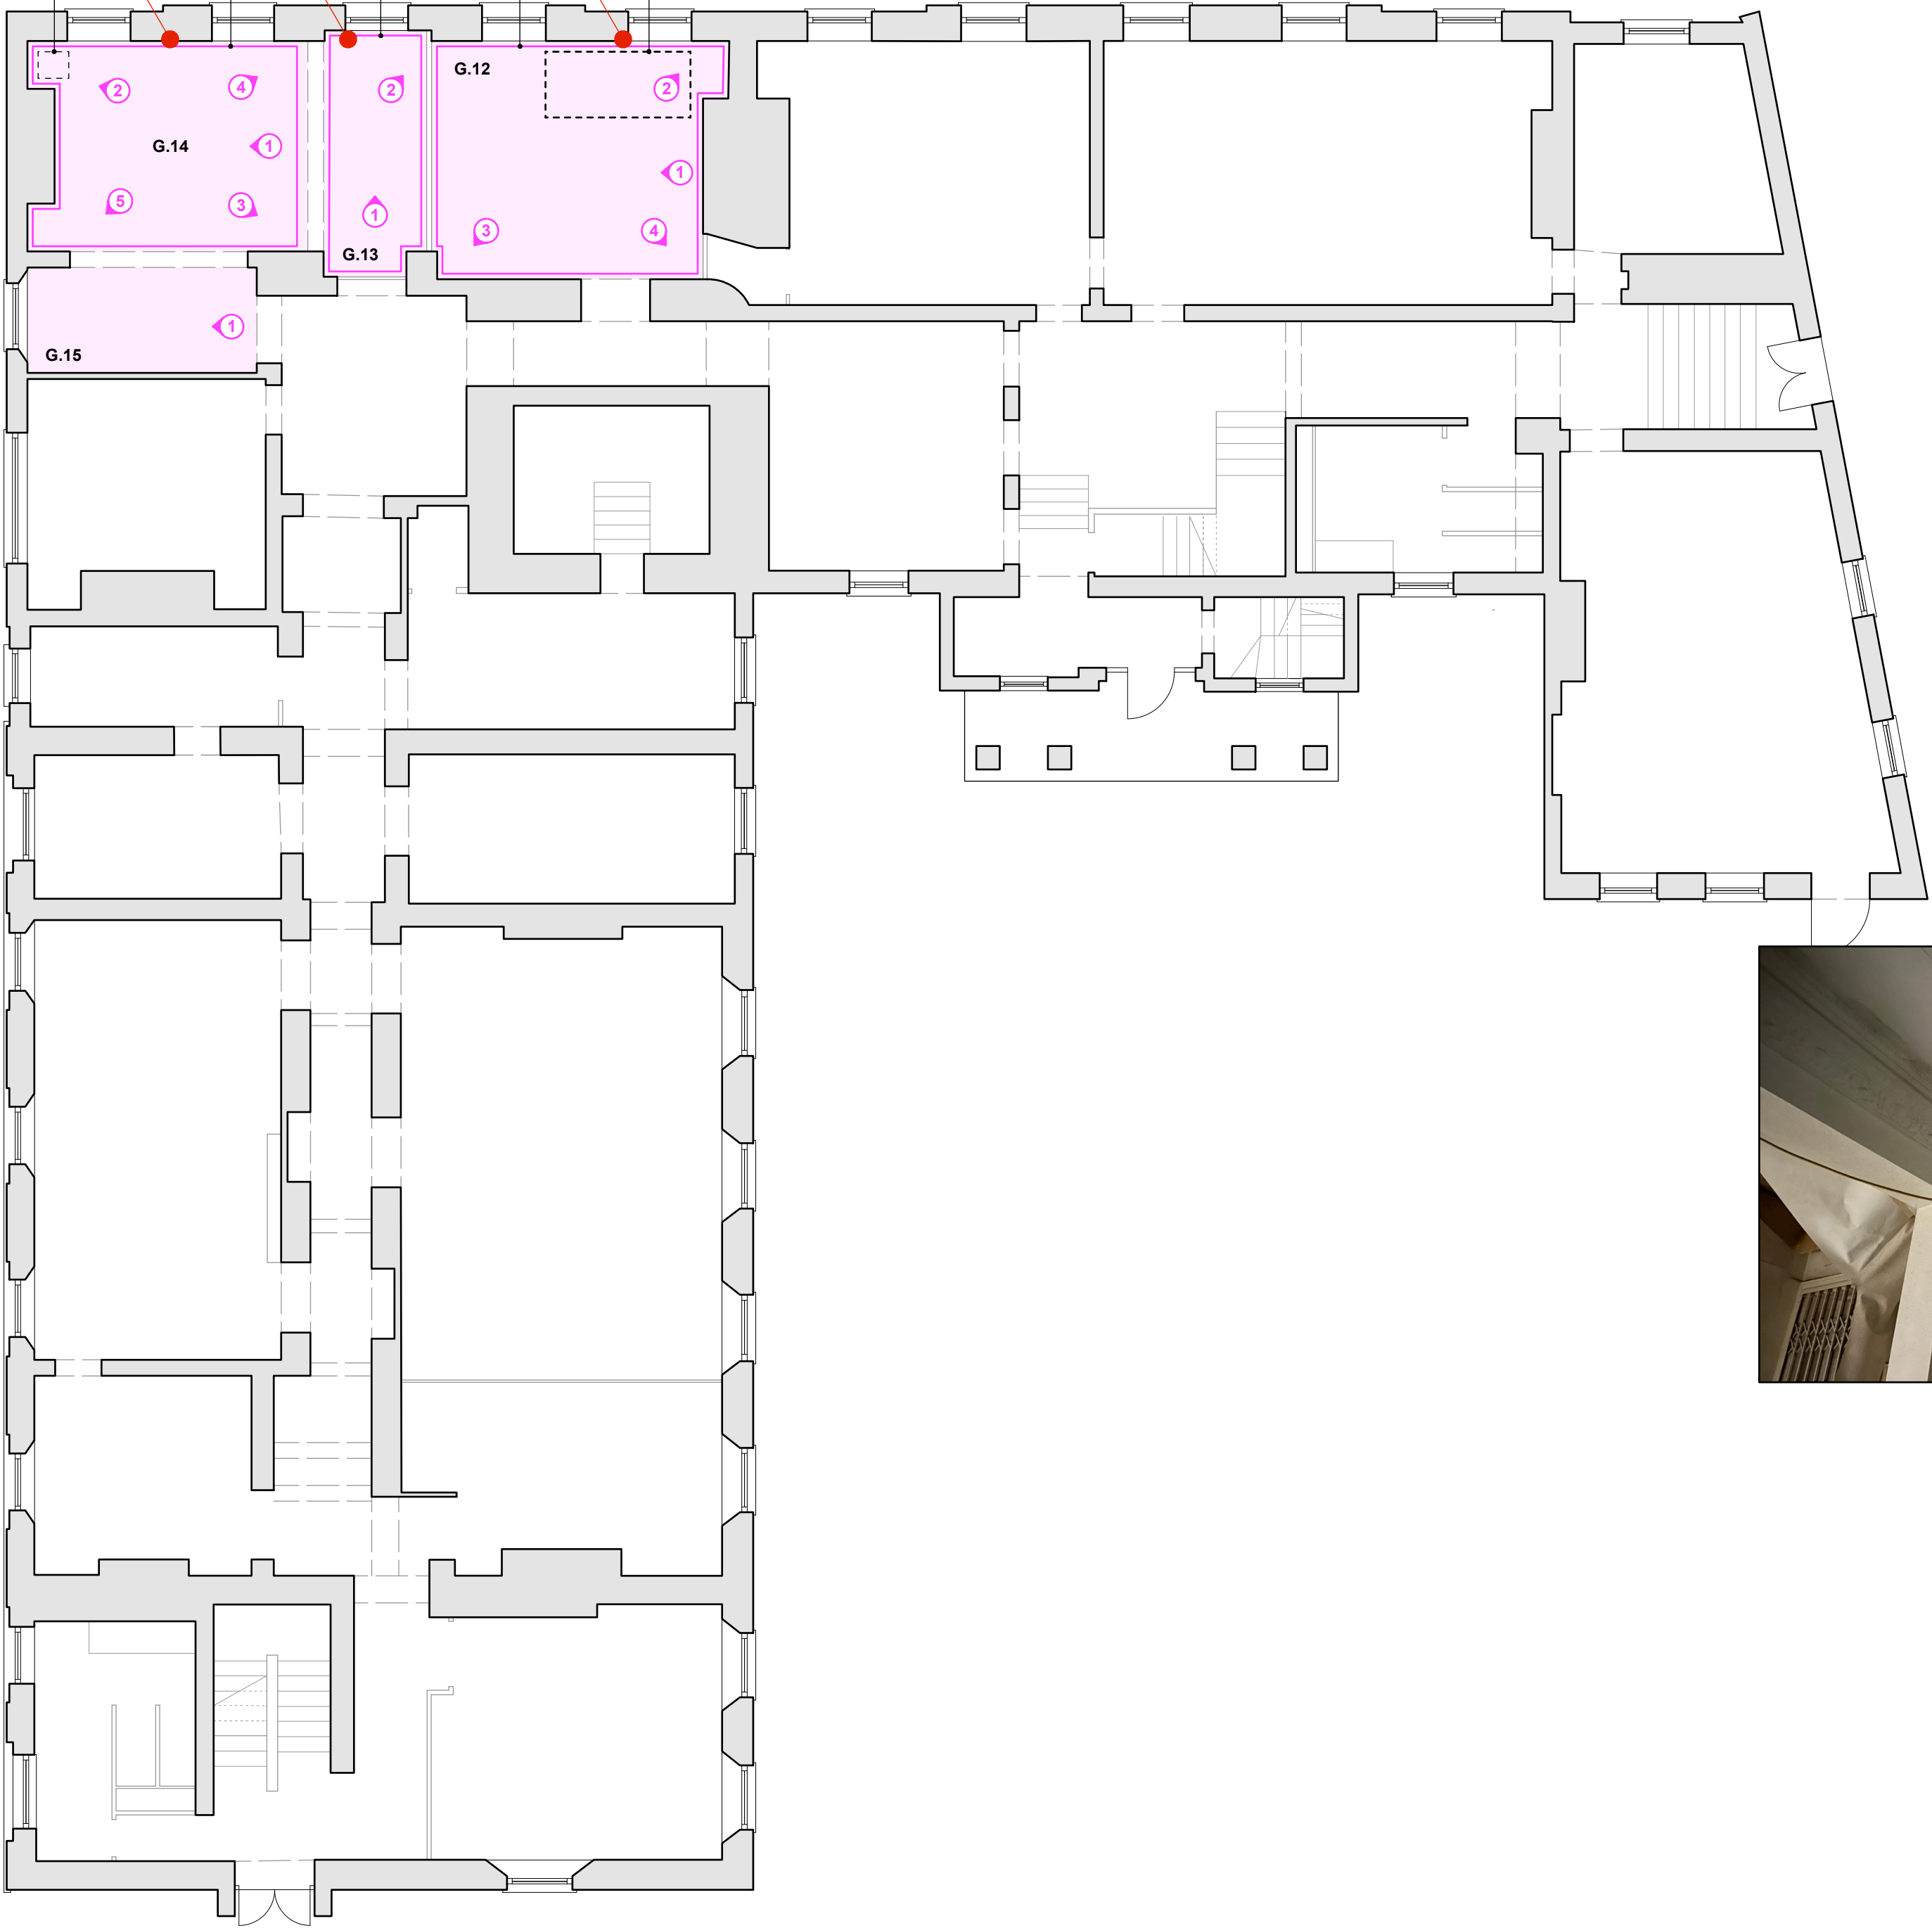
collapsed/damaged ceiling  
(black dashed line)

collapsed ceiling  
(black dashed line)

existing lathe and plaster ceiling  
to be underboarded  
[with 2 layers of fire board]  
existing cornice to be retained  
repaired as necessary
