# CSM - Whiteley Hall

Design and Access Statement  
October 2022

Project name: CSM – Whiteley Hall

Project number: 9357

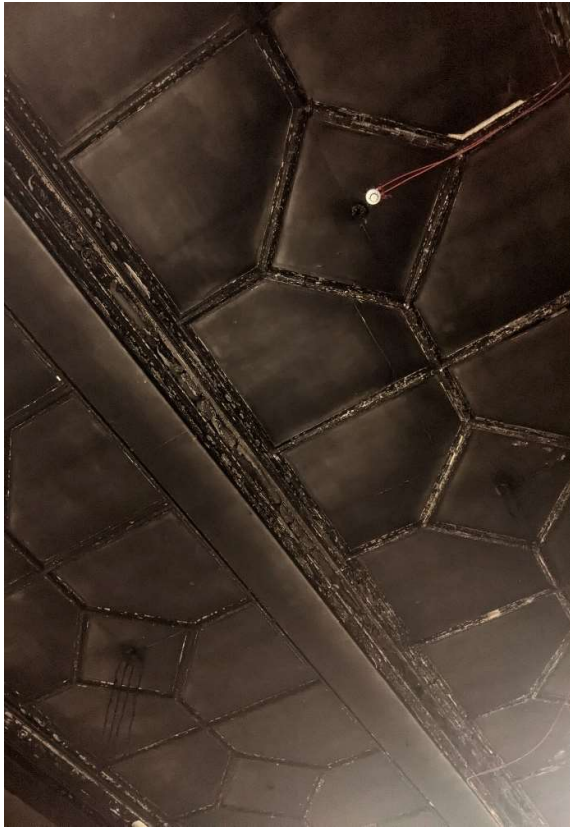
The ceiling is comprised of plaster mouldings with panels above which have been plastered over. At a later stage this has been underdrawn with a fibrous board fixed back on a metal mesh wire and plastered over. It is clear there have been several phases of intervention and repair to the ceiling of Whiteley Hall.

Whiteley Hall - Fire Damaged Ceiling

It is proposed that the ceiling be removed in its entirety and a line of FireLine plasterboard installed in order to provide a fire secure separation between the Hall and the dormitories above. Given the precedent of fire in the Hall it is essential that the client protects the upper floors as far as possible. The new ceiling will include new mouldings with profiles designed to match the existing exactly in every respect. In this way the works will both protect the Millgate Building long term and retain the visual character of Whiteley Hall.

This work will inevitably lead to a loss of historic fabric in order to provide fire protection. Visual character will be retained by reinstating the ceiling mouldings from careful copies of the existing scheme. Refer to appendix photos.

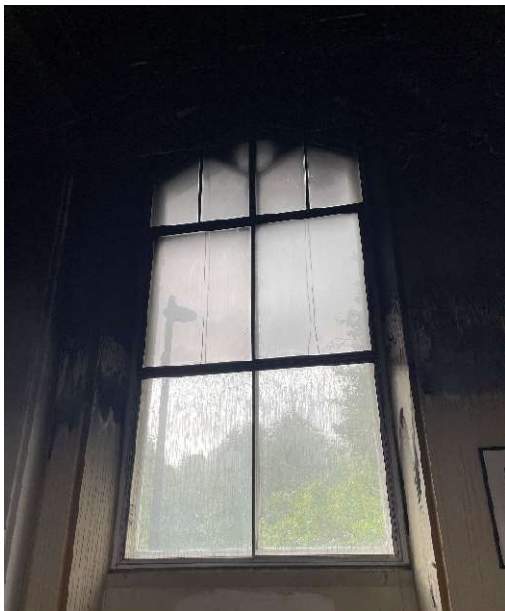
Whiteley Hall - Damage to Secondary Glazing

The existing external windows have minimal impact from the fire and will be cleaned and redecorated. Where isolated glass panes have been damaged or removed these will be replaced to match the existing and adjacent panes. It is proposed that the fire damaged 20<sup>th</sup> century secondary glazing will be removed and replaced with higher quality units designed to respond to the transoms and mullions of the external glazing. Refer to appendix photos. New secondary glazing will be added to the west elevation to provide additional protection to the external glazing. All new work will be recessed back from the reveals so that the historic details remain dominant.

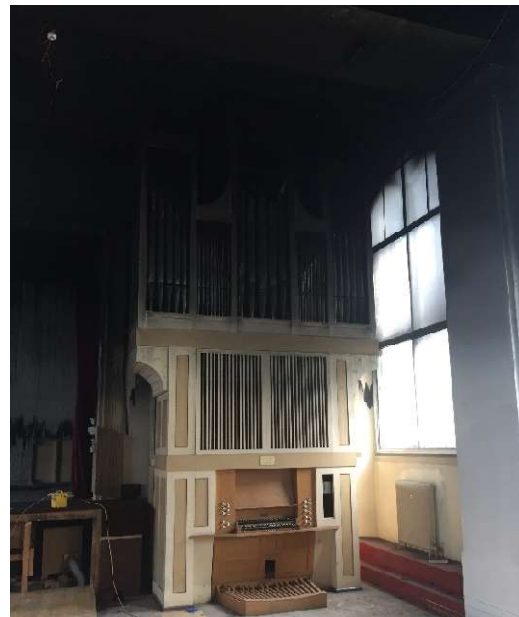
The existing organ is not original to the Hall and has been significantly damaged by the recent fire. It is proposed that this is removed and replaced with the new organ as described in the drawing set.

Whiteley Hall - Damage to Existing Organ

This work will involve the isolated strengthening of the floor of the Hall to allow for the additional weight of the new organ but will otherwise have minimal impact on the Hall. The strengthening of the floor will be done in co-ordination with the installation of the new floor ensuring minimal disruption to the historic fabric. Refer to appendix photos.
