PRELIMINARY ISSUE

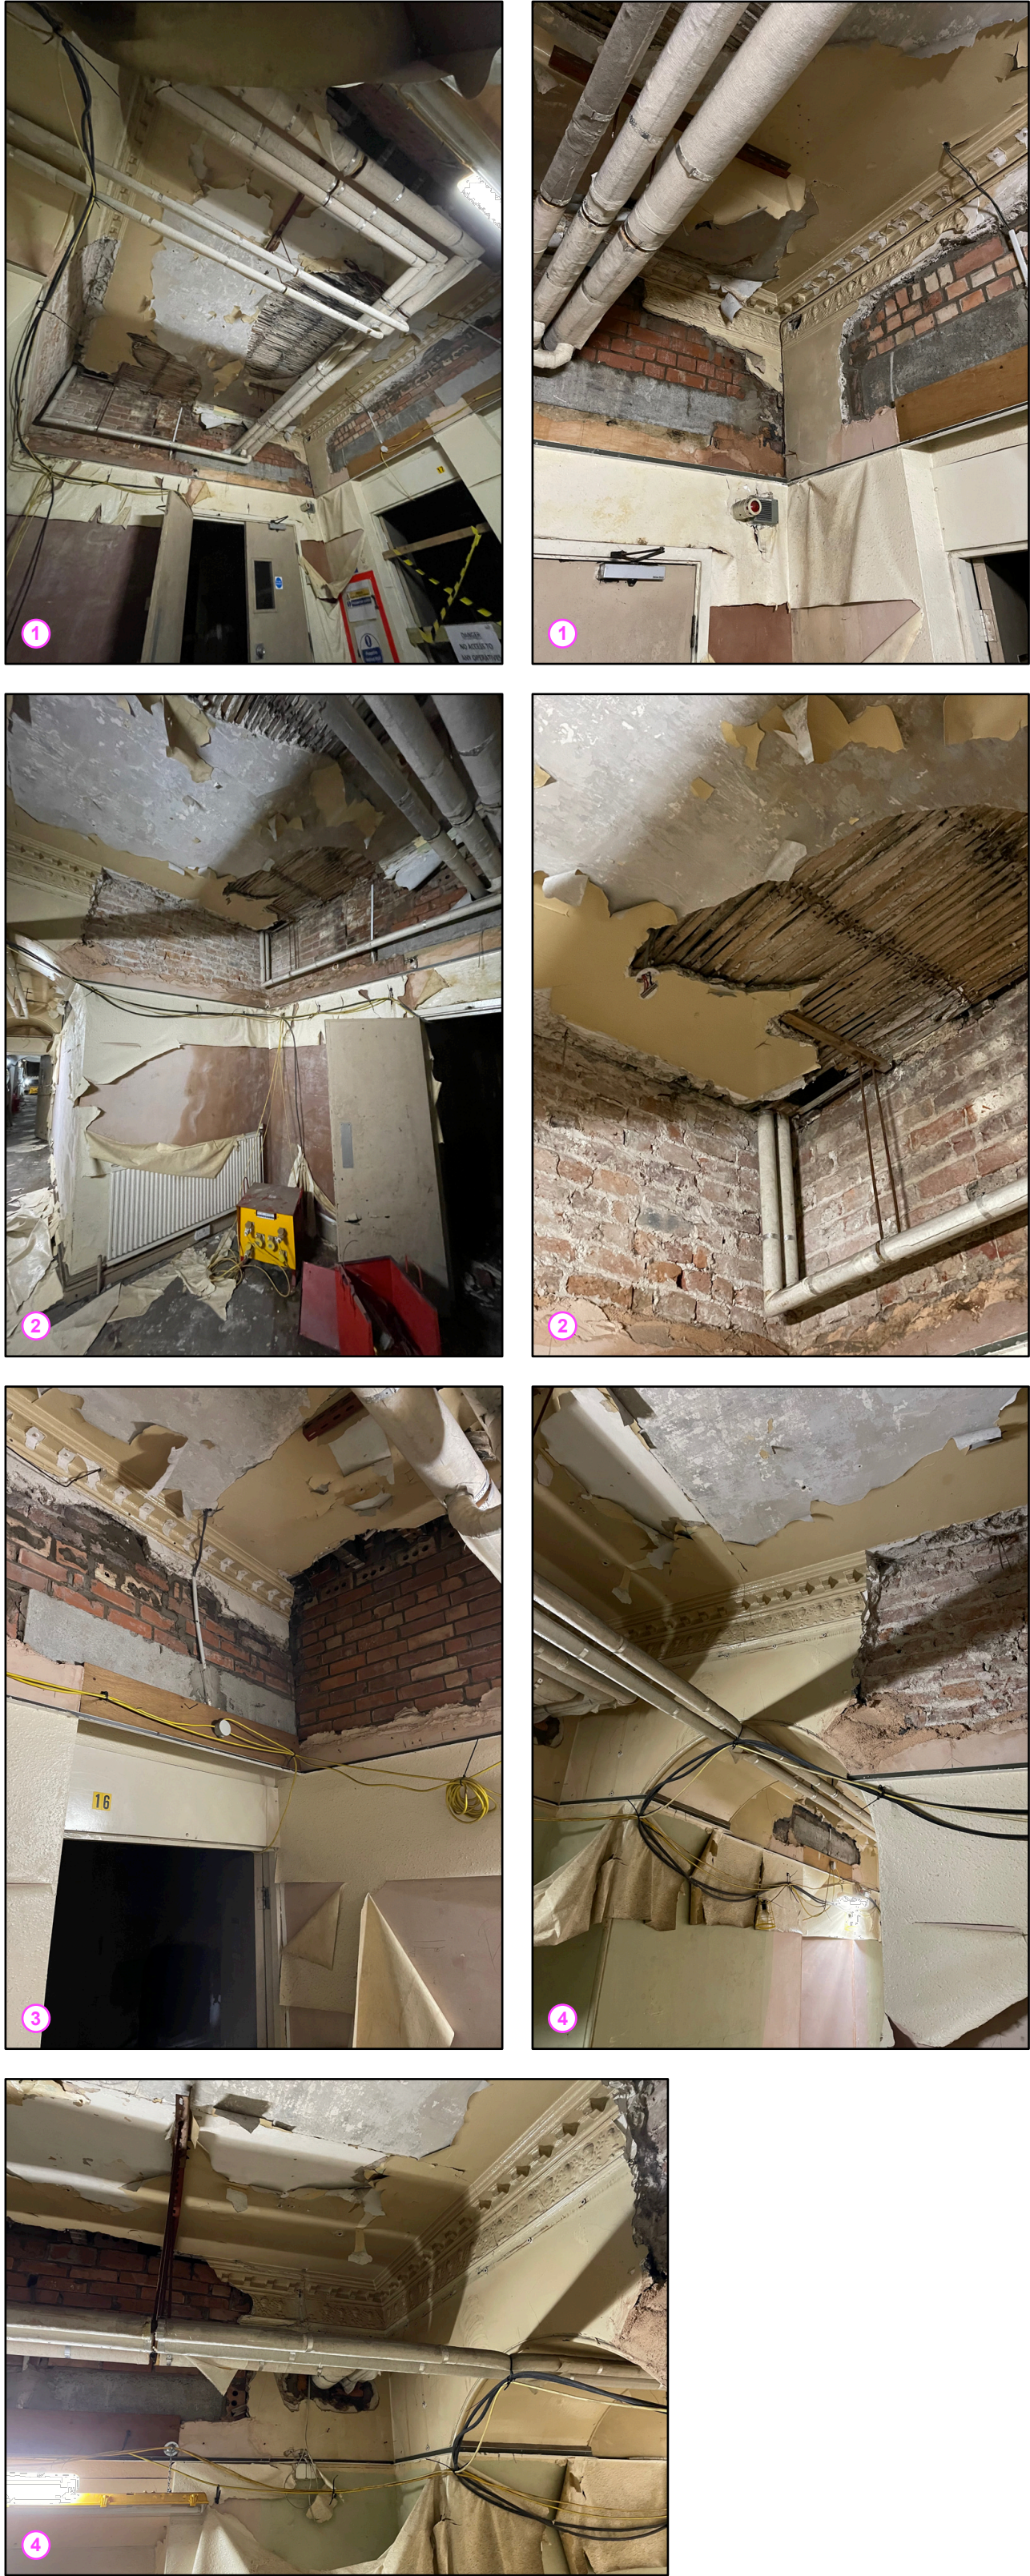
ROOM G.16

- Cornice as noted on the plan
- Cornice missing and/or damaged in various areas
- Partially collapsed ceiling as noted on the plan
- Ceiling is damaged
- Exposed pipework

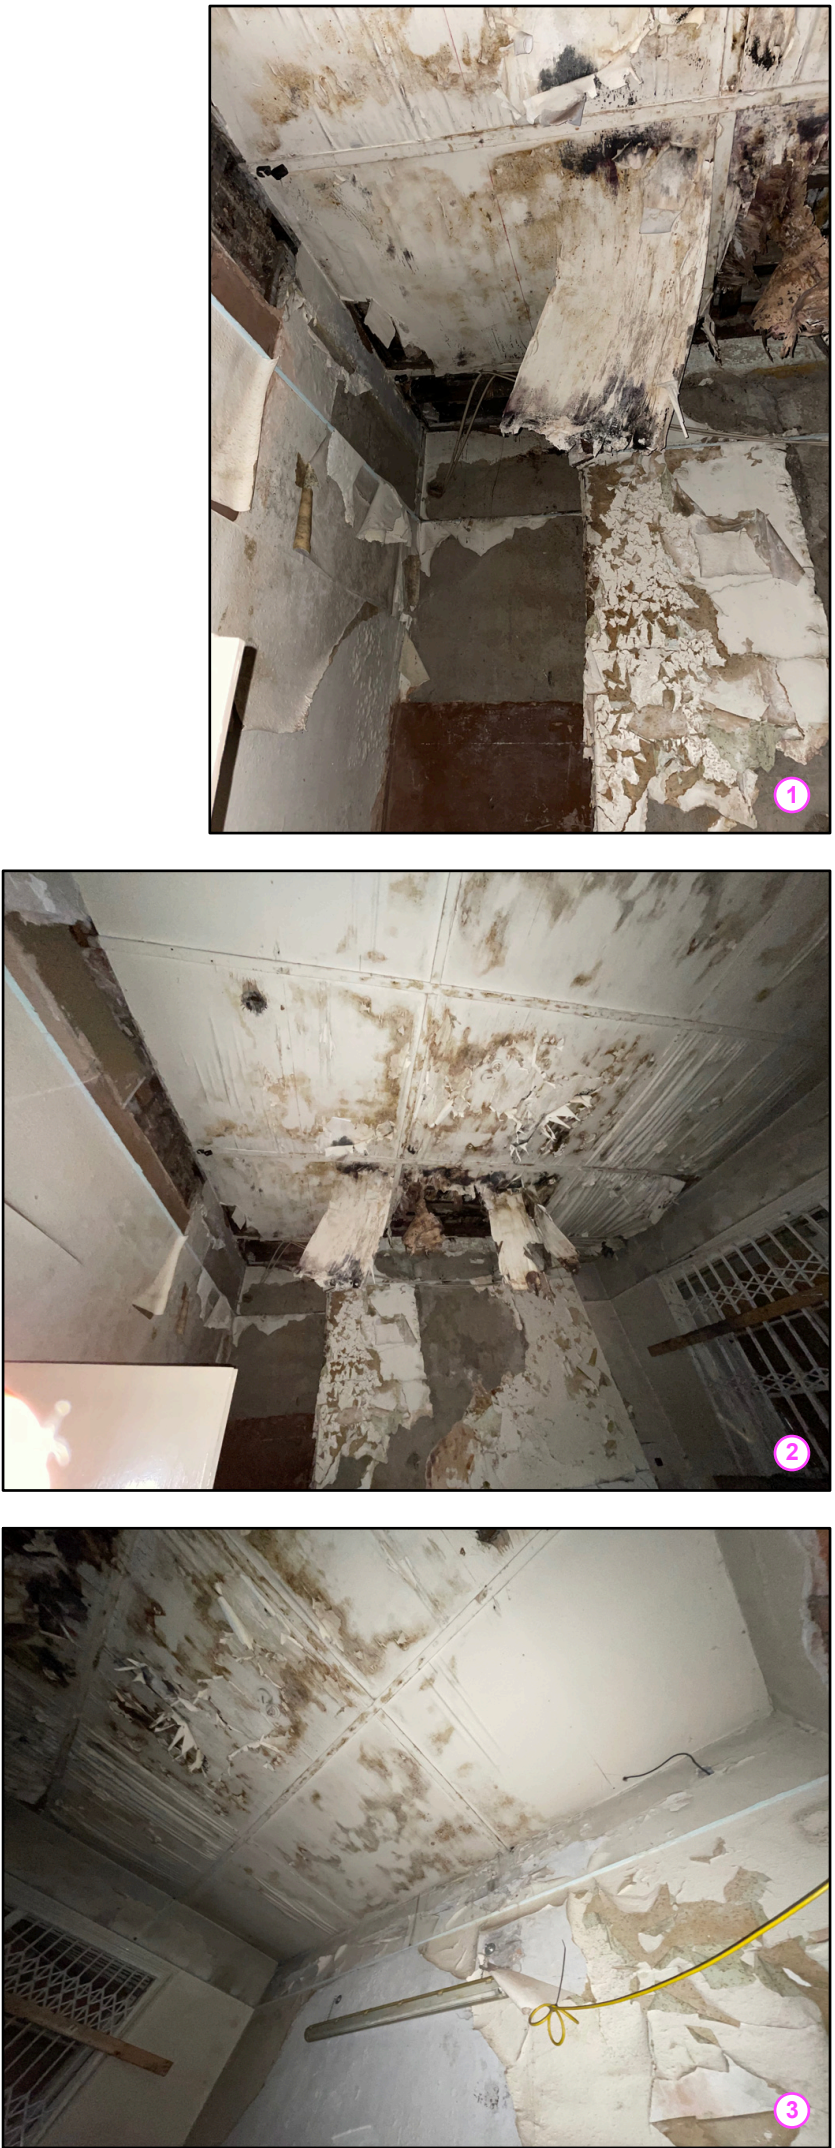
ROOM G.17

- Restricted access - Room is inaccessible due to collapsed ceiling and/or unsafe floor structure
- No cornice
- Ceiling partially collapsed - the rest looks damaged
- Looks like panelled ceiling

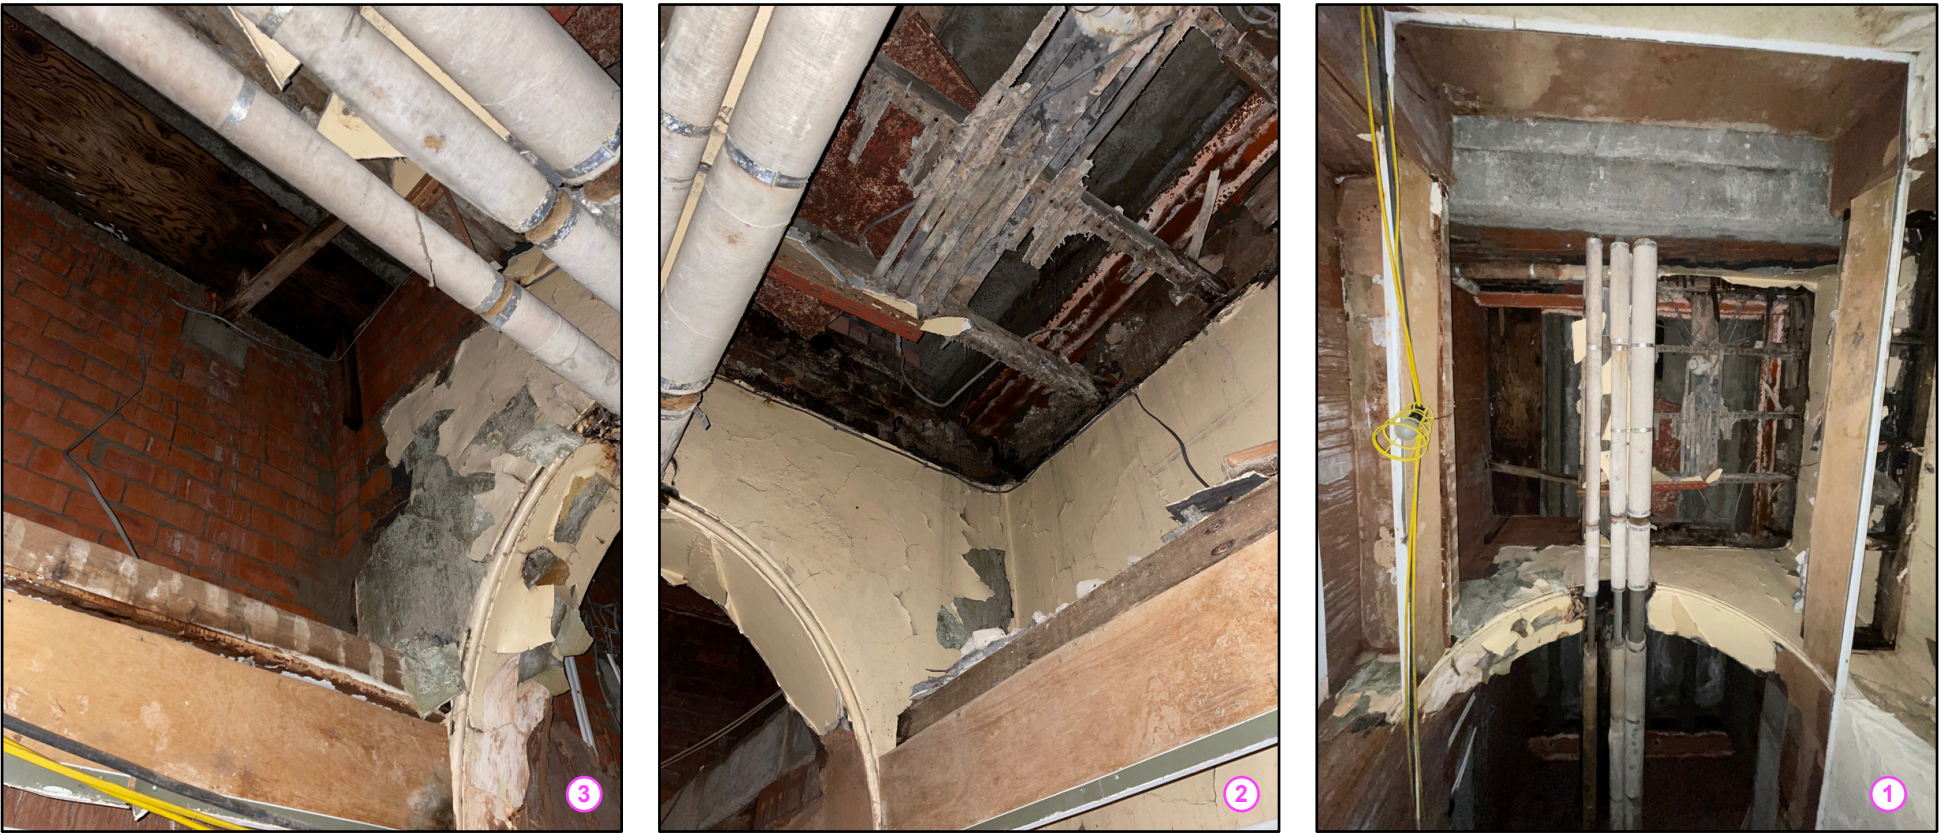
ROOM G.18

- Ceiling is gone completely
- No cornice
- Exposed pipework
