| <b>Project:</b> | NatWest Roof Works, Oxford Road | |
| <b>WML reference number:</b> | 10731-WML-00-XX-RP-S0001 | 14 <sup>th</sup> September 2022 |

| Survey Brief: | Site review with regard to condition of existing roof structure and rear parapet masonry |

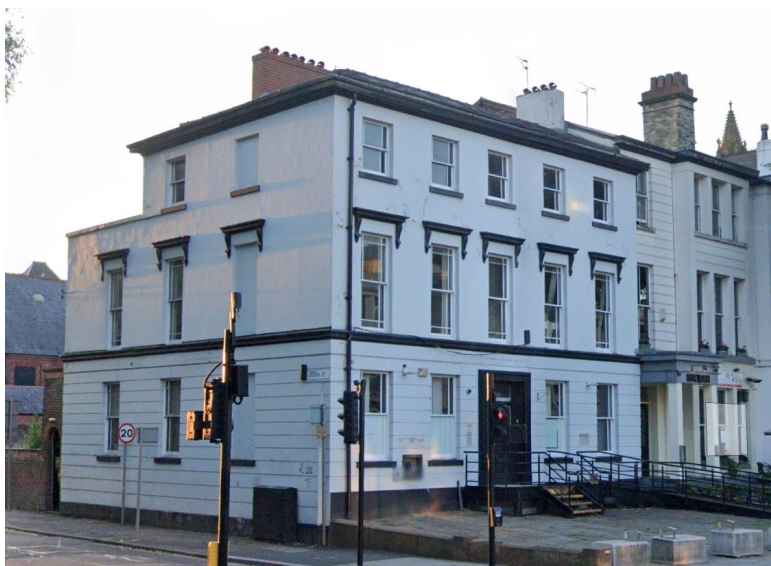
**Front view, from Oxford Road**

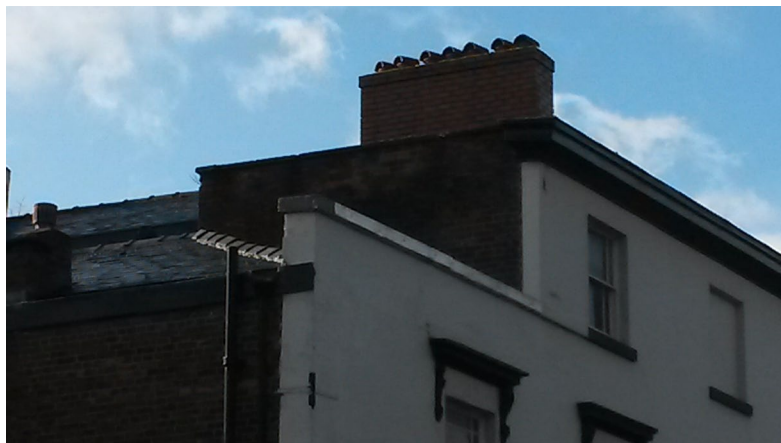
**Rear view of existing parapet, from Dover Street**

- With regard to the rear parapet, the Vertical Access Report recommended taking down and rebuilding, due to the loose condition which was considered unsafe. We thereafter assisted the University in looking for alternative solutions, including drilling long vertical bars through the top of the wall to reinforce the connection to the sound masonry below eaves level (rejected by the Contractor as impractical) and fixing the wall to vertical cantilever scaffold tubes, which is the solution employed and seen on the photographs. This is obviously of a temporary nature and the rebuilding of the wall is likely to be necessary at some point within, say, the next 5 years.

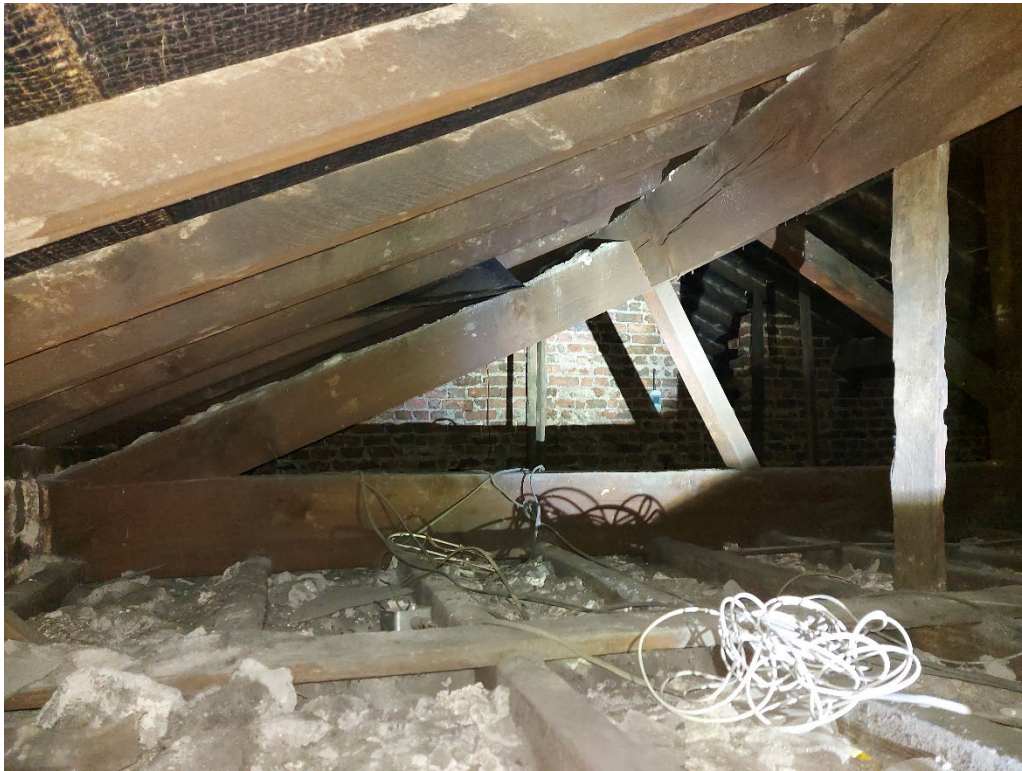
**Photograph 1**  
**View of roof from access hatch – traditional cut rafters and purlins,  
king post truss at mid-point**

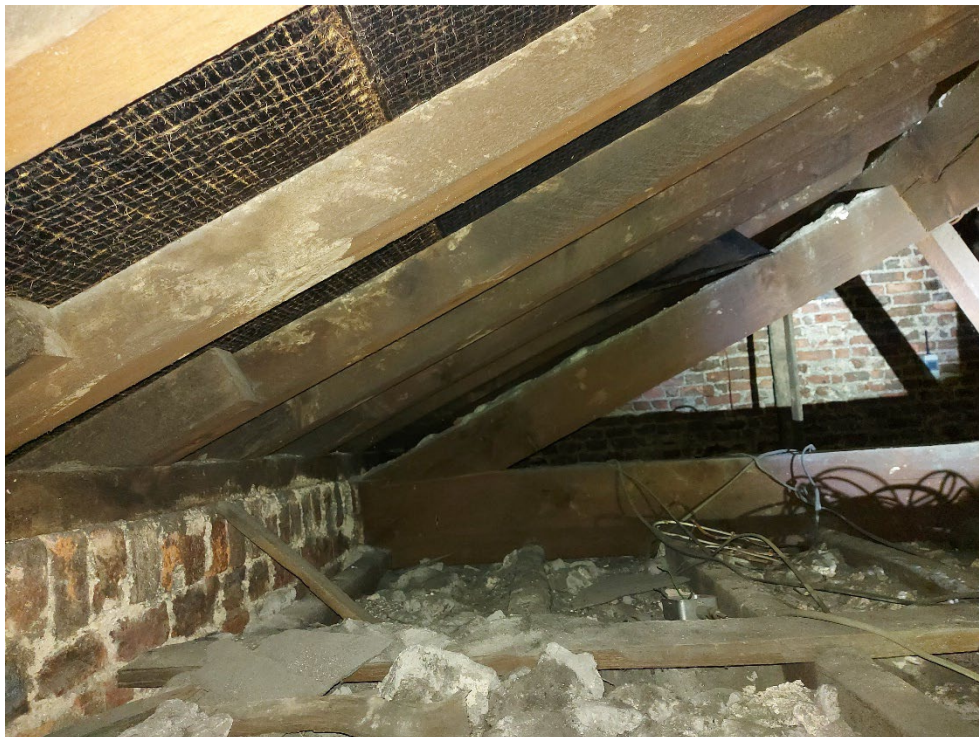
- From our visual observations the roof timbers appear to be in sound condition, with no signs of distress or excessive deflection. The existing ceiling joists appear to be more substantial than would normally be expected, and as such should be capable of supporting any insulation necessary to upgrade the building. The roofing felts noted on the photographs support the view that the roof coverings have been replaced in the recent past. We would expect any defects within the roof structure to have been remediated or repaired at that time.

**Photograph 2**  
**View on eaves (Oxford Road side) – timbers appear to be in good condition.  
Substantial ceiling joists**

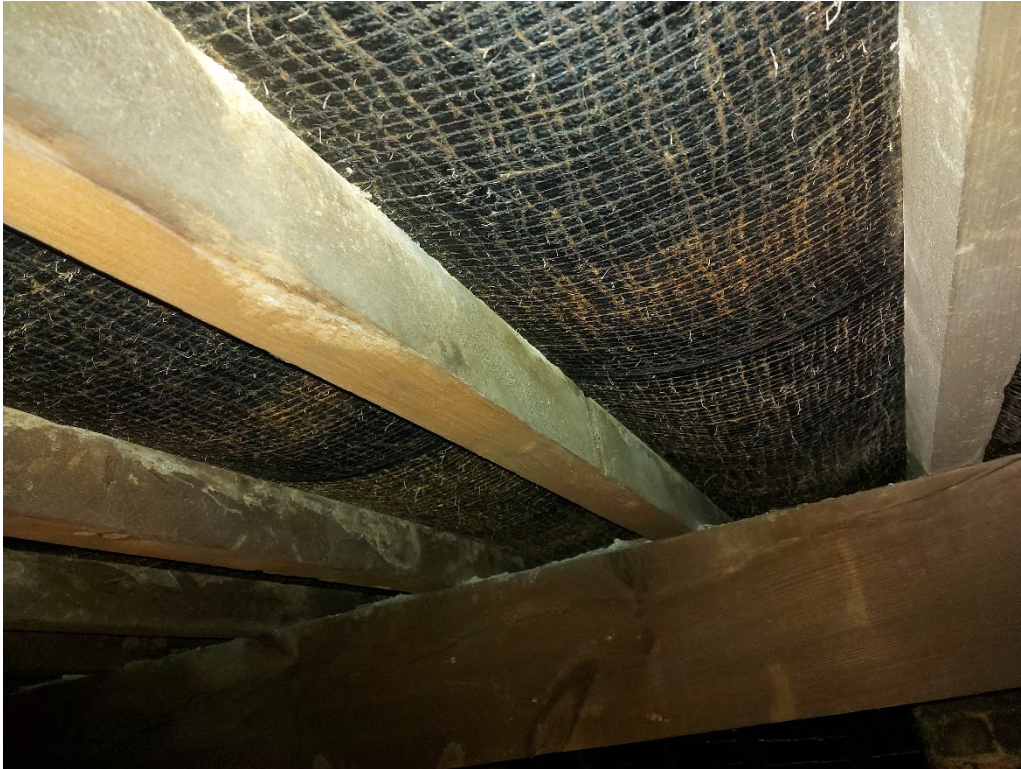
**Photograph 3**  
**Oxford Road side – roofing felt in good condition**

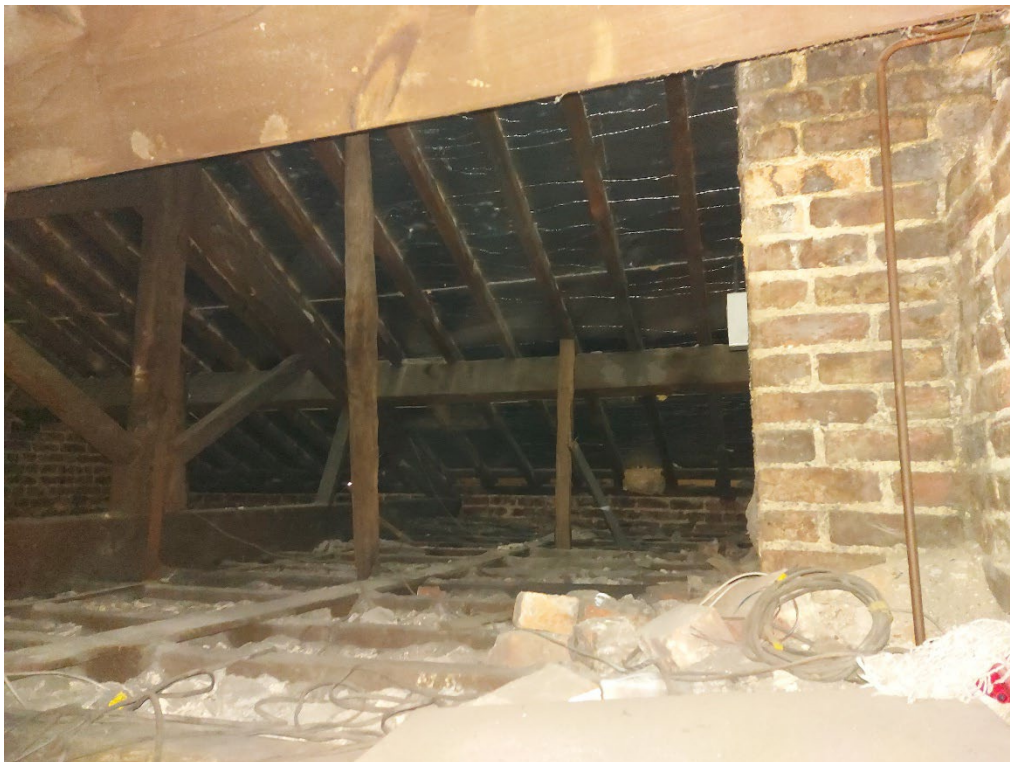
**Photograph 4**  
**Opposite elevation appears to be in good condition. Reflective silver felt over (difficult to discern on photograph), obviously recent**

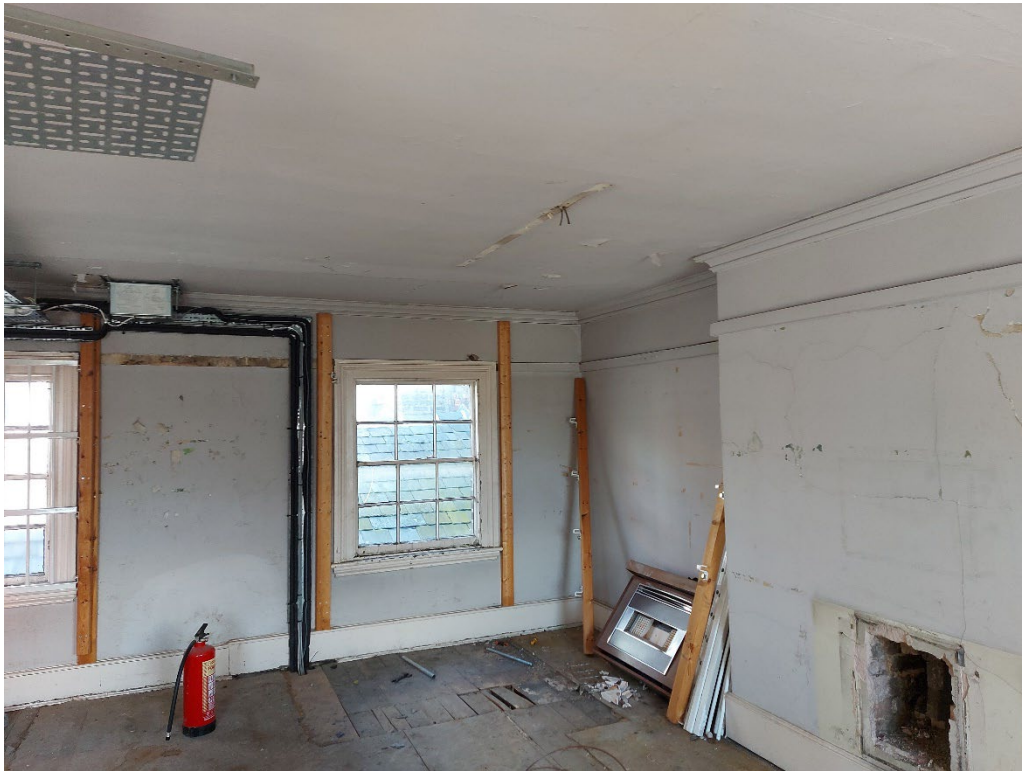
**Photograph 5**  
**Ceiling soffit generally in good condition, no cracking**

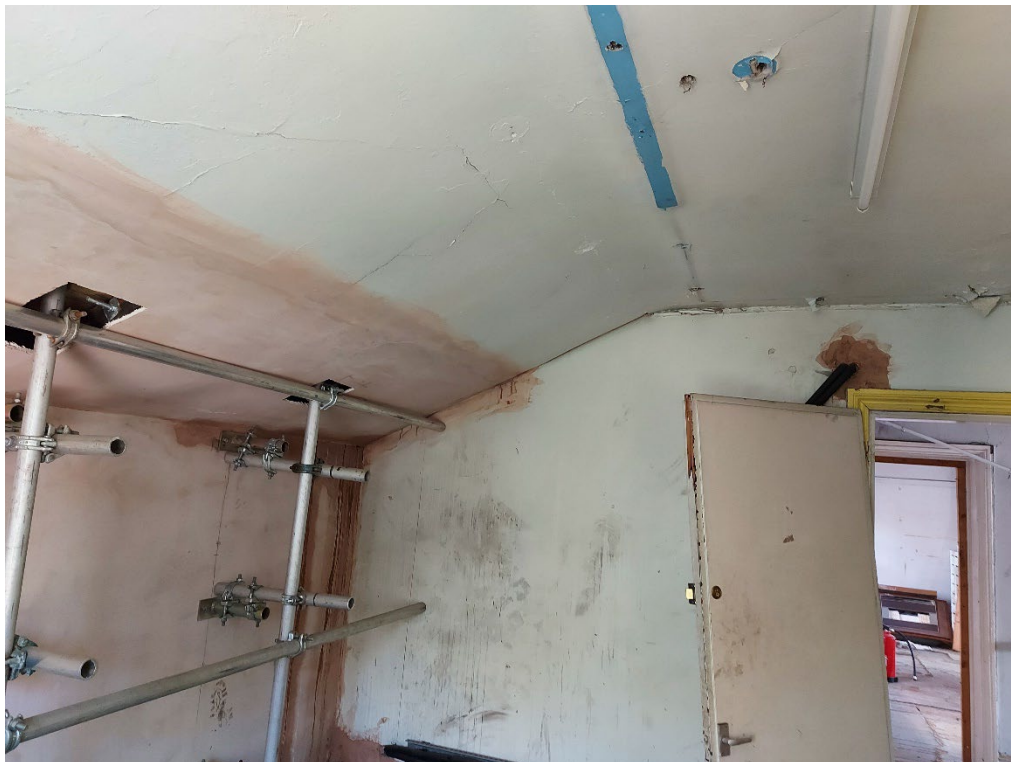
**Photograph 6**  
**Rear annexe (Dover Street side) – scaffold support to parapet wall over**

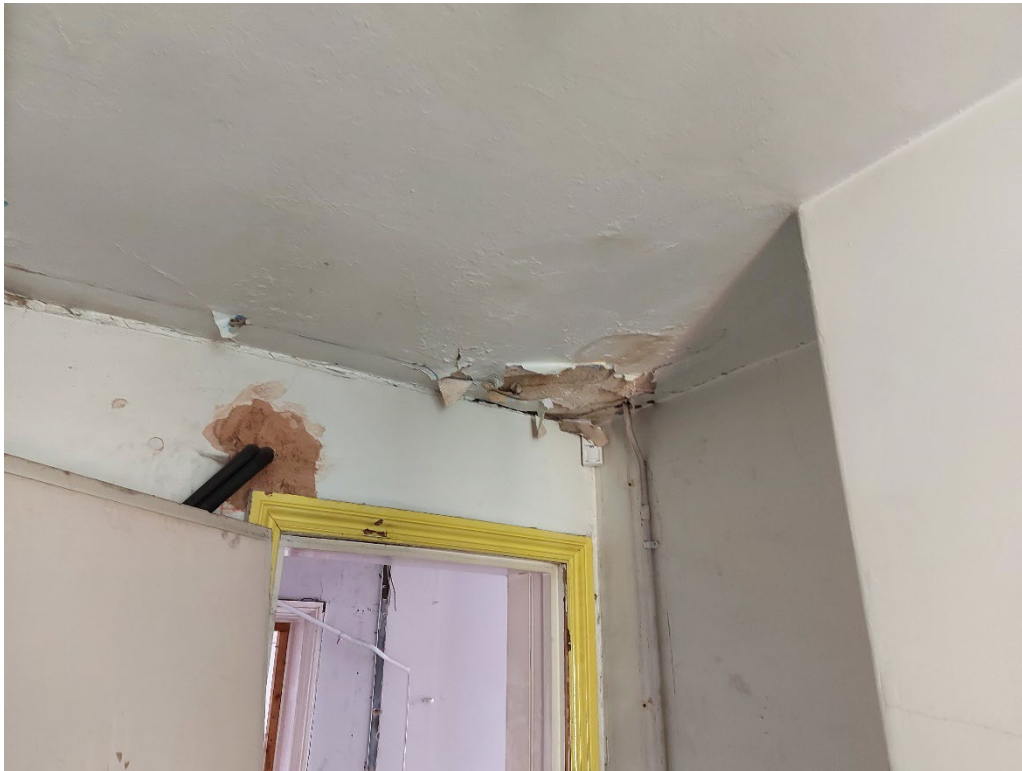
**Photograph 7**  
**Rear annexe, over entrance door – evidence of past leakage in lean-to roof**

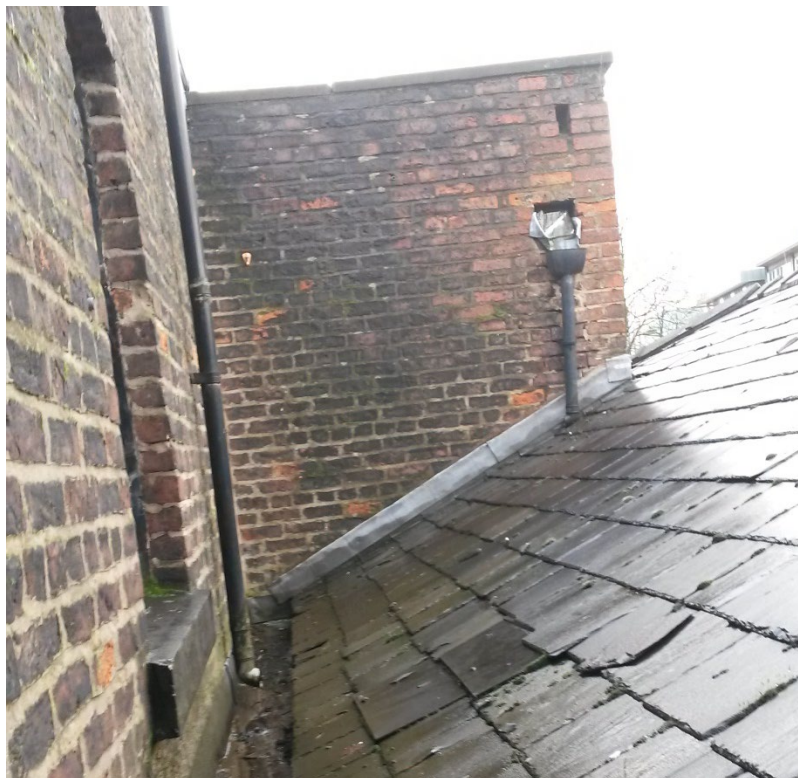
**Photograph 8**  
**Parapet wall (from rear window)**

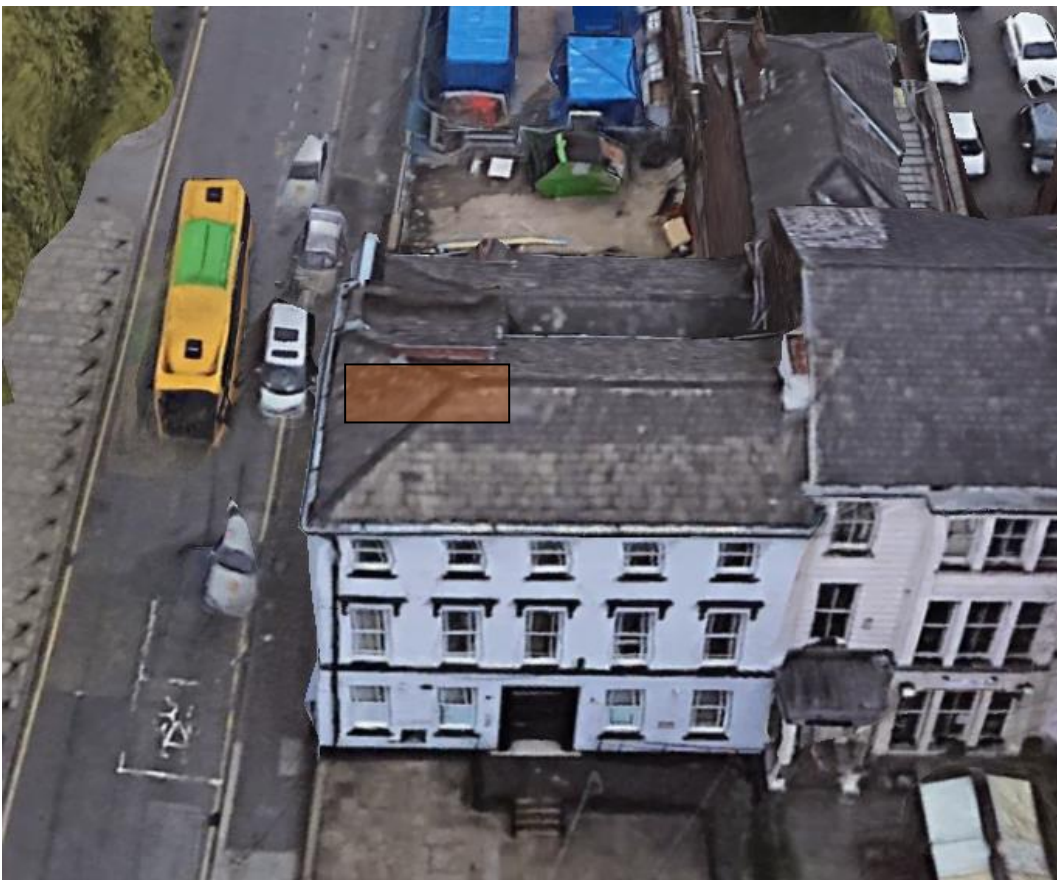
To carry out leak investigation and associated repairs to the highlighted area below.

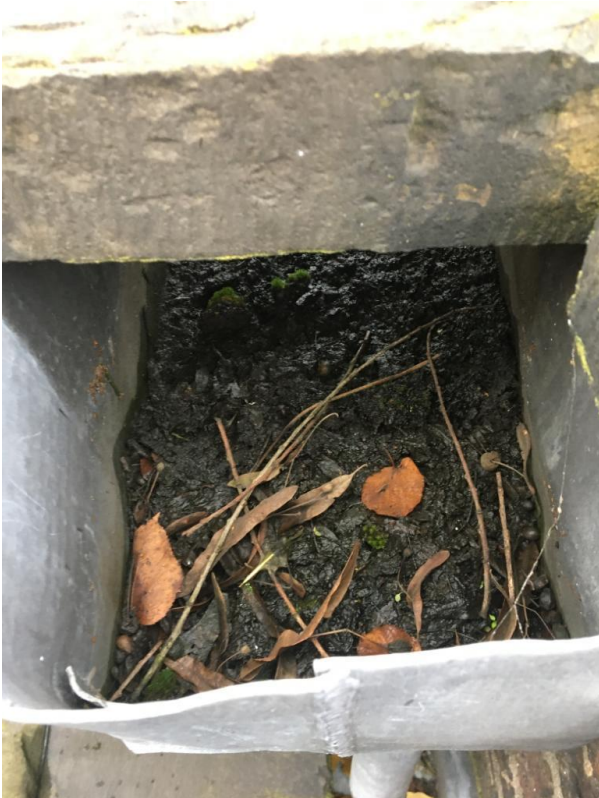
Hopper found full of debris.

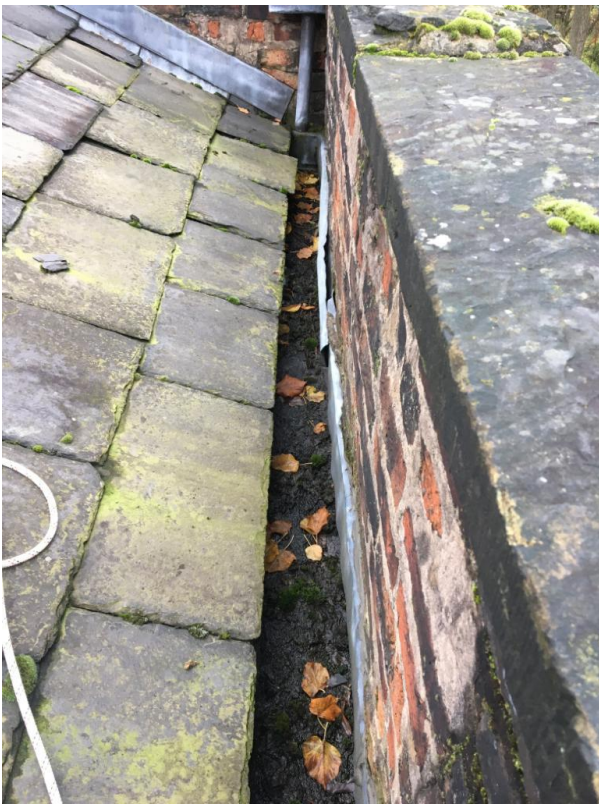
Gutter found full of debris.

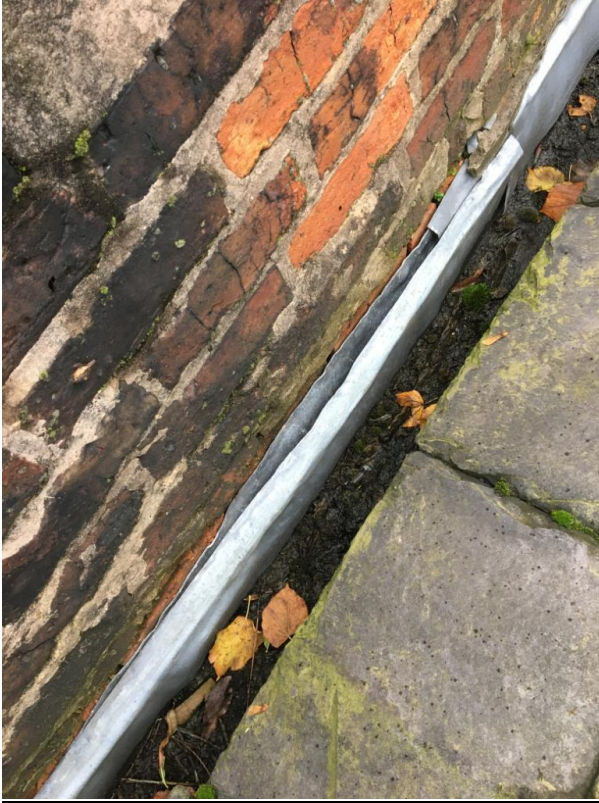
Gutter found full of debris.

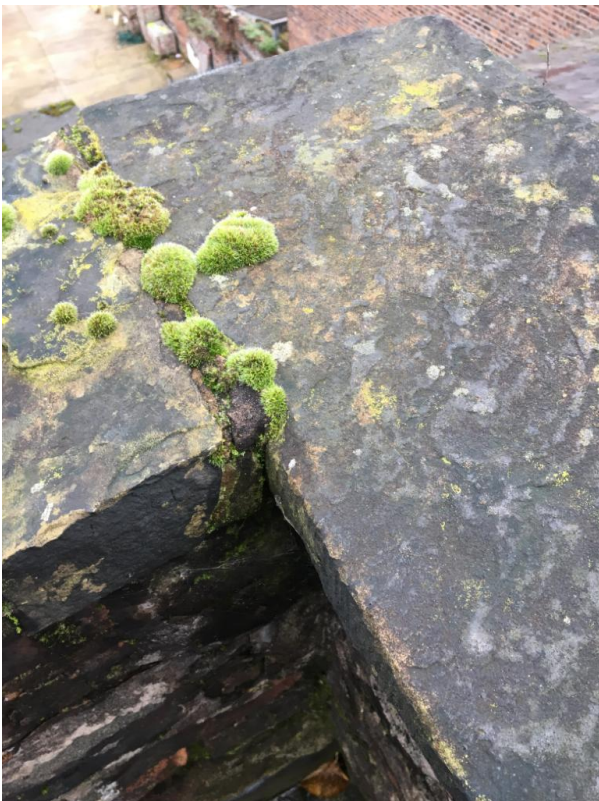
Failed coping stone mortar joint.

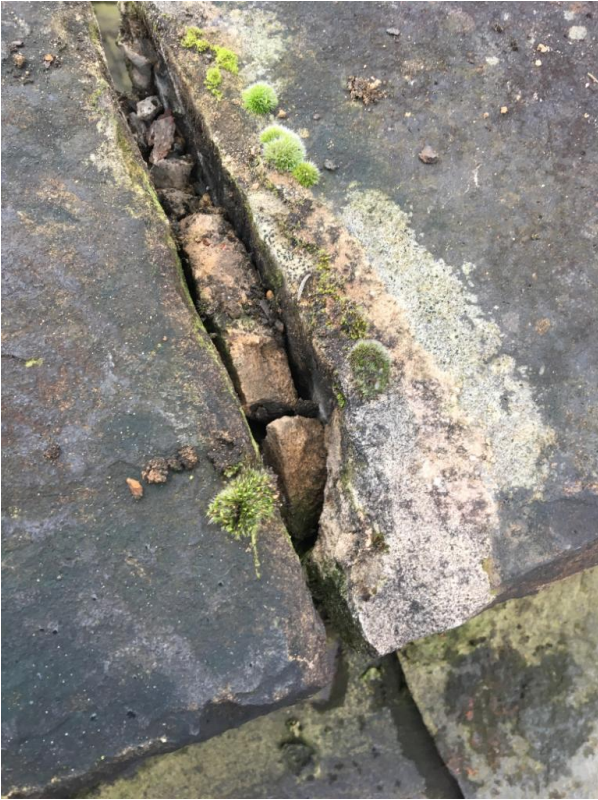
Failed coping stone mortar joint.

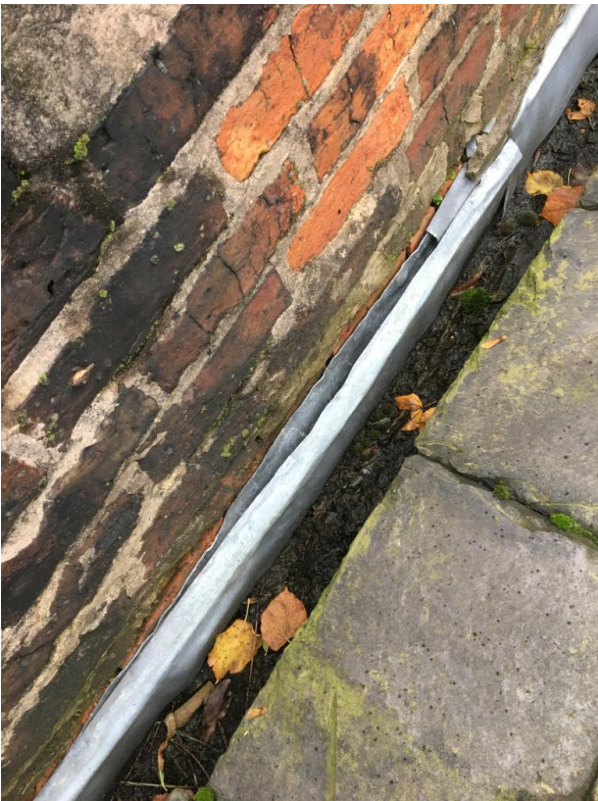
Lead displaced.

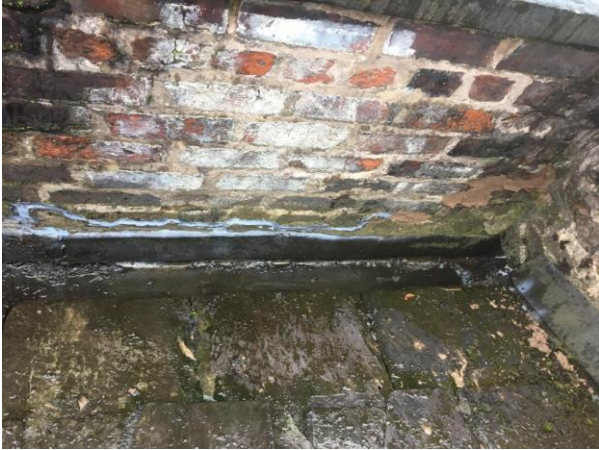
Crack filled with mastic due to the inadequate room for mortar raking equipment(thin crack). Wider crack mortar filled.

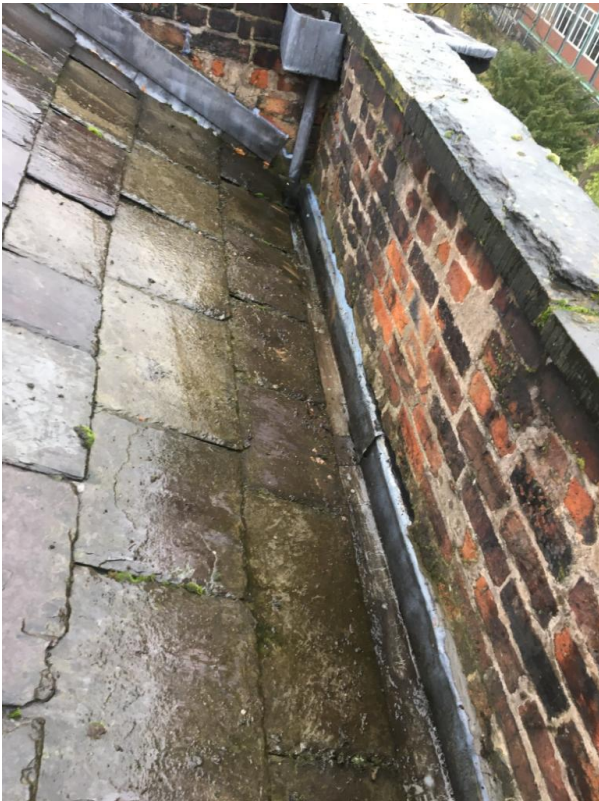
Many bricks found to be spalled and soft/degrading. Mortar soft/poor condition. The parapet was found to be in very poor condition. Very little effort was required to move the parapet indicating that the whole parapet is in poor condition.

Take down existing parapet wall. Wall to be re-built with new matching brick. New lead flashings and gutter to be installed.

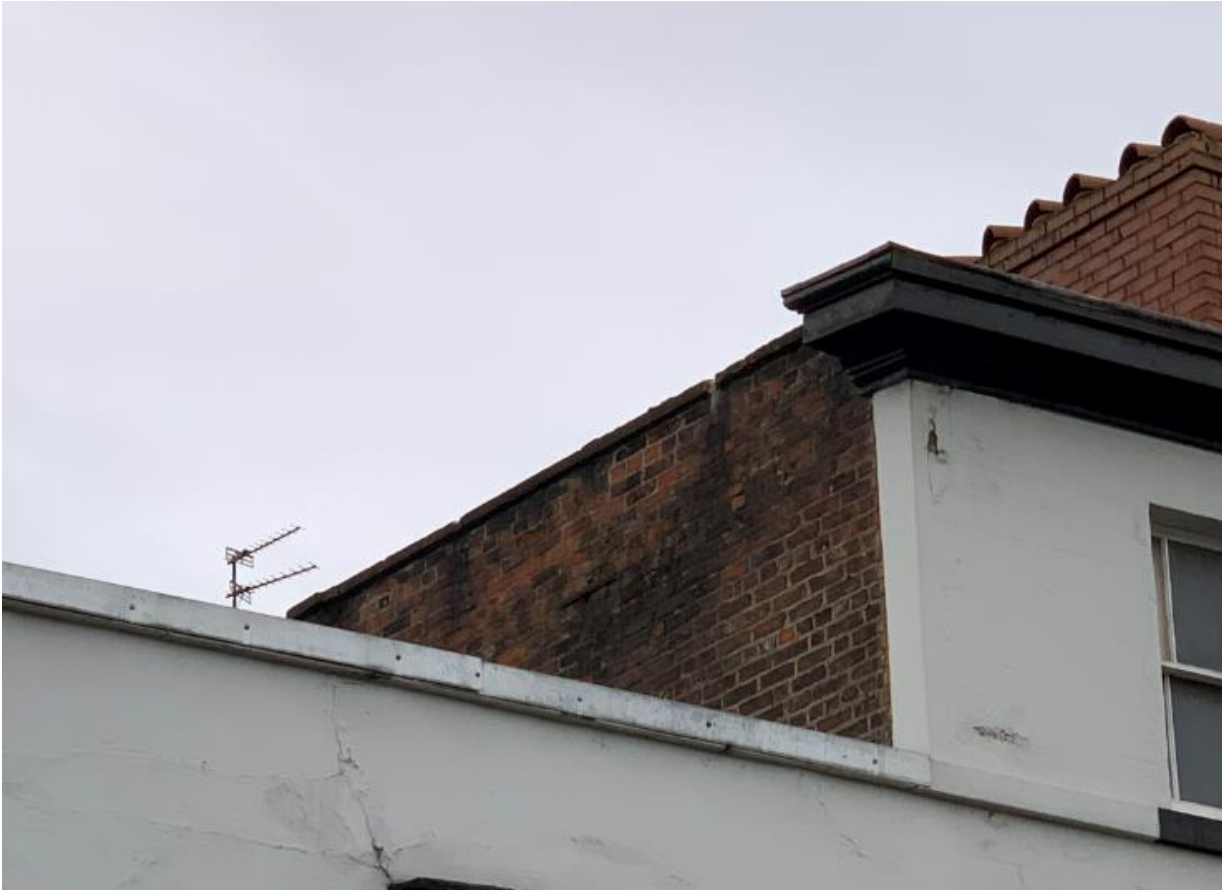
The above image shows the brickwork on the outside of the parapet wall to be in poor condition.
