# **P1212 Ormond Building, Manchester**

## **Structural Investigation Report**

**02/04/2022**

| <b>Report Reference:</b> | P1212/Report/001/R1 |

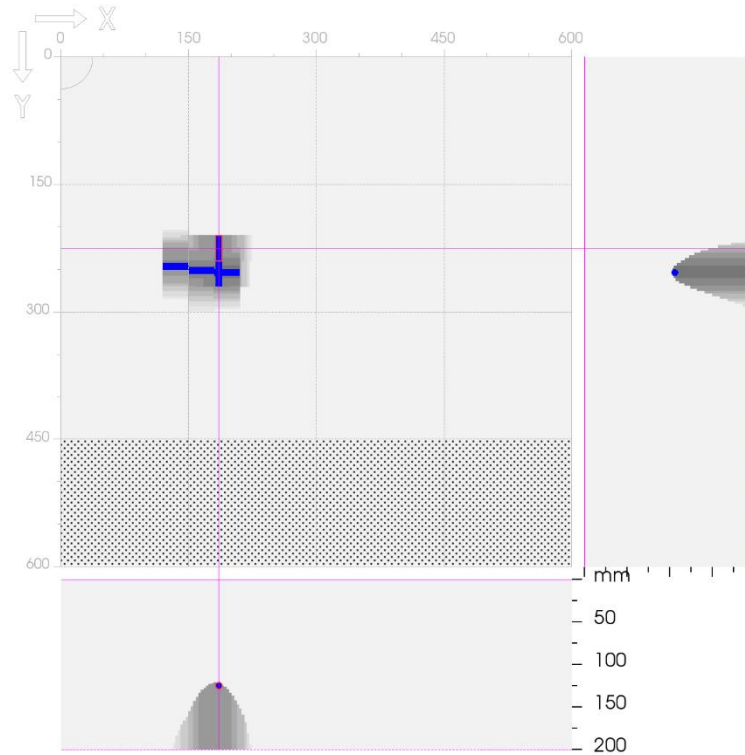
Scan File: Room 2 Top of Basement Slab.fscan  
Serial number: 310200011  
Date / Time: 2022-04-02 07:24:03  
Comment: -

| Comment: | Unable to detect clear reinforcement pattern | | |

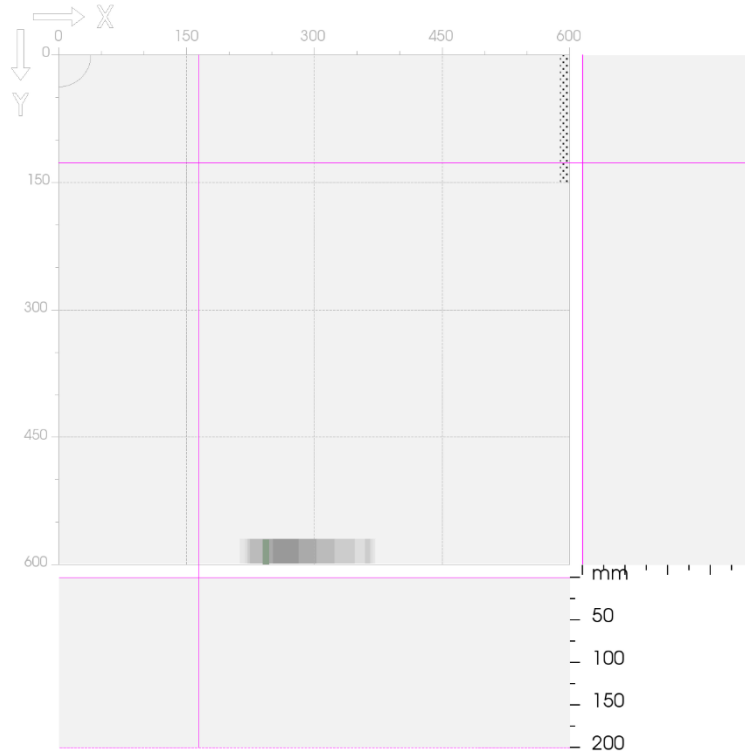
Scan File: Room 1 Top of Basement Slab.fscan  
Serial number: 310200011  
Date / Time: 2022-04-02 07:15:37  
Comment: -

| Comment: | Unable to detect clear reinforcement pattern | | |

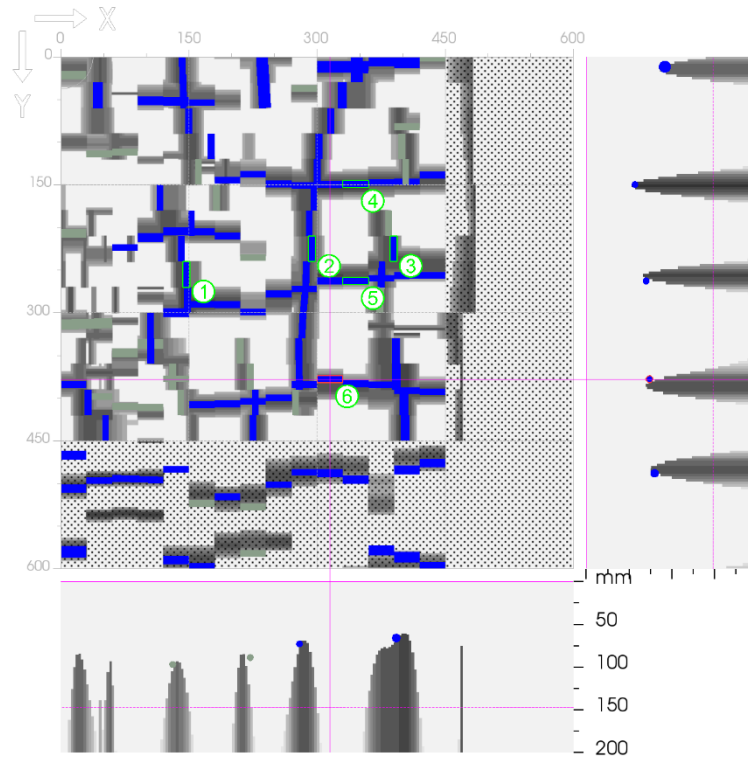
Scan File: Room 1 Soffit of Ground Floor Slab.fscan  
Serial number: 310200011  
Date / Time: 2022-04-02 06:48:29  
Comment: -

| Comment: | Reinforcement Grid 150 x 150 | | |

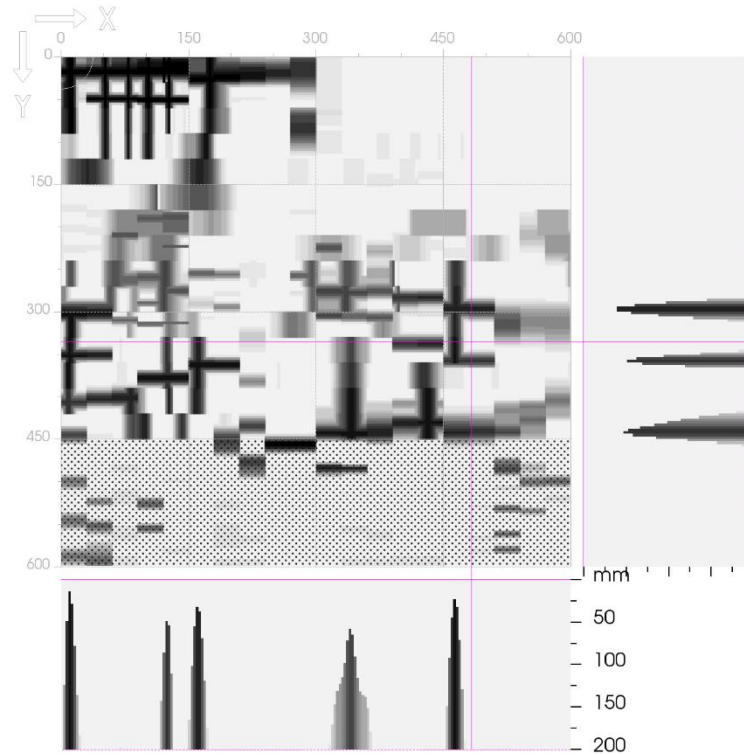
Scan File: Room 2 Top of Plinth.fscan  
Serial number: 310200011  
Date / Time: 2022-04-02 07:26:55  
Comment: -

| Comment: | Unable to detect clear reinforcement pattern | | |

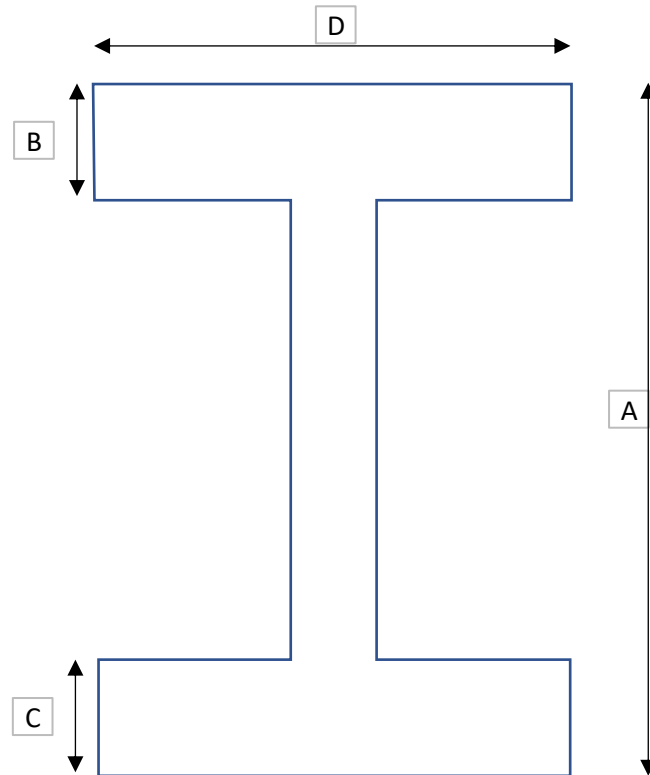
### Beam D1

| Pre Corrosion Removal | | |
|---|---|---|
| A | Beam Depth | 140.25 |
| B | Top Flange | 23.94 |
| C | Bottom Flange | 17.68 |
| D | Flange Width | 118.90 |

| Post Corrosion Removal | | |
|---|---|---|
| A | Beam Depth | 125.89 |
| B | Top Flange | 6.98 |
| C | Bottom Flange | 14.38 |
| D | Flange Width | 117.77 |

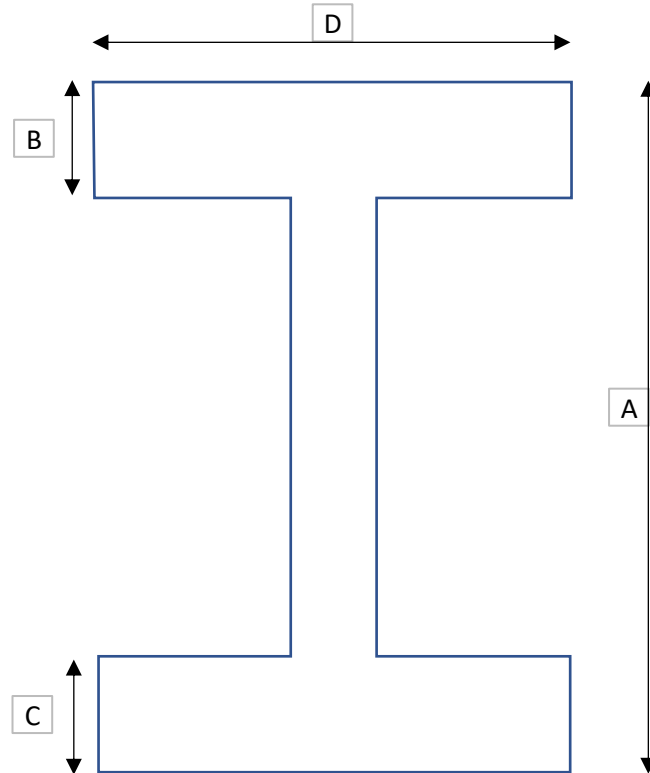
**Beam D2**

| Pre Corrosion Removal | | |
|---|---|---|
| A | Beam Depth | 127.96 |
| B | Top Flange | 10.96 |
| C | Bottom Flange | 12.32 |
| D | Flange Width | 115.30 |

| Post Corrosion Removal | | |
|---|---|---|
| A | Beam Depth | 127.18 |
| B | Top Flange | 10.39 |
| C | Bottom Flange | 11.22 |
| D | Flange Width | 115.30 |

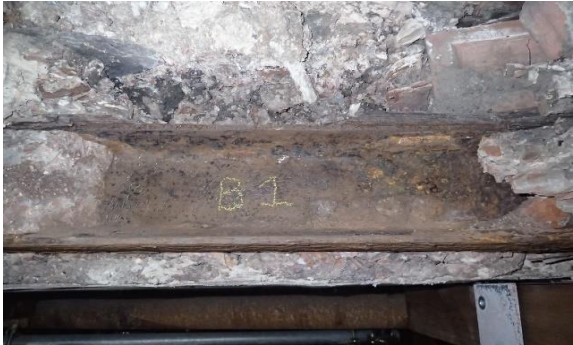
| <b>Photo Ref.</b> | 1 | |

| <b>Description</b> | D1 Pre Corrosion Removal | |

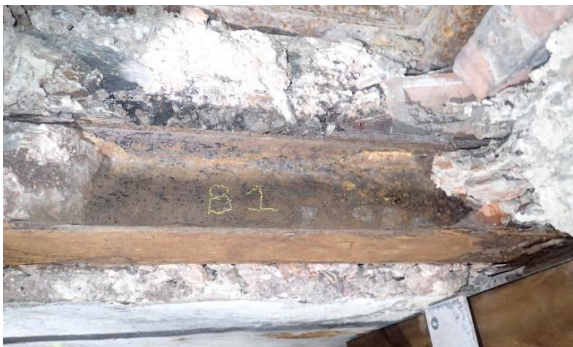
| <b>Photo Ref.</b> | 2 | |

| <b>Description</b> | Post Corrosion Removal | |

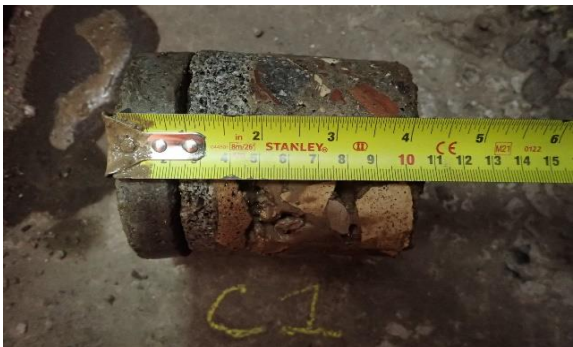
| <b>Photo Ref.</b> | 3 | |

Core 1 was made up of three parts with the first layer being 22mm of screed the second layer being 25mm of concrete with an aggregate size 6mm, and the third layer being 55mm of concrete with an aggregate size of 32mm.

| <b>Description</b> | Extracted Core | |

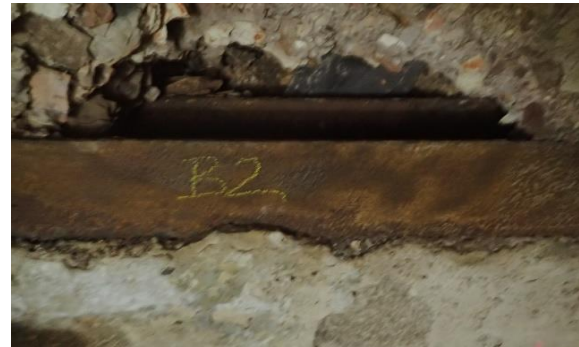
Photo Ref. 4

Description Pre Corrosion Removal

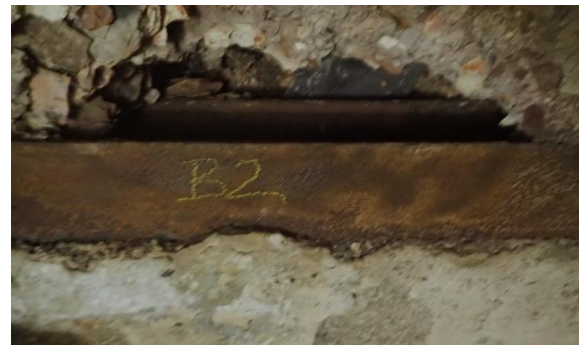
Photo Ref. 5

Description Post Corrosion Removal

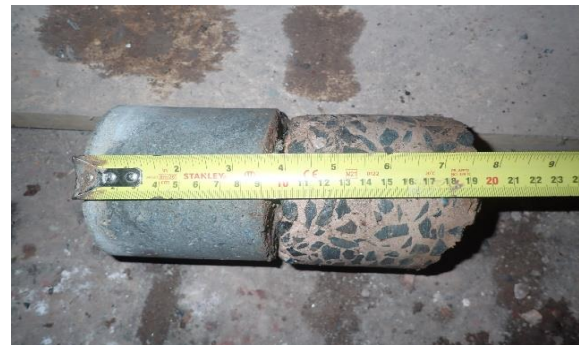
Photo Ref. 6

Core 2 was made up of two layers of concrete with the first being 90mm in length with 6mm aggregate and the second layer being 95mm in length with 22mm aggregate.

Description Extracted Core
