**Project Number: CL 45355 & CL 45356**

**Project Description: Fire Alarm & Emergency Lighting Replacement**

**Location: Victoria Baths - Hathersage Road, Manchester, M13 0FE**

Survey Review (CP&P Survey Date) – June 2022

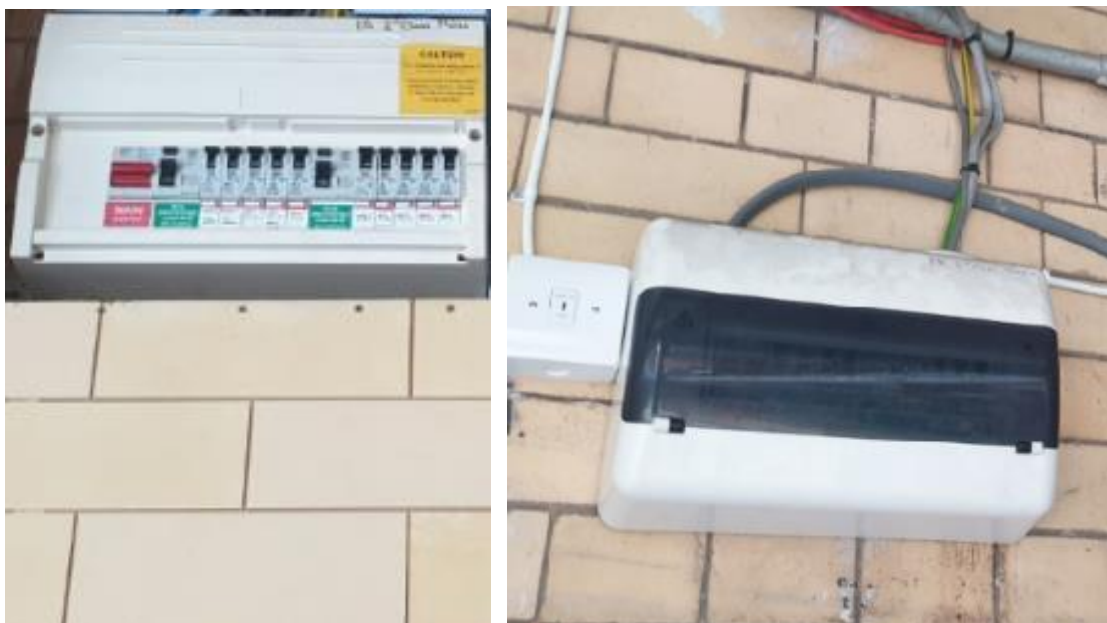
We have had not had sight of the periodic inspection report, no distribution board labels are present for the previous or next recommended date of inspections.

A new periodic inspection report is required if the building records cannot be located.

The new inspection would highlight any issues with the electrical installation.

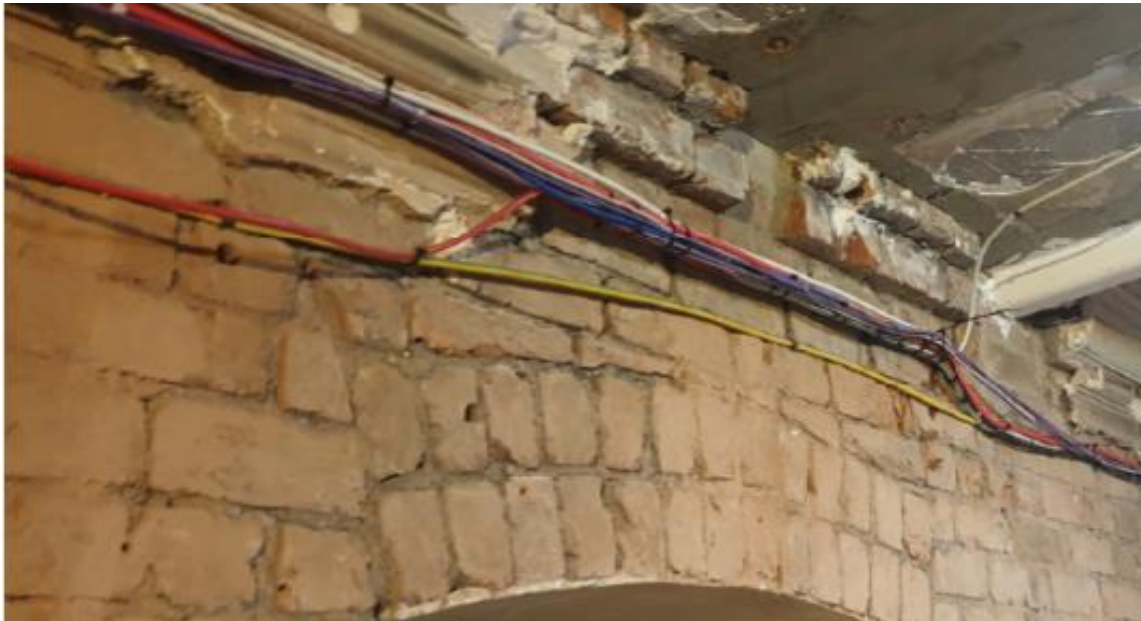
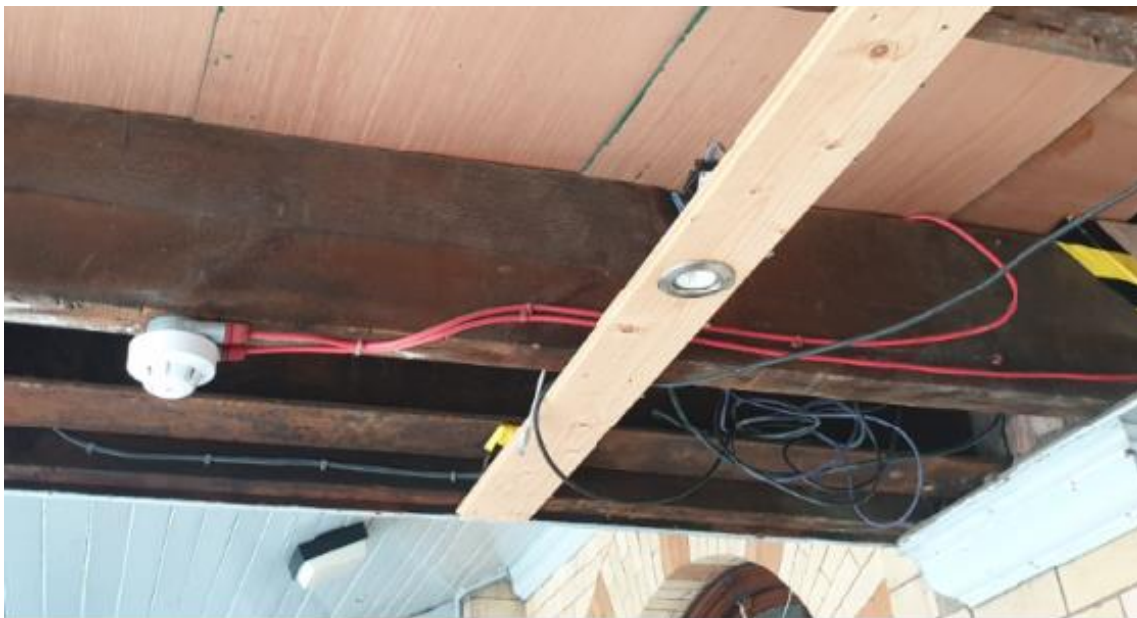
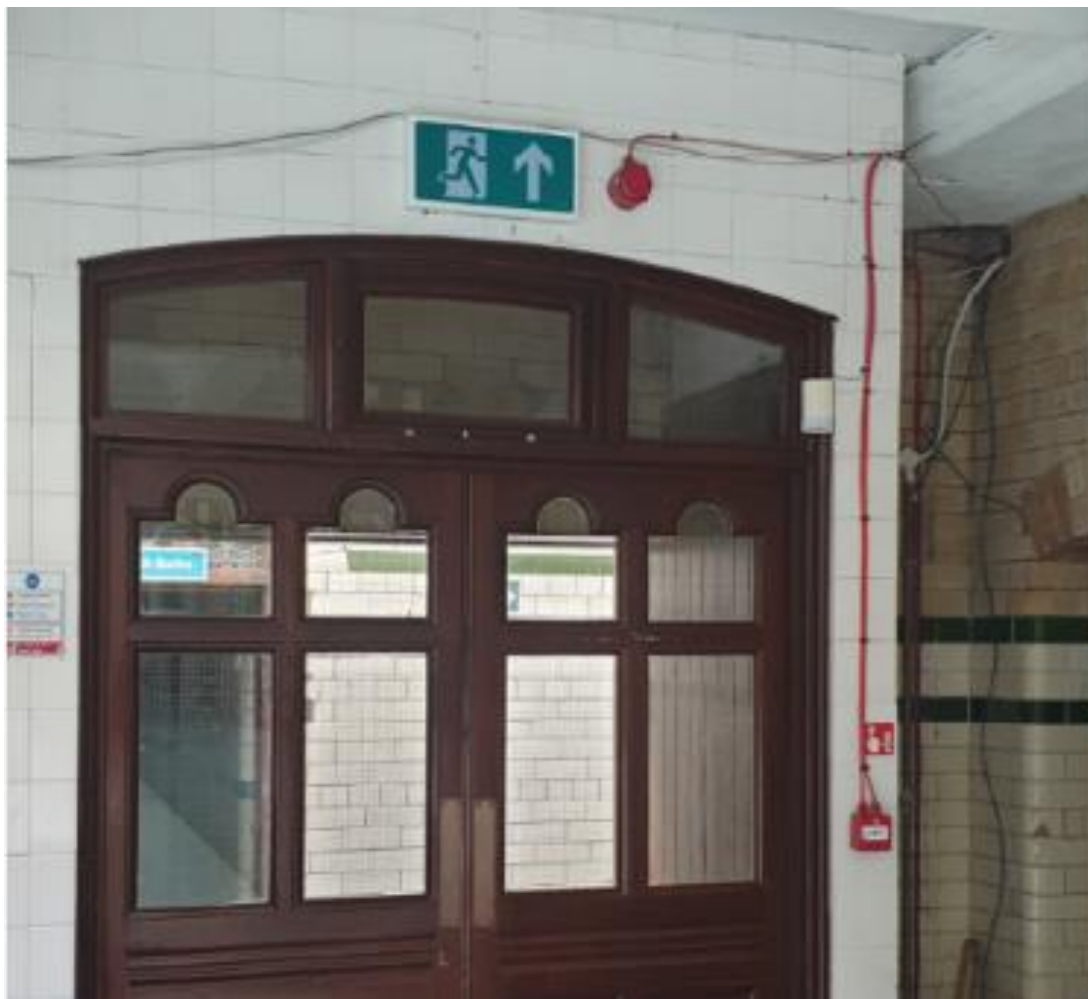
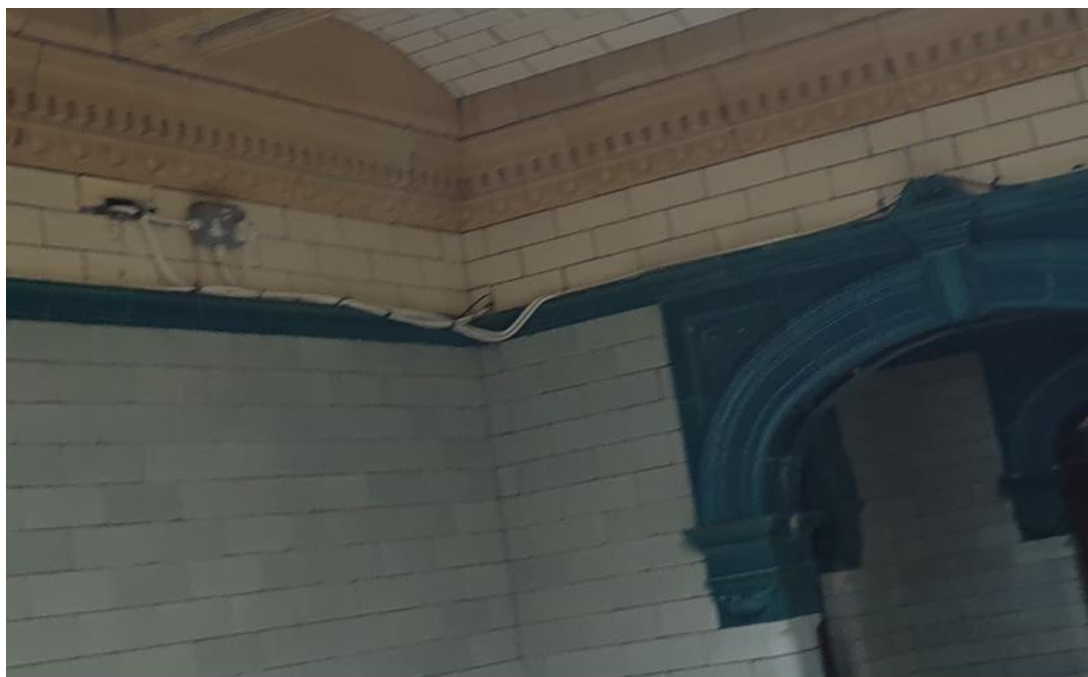
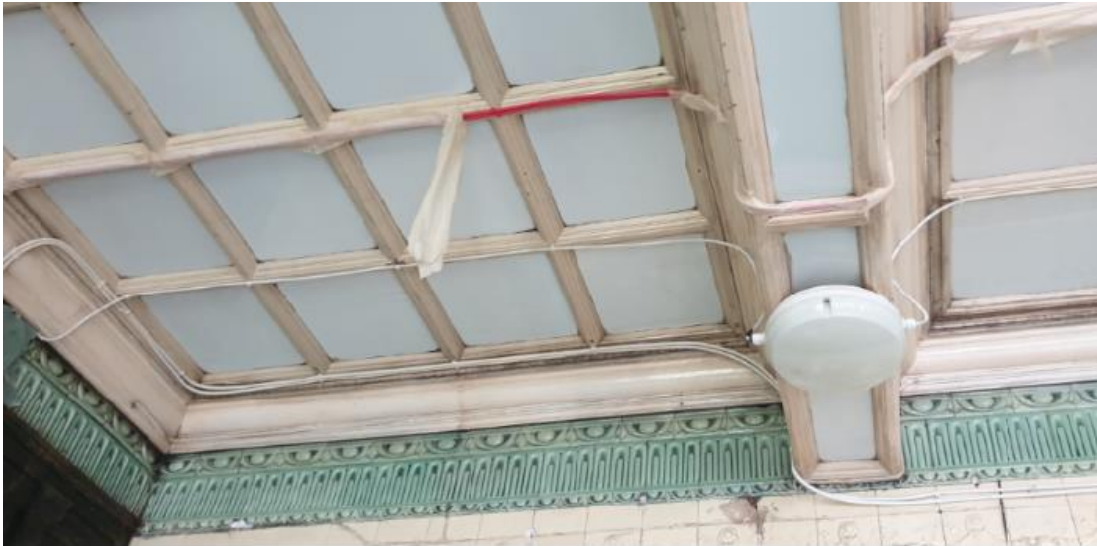
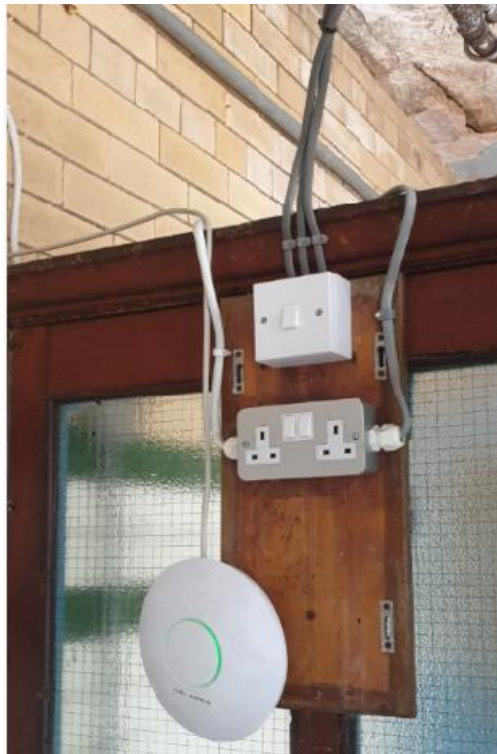
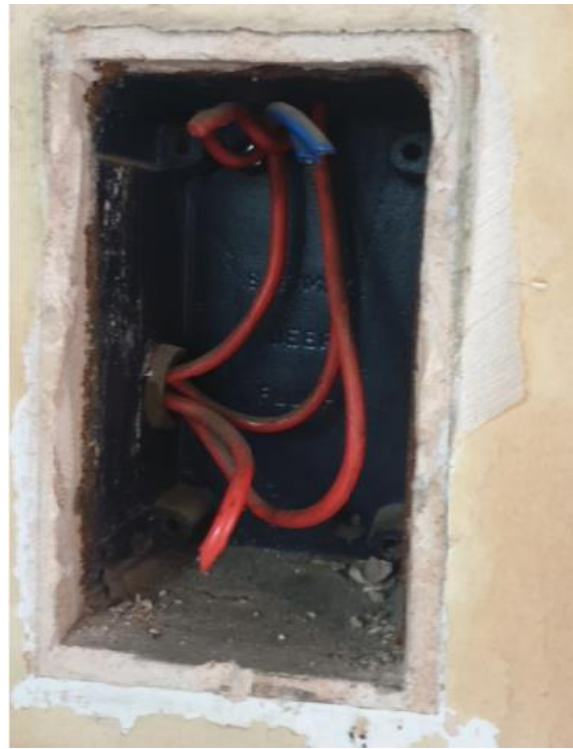
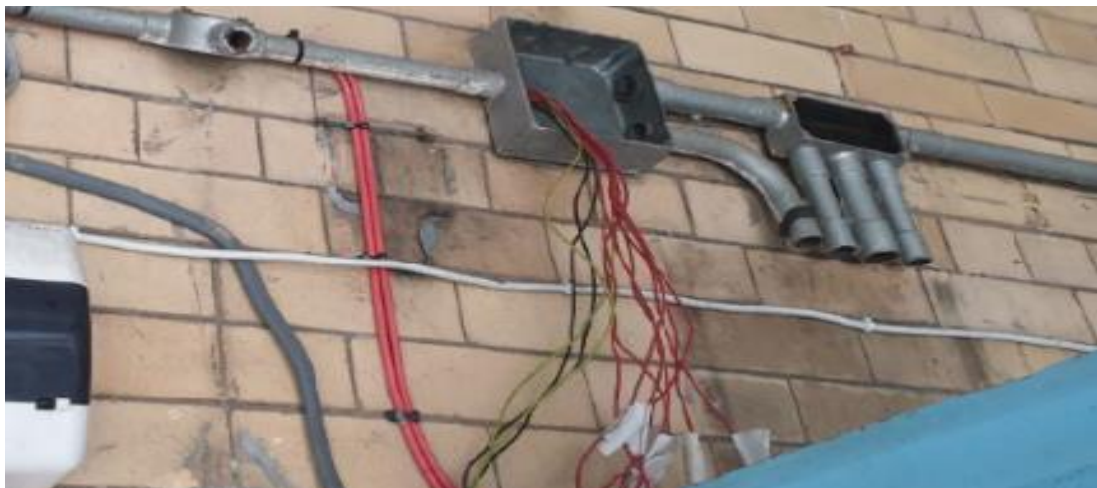
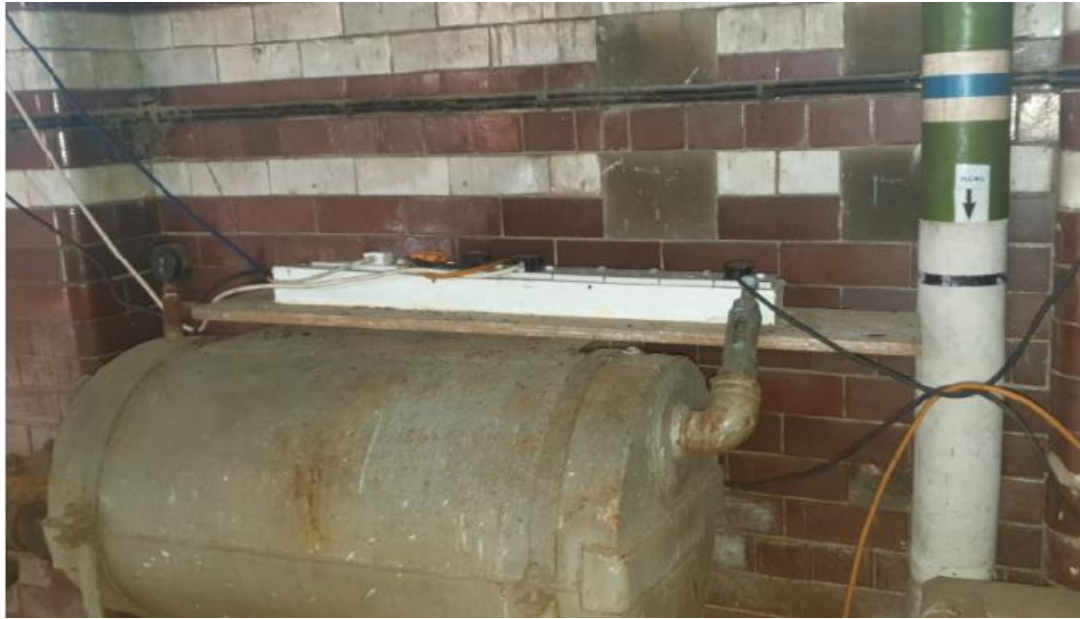
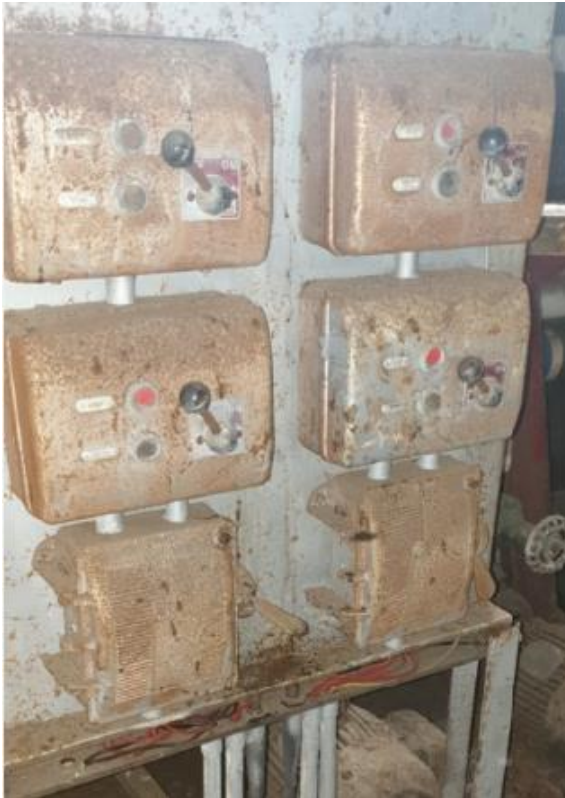
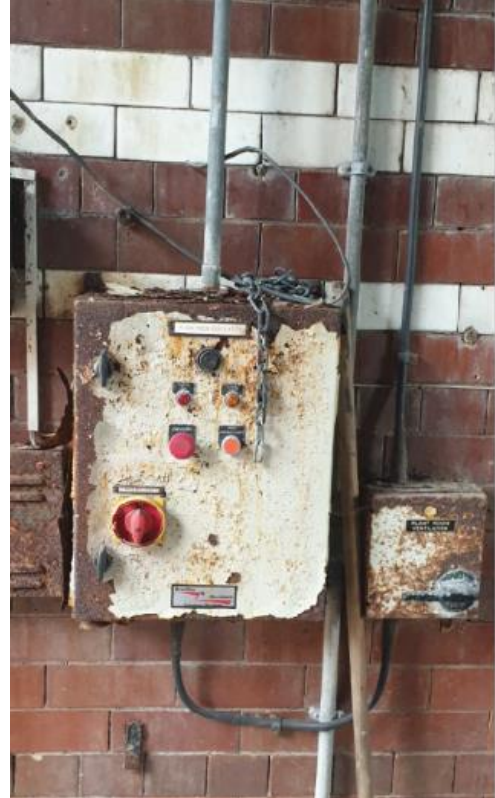
A number of electrical services have been added and removed by the building users and by production companies. The boiler room currently has no power, with the sockets and lighting taken from a multi gang extension lead.

Photos below show areas which require addressing but would not be part of fire alarm or emergency lighting project. Unsupported cables, mounting positions and cable runs may also cause an issue under fire conditions.
