# Essential Repairs to the Roof

## 1830 Warehouse

Science & Industry Museum

Design and Access Statement

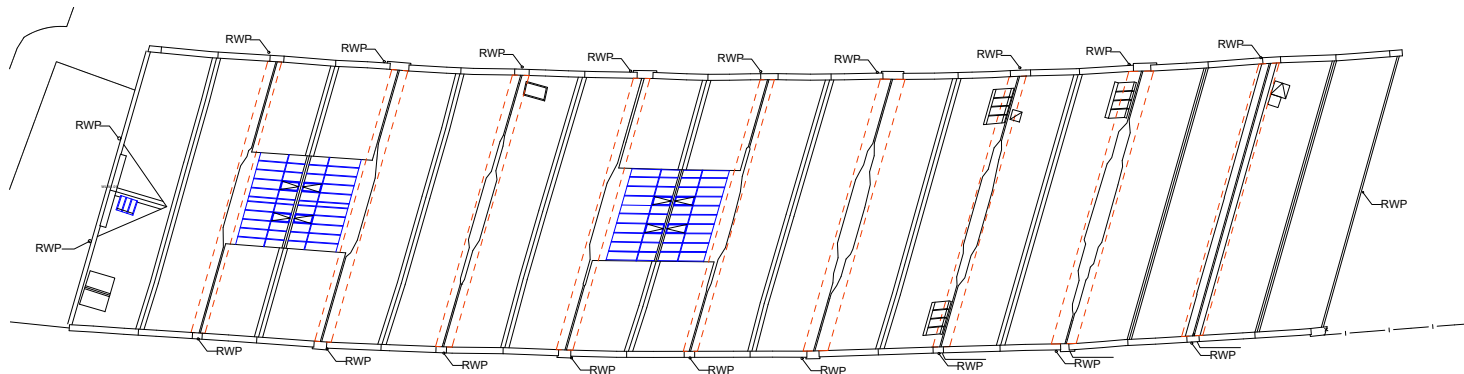
Plan of the roof with valley gutters highlighted with dashed red outline

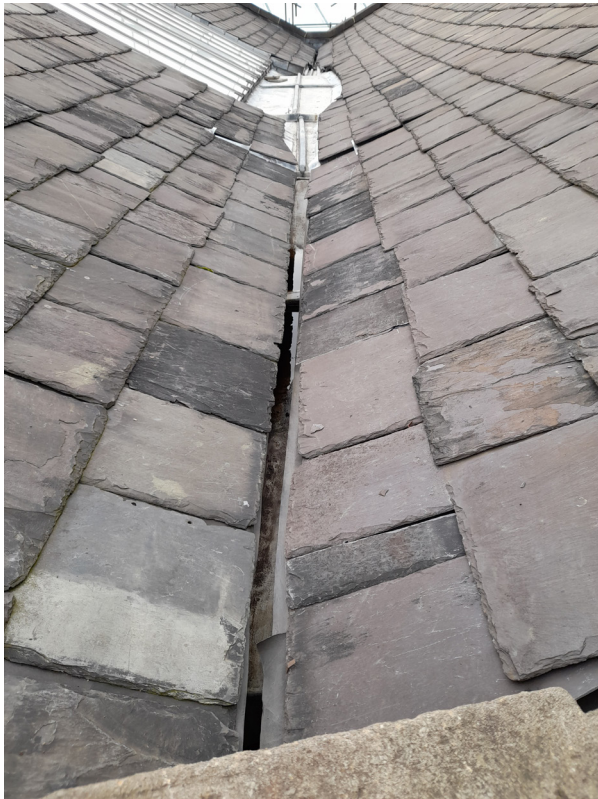
View of a valley gutter from above

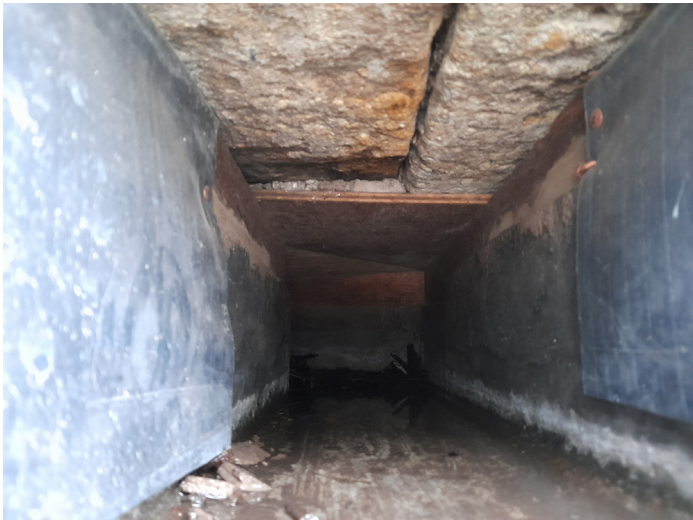
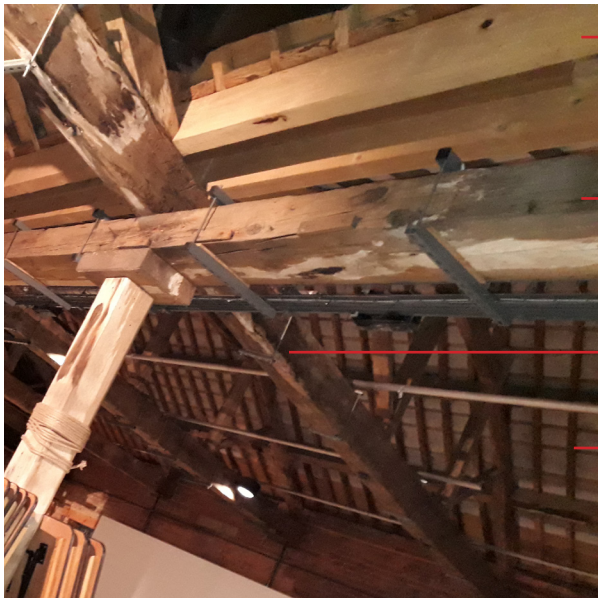
View of a valley beam gutter from below

Twin Valley Purlins

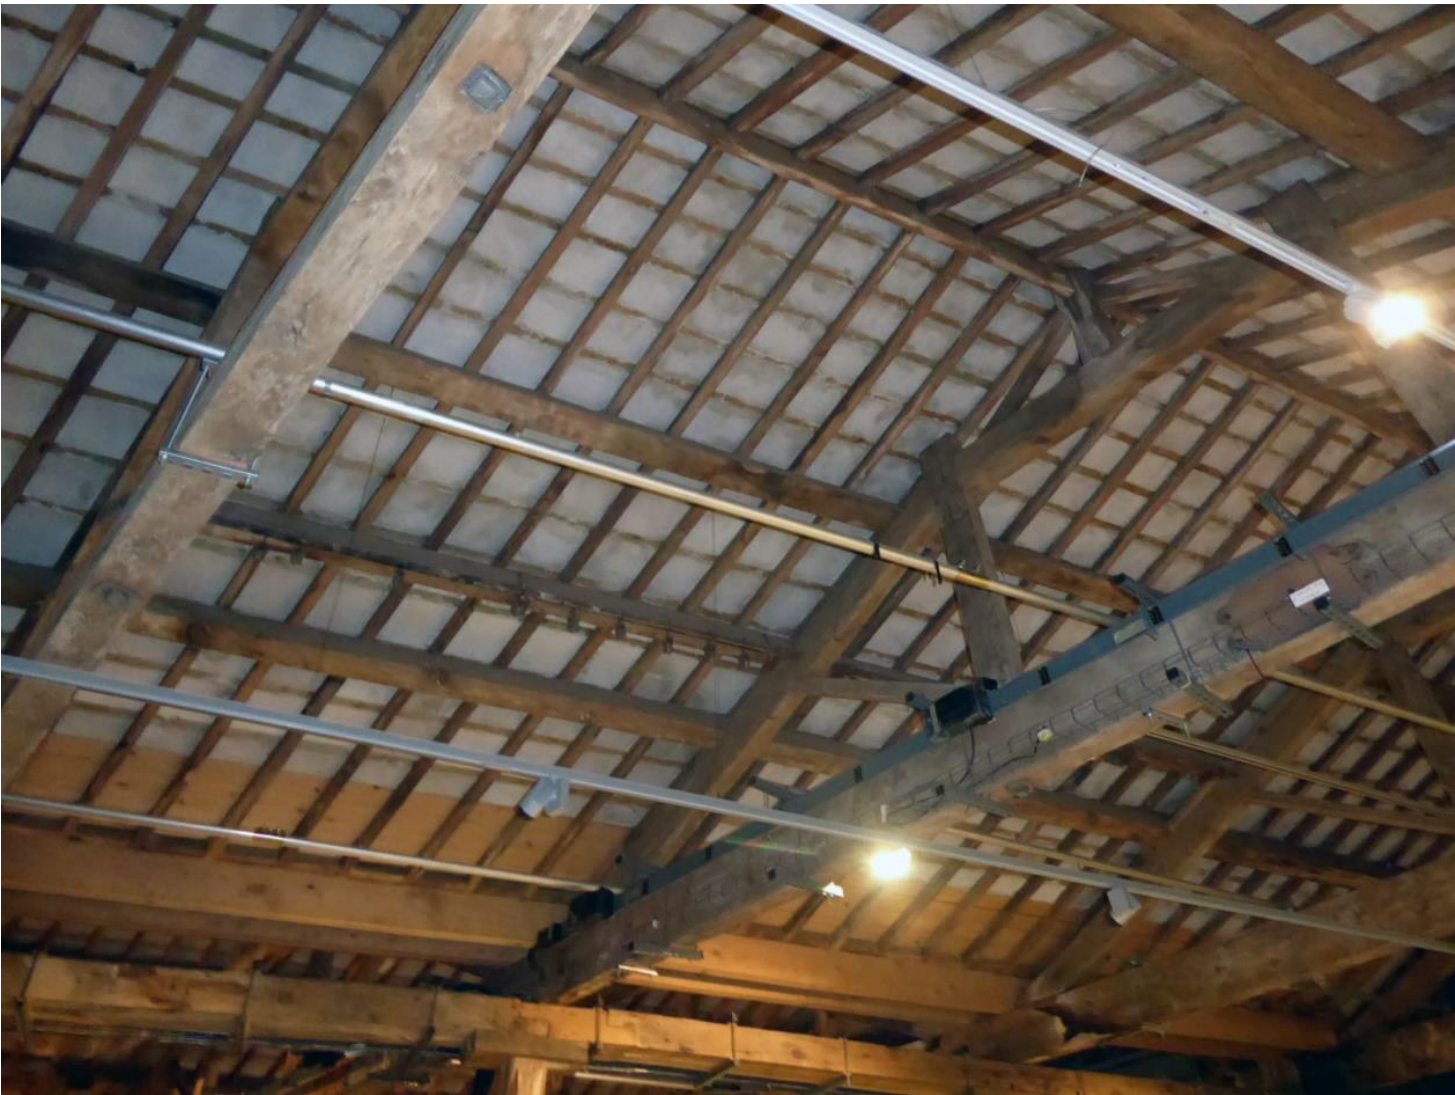
- Hutton & Rostron’s investigation and analysis concluded that the preparation of the mortar and its application are wholly inadequate and likely relate to a misinterpretation of the specification by an inexperienced tradesperson and go on to state that ultimately, further areas of torching which are currently ‘sound’ are likely to fail and the museum should expect similar instances of falling material in the future.

Internal view of the torching.

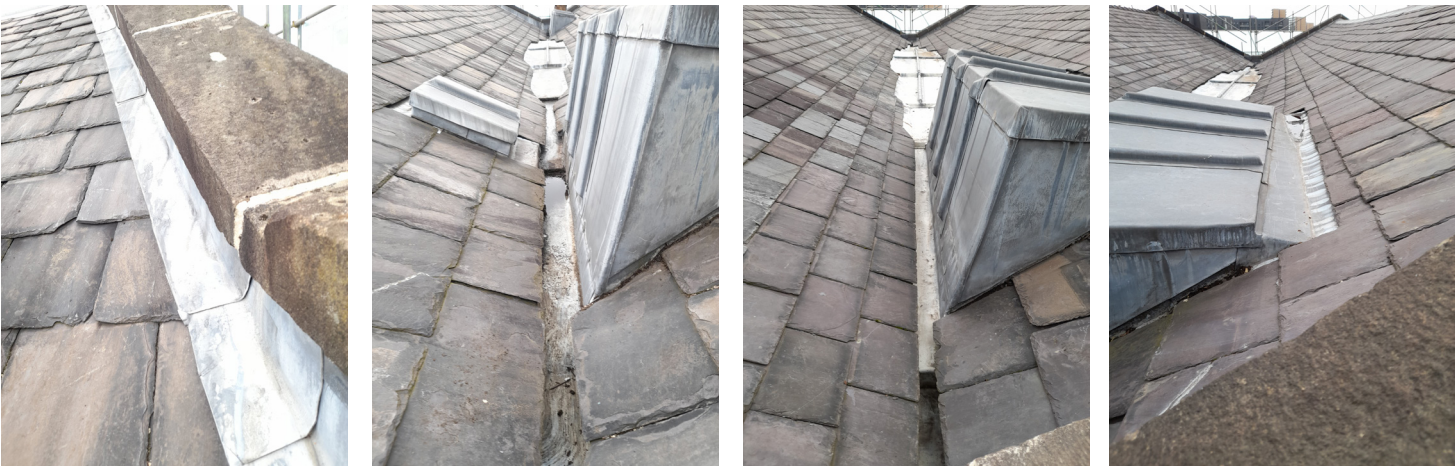
Example images of the existing roof above the Bay 4 Torching. The archive drawings indicate that second hand slates were laid in the 1990’s when the existing torching was installed.

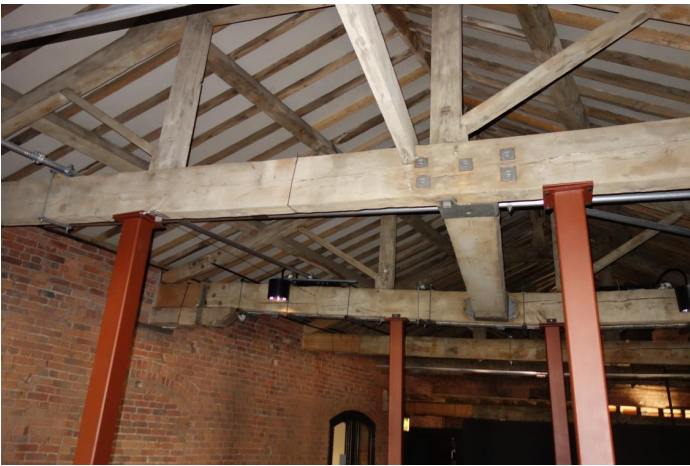
Square Hollow Section columns (4No), serve to prop failed trusses at the East side of Bay 2.

- Bay 2:
  - Repair damaged bottom chords of 3no. trusses with spliced timber repair or bolted overplate. Temporary support required during works.
  - The failure of the bottom chord of the southern truss in Bay 2 should be addressed using localised plate repairs.
  - To facilitate removing the propping, the bottom chord of the truss should be strengthened across the length of the failed chord using new steel plate details. A repair detail would involve plates bolted either side of the bottom chord to span from primary valley beam to wall. Failure and significant bowing of existing bottom chords makes member recovery difficult. Careful consideration of temporary works would be required for all remediation options.
- Bay 1:
  - Bolt/resin repair to split in truss top chord.
- Refer to Methodology Appendix B.3.

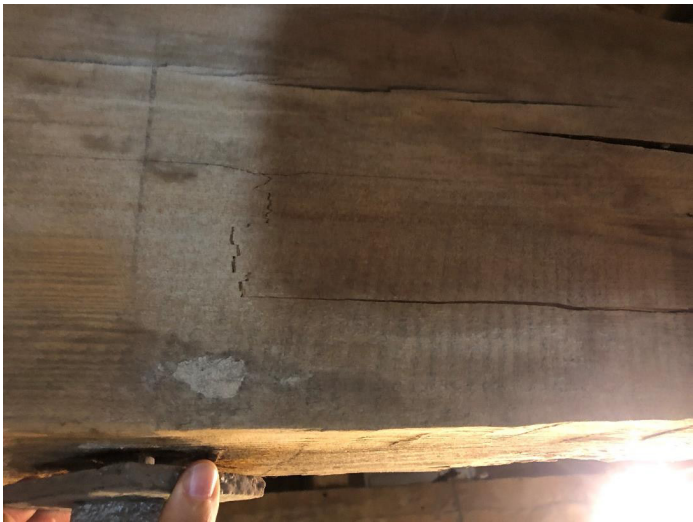
Close up of roof truss cracking, to the south of propped trusses in Bay 2, with cracking of main tie.

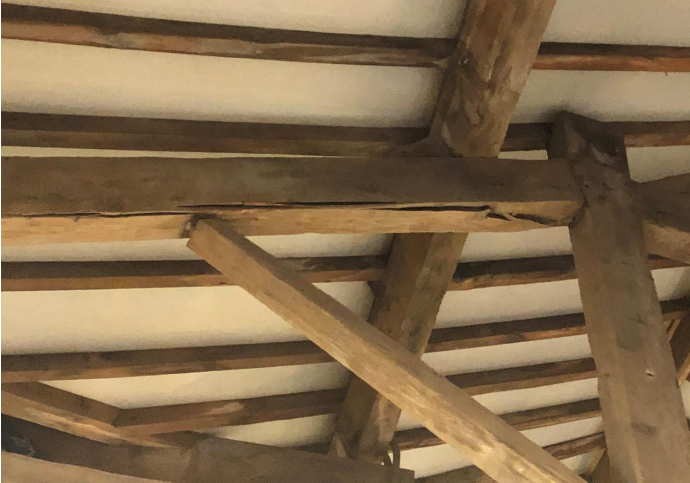
Roof truss in Bay 1 showing high level splitting in principal rafter.
