**Condition Report and Repair Schedule**  
27-33 King Street West, The Carriage Works and Warehouse

This Condition Report and Repair Schedule has been produced on behalf of Property Alliance Group to accompany the Planning and Listed Building Consent application for the redevelopment of 27-33 King Street West, The Carriage Works and Warehouse.

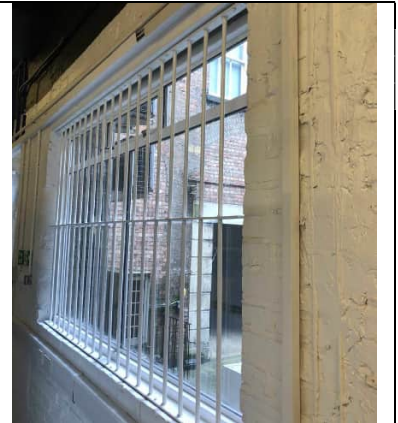
G02

| Item | Spalling paint to existing brickwork |

| Specification | (MAS-001) Masonry repair |

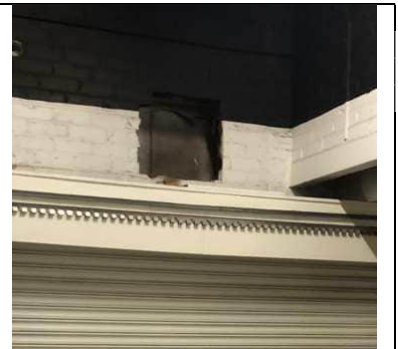
G04

| Item | Missing mortar |

| Specification | (MAS-002) Masonry repointing |

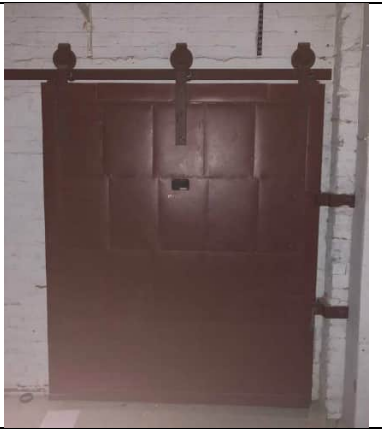
G08

| Item | Non-Original sliding metal fire door | |
| Description | 08 - Metal sliding door with feature rail and rollers was noted to the west of the room. Likely 1960's to match other similar fire doors noted elsewhere<br>Room GF 09 – Metal hinged double door. | |
| Condition | 01 | |

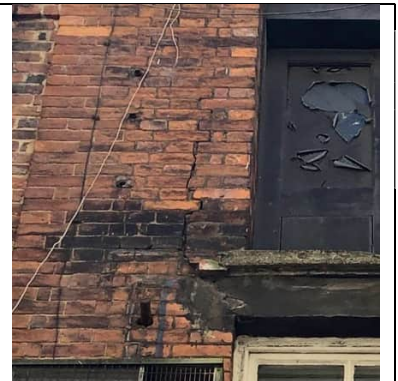
E  
102

| Item | Damaged stone cills |

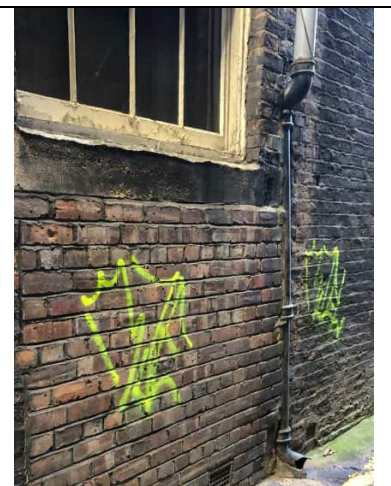
E  
202

| Item | Stone cill spalling |

| Specification | (MAS-001) Masonry repair |

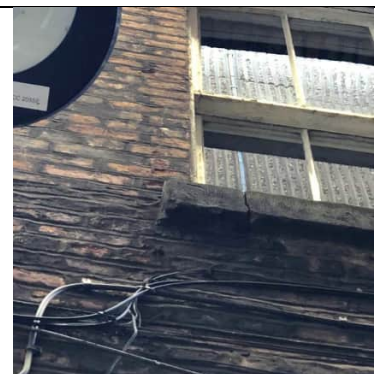
E  
205

| Item | Missing bricks |

| Specification | (MAS-001) Masonry repair<br>(MAS-002) Masonry repointing |

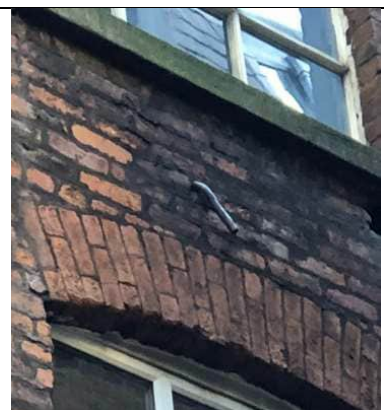
E  
216

| Item | Loose brickwork |

| Specification | (MAS-001) Masonry repair |

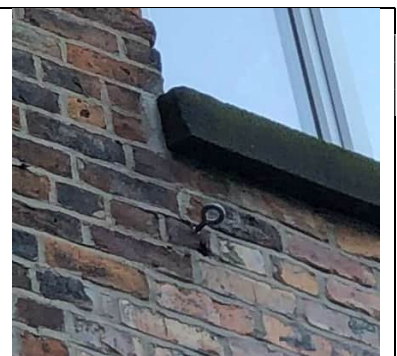
E  
302

| Item | Poor quality brick infill |

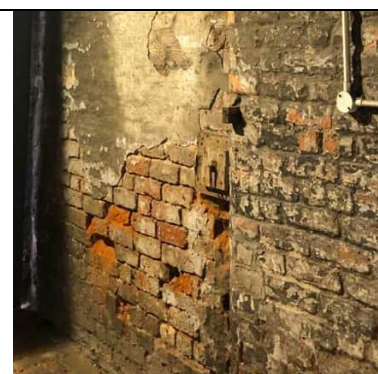
E  
708

| Item | Damaged brickwork and eroded pointing |

| Specification | (MAS-001) Masonry repair<br>(MAS-002) Masonry repointing<br>(where deemed necessary) |
