9518 | Manchester Art Gallery

Roof Lantern Condition Report

November 2022

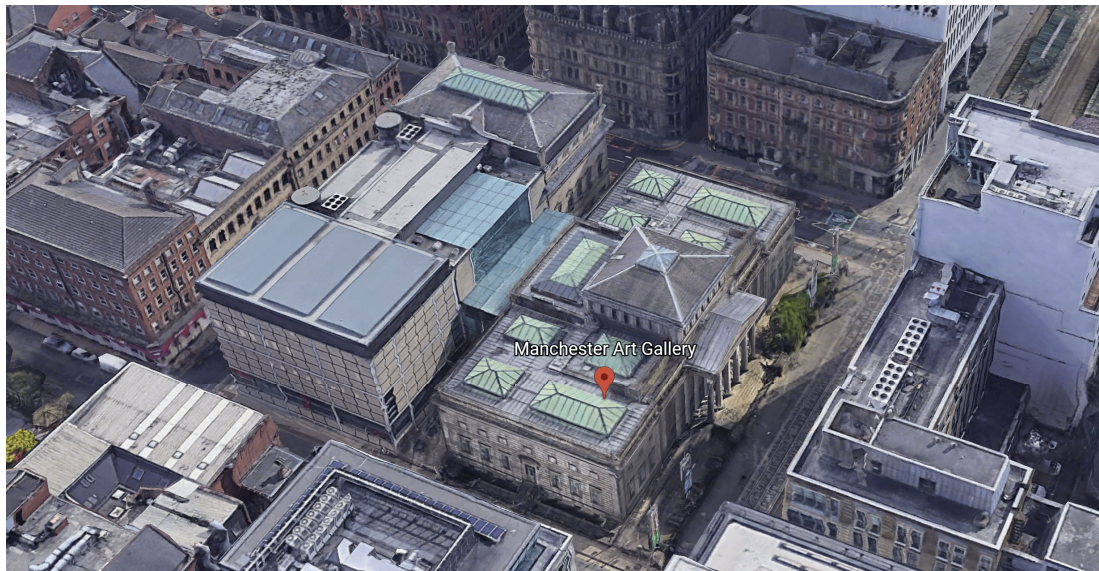
**Roof:** The central entrance foyer roof is a slate pitched pyramidal roof with lead hips. This terminates at a central glazed timber framed lantern with a louvered upstand. The roof is accessed at low level via a fixed ladder to the lower flat roofs and a fixed ladder to the rear lantern elevation. This, however, does not give safe access to the slate roof, or the glazed lantern above.

**Condition:** The glazed lantern is at the end of its life and requires wholesale replacement. This was identified in the recent Donald Insall Associates condition survey and has been confirmed as part of this inspection. The lantern has, for some time, been supported by an external webbing strap. This has been fitted as a temporary support to avoid lateral spread to the vertical timber louvers. This, and the lantern as a whole, have not been maintained. As a result, the webbing strap shows signs of UV degradation and stress. Failure of this tension strap could cause catastrophic failure and the sequential collapse of the lantern. As a result these works have already been identified as urgent.

**Louvers:** It is assumed that the louvers to the vertical sides of the lantern are fixed, and remain open at all times. These would have formed part of the original buildings natural ventilation strategy. Replacement should consider the use of aluminium louvers externally, and motorised dampers to allow their operation to be controlled as part of the buildings BMS system. If this is not possible, 'dummy' louvers should be fitted externally and a blank insulated panel detailed internally.

**Recommendations:** The glazed lantern should be replaced by a new, aluminium framed lantern which matches the proportions of the existing design, but avoids onerous maintenance by being an aluminium frame. The opportunity should be taken to double glaze the lantern as discussed in 2.2 below.

**Finish:** The glazed roof lights to the galleries that surround the entrance were replaced with aluminium framed roof lights as part of the 2002 refurbishment. The new central lantern should be in a dark grey to match these roof lights. Whilst Polyseter Powder Coating may be considered appropriate, an anodised finish is higher quality, and longer lasting, and suitable for use on a grade I listed building.

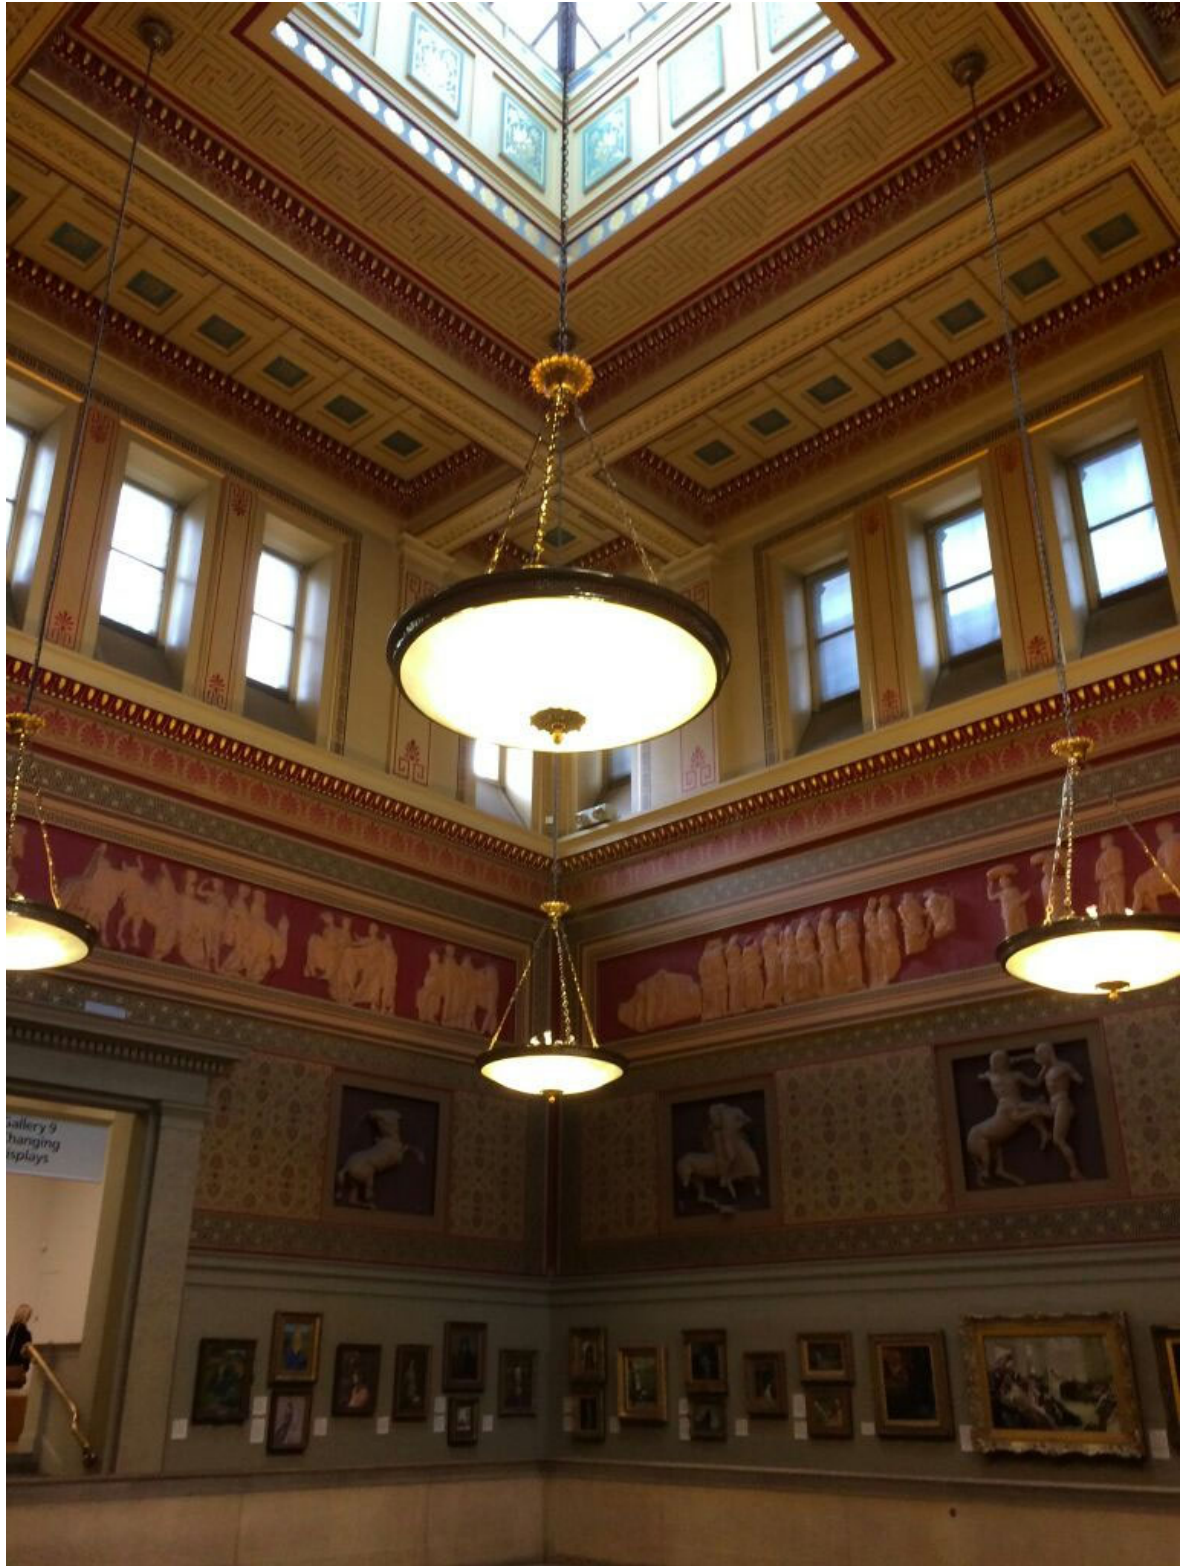
**Central Glazed Lantern:** The central glazed lantern is formed of a timber framed lantern with a pyramidal pitched form. There are vertical louvered risers to each of the four sides. This sits at the apex of the pitched slate roof. It should be noted that the condition of the roof void to the slate pitched roof was unable to be safely inspected due to the lack of safe access to the fixed ladder access system (see 2.3.1 below).

It should be noted that water ingress through the lantern has been noted within this entrance foyer. This area is not only used by the public to access the galleries and facilities beyond, but is a gallery in its own right, with artworks and sculptures on public display. It is essential that the replacement lantern aids improved environmental conditions within the space for the display of artifacts, as well as protecting the decorative finishes of the Grade I listed interior.

**Condition:** The condition of the lantern is recorded in the external section above, but the high levels of Ultraviolet light were noted as part of the internal inspection. Consideration should be given to the introduction of glazing that filters out high levels of UV light as part of the specification of the roof glazing. Environmental control and security should also be considered as part of the glass specification.

**Recommendations:** The use of a UV coating should be specified for the glass, which should also be a double glazed 'anti-bandit' unit with toughened glass to the exterior, and laminated glass to the interior pane. This will provide additional safety and security to the building.
