# Hutton + Rostron Environmental Investigations Limited

## 11 Bloom Street, Manchester: Plaster condition survey

Site note 5 for 17 April and 26 July 2021, job no. 212.57  
REVISION A - 25.04.22

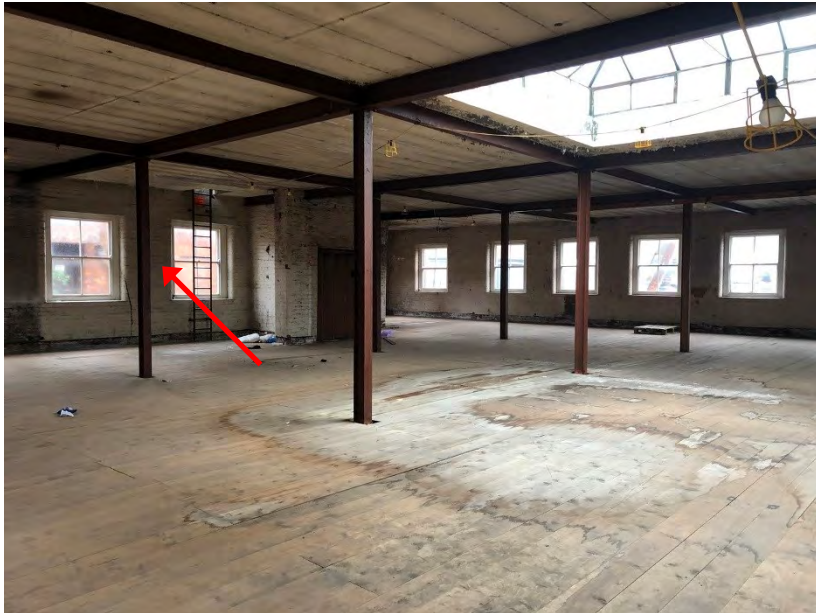
**Fig 1:**

Fourth floor; showing white paint to the external walls. There was no evidence that the walls had ever been plastered at this level

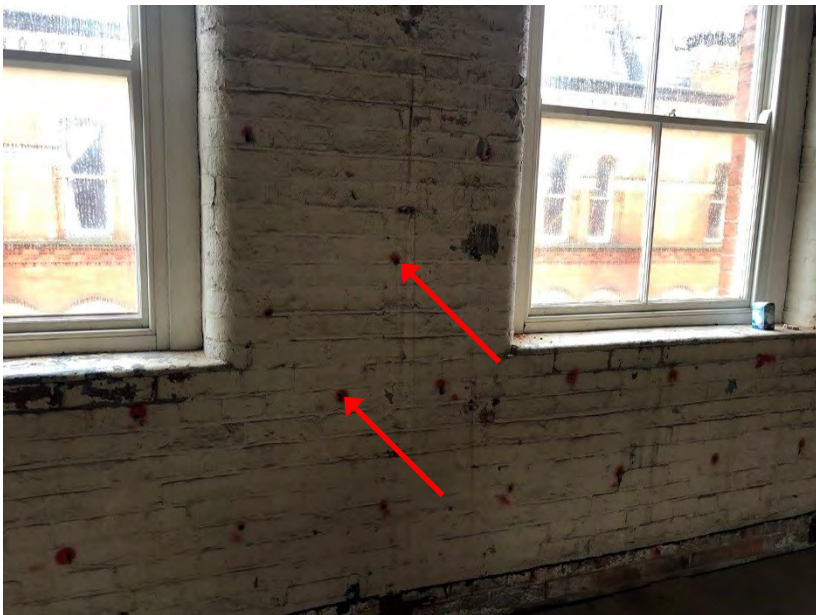
**Fig 2:**

Fourth floor; showing evidence of dry rot irrigation/injected fungicide to the external walls

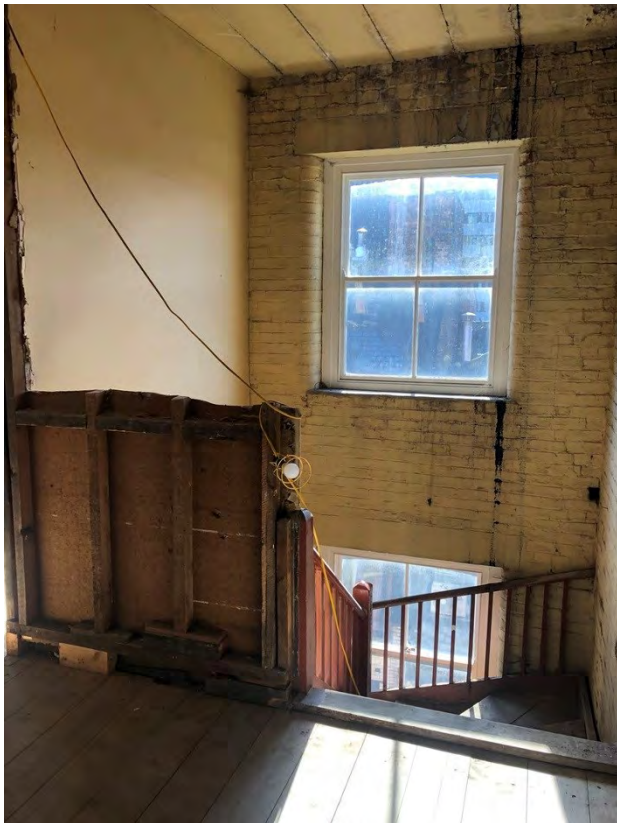
**Fig 3:**

Fourth floor, South staircase; showing softwood stud partitions lined with insulated fibreboard and plasterboard. This partition post-dates the fire

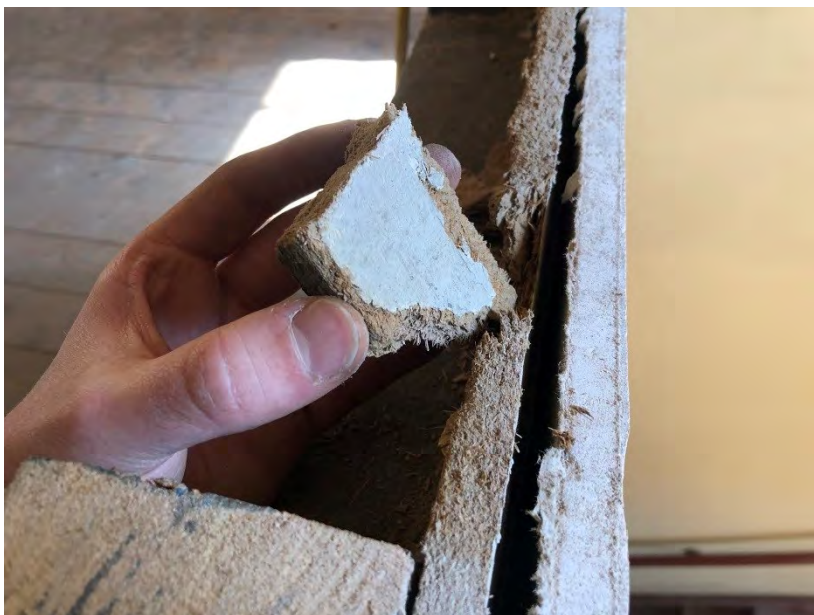
**Fig 4:**

Fourth floor, South staircase; showing a close-up of the insulated fibreboard which had been overlaid with plasterboard

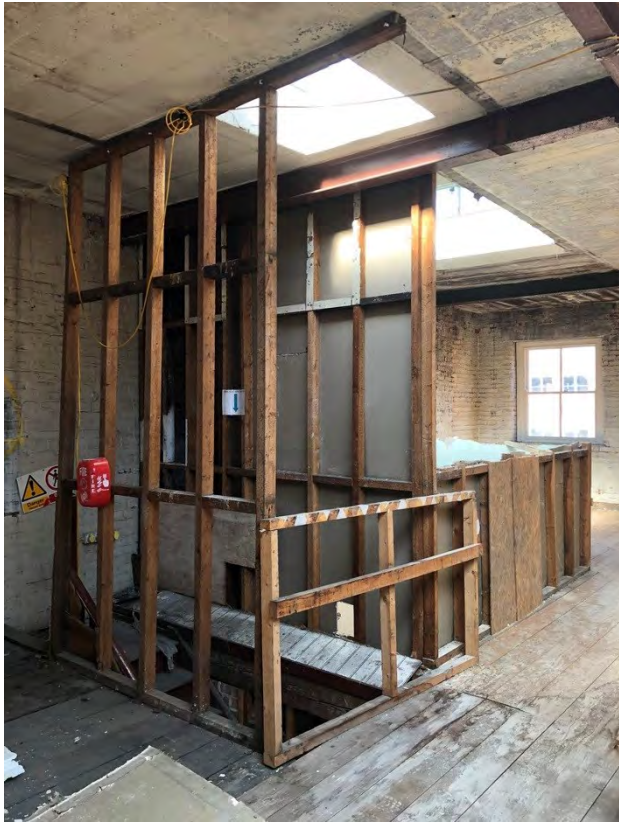
**Fig 5:**

Fourth floor, West staircase; showing the non-original softwood stud partition around the staircase that leads to the Fourth floor. Plasterboard had recently been removed

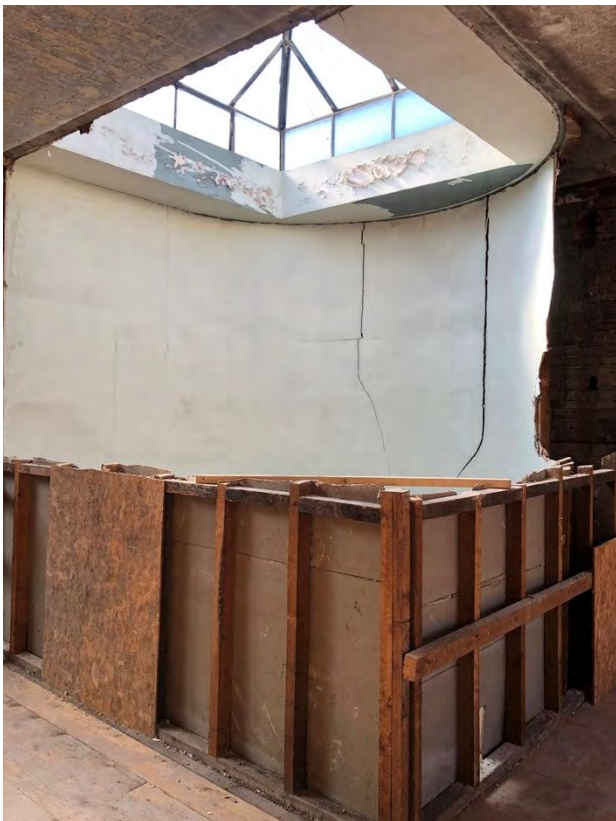
**Fig 6:**

Fourth floor, West staircase; showing the non-original softwood stud partition that bounds the spiral staircase. The finishes were of modern gypsum plasterboard

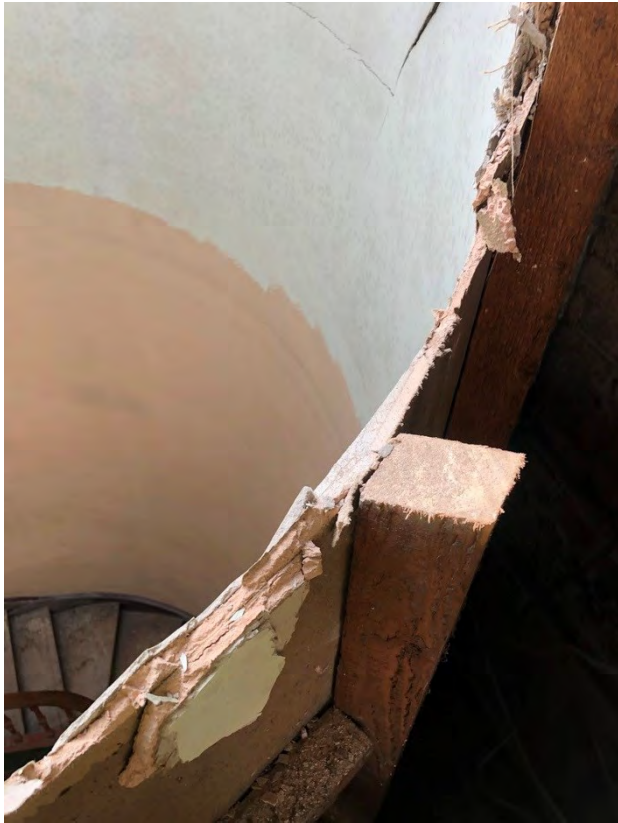
**Fig 7:**

Fourth floor, West staircase; showing a close-up of the two skins of gypsum plasterboard

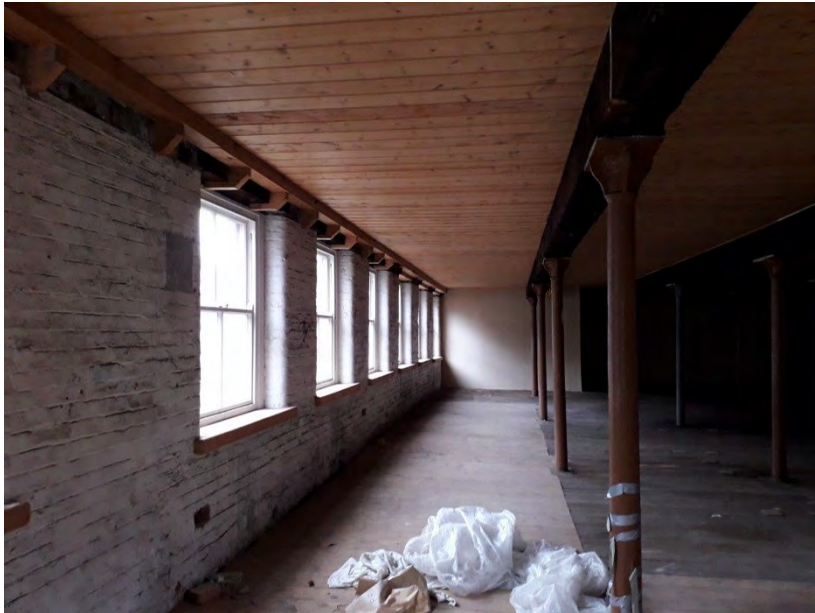
**Fig 9:**

Third floor; showing white paint to the south east wall and plasterboard to the southern staircase partition

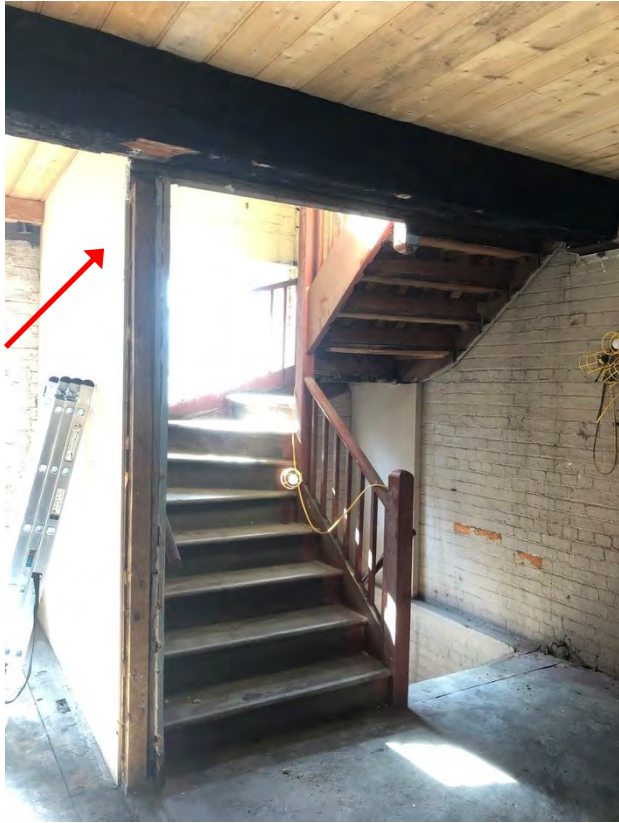
**Fig 11:**

Third floor, South staircase; showing softwood stud partitions lined with insulated plasterboard. This partition post-dates the fire

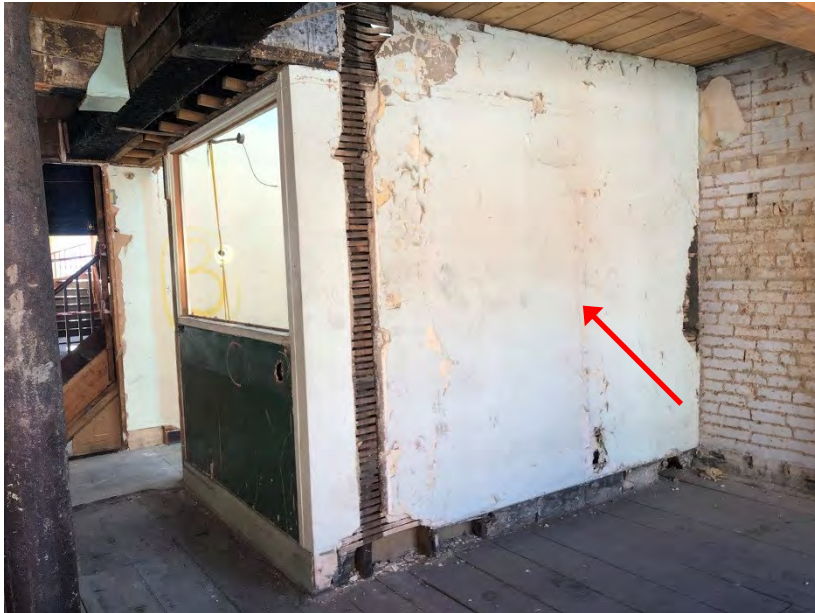
**Fig 13:**

Third floor, West staircase; showing the north west stud partition that was lined with softwood lath and lime plaster. Although there was localised mechanical damage and cracking of the lime plaster, the plaster 'keys' were intact where visible and the lath and plaster was largely repairable

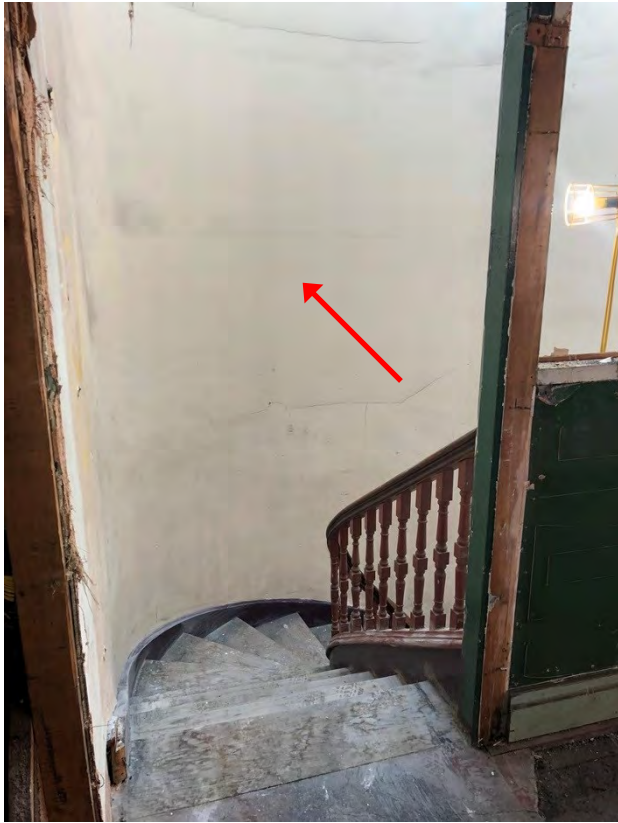
**Fig 15:**

Third floor, West staircase; showing a general view of the staircase that was of softwood construction. No significant decay detected in the structure and timbers were dry. The partition walls bounding the staircase were lined with plasterboard above but lath and plaster below

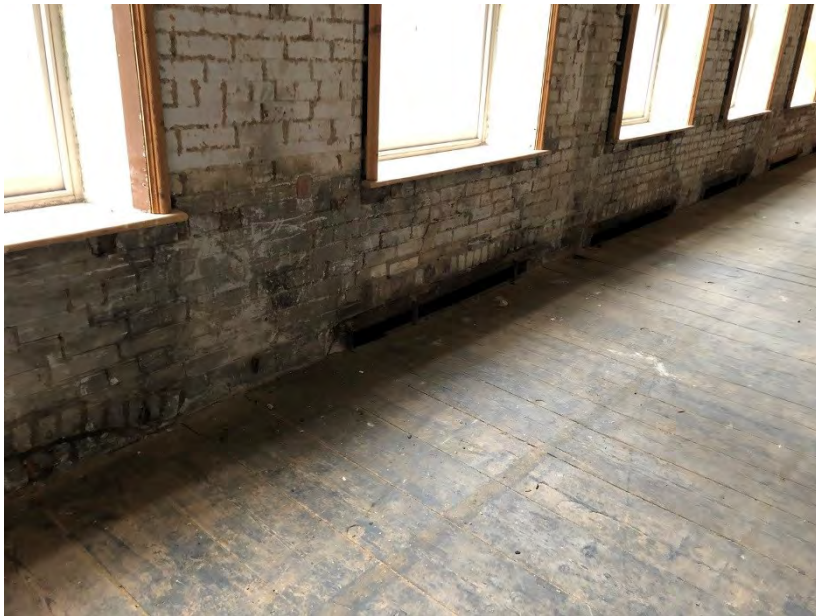
**Fig 19:**

Second floor, North east wall; showing blue/white paint scheme to the external wall. Note that lime plaster had been removed from this wall post-fire

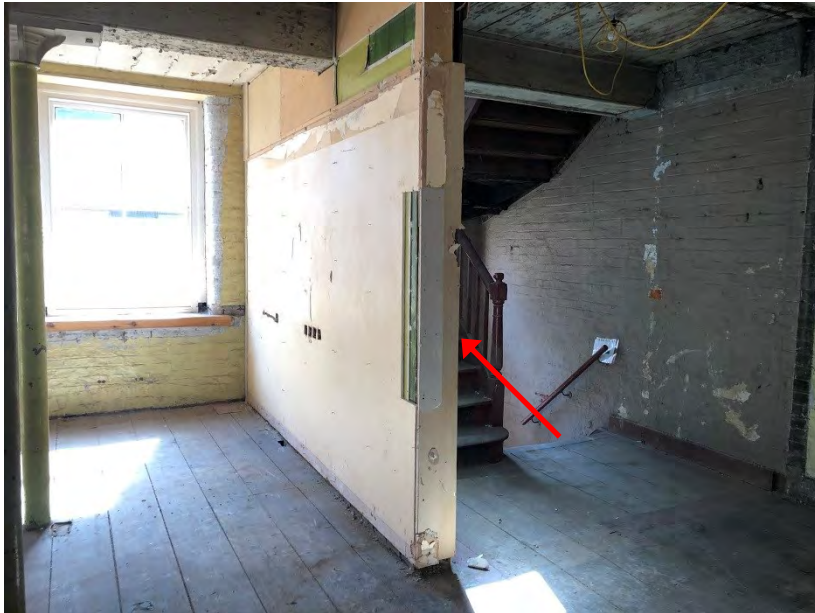
**Fig 21:**

Second floor, South staircase; showing the stud partition that included lath and plaster concealed behind the plasterboard outer linings. The modern finishes require removal before detailed assessment of the lath and plaster can be undertaken

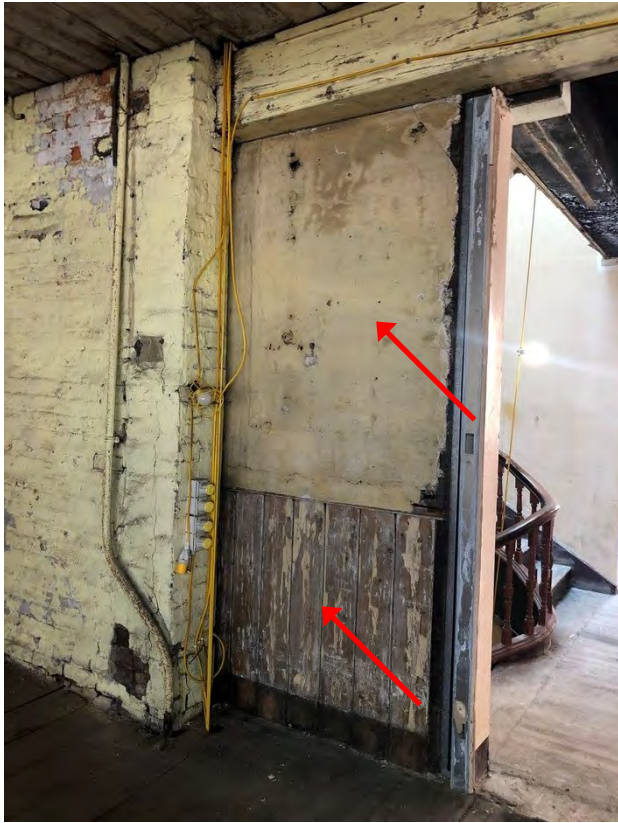
**Fig 23:**

Second floor, West staircase; showing a small area of lath and plaster and vertical softwood timber dado panelling. There was localised mechanical damage but the lath and plaster was repairable. There was no significant defect in the timber panelling

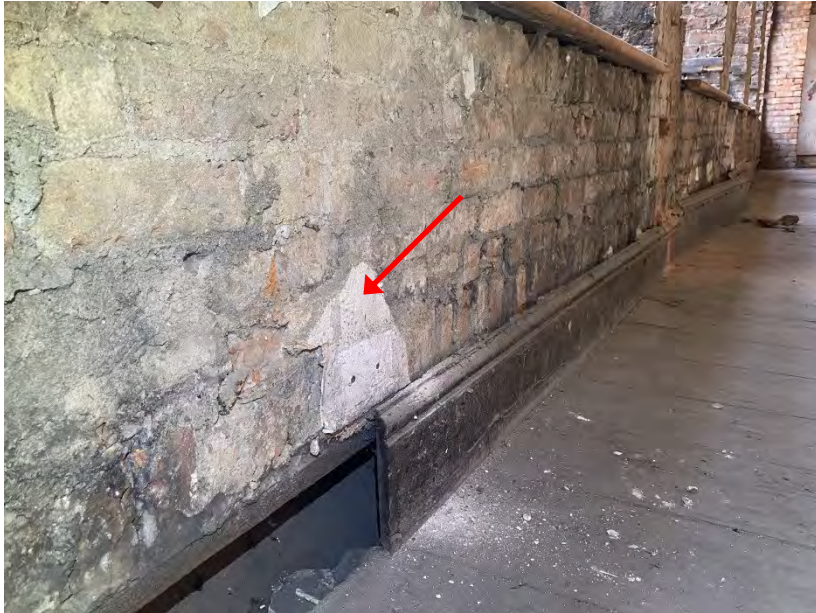
**Fig 27:**

First floor, North west elevation; showing a short section of retained softwood skirting board. Note that the brickwork to this wall was previously plastered with lime

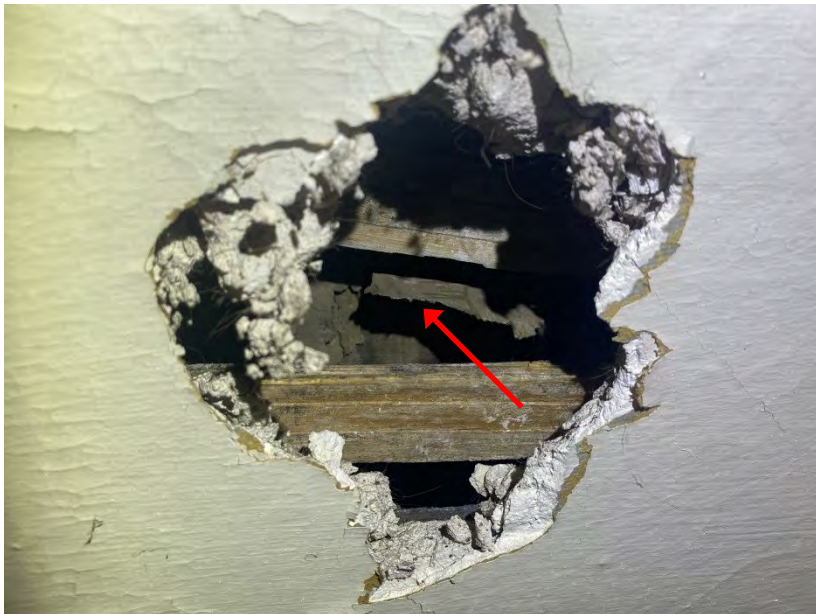
**Fig 29:**

First floor, Bay no.9-10; showing a view through an opening in the lath and plaster ceiling. Note earlier wallpaper applied to the underside of the floor as found elsewhere

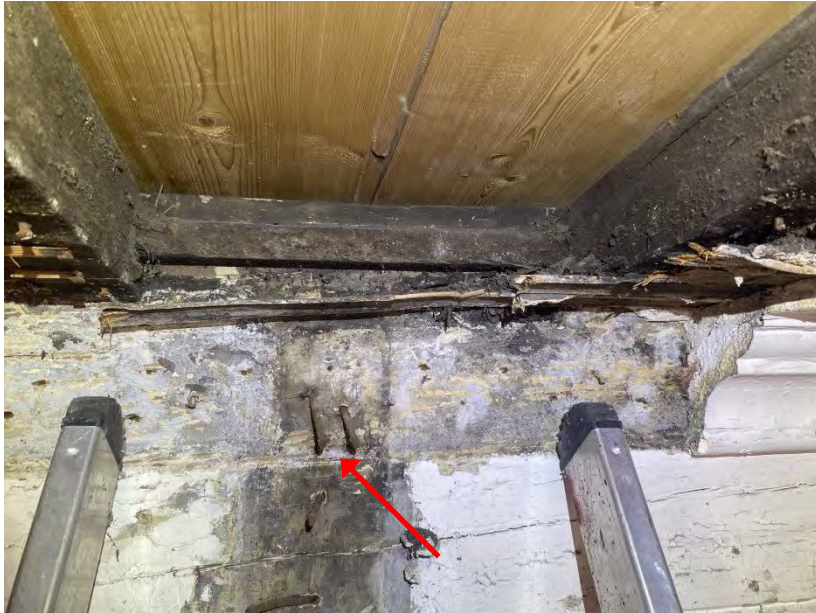
**Fig 31:**

First floor, Bay no.8-9; showing nails that provide a fixings for the lime plaster cornice to the floor beam. The nails had corroded and the cornice was vulnerable to detachment

- 2 First floor ceilings: The existing lath and plaster and plaster cornice was largely beyond repair due to mechanical damage and corrosion of nail fixings and consideration should be given to wholesale replacement like for like. However, as these ceilings are non-original there may be argument for their removal and the client should seek advice from PBA. Alternatively, there may be scope in the design to preserve these existing ceilings above new ceiling structures without the need for repair

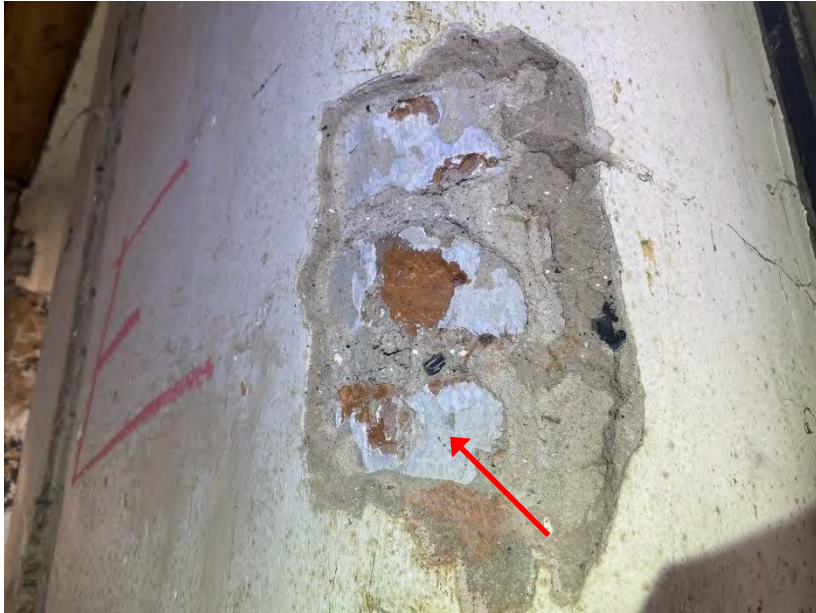
**Fig 35:**

First floor, Lift area; showing earlier paint finish to the brickwork beneath the lime plaster

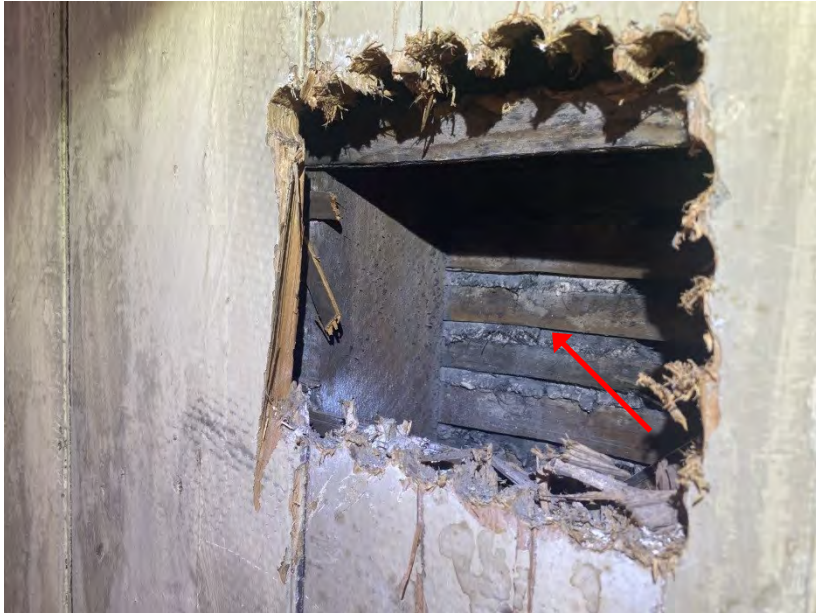
**Fig 37:**

First floor, South staircase; showing a view through the timber panelling identifying lath and plaster to either side of the studwork. Note that the plaster 'keys' were inadequate

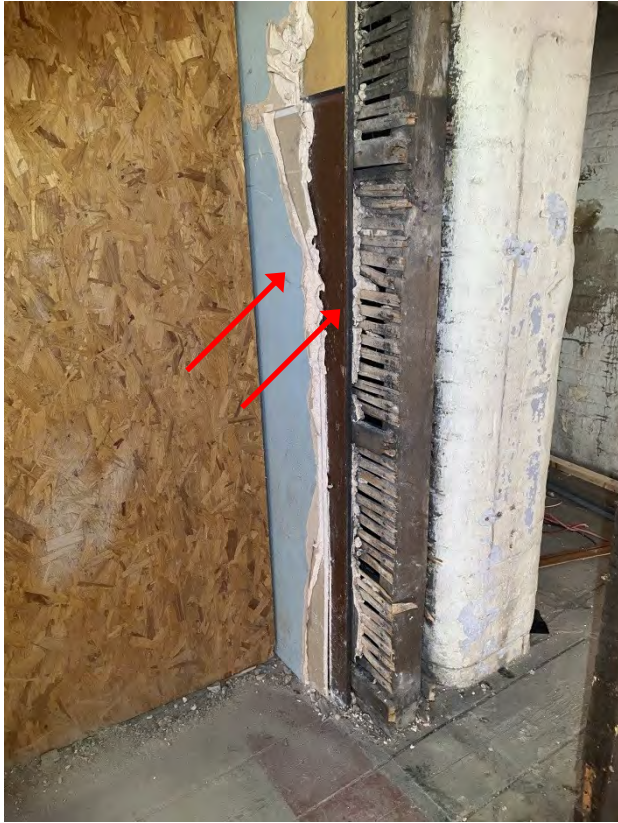
**Fig 39:**

First floor, South staircase; showing modern plasterboard and timber panelling applied over lath and plaster

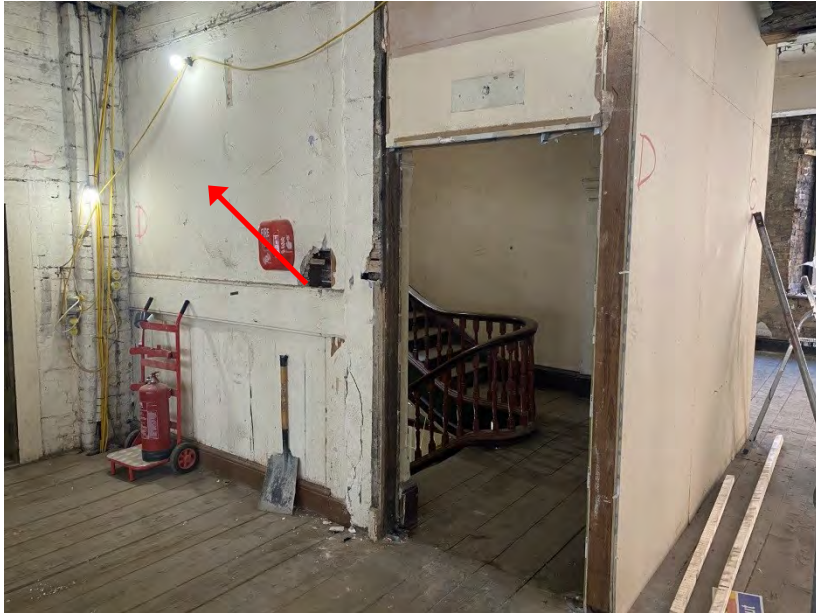
**Fig 41:**

First floor, West staircase; showing lath and plaster with softwood skirting to the staircase partition. Plaster was generally in fair condition with localised mechanical damage

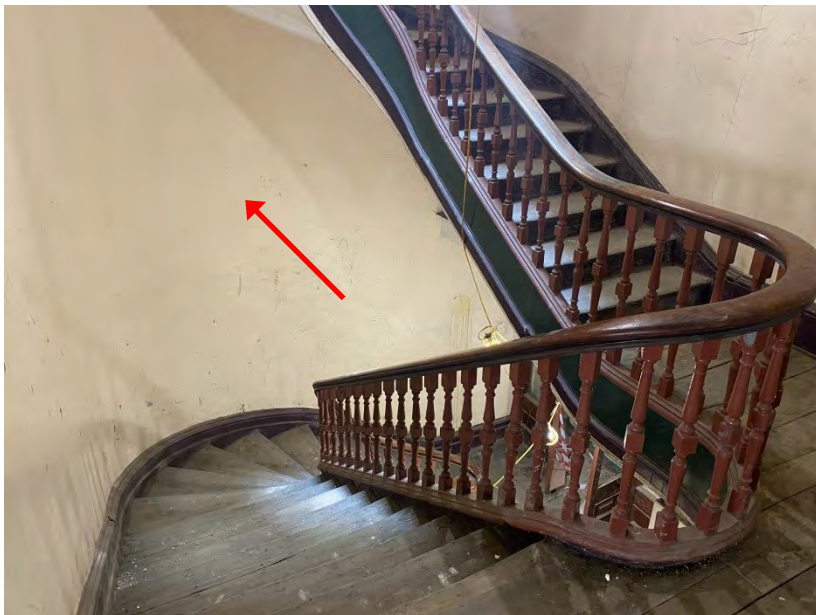
**Fig 42:**

First floor, West staircase; showing lath and plaster within the stairwell

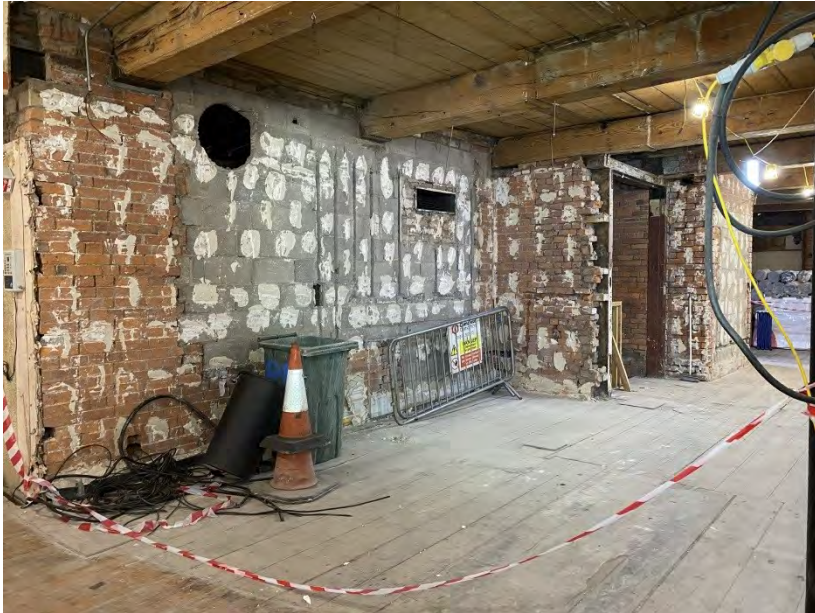
**Fig 43:**

Upper ground floor; showing plaster dabs following removal of plasterboard. There were no earlier plaster or paint finishes

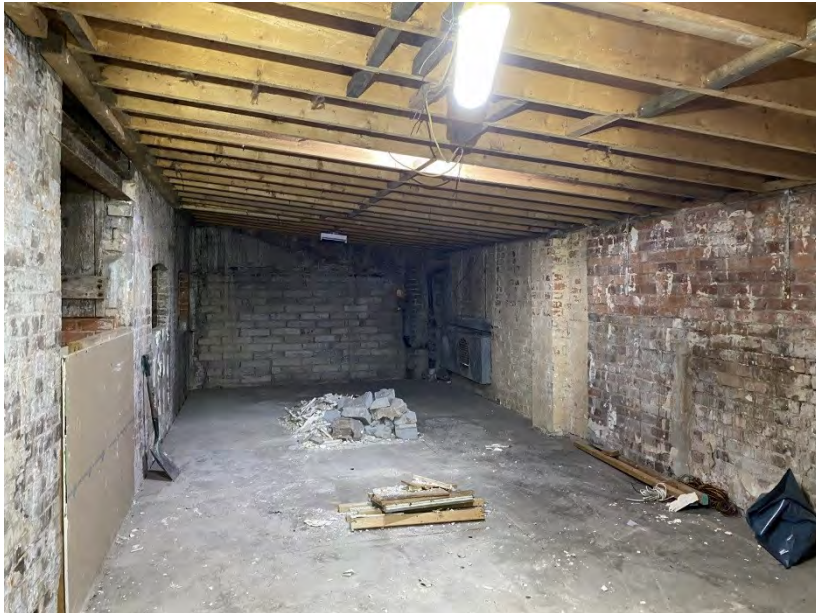
**Fig 45:**

Upper ground floor, North east extension; showing painted brick and some use of plasterboard. There were no historic lime plasters in this area

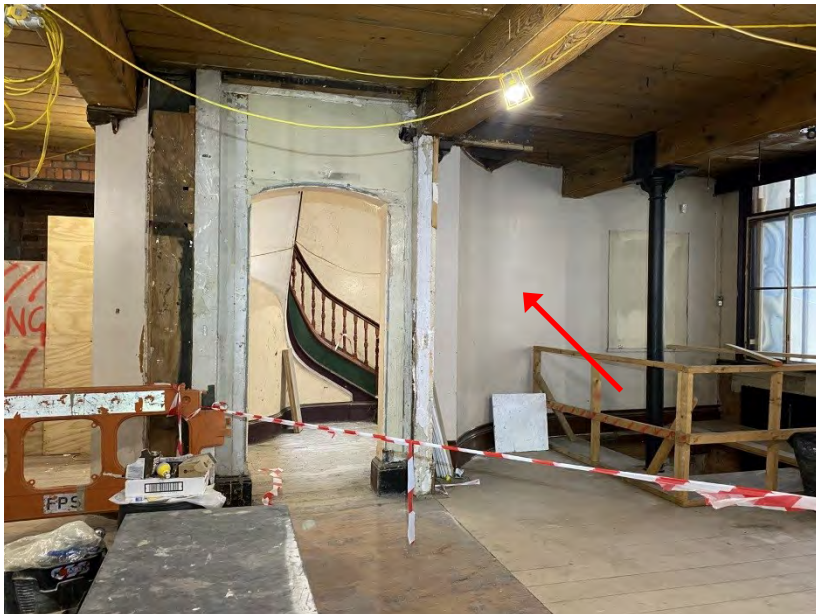
**Fig 47:**

Upper ground floor, West staircase lobby; showing lath and lime plaster to the stud partitions. Plaster was in good condition

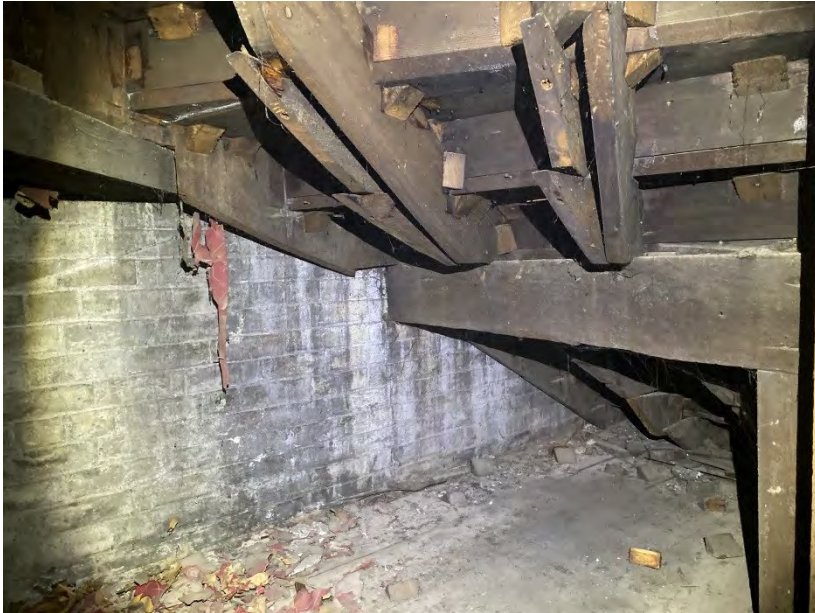
**Fig 49:**

Upper ground floor, West staircase;  
showing a view of the underside of the  
staircase

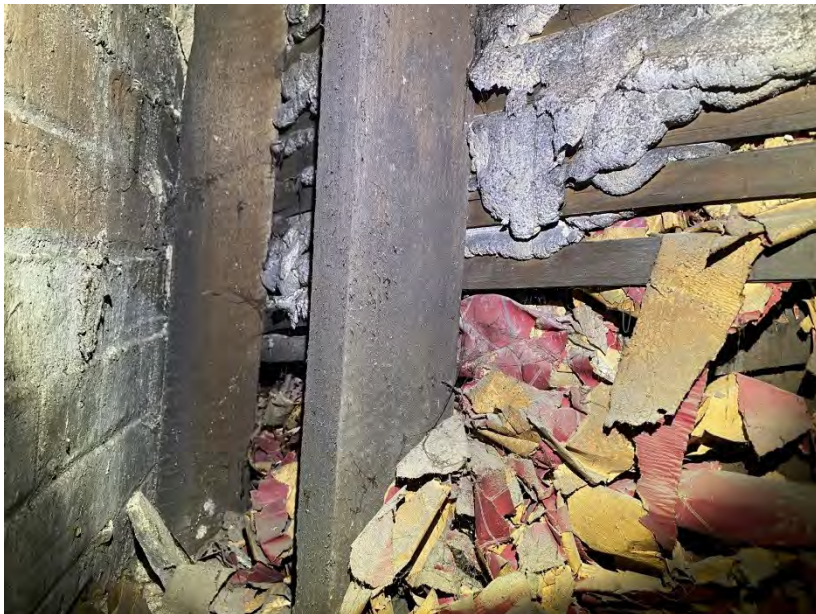
**Fig 51:**

Upper ground floor, West staircase; showing the backside of the lath and plaster to the staircase partitions. Note the newspaper/magazines wedged between the staircase and the laths

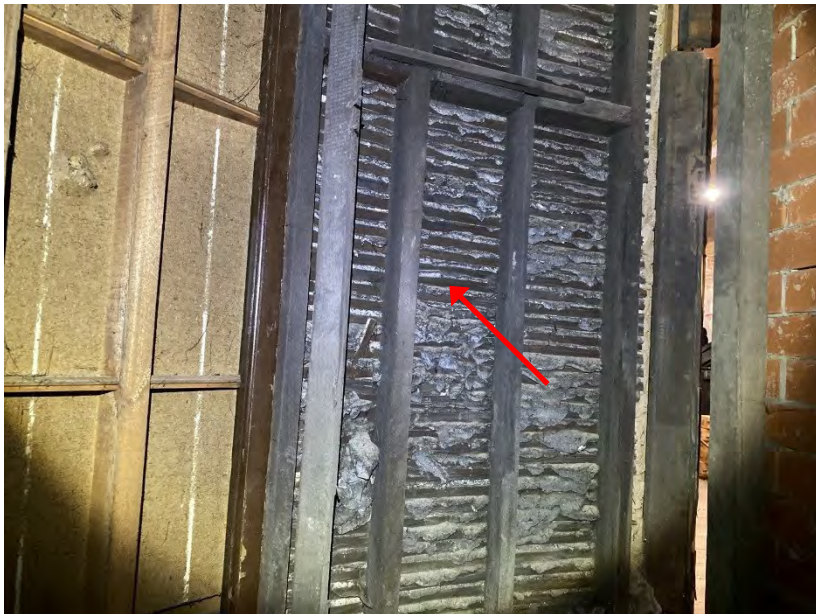
**Fig 53:**

Upper ground floor, West staircase; showing the backside of the lath and plaster as well as later timber fibreboard to the staircase. The plaster 'keys' in this partition were inconsistent on original application

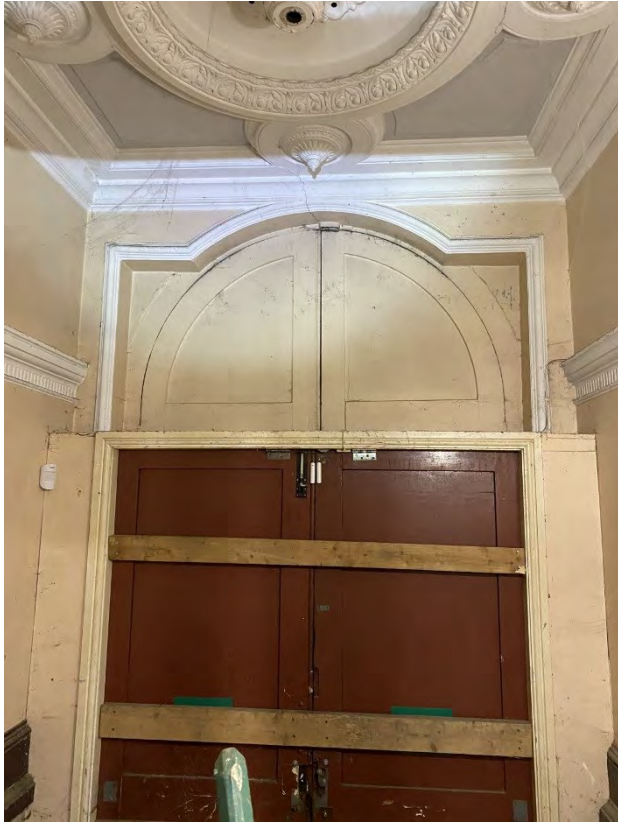
**Fig 55:**

Upper ground floor, West entrance lobby; showing a decorative lath and plaster ceiling and lime plaster to the external walls

- 5 West entrance lobby: Allow for localised repair of the ornamental plaster ceiling, mouldings and cornice including the reinstatement of missing enrichments to match the existing mouldings. Defective/debonding areas of lime wall plaster should be removed and reinstated like for like. The tiling should be cleaned of paint and loose/missing tiling reinstated. It may be necessary to temporarily remove the First floor floorboards above to enable detailed inspection of the decorative ceiling from above and provide access to undertake repairs. Extent of repairs to be confirmed following detailed condition assessment by the conservation plasterer

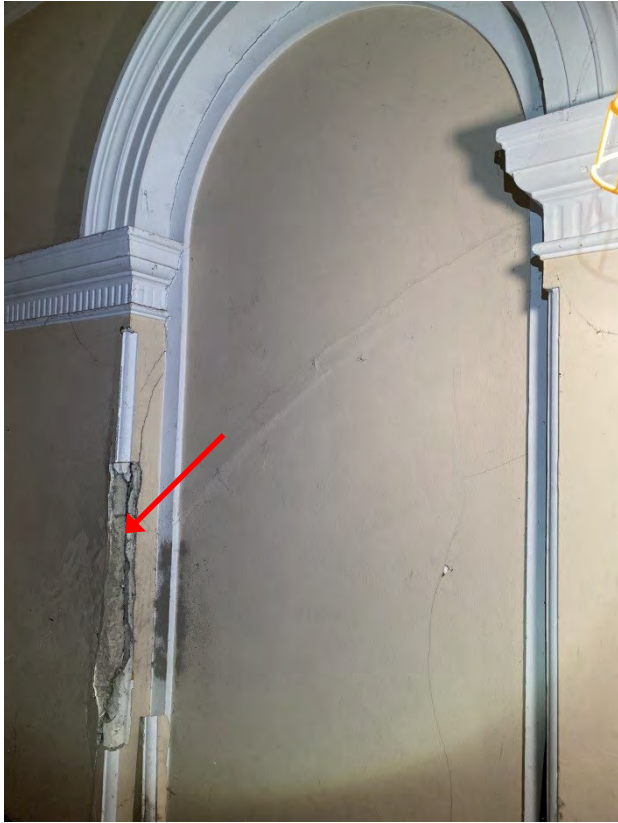
**Fig 57:**

Upper ground floor, West entrance lobby; showing lime plaster and decorative mouldings to the internal brick wall. Plaster was generally in fair condition but with localised mechanical damage

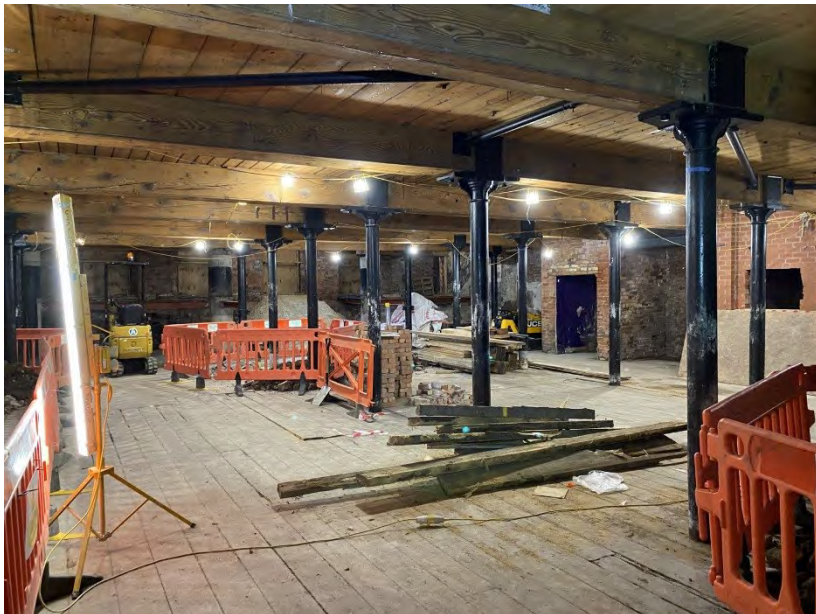
**Fig 59:**

Lower ground floor; showing a general view of the undecorated masonry

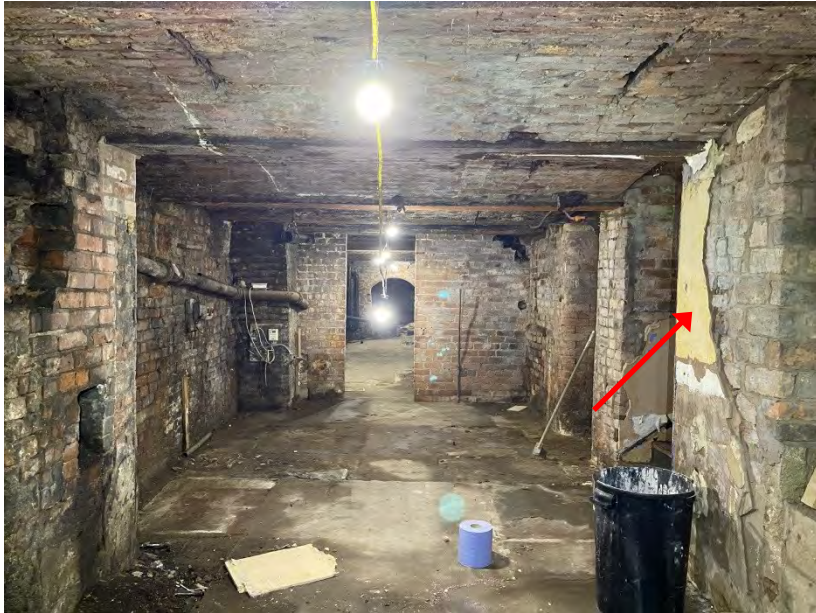
**Fig 61:**

Lower ground floor, North east extension; showing some use of non-original gypsum plaster. Plaster had almost entirely debonded from the masonry
