# CCTV Report

1133 Rochdale Road,  
Manchester, M9 8DS

21/07/2022

43437CCTV-01

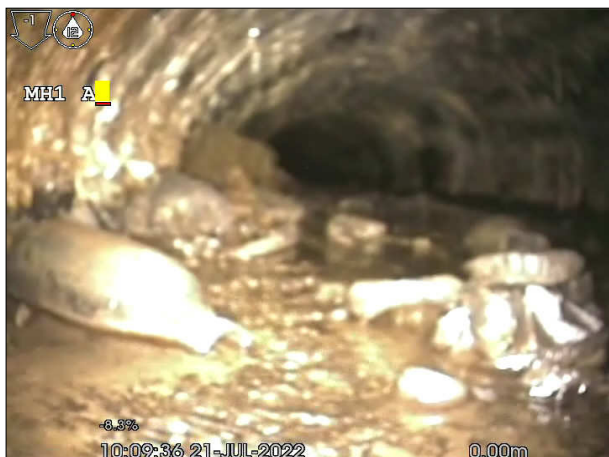
| 1:150 | position | code | observation | counter | photo | grade |
|---|---|---|---|---|---|---|
| | 0.20 | S1 DES | Debris silt, 25 % cross-sectional area loss, Start | 00:00:00 | 4_4a | (Serv) 1 |

Photo: 4\_4a, 00:00:00  
0.2m, Debris silt, 25 % cross-sectional area loss, Start

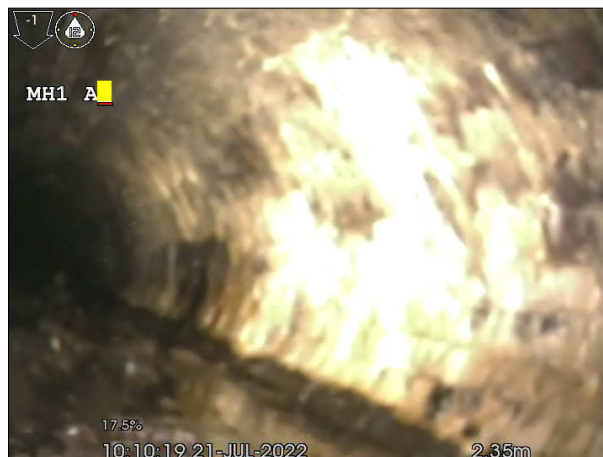
Photo: 1\_5a, 00:00:00  
2.35m, General Condition photograph

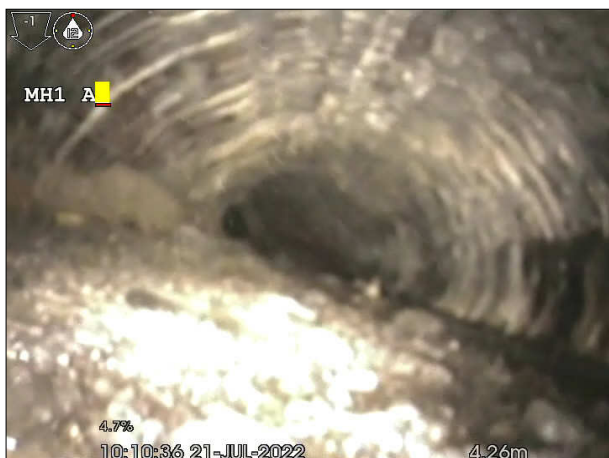
| 1:150 | position | code | observation | counter | photo | grade |
|---|---|---|---|---|---|---|
| | 4.26 | C1 DES | Debris silt, 35 % cross-sectional area loss, Changed | 00:00:00 | 1_6a | (Serv) 1 |

Photo: 1\_6a, 00:00:00  
4.26m, Debris silt, 35 % cross-sectional area loss, Changed

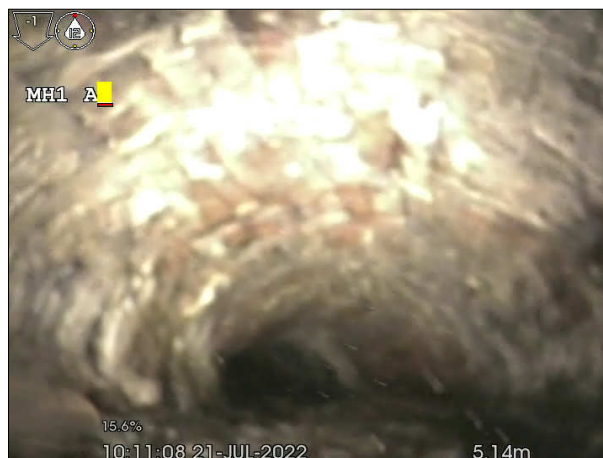
| 1:150 | position | code | observation | counter | photo | grade |
|---|---|---|---|---|---|---|
| | 5.00 | C1 DES | Debris silt, 40 % cross-sectional area loss, Changed | 00:00:00 | 1_7a | (Serv) 1 |

Photo: 1\_7a, 00:00:00  
5m, Debris silt, 40 % cross-sectional area loss, Changed

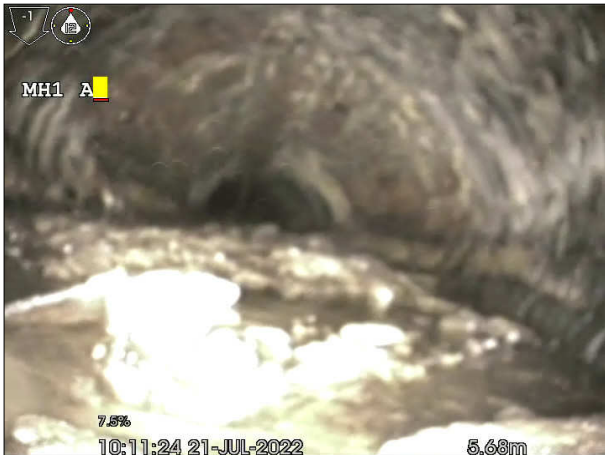
| 1:150 | position | code | observation | counter | photo | grade |
|---|---|---|---|---|---|---|
| | 6.00 | C1 DES | Debris silt, 45 % cross-sectional area loss, Changed | 00:00:00 | 1_8a | (Serv) 1 |

Photo: 1\_8a, 00:00:00  
6m, Debris silt, 45 % cross-sectional area loss, Changed

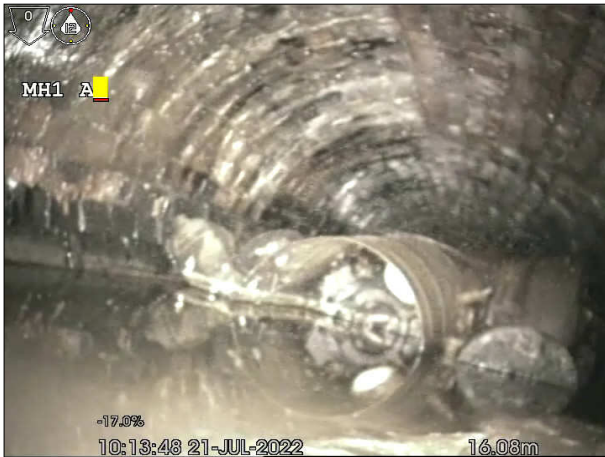
| 1:150 | position | code | observation | counter | photo | grade |
|---|---|---|---|---|---|---|
| | 18.10 | DE | Debris, 95 % cross-sectional area loss | 00:00:00 | 14_14a | (Serv) 1 |
| | 18.10 | SA | Survey abandoned, Remark: Unable to survey beyond blockage. | 00:00:00 | | (Misc) 0 |

Photo: 14\_14a, 00:00:00  
18.1m, Debris, 95 % cross-sectional area loss

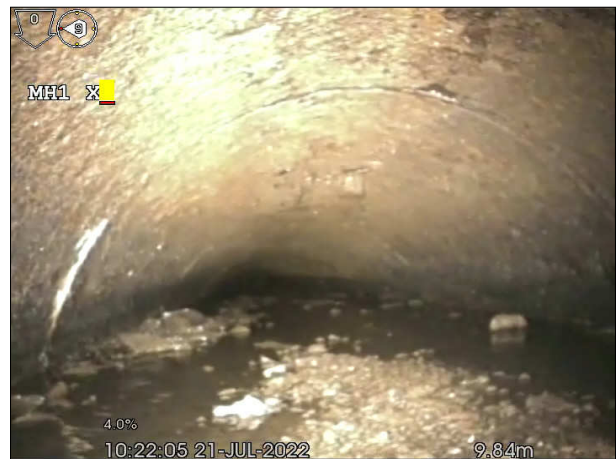
| 1:100 | position | code | observation | counter | photo | grade |
|---|---|---|---|---|---|---|
| | 9.84 | DES | Debris silt, 40 % cross-sectional area loss | 00:00:00 | 25_9a | (Serv) 1 |

Photo: 25\_9a, 00:00:00  
9.84m, Debris silt, 40 % cross-sectional area loss

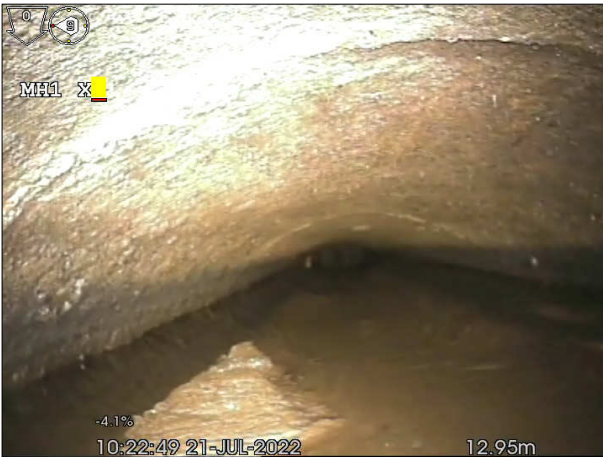
| 1:100 | position | code | observation | counter | photo | grade |
|---|---|---|---|---|---|---|
| | 12.95 | SA | Survey abandoned, Remark: Unable to survey beyond blockage. | 00:00:00 | 27_11a | (Misc) 0 |

Photo: 27\_11a, 00:00:00  
12.95m, Survey abandoned, Remark: Unable to survey beyond  
blockage.
