**project**  
51-53 richmond st, manchester  
**job no.**  
7593  
**title**  
Warehouse Existing Lower Ground Floor Finish Plan  
**scale**  
1:100 @ A3  
**drawing no.**  
**al(05)0080**

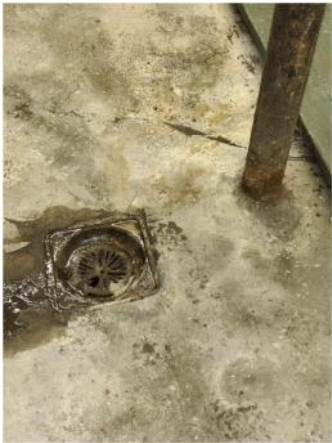
Photo 2

The basement floor is non-original concrete slab which dishes towards central low point and floor gulley.

Another floor gulley is present in the rear corner.

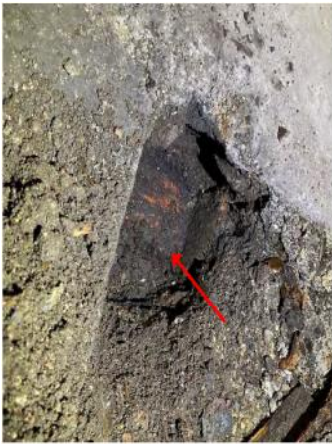
Photo 3

The floor was covered with concrete and a cementitious screed, but localised excavation revealed an earlier brick floor beneath.

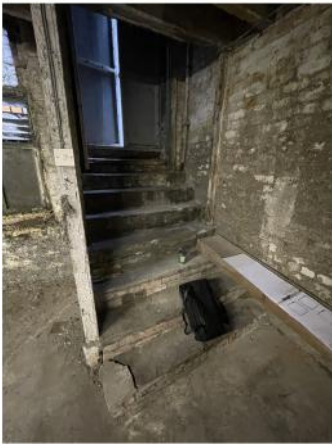
Photo 4

Basement accessed via a set of existing stone steps from the street.

The basement appears to have been disused for a prolonged period.

Timber enclosures around steps up to the ground floor encroach into the basement at ceiling level.

The rear wall and far corner of the basement are particularly saturated. Two waste pipes in the far corner are damaged and leaking. These are cast into the basement slab.

Film-forming paint finishes applied over the brickwork had failed. These finishes were inappropriate as they inhibited advantageous moisture equilibration and drying.

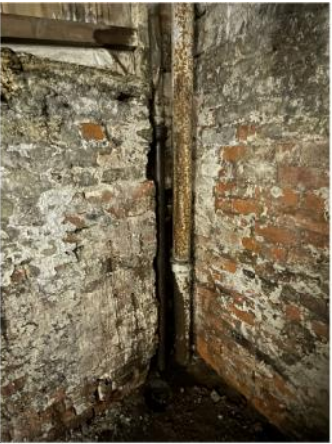
Photo 5

There are two low level former hatches present in the front elevation.

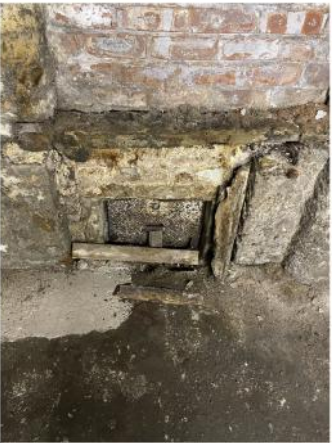
Photo 6

Significant and prolonged moisture ingress into the basement has occurred. The moisture appears to be penetrating both the walls of the basement as well as from high level.

Brickwork has been inappropriately repointed with a hard cementitious mortar which had encouraged some spalling in the bricks below ground level.

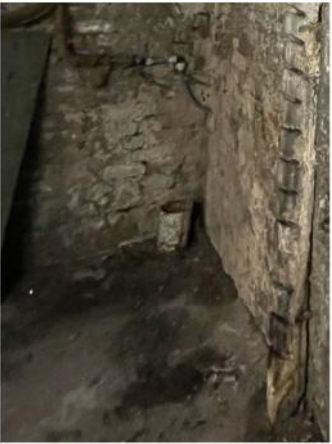
Photo 7

Partially infilled windows to the front elevation and entirely infilled windows to the rear.

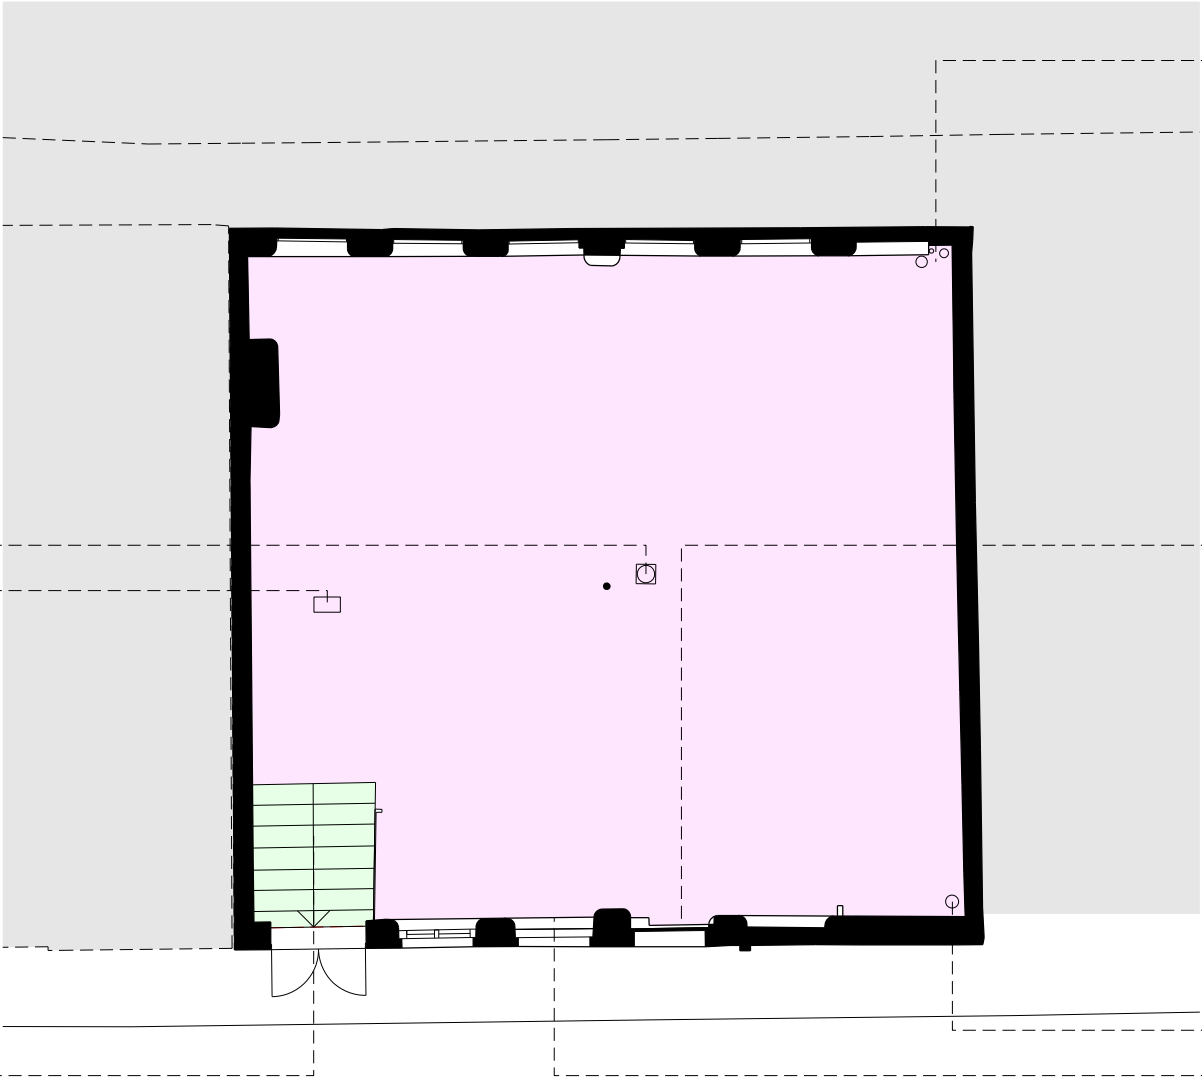
| | Existing non-original concrete slab dishes towards central low point and floor gulley |
| | Existing non-original floorboards replaced following basement fire |

| | Non-original chipboard panels fixed to existing floor along high traffic routes |

| | Solid timber planks fixed to existing floor boards. Assumed for strengthening floor below heavy machinery |
