# Contaminated Land Phase One Desk Study & II Intrusive Investigation for proposed residential development at Land Off Chapel Street, Manchester, M19 3QB.

Burke Developments Ltd,  
Norwood,  
Greenacres,  
Oldham,  
OL4 3EX

May 2023

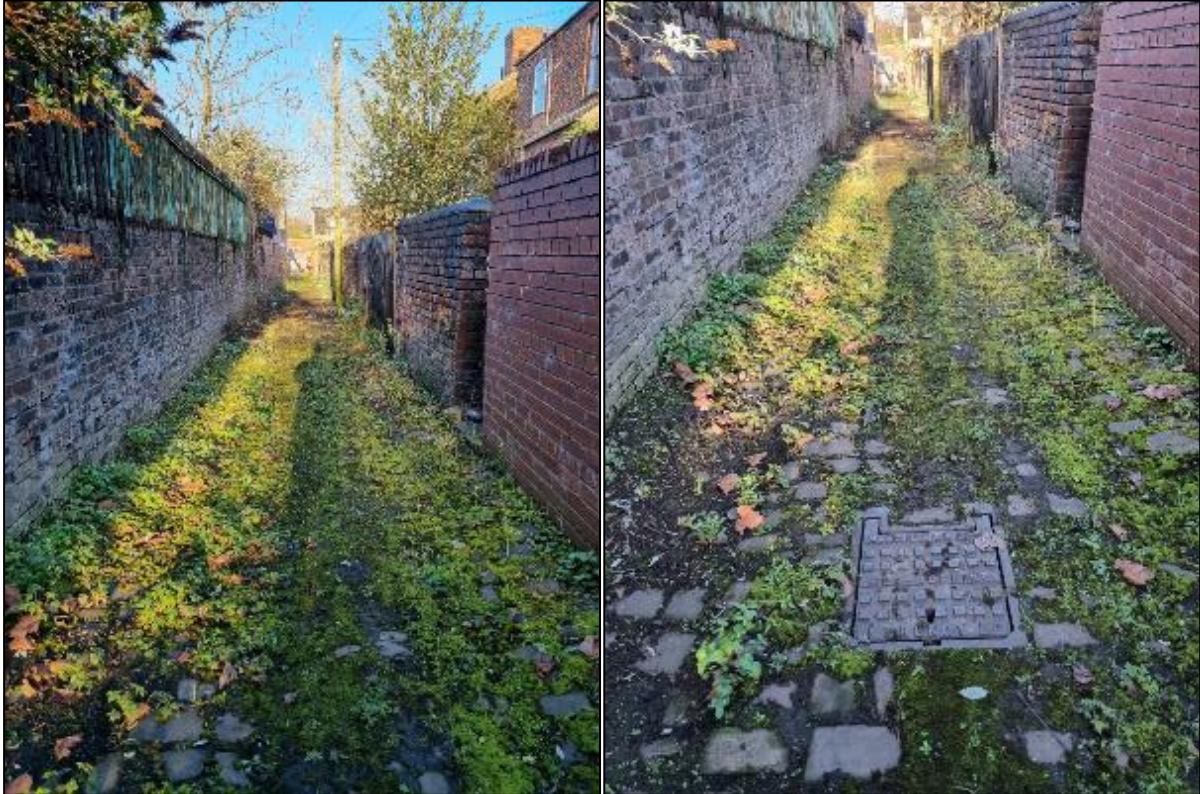
The alleyway around the site, eastern boundary looking north.

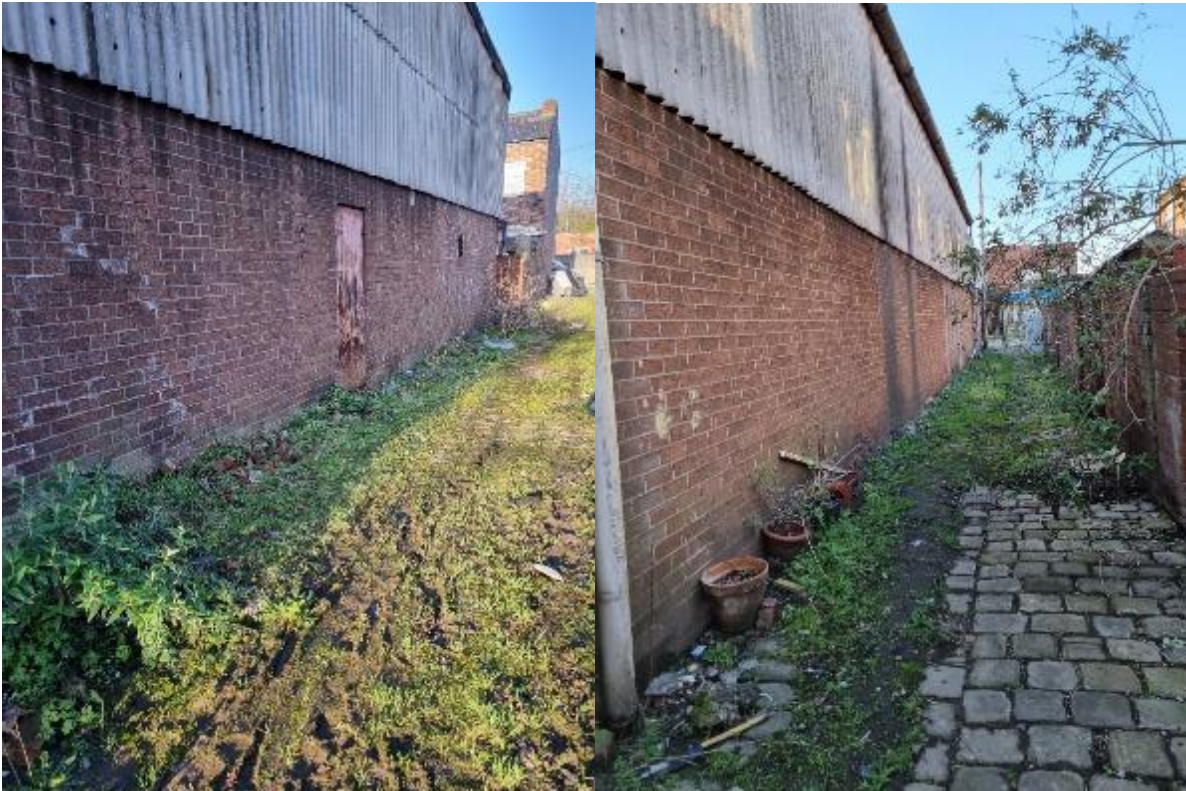
Northern boundary looking west.

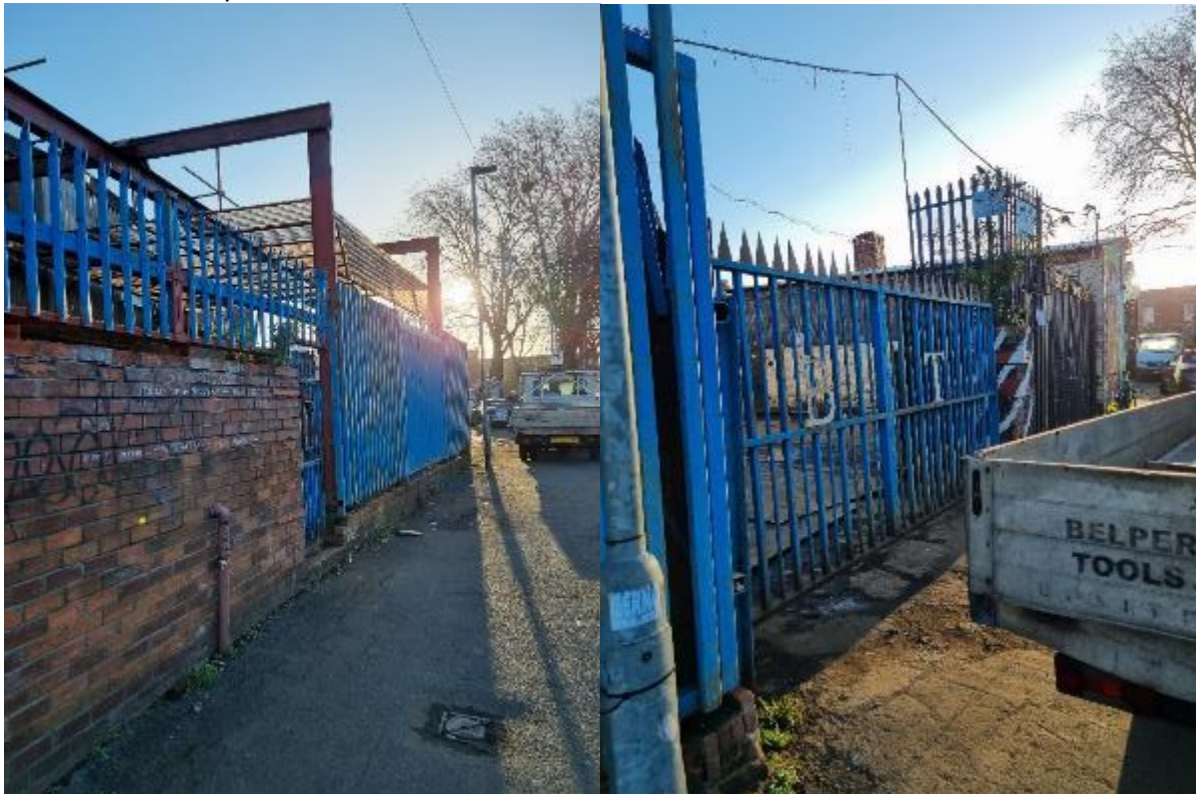
Southern boundary of the site

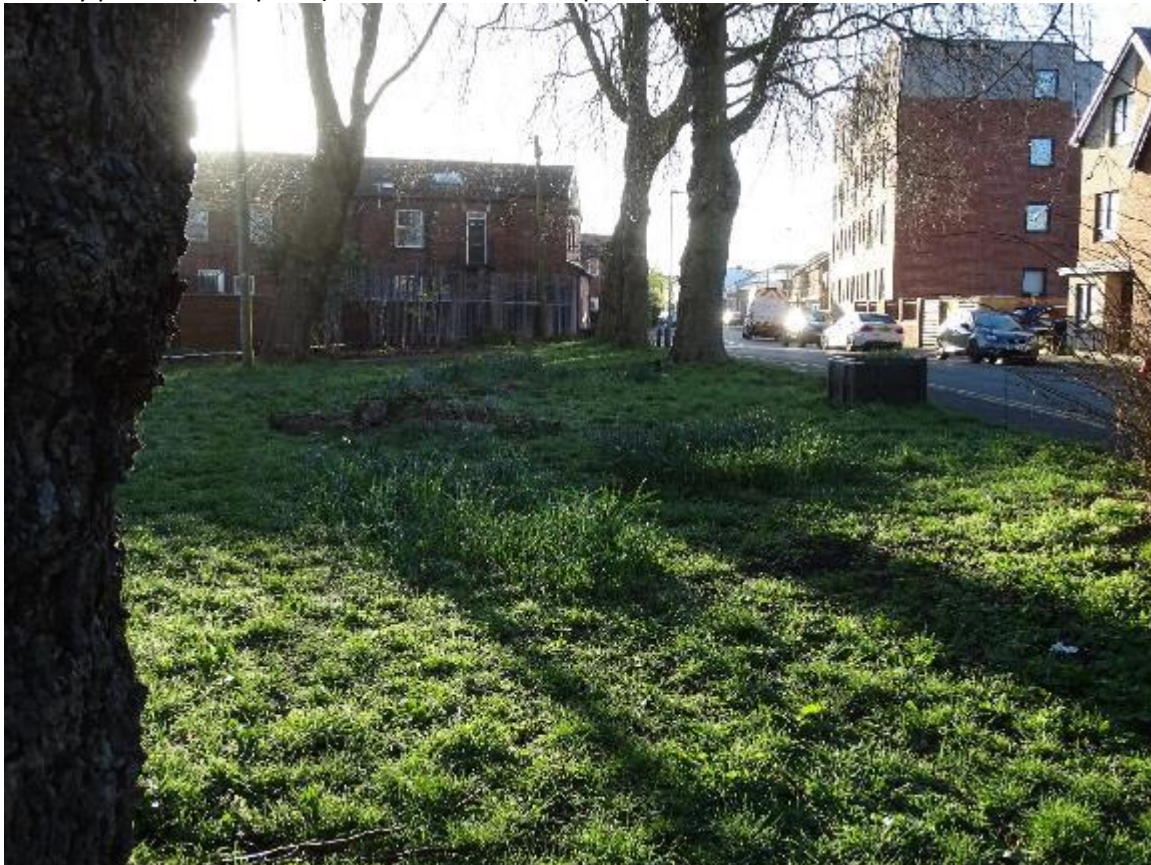
Nearby public open space (historic watercourse/pond)

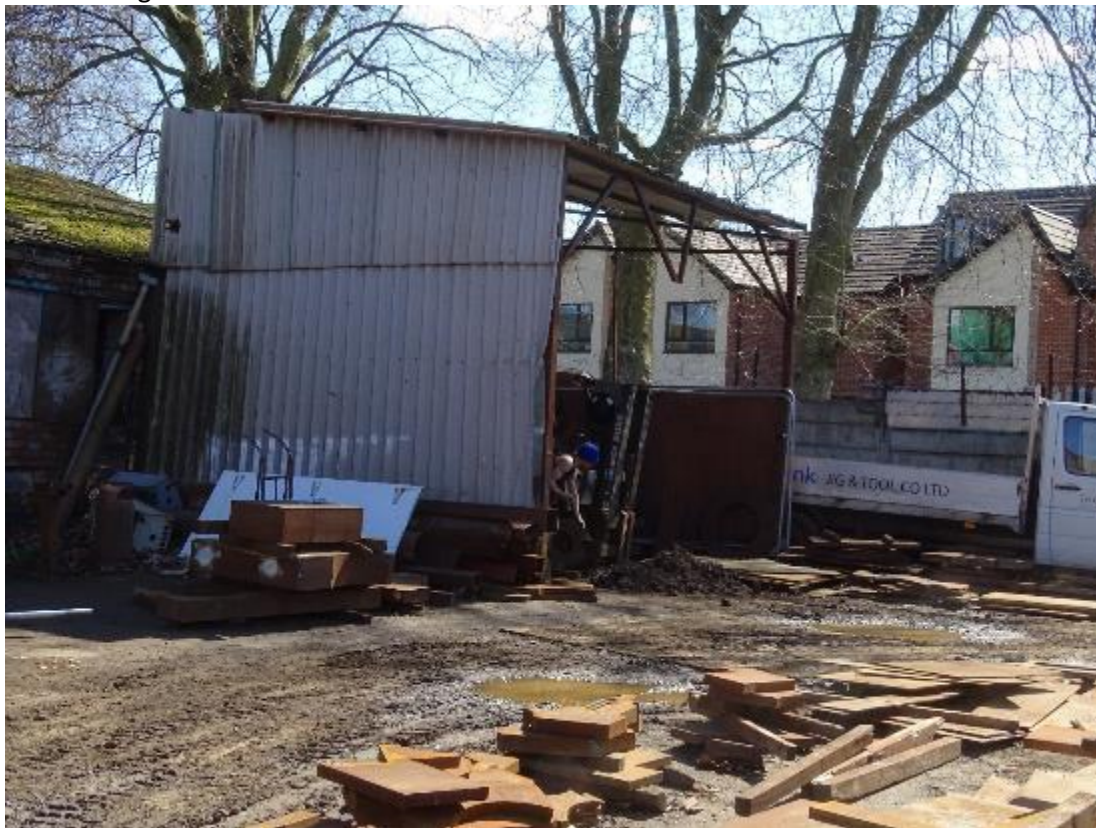
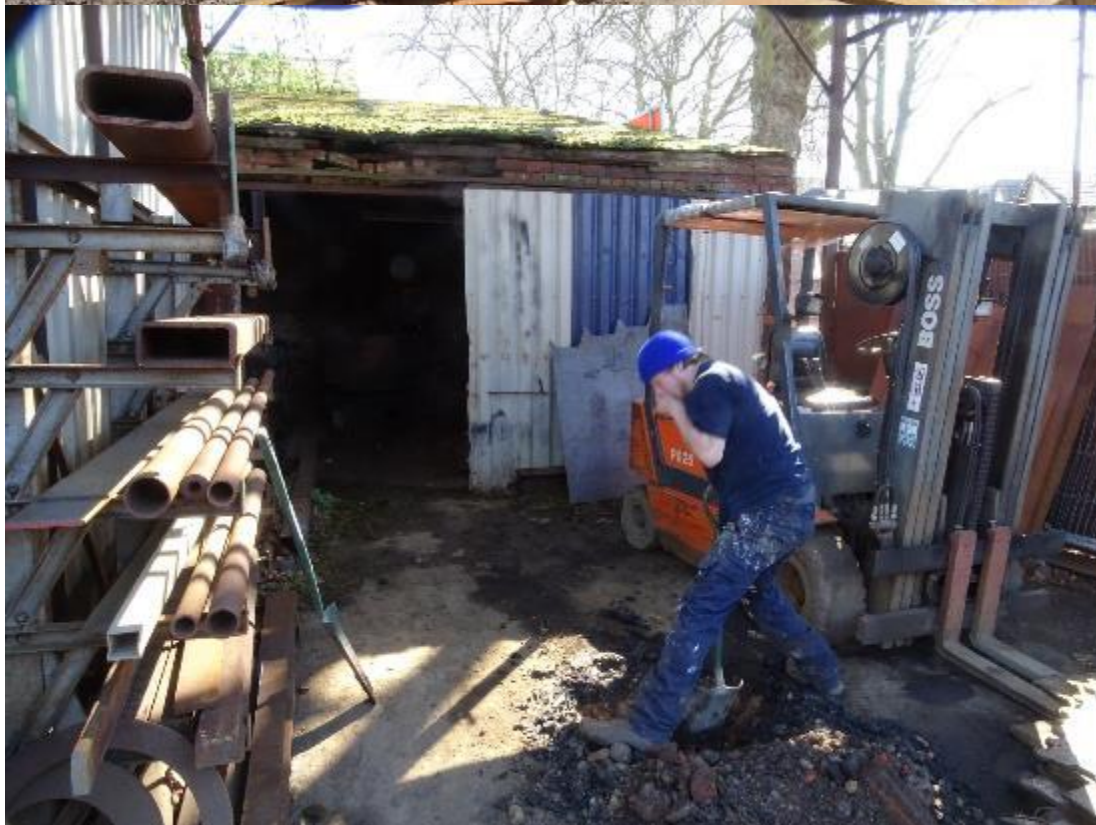
Finally on the far east of the site is another old single storey brick-built building with a slate roof and concrete base. A metal lean-to is located at the southern end. An old toilet block at the far northern end. The building contains metal cutting equipment.

The building to the East of the site

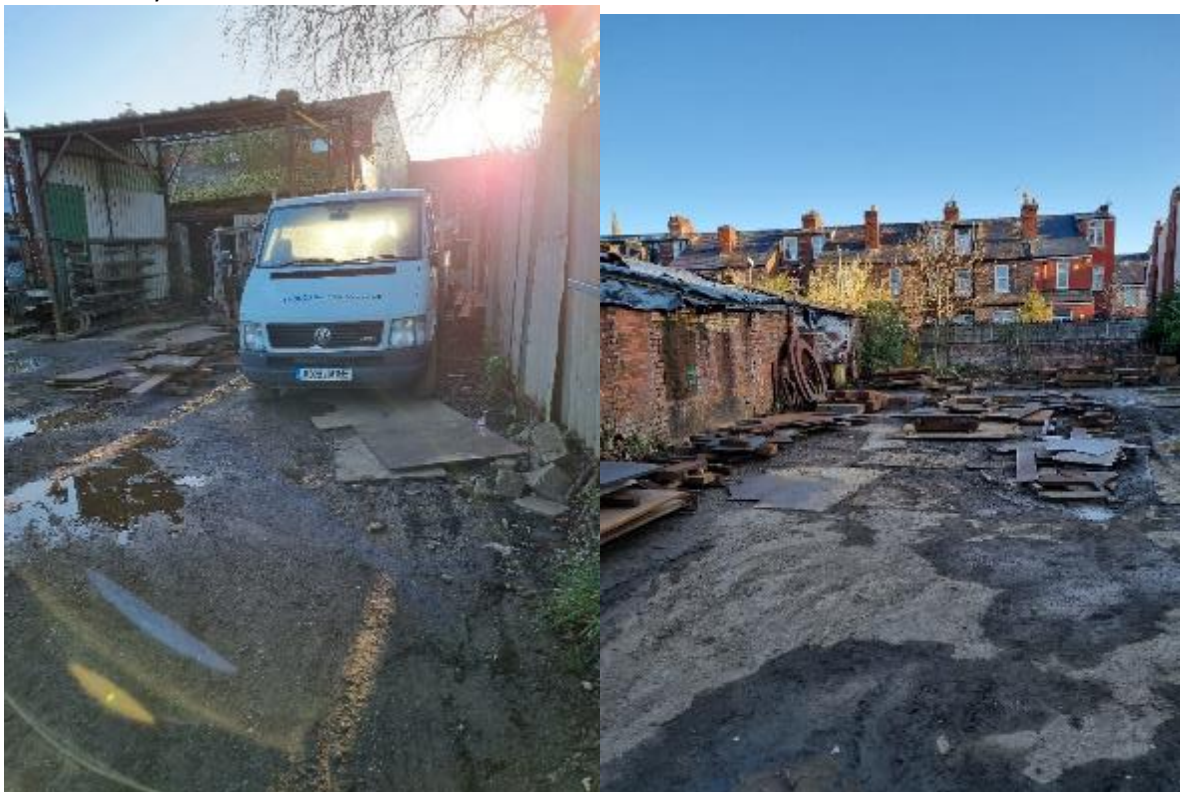
To the east of this building was a further storage yard. Originally having a concrete base this has been significantly broken up in places and consists of mud and puddles along the main travel path through the site.

The eastern yard

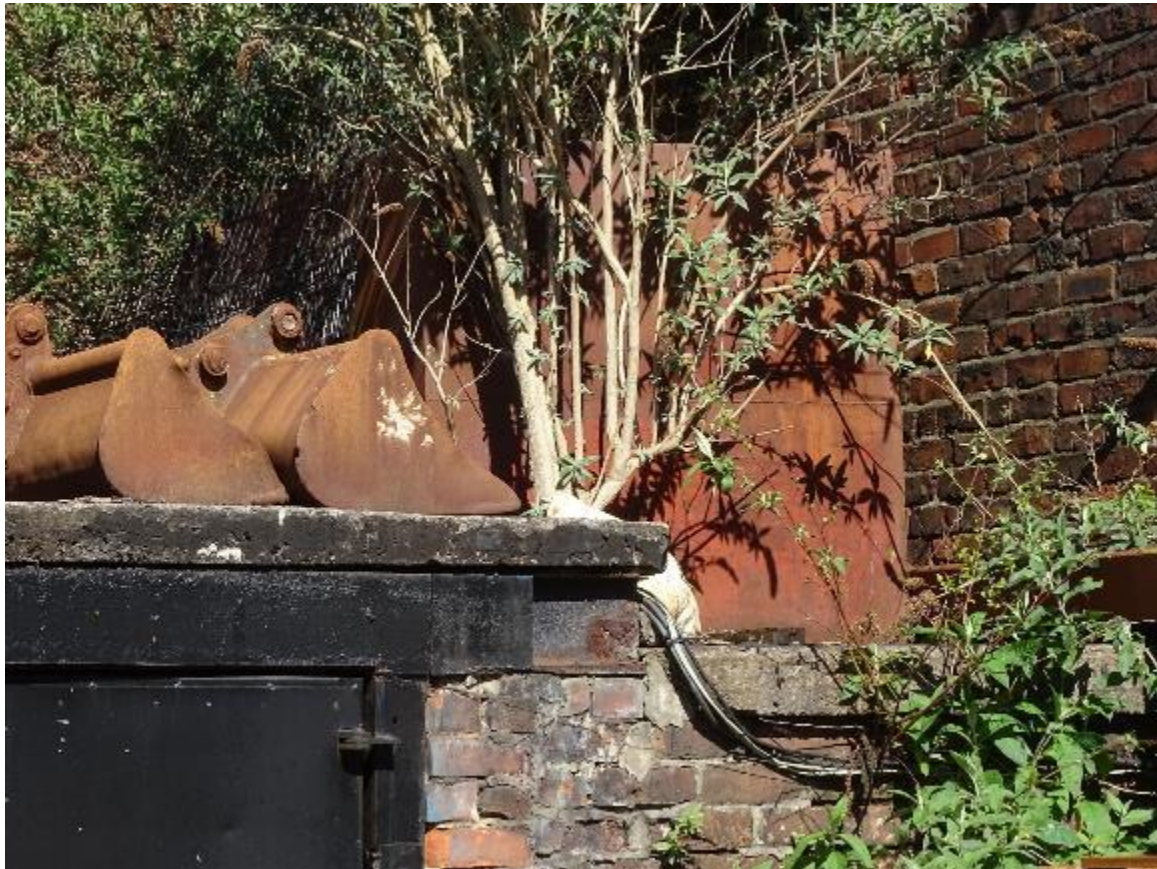
Running along the centre of the site was an old dilapidated single storey brick building. Removed in the middle to allow access across the full site. What was left of the roof was slate. The building had a concrete floor.

The building to the north of the site

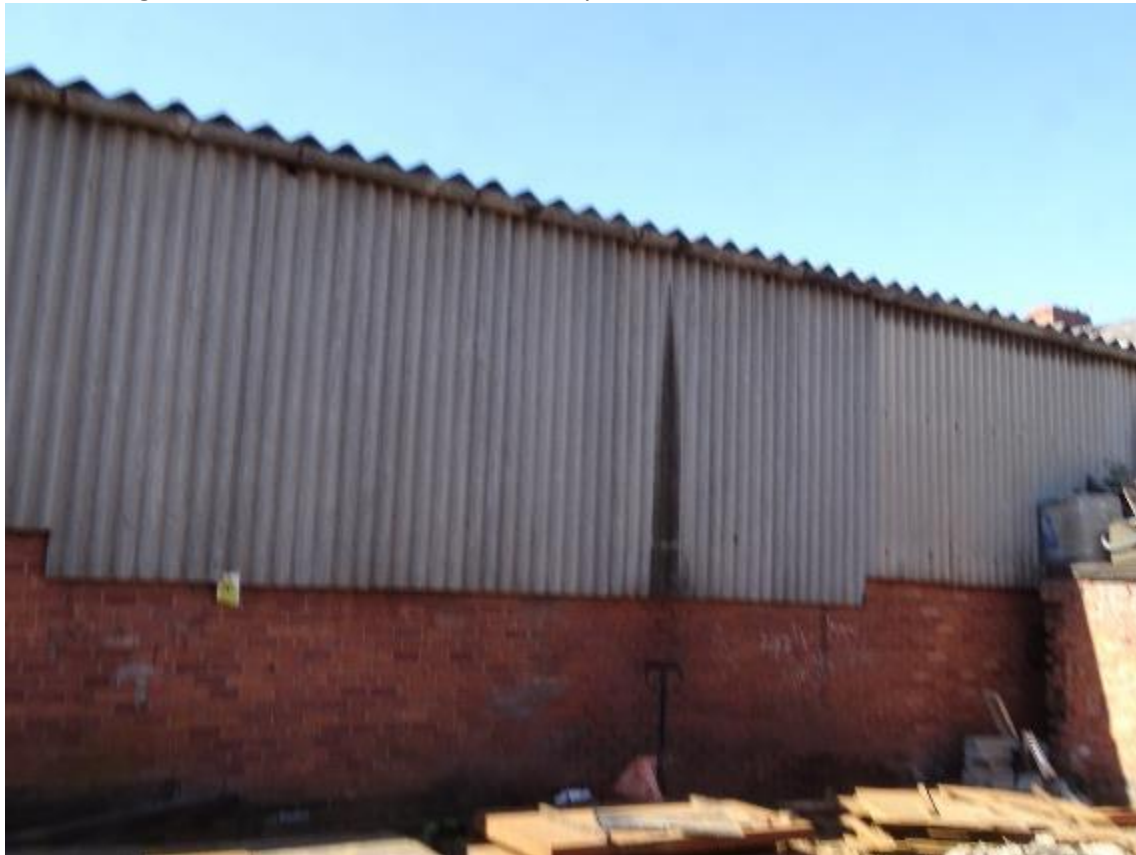
The site split into different sections by the buildings currently present. To the west a large two storey workshop, constructed with a solid concrete floor, brick walls with corrugated Cementous sheeting to the top half of the wall and the roof. The building contains offices, welfare facilities and an engineering workshop. No evidence of fuel or chemical storage was present at the time of the walkover and the site was still in use.

The building to the west of the site and western yard

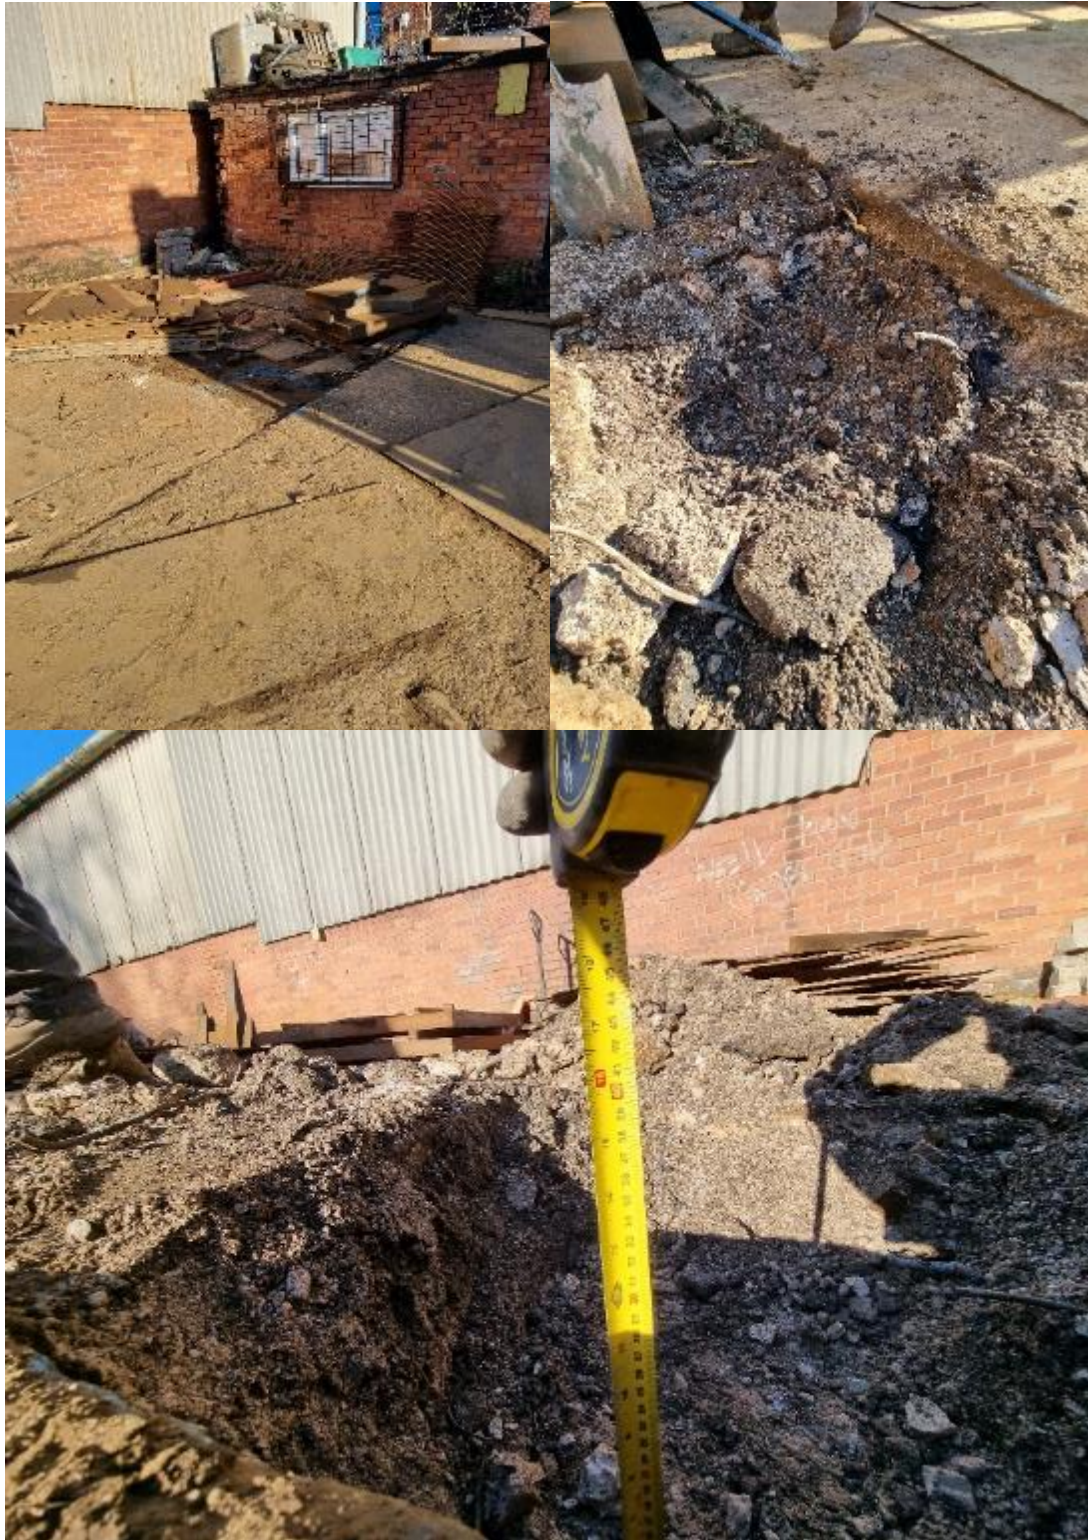
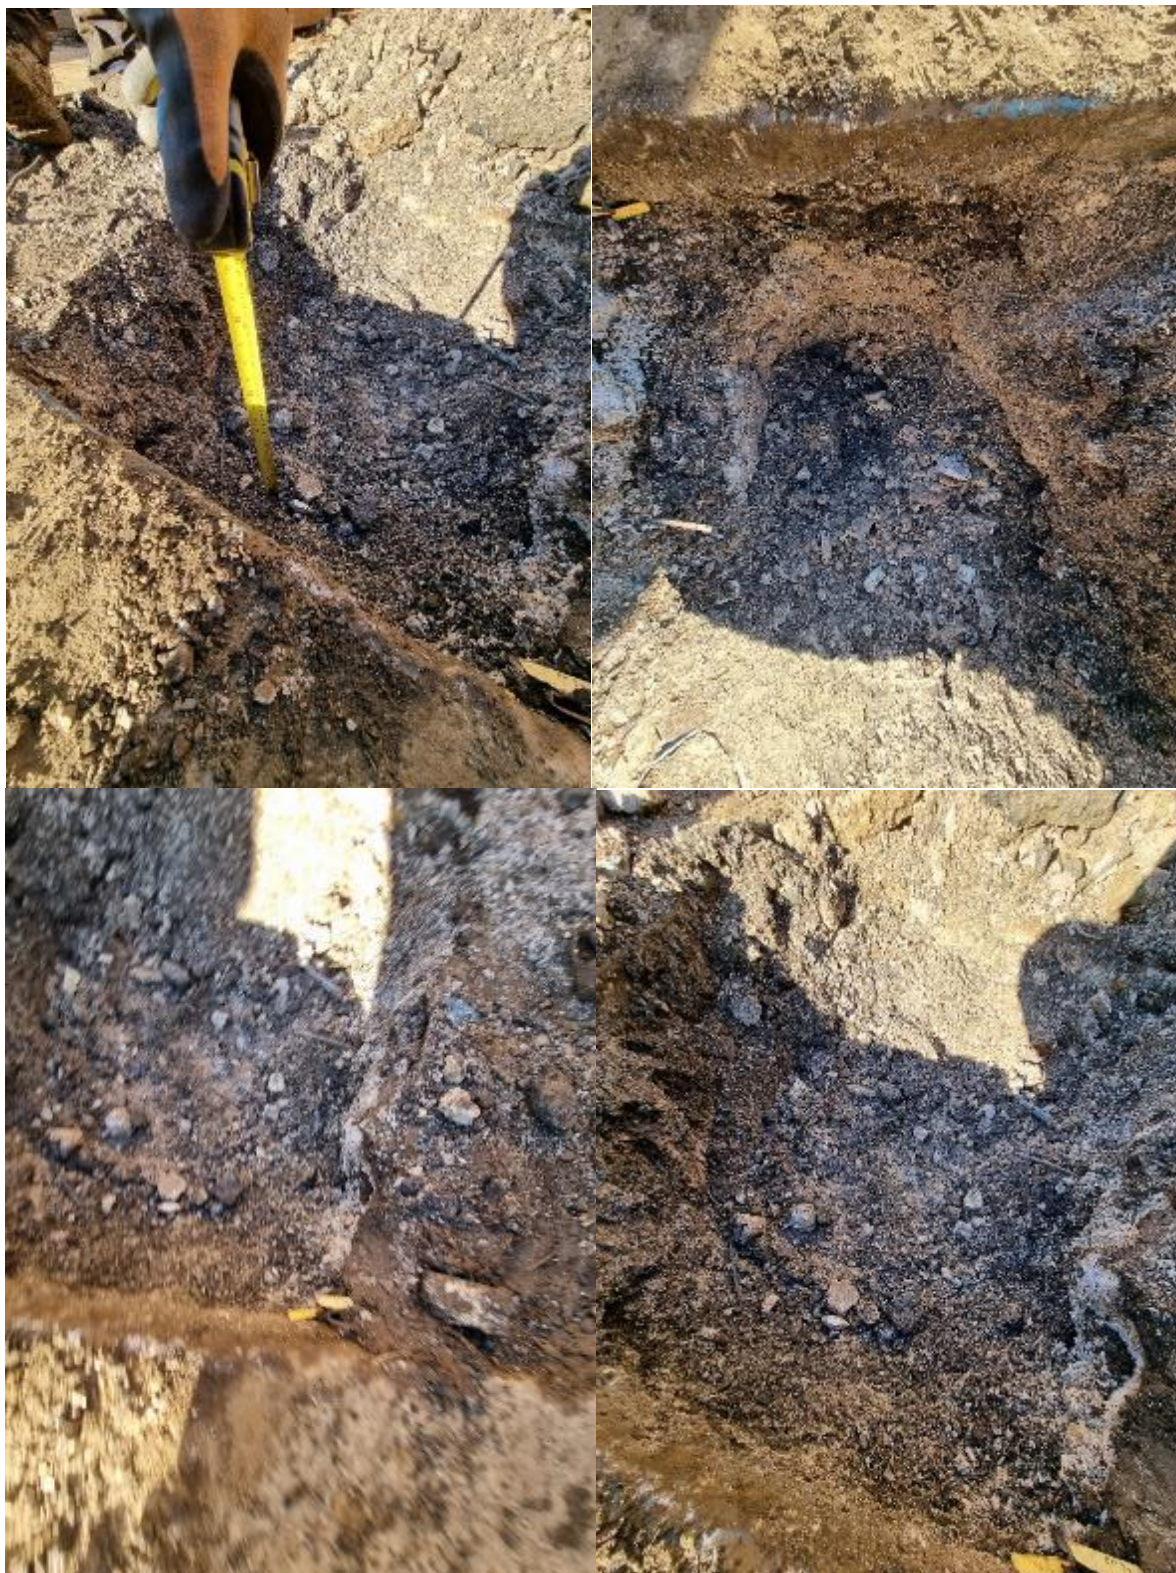
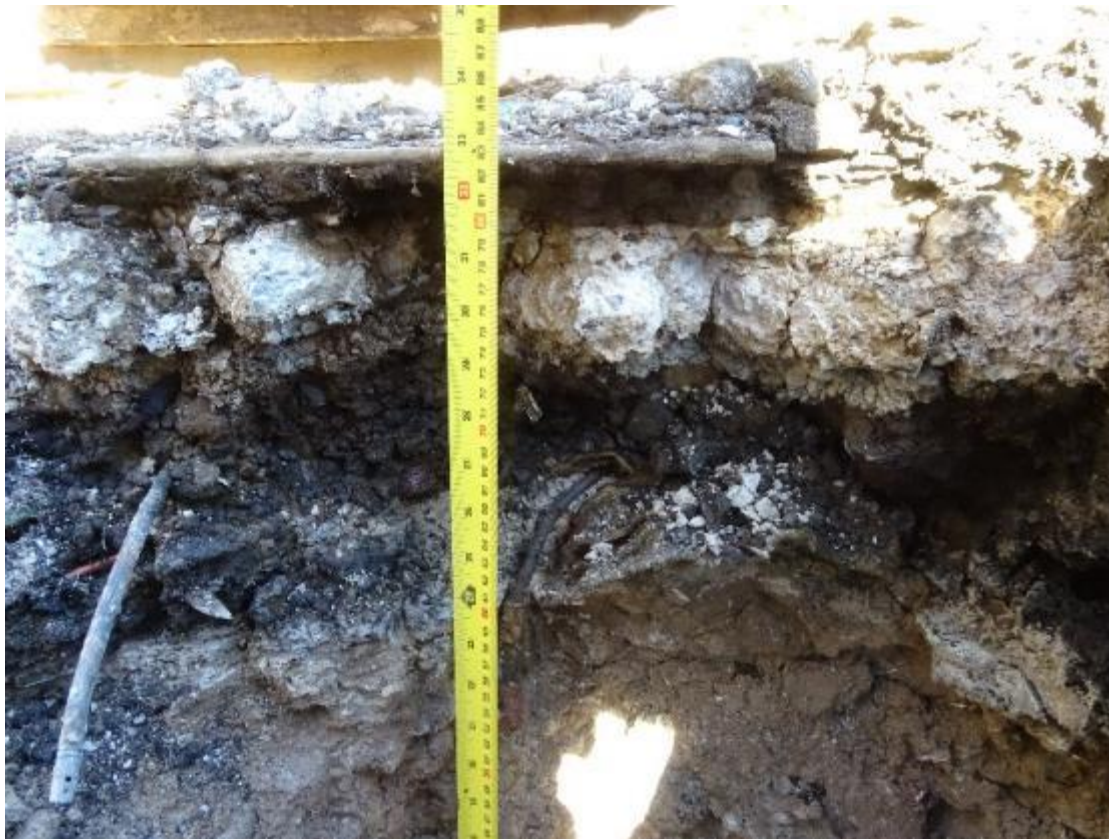
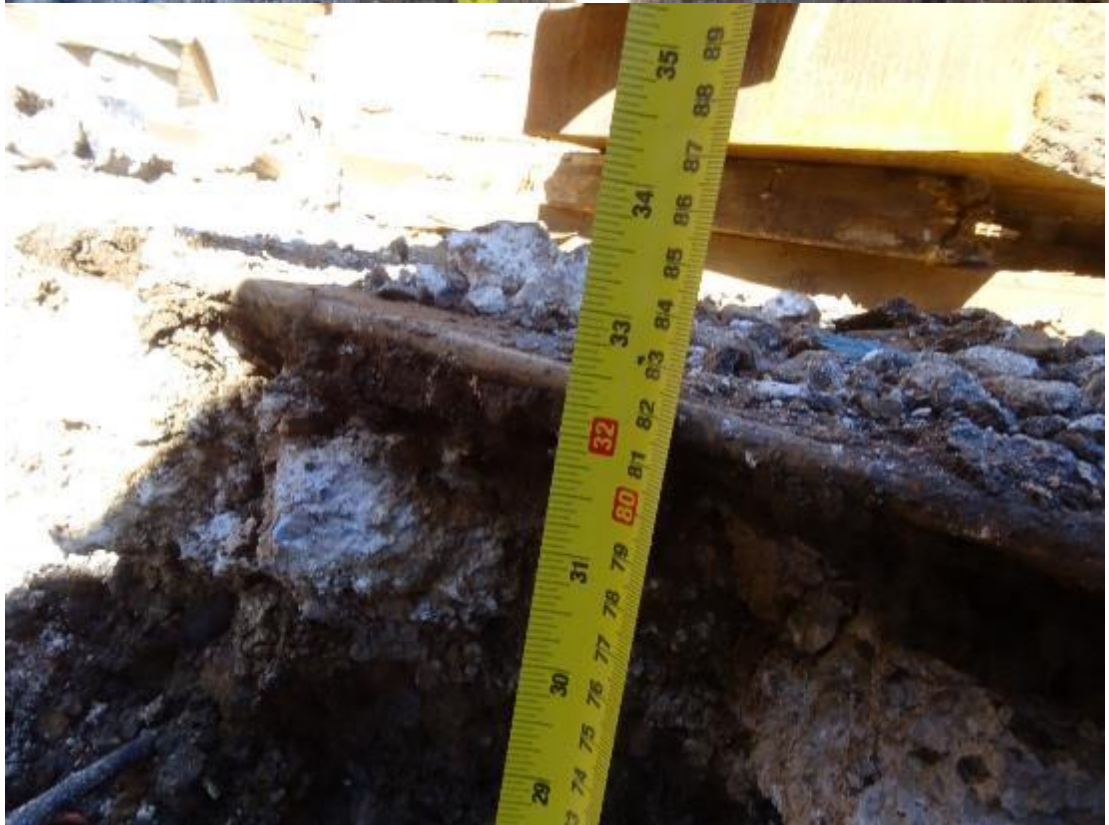
### **Trail Pit 1 – Rear northwest western yard**

| Trail pit 1 – | north of western yard |
| Water found at 0.8m | |

identified in Trail pits 1b, 3a, 5a and 6a, with further validation of the removal undertaken. This will also remove the heavy metal and asbestos contamination in these areas. Trail pit 8a also contained heavy metal contamination and this should also be removed. A clean cover system of 600mm in all garden amenity areas and 450mm in landscaped areas is then recommended.

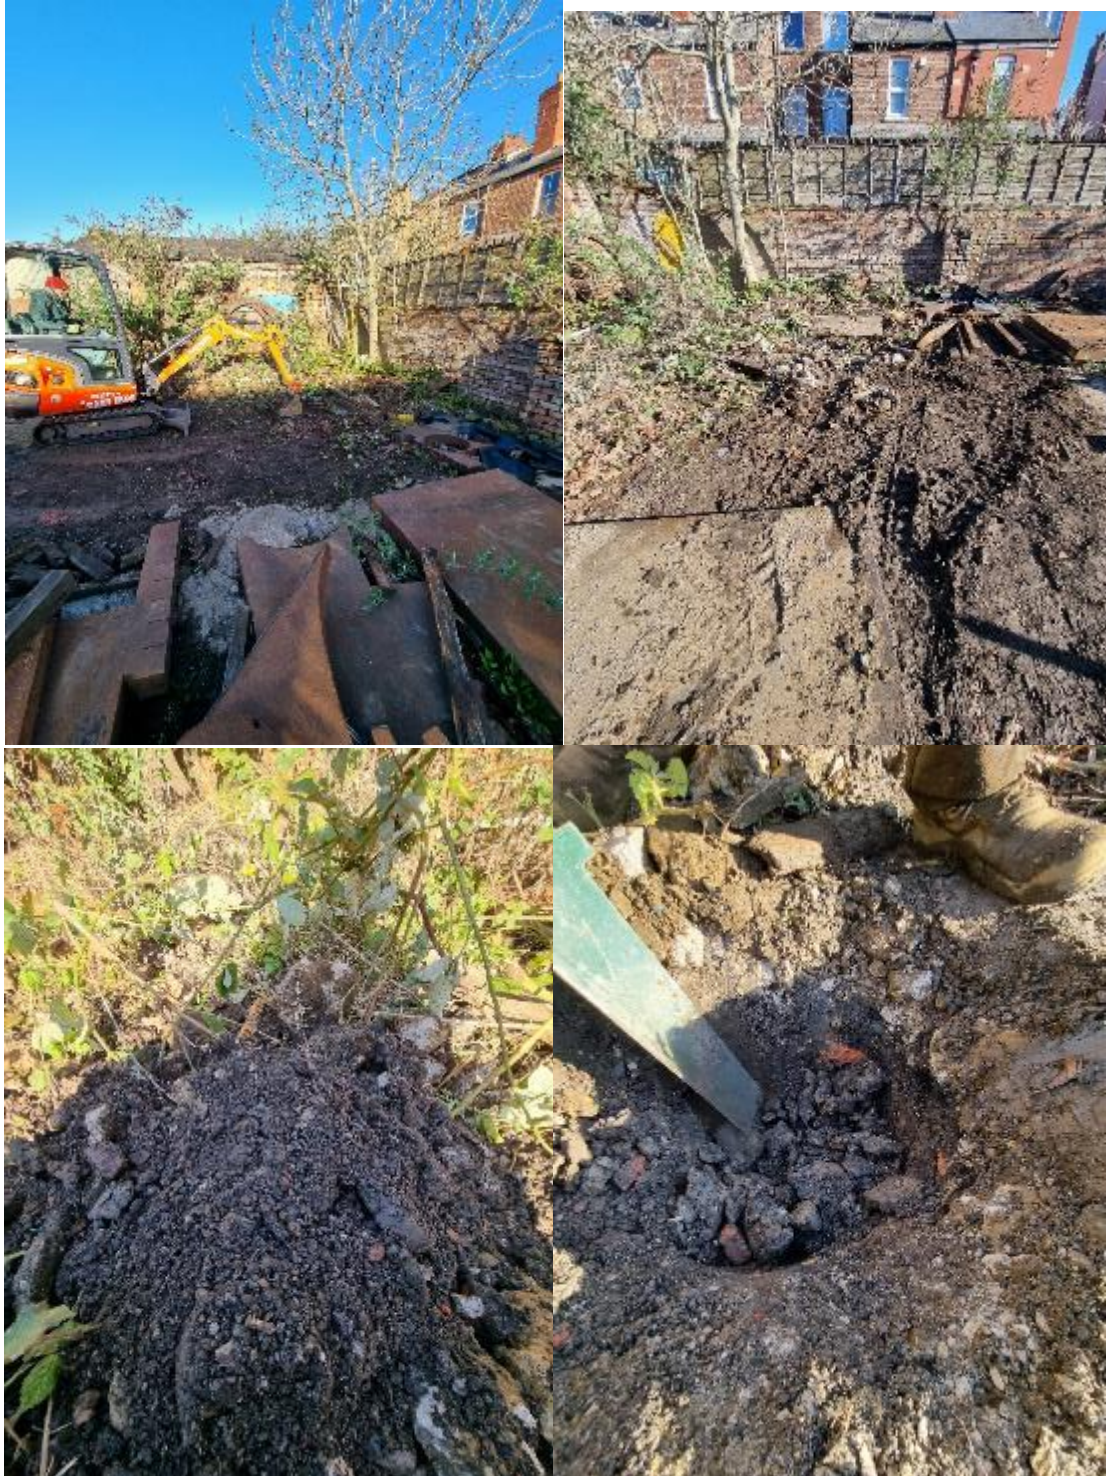
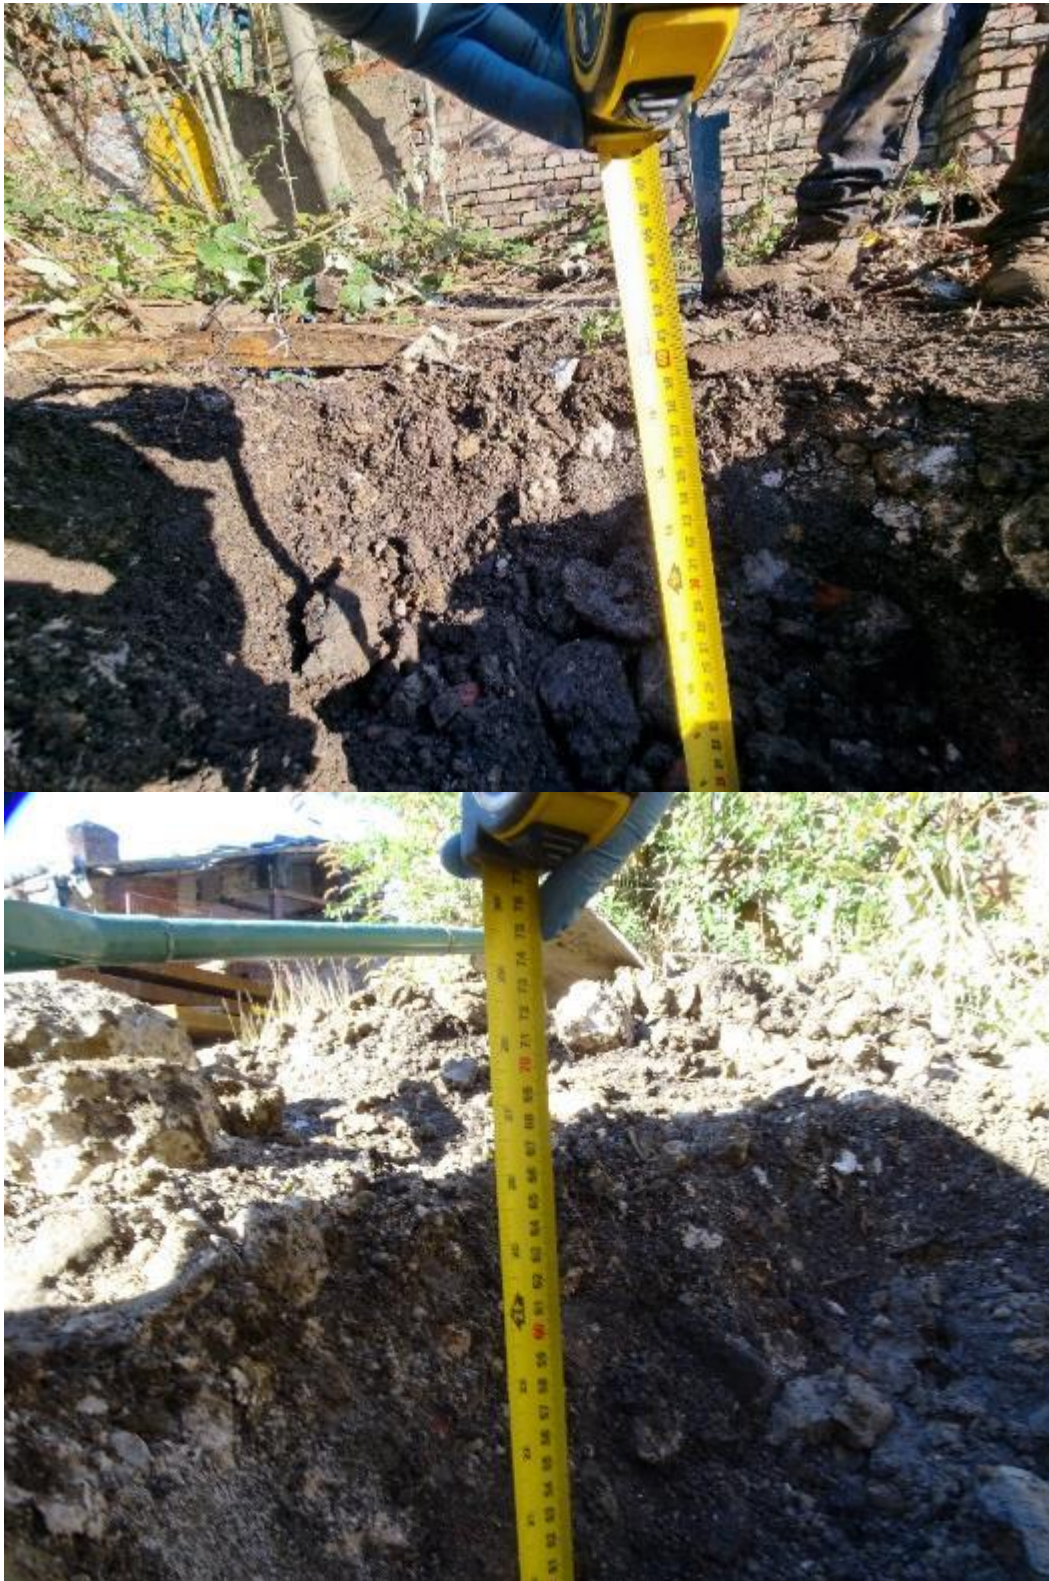
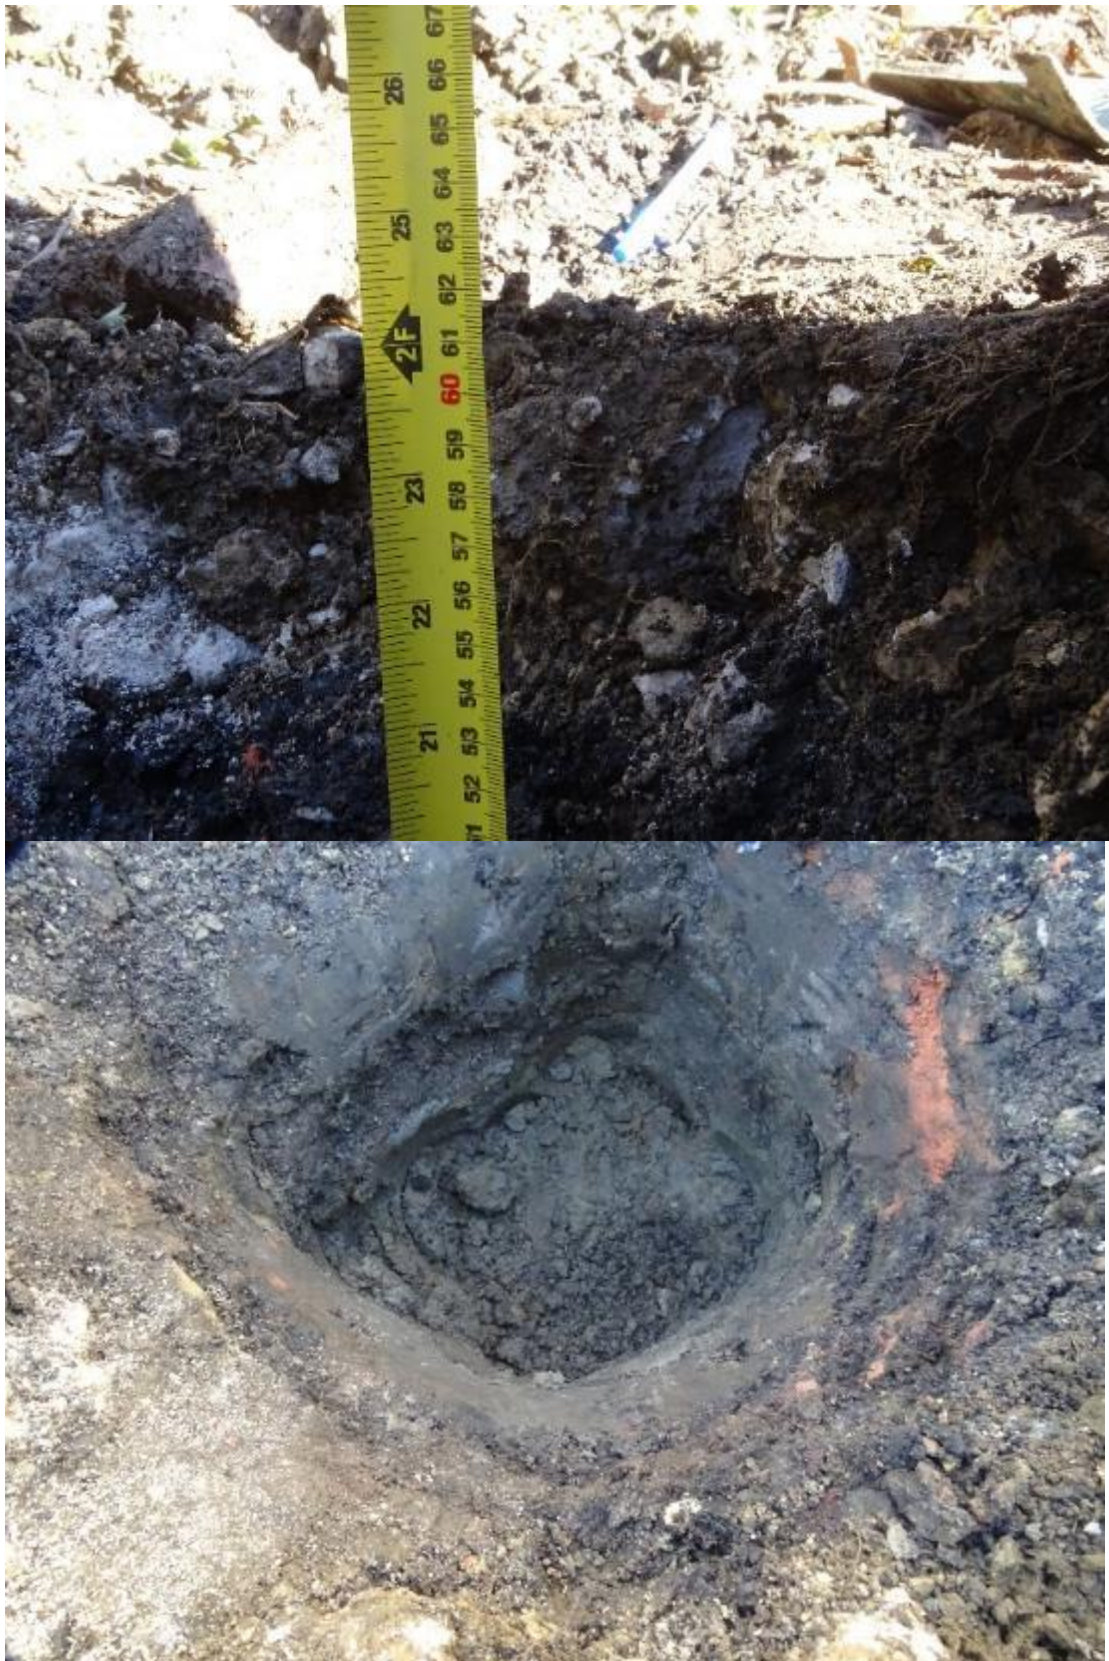
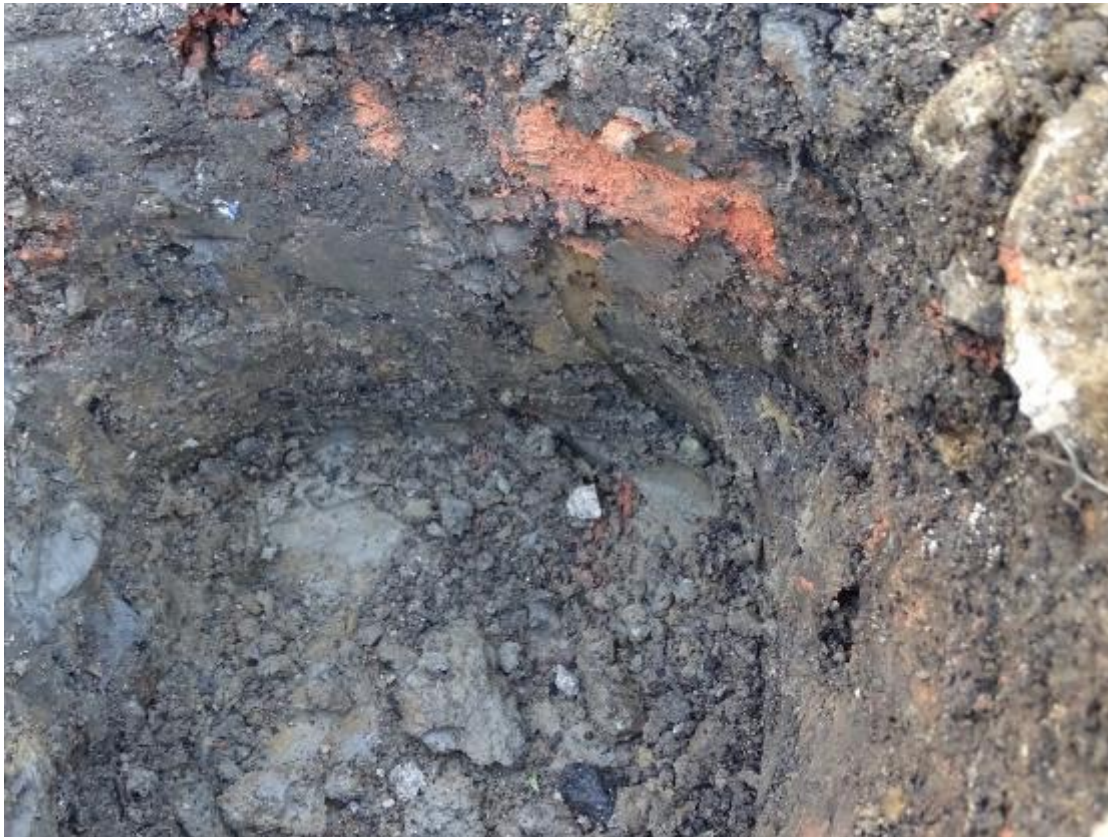
## Trail Pit 2 – Rear northwest of eastern yard

Trail pit 2, had a similar concrete apron below which sandy, gravel was encountered to 600mm where a clay layer was found.

| Trail pit 2 – | north boundary east yard |
| 0.00-0.08m | some soil and ~100mm of concrete |
