# Contaminated Land Phase One Desk Study & II Intrusive Investigation for proposed residential development at Land Off Chapel Street, Manchester, M19 3QB.

Burke Developments Ltd,  
Norwood,  
Greenacres,  
Oldham,  
OL4 3EX

May 2023

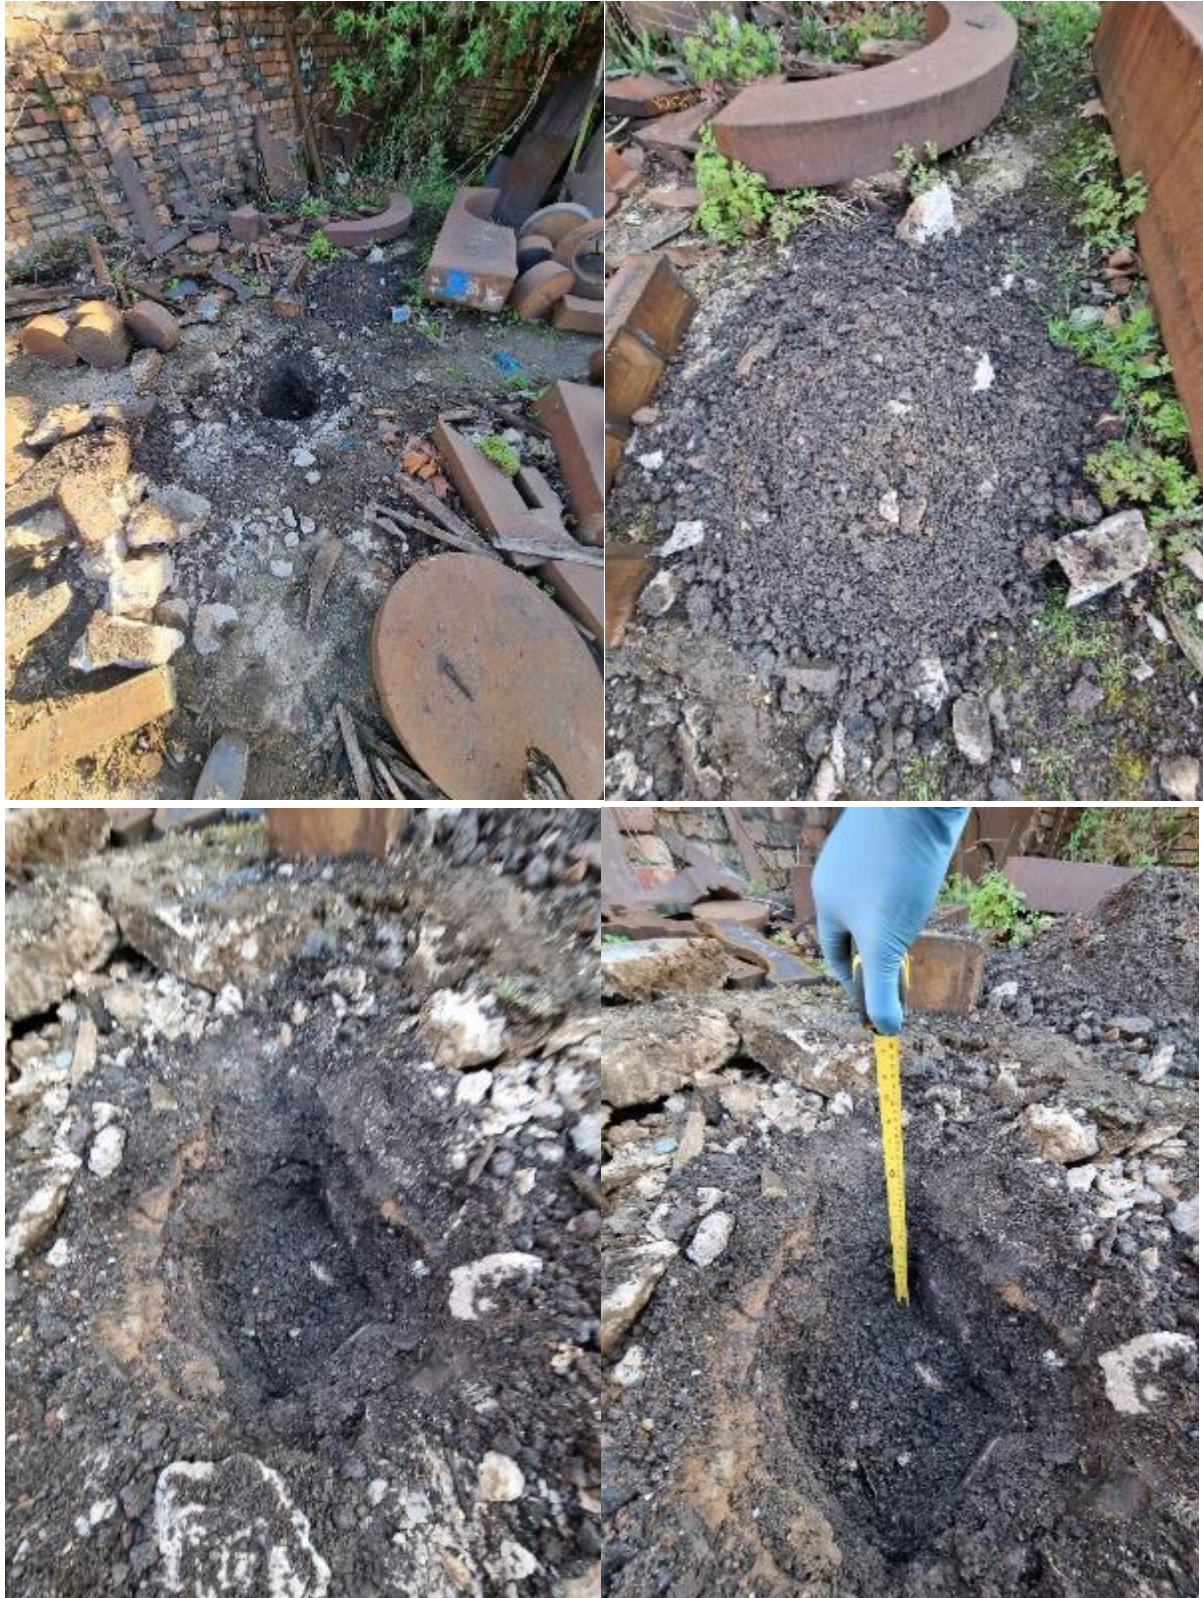
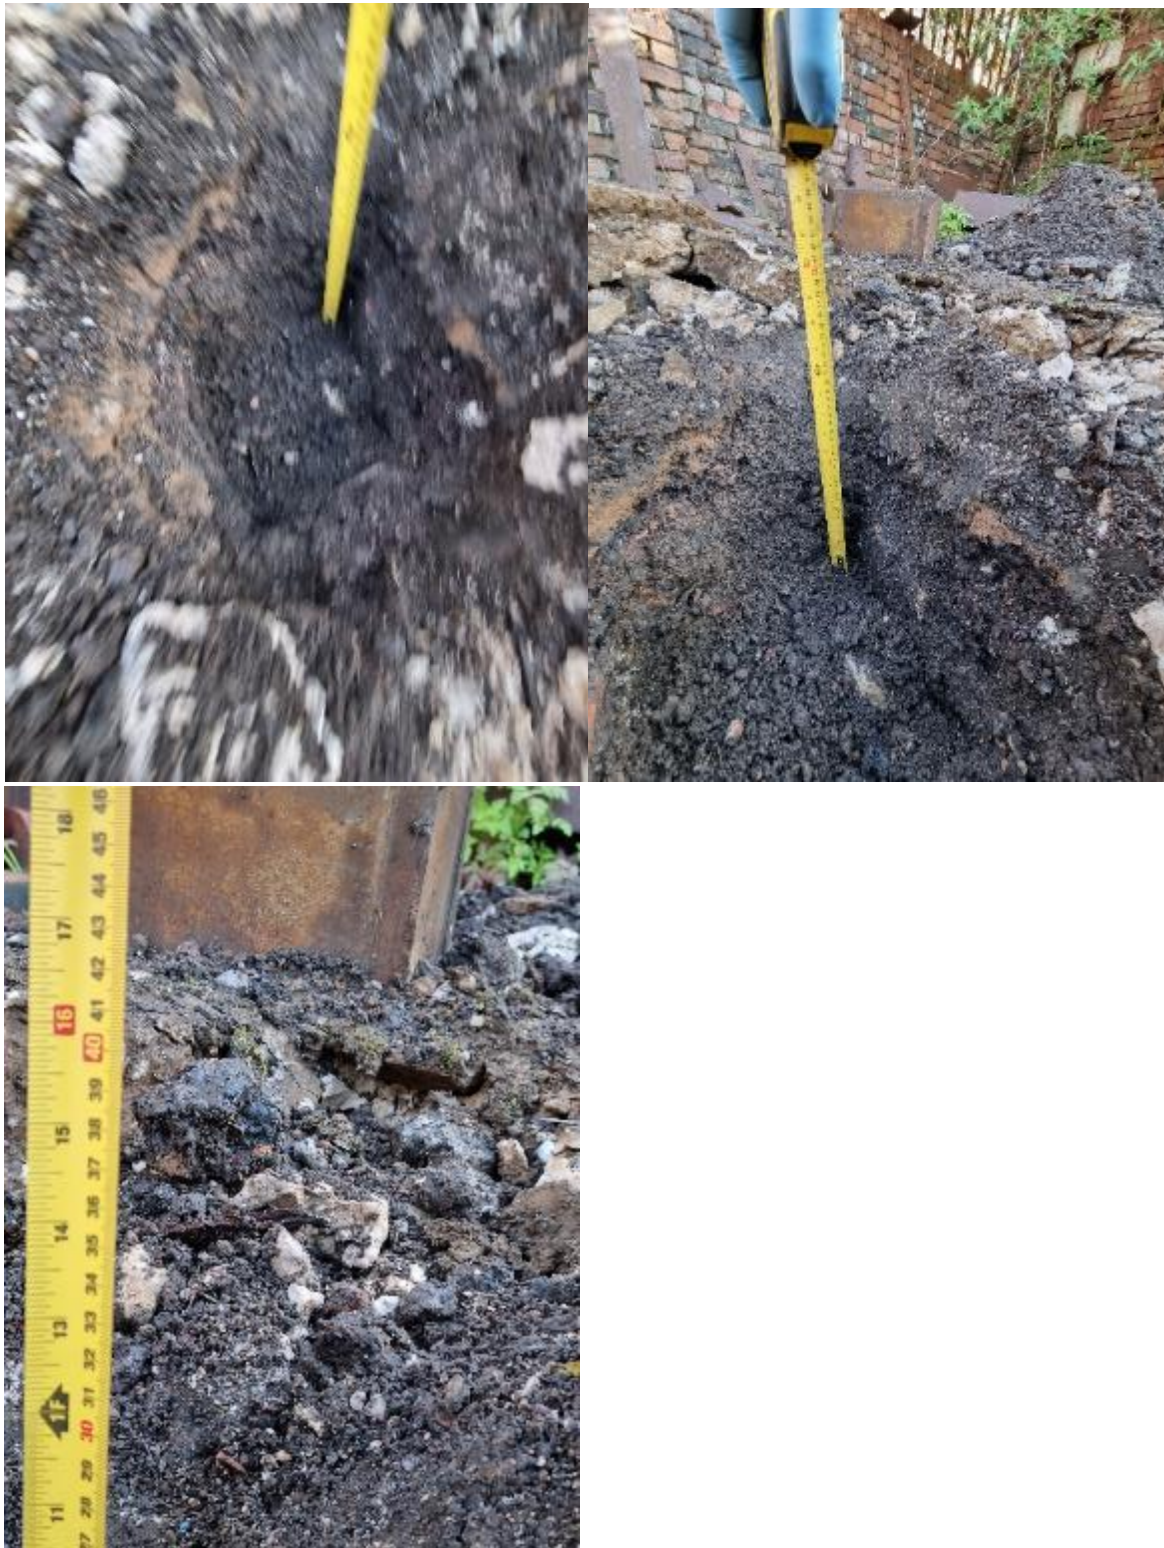
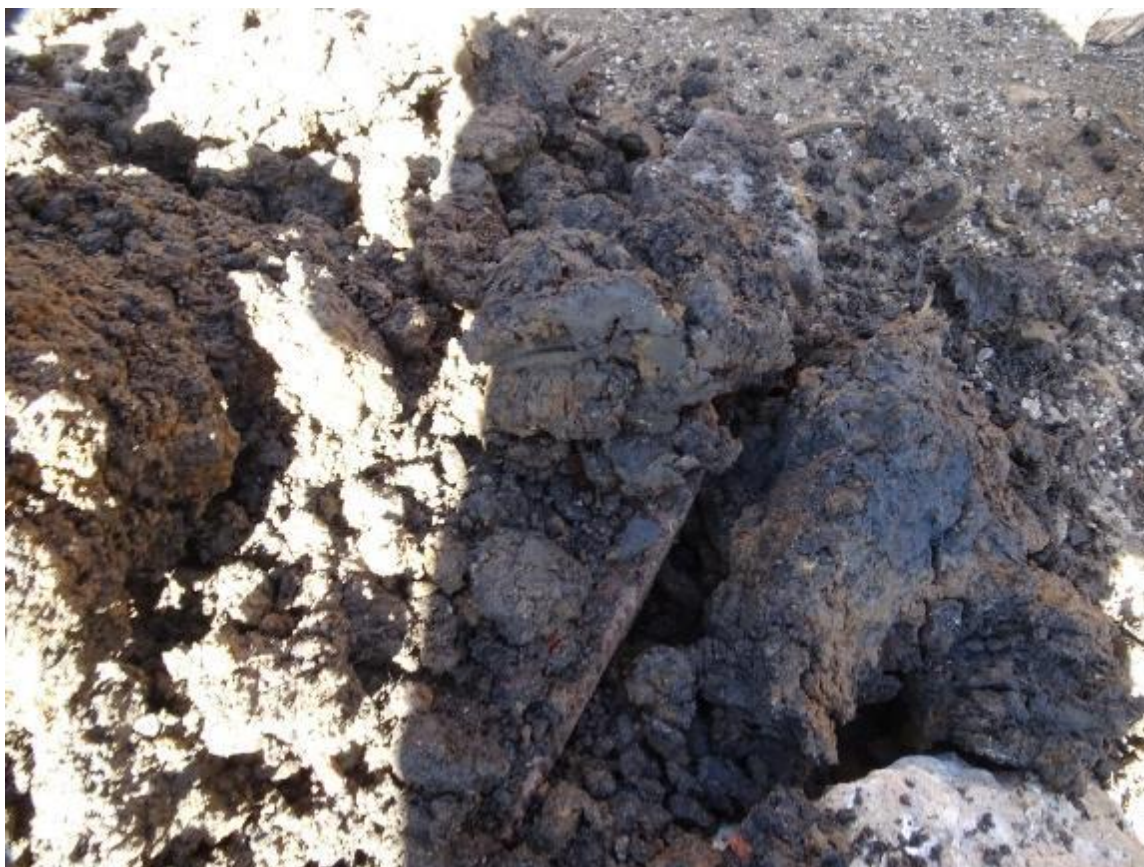
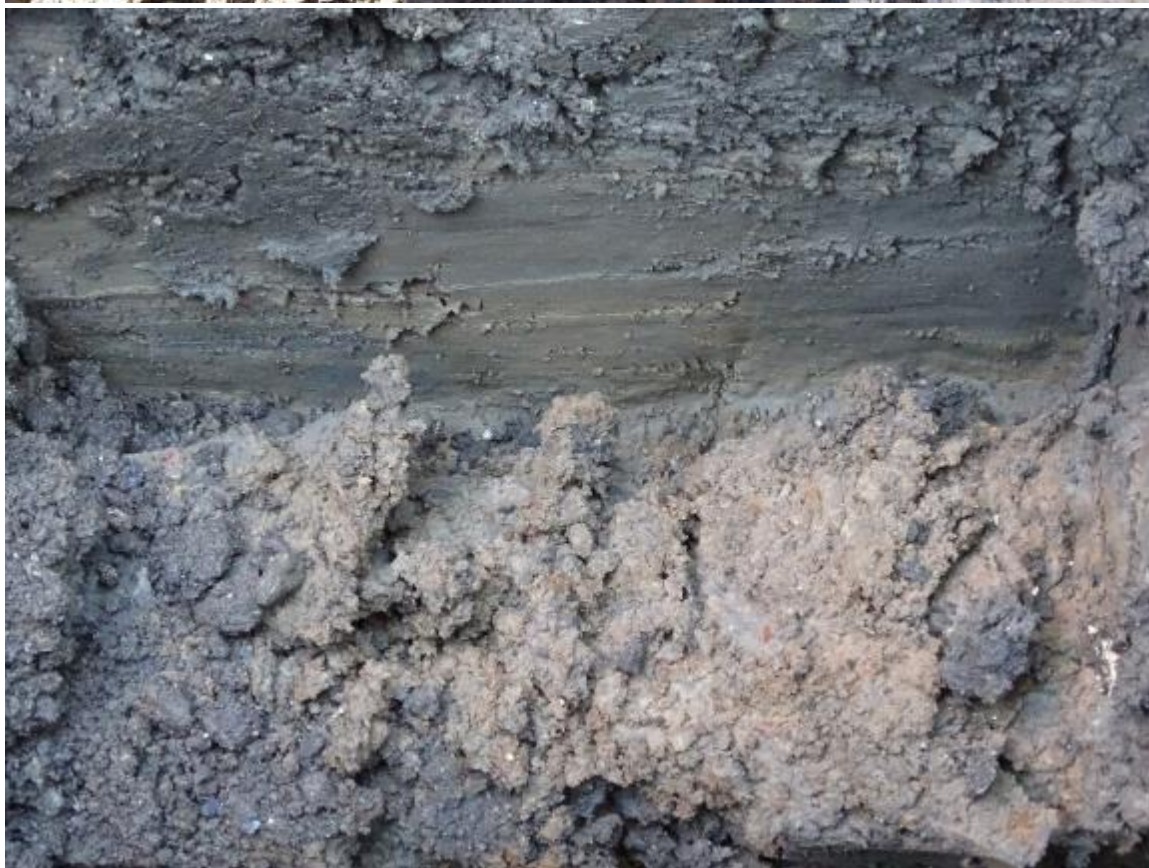
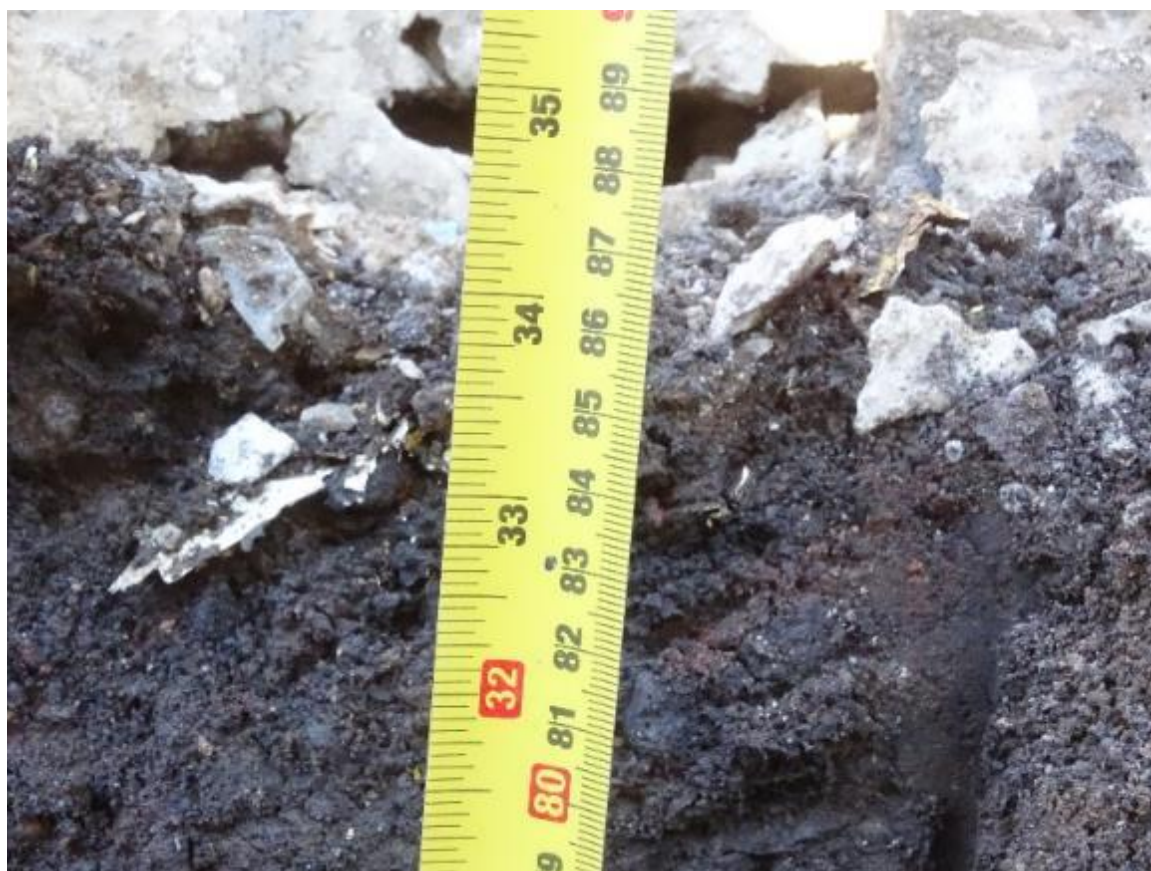
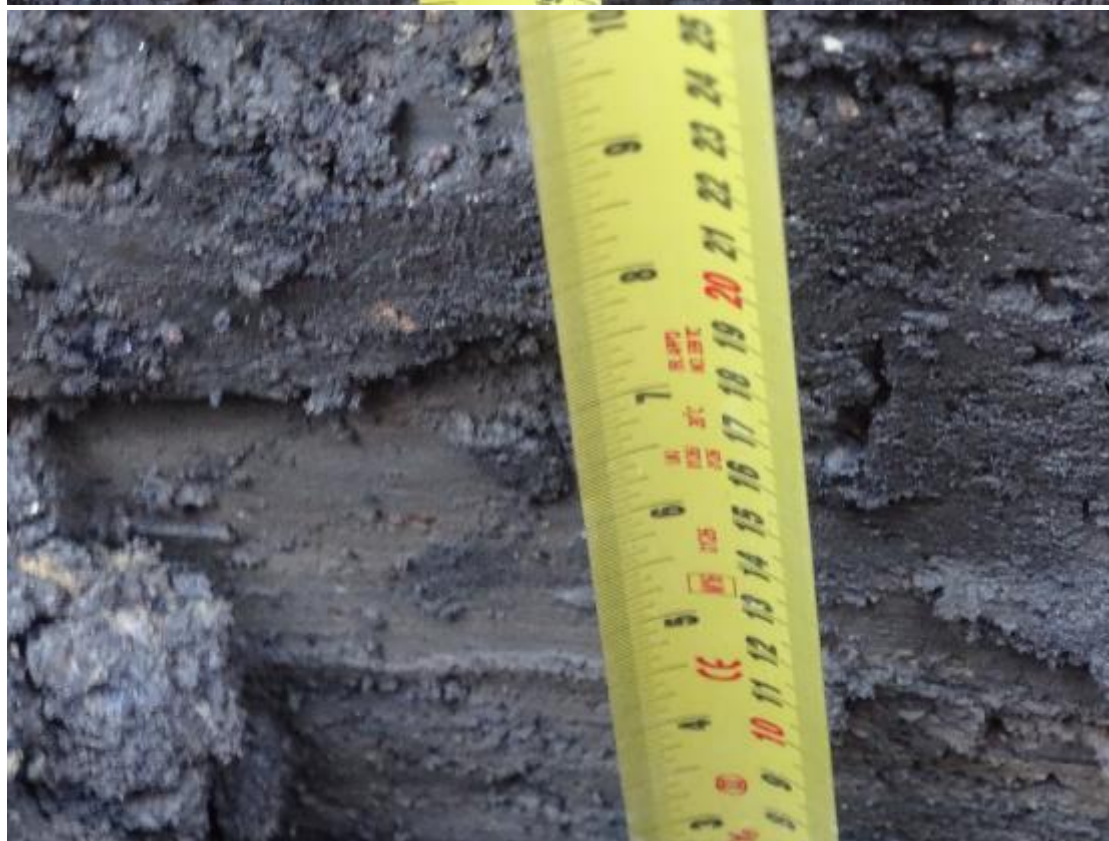
### Trail Pit 3 – Rear northwest of eastern yard

| Trail pit 3 – | north boundary east yard |

identified in Trail pits 1b, 3a, 5a and 6a, with further validation of the removal undertaken. This will also remove the heavy metal and asbestos contamination in these areas. Trail pit 8a also contained heavy metal contamination and this should also be removed. A clean cover system of 600mm in all garden amenity areas and 450mm in landscaped areas is then recommended.

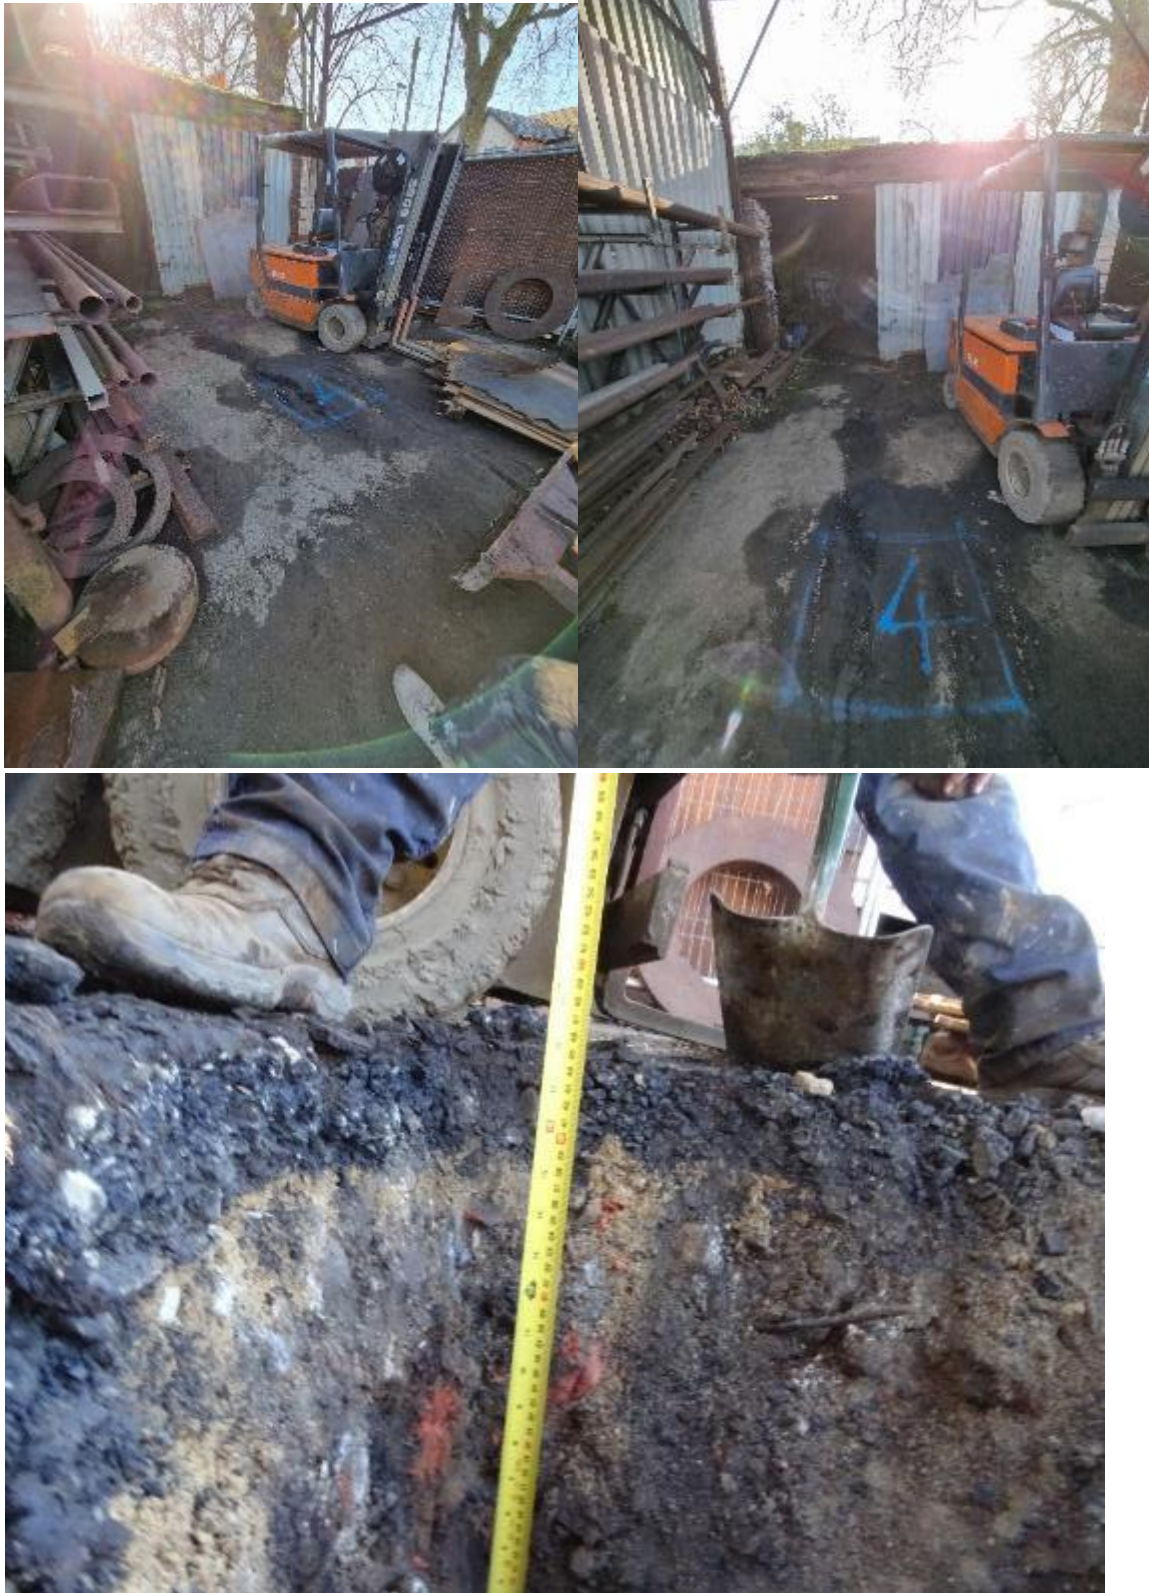
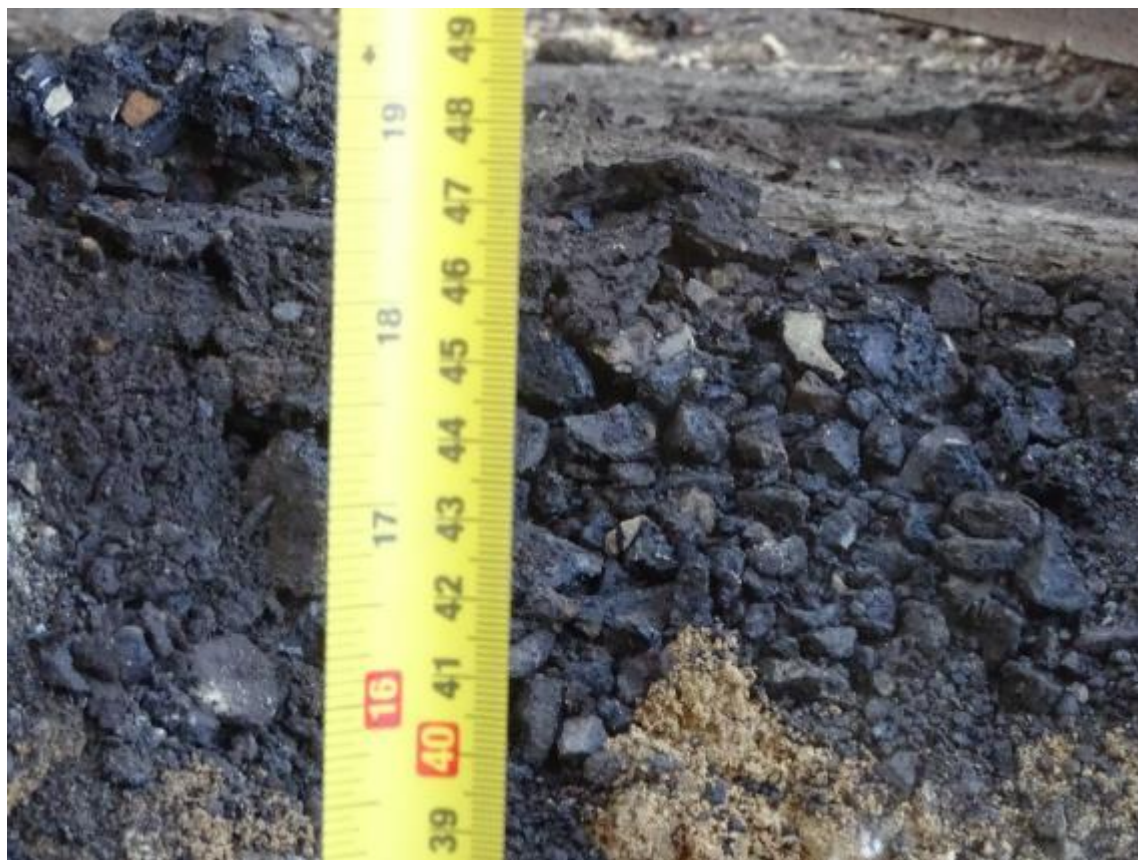
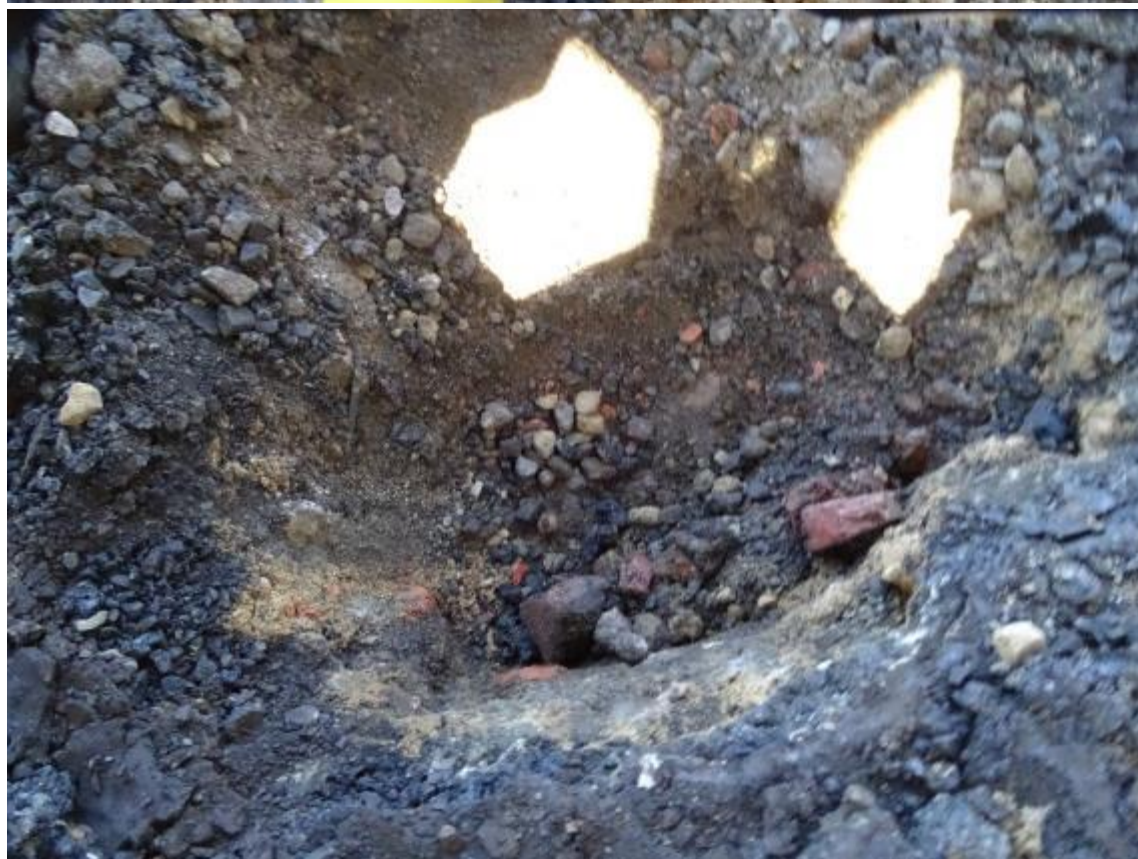
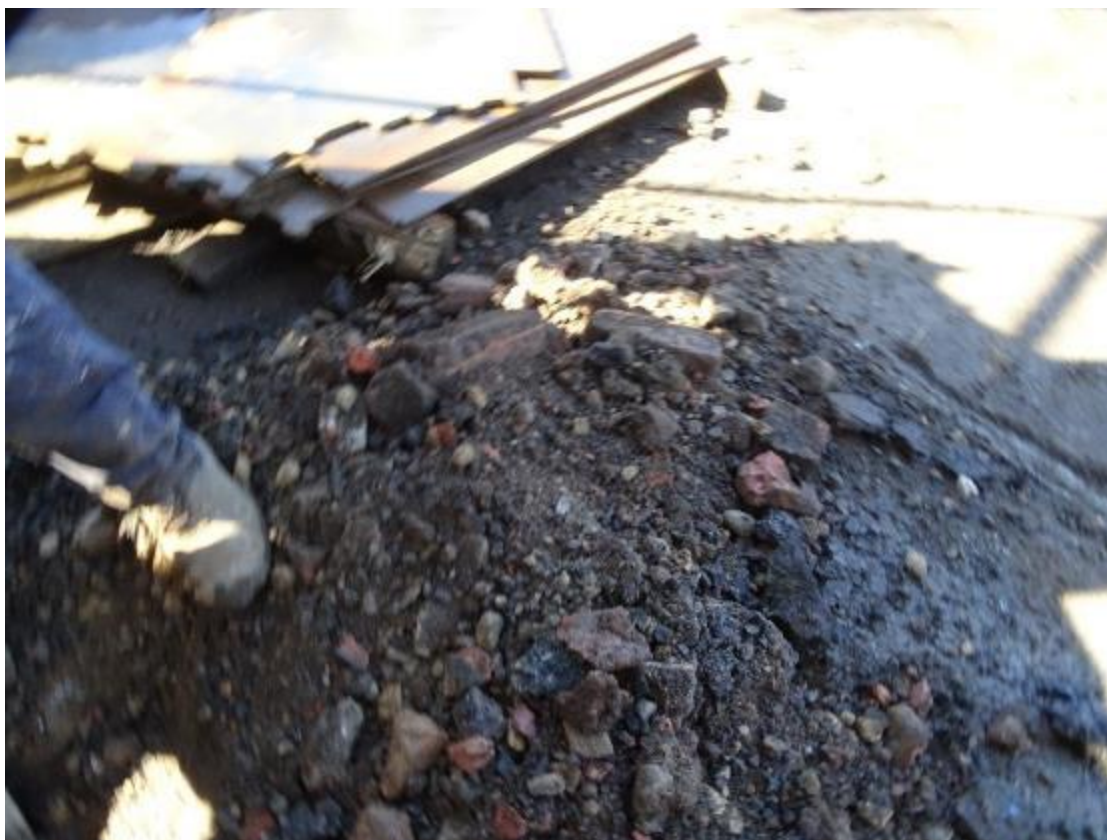
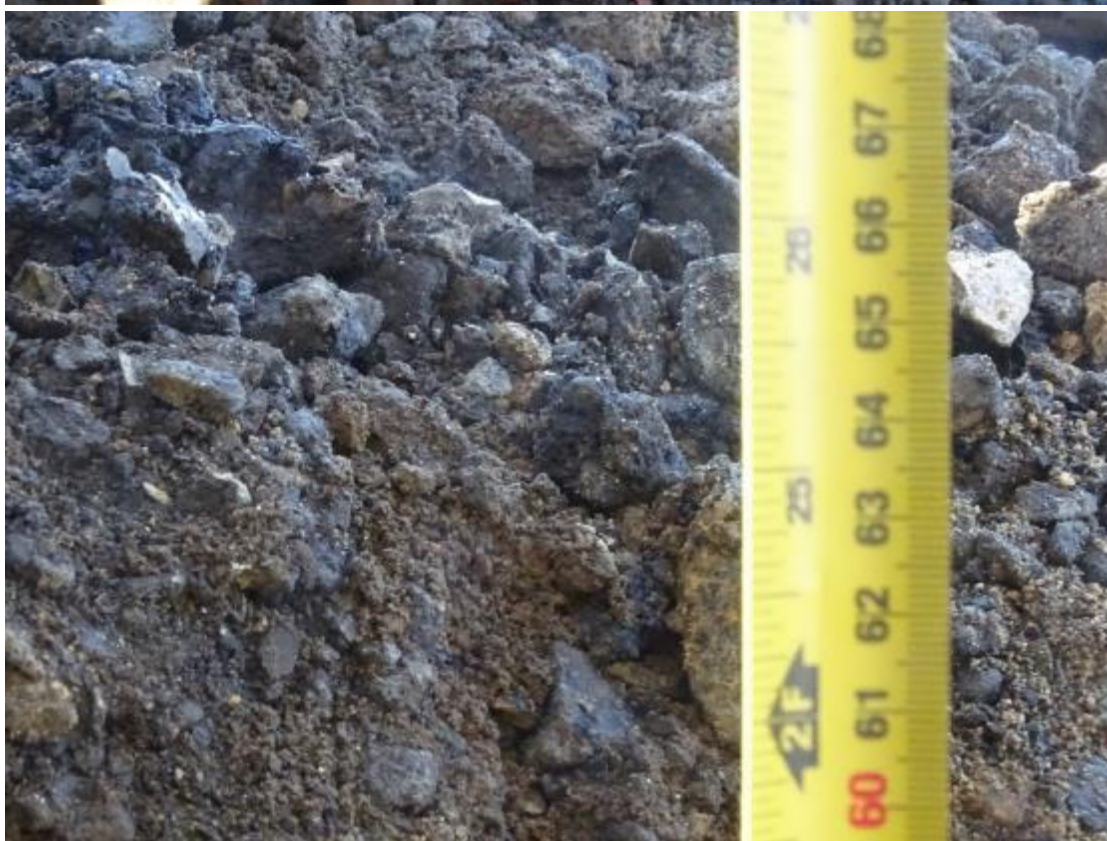
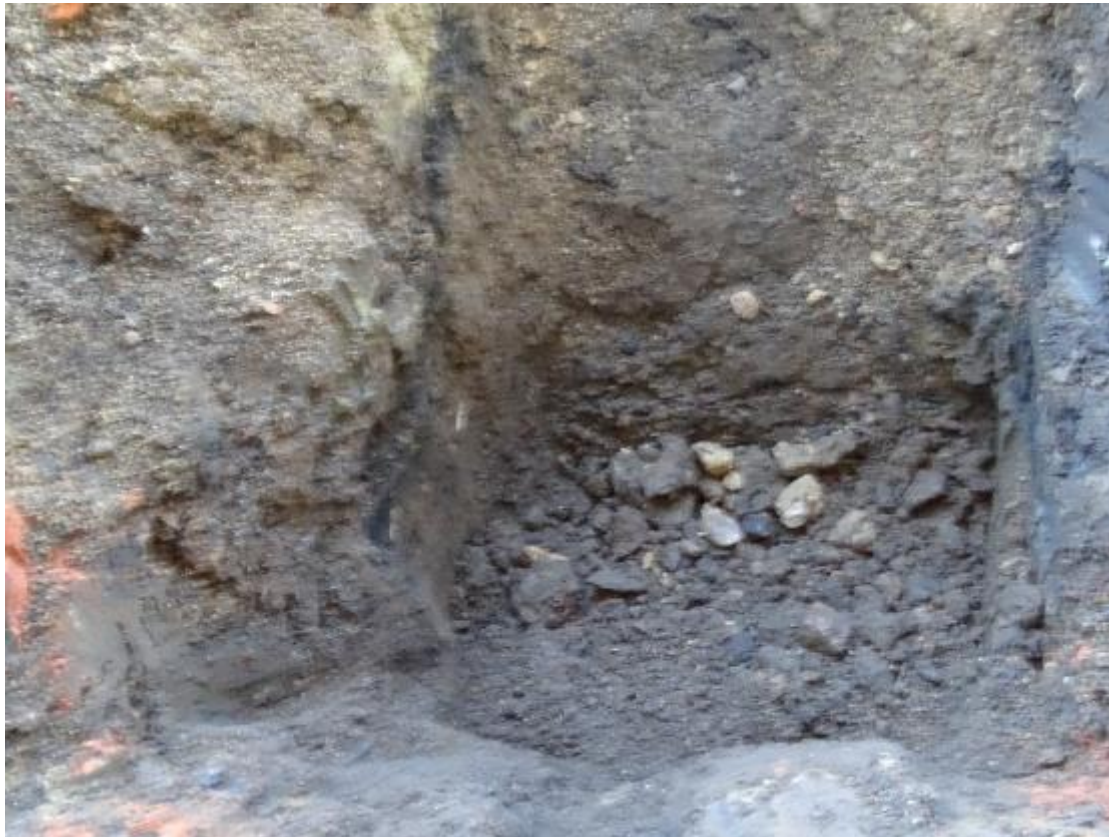
**Trail Pit 4 – Front south-eastern corner**

| Trail pit 4– | southeast corner, under lean-to |
| 0.00-0.06m | asphalt |

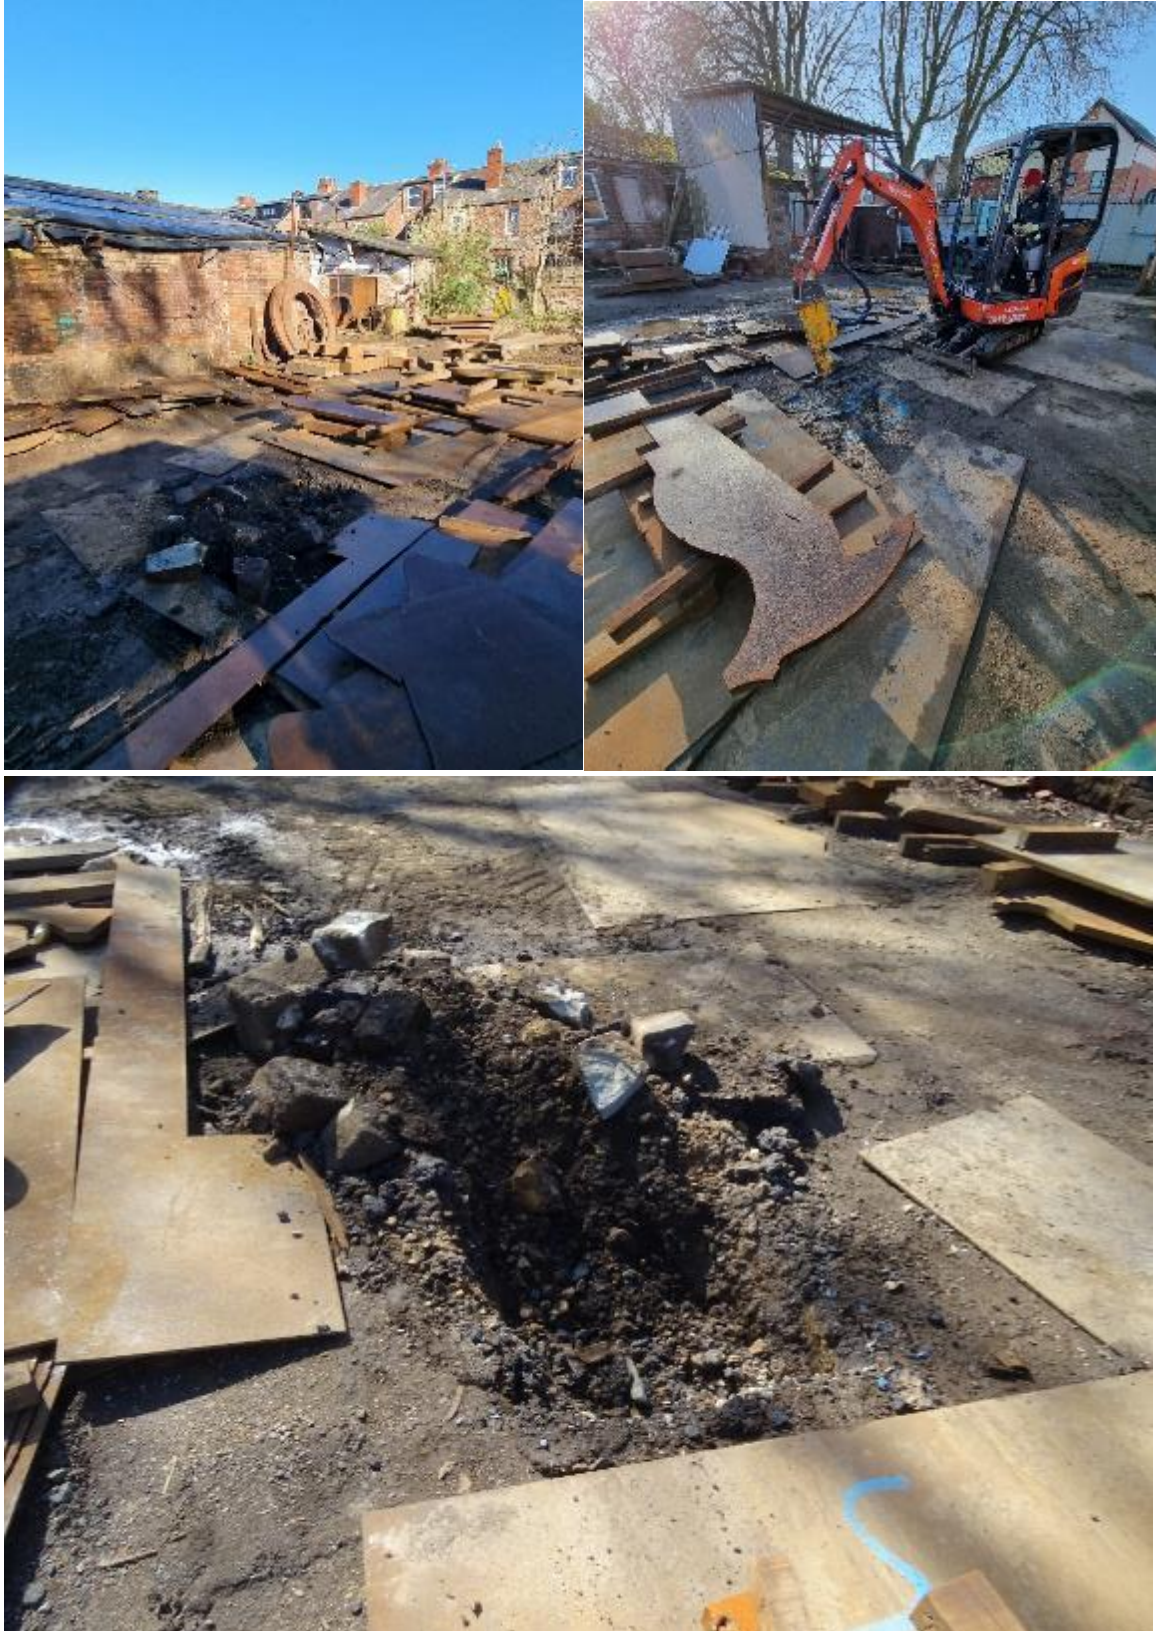
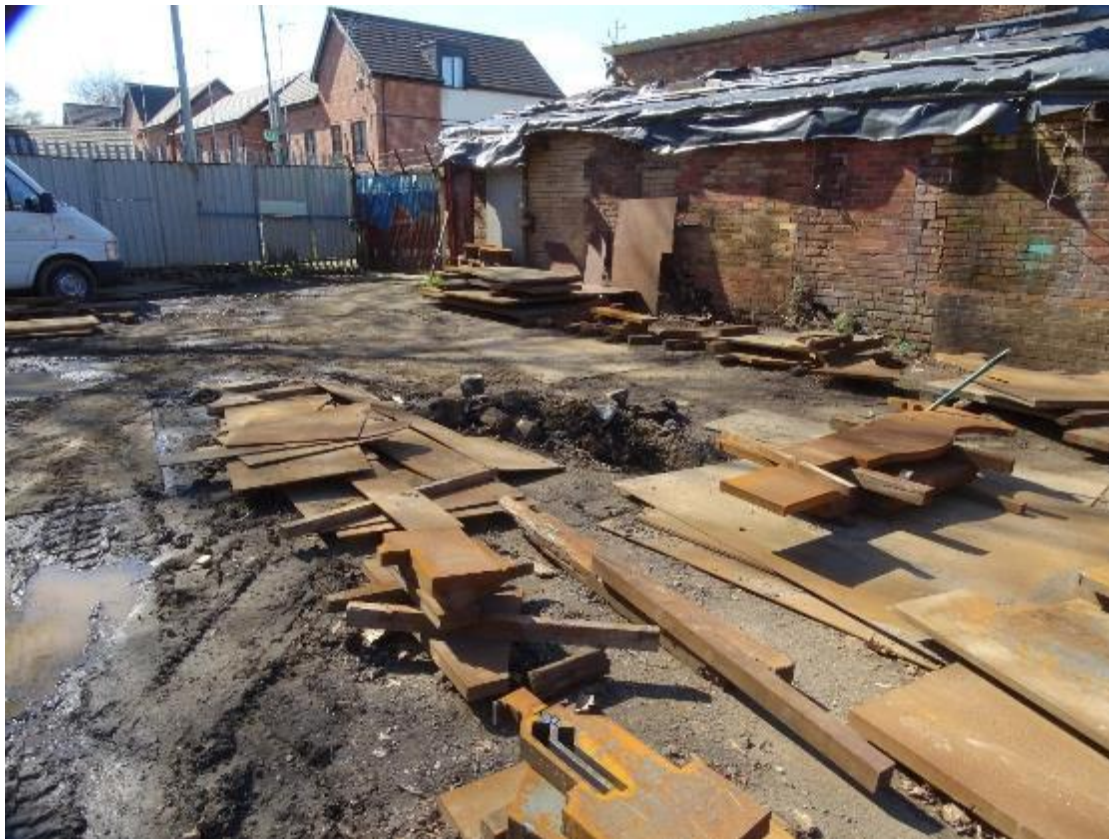
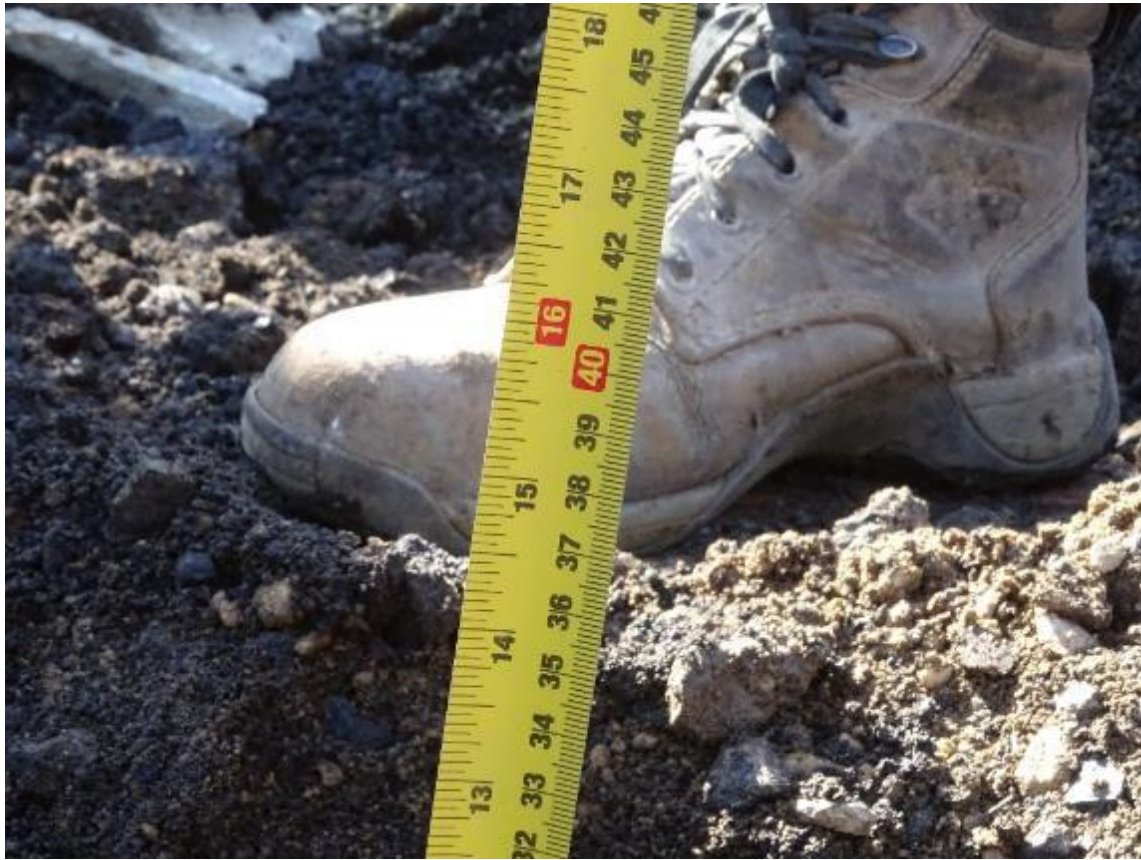
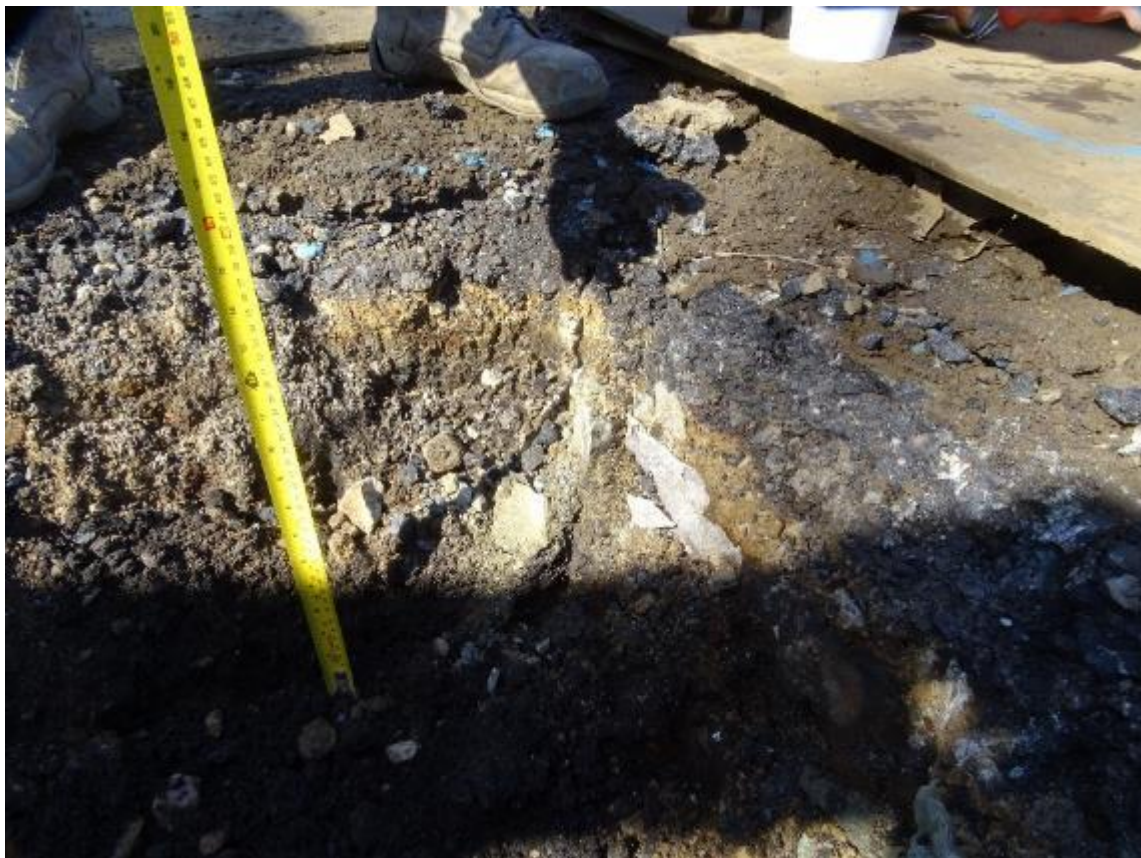
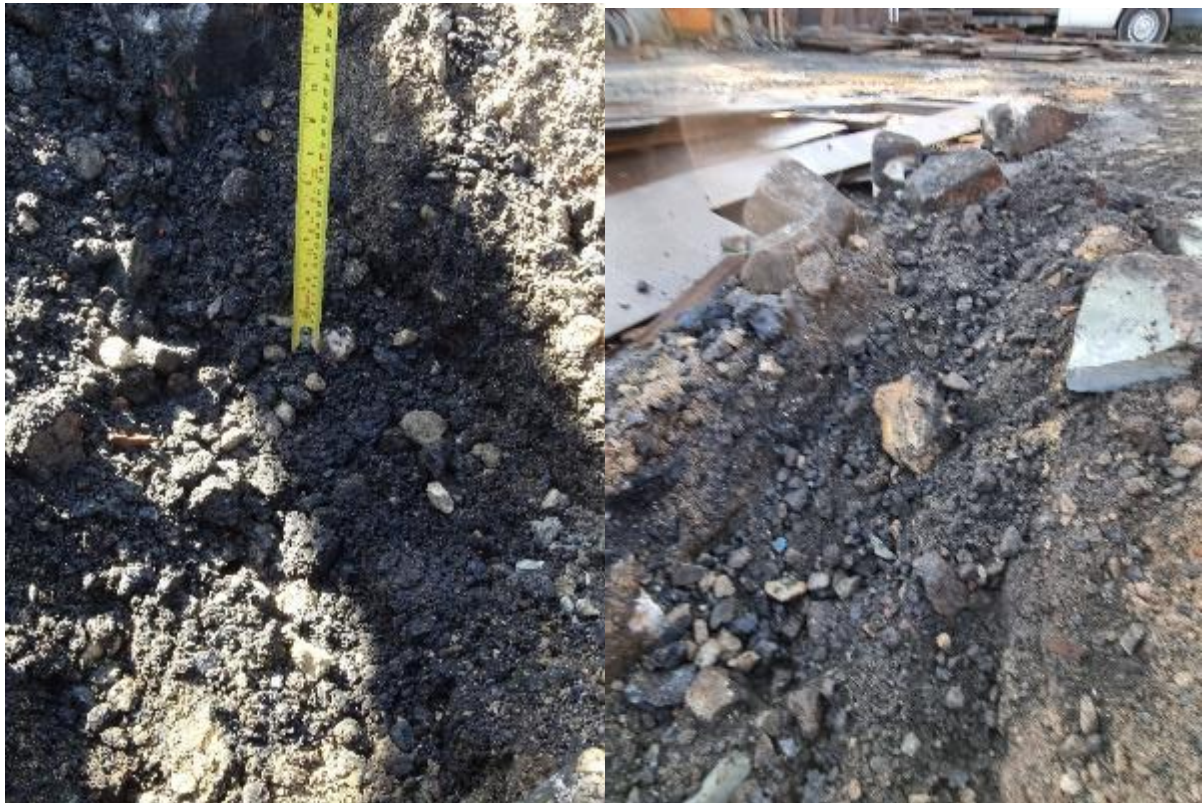
## Trail Pit 5 – Eastern yard centre

Trail pit 5 located in the centre left of the eastern yard, immediately below a layer of asphalt cobbles were found with smaller stone down to 220mm gravel, sand and sandstone was found down to 600mm bgl

| Trail pit 5 – | centre of eastern yard |
| 0.00-0.10m | asphalt |
