# Contaminated Land Phase One Desk Study & II Intrusive Investigation for proposed residential development at Land Off Chapel Street, Manchester, M19 3QB.

Burke Developments Ltd,  
Norwood,  
Greenacres,  
Oldham,  
OL4 3EX

May 2023

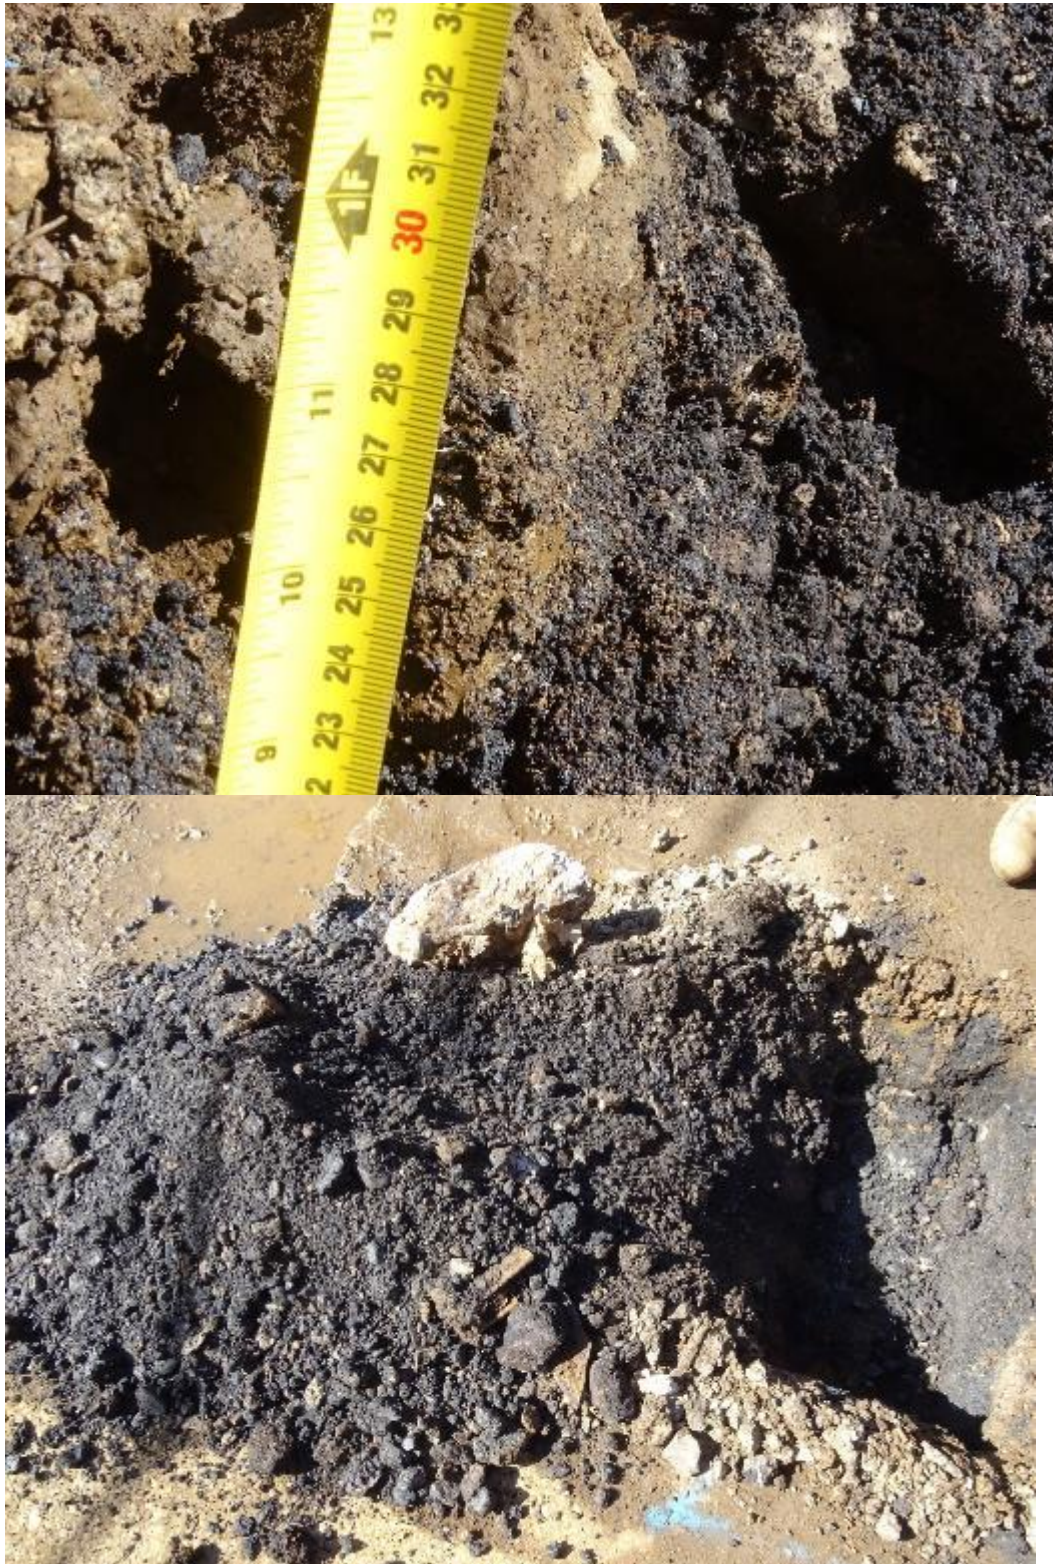
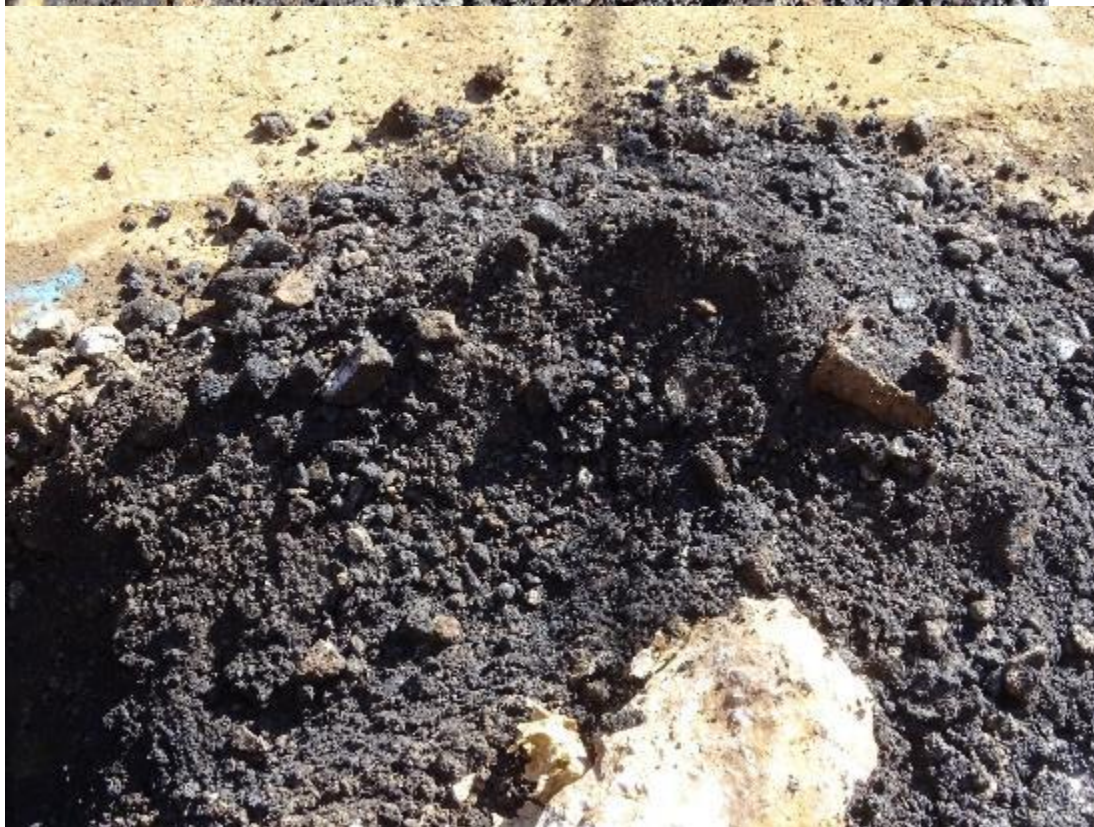
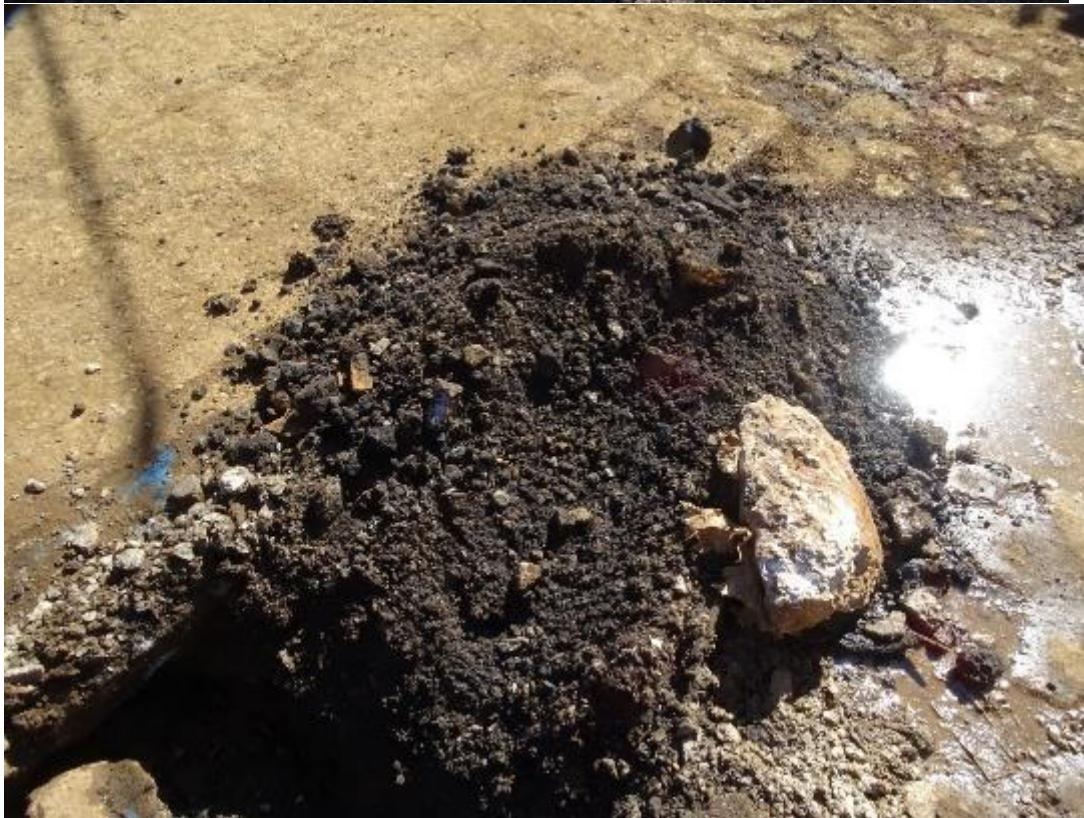
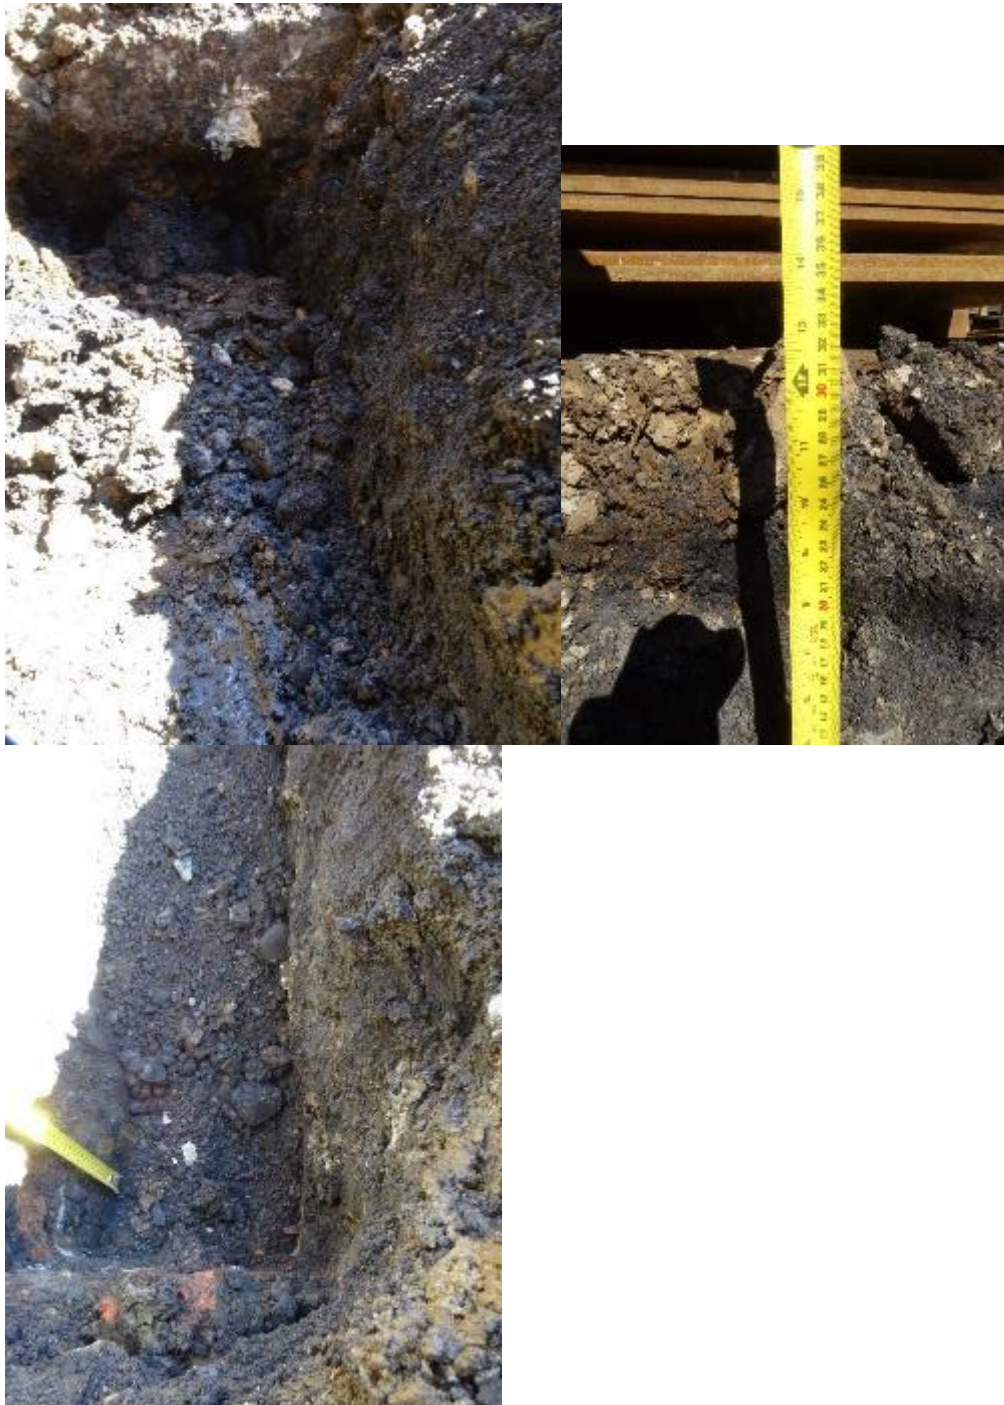
Sample 6

| Trail pit 6 – | south of western yard |
| 0.00-0.08m | concrete |

identified in Trail pits 1b, 3a, 5a and 6a, with further validation of the removal undertaken. This will also remove the heavy metal and asbestos contamination in these areas. Trail pit 8a also contained heavy metal contamination and this should also be removed. A clean cover system of 600mm in all garden amenity areas and 450mm in landscaped areas is then recommended.

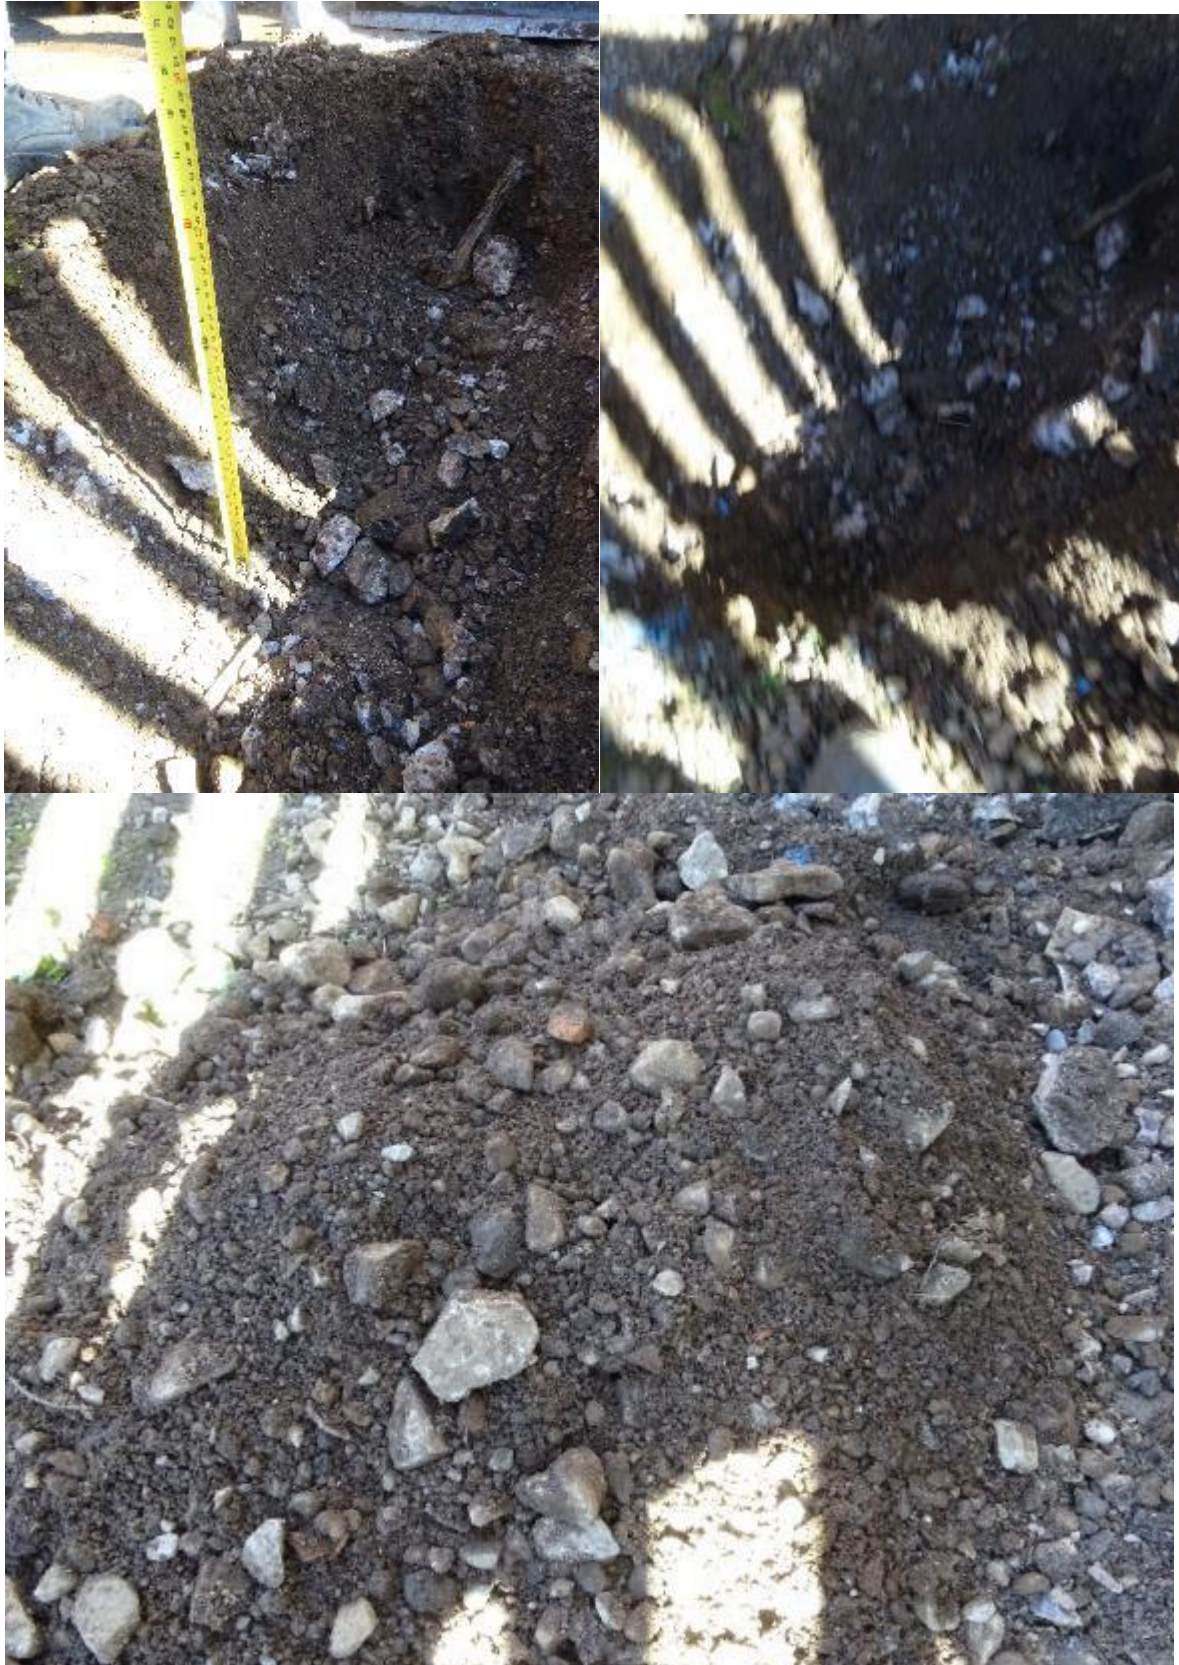
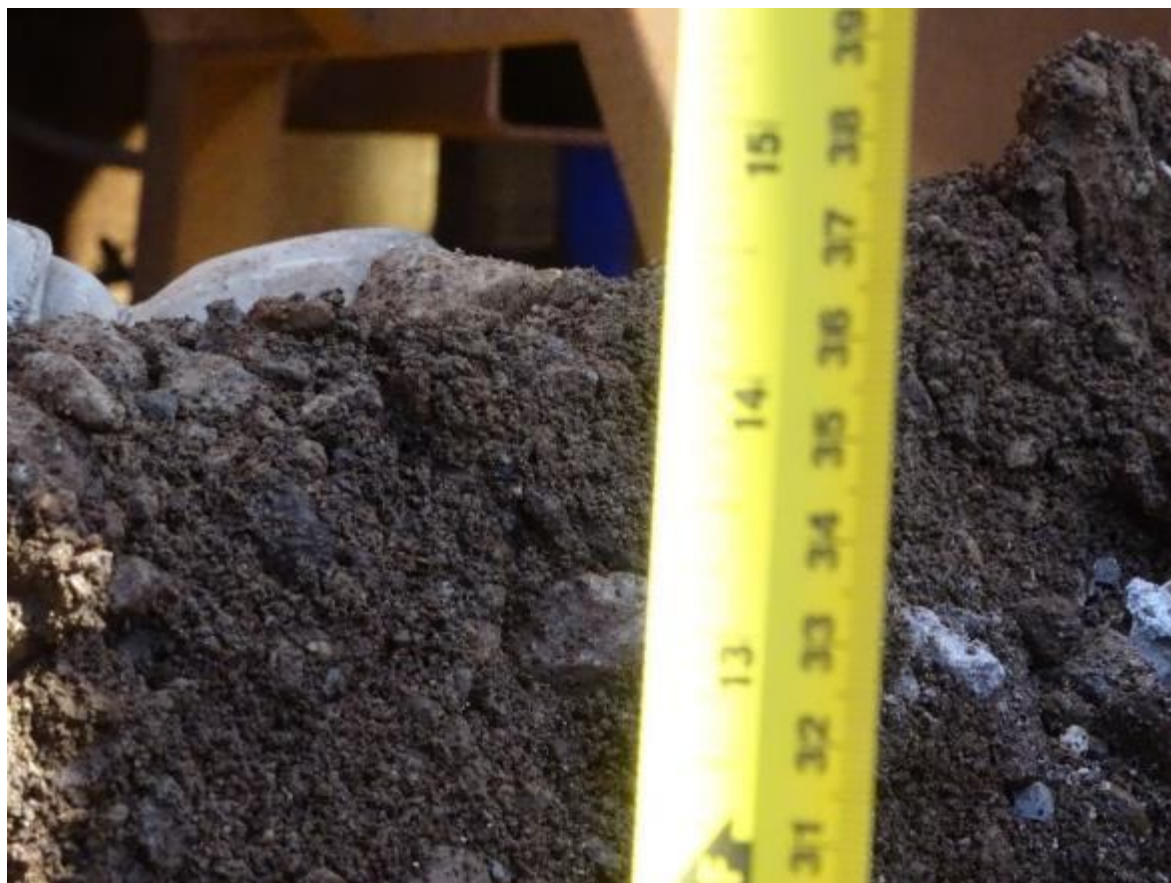
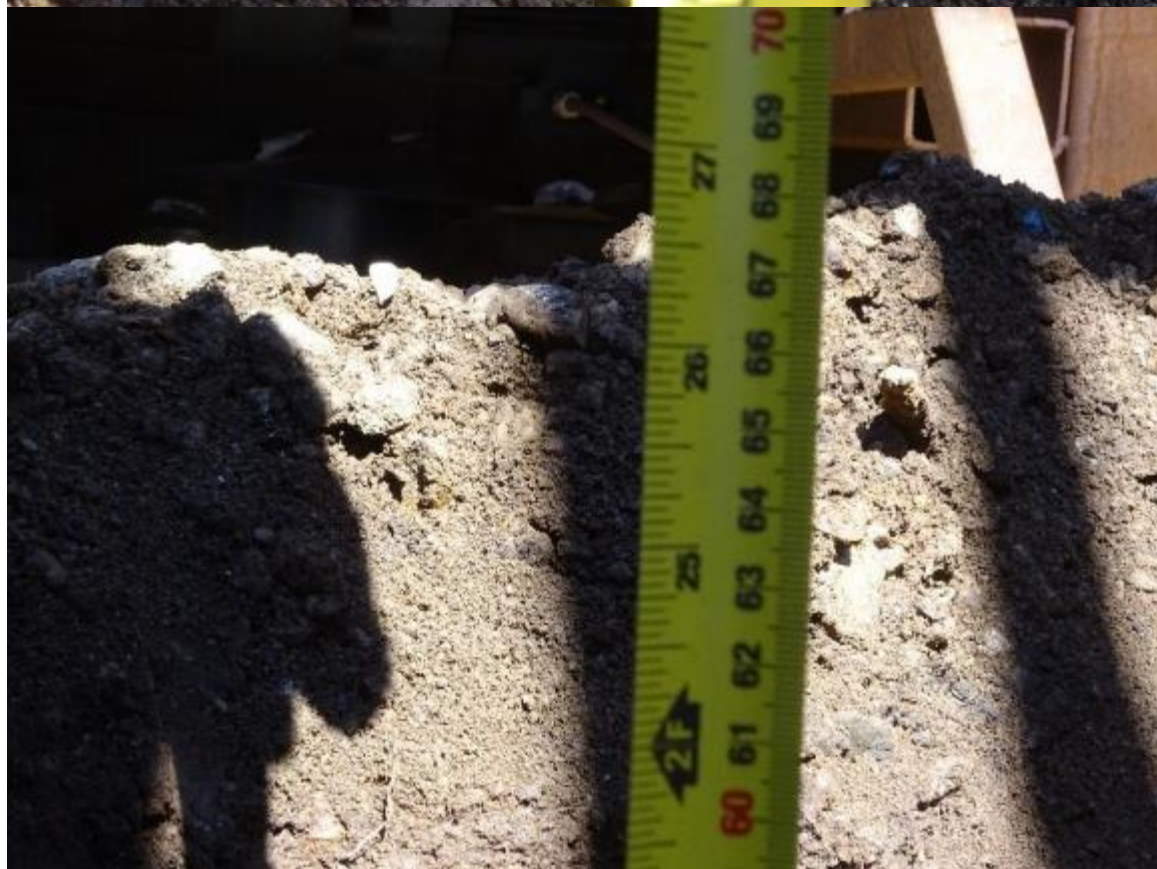
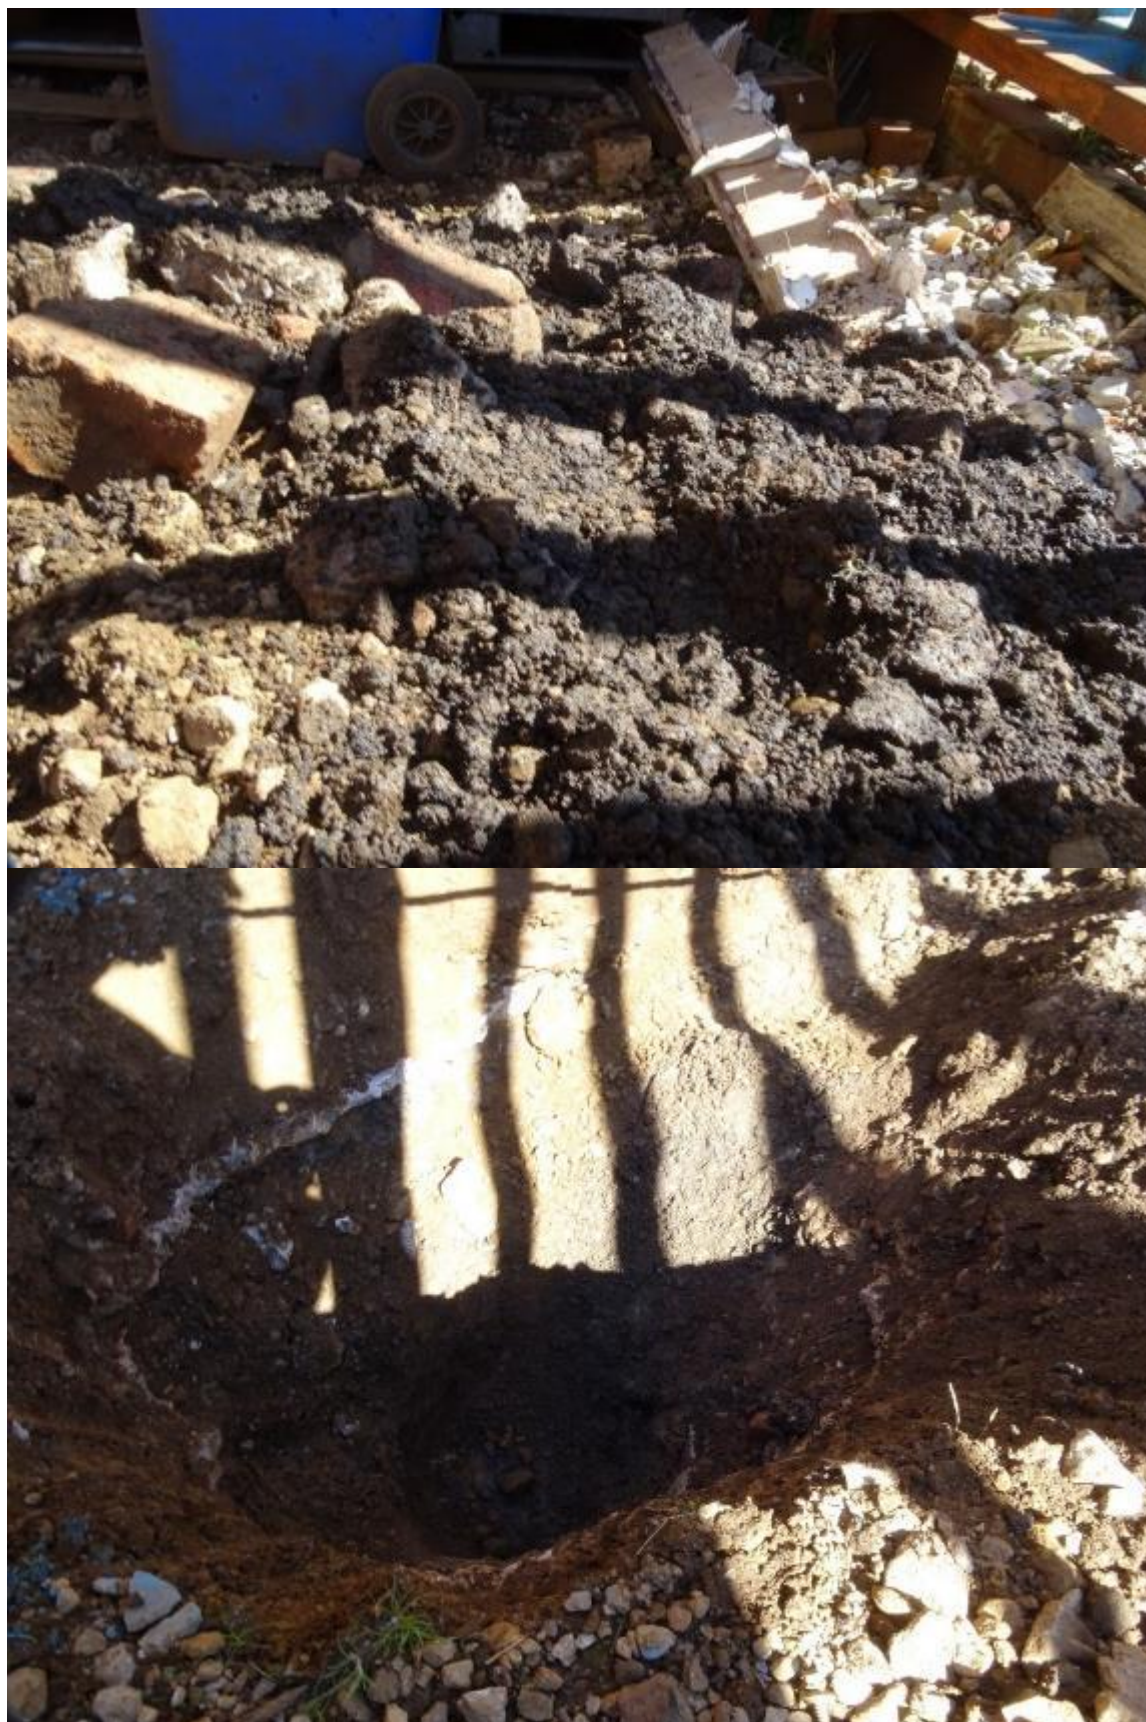
**Trail Pit 7 – Front southwestern corner**

Trail pit 7 located tot eh front of the main building in the southwest corner of the site. The surface consisted of broken concrete/stone, with sandy loam, gravel in the shallow layer. A further concrete base was uncovered at 400-450mm with sandy clay found below this.

| Trail pit 7 – | southwest boundary |
| 0.00-0.10m | broken concrete and stone. |

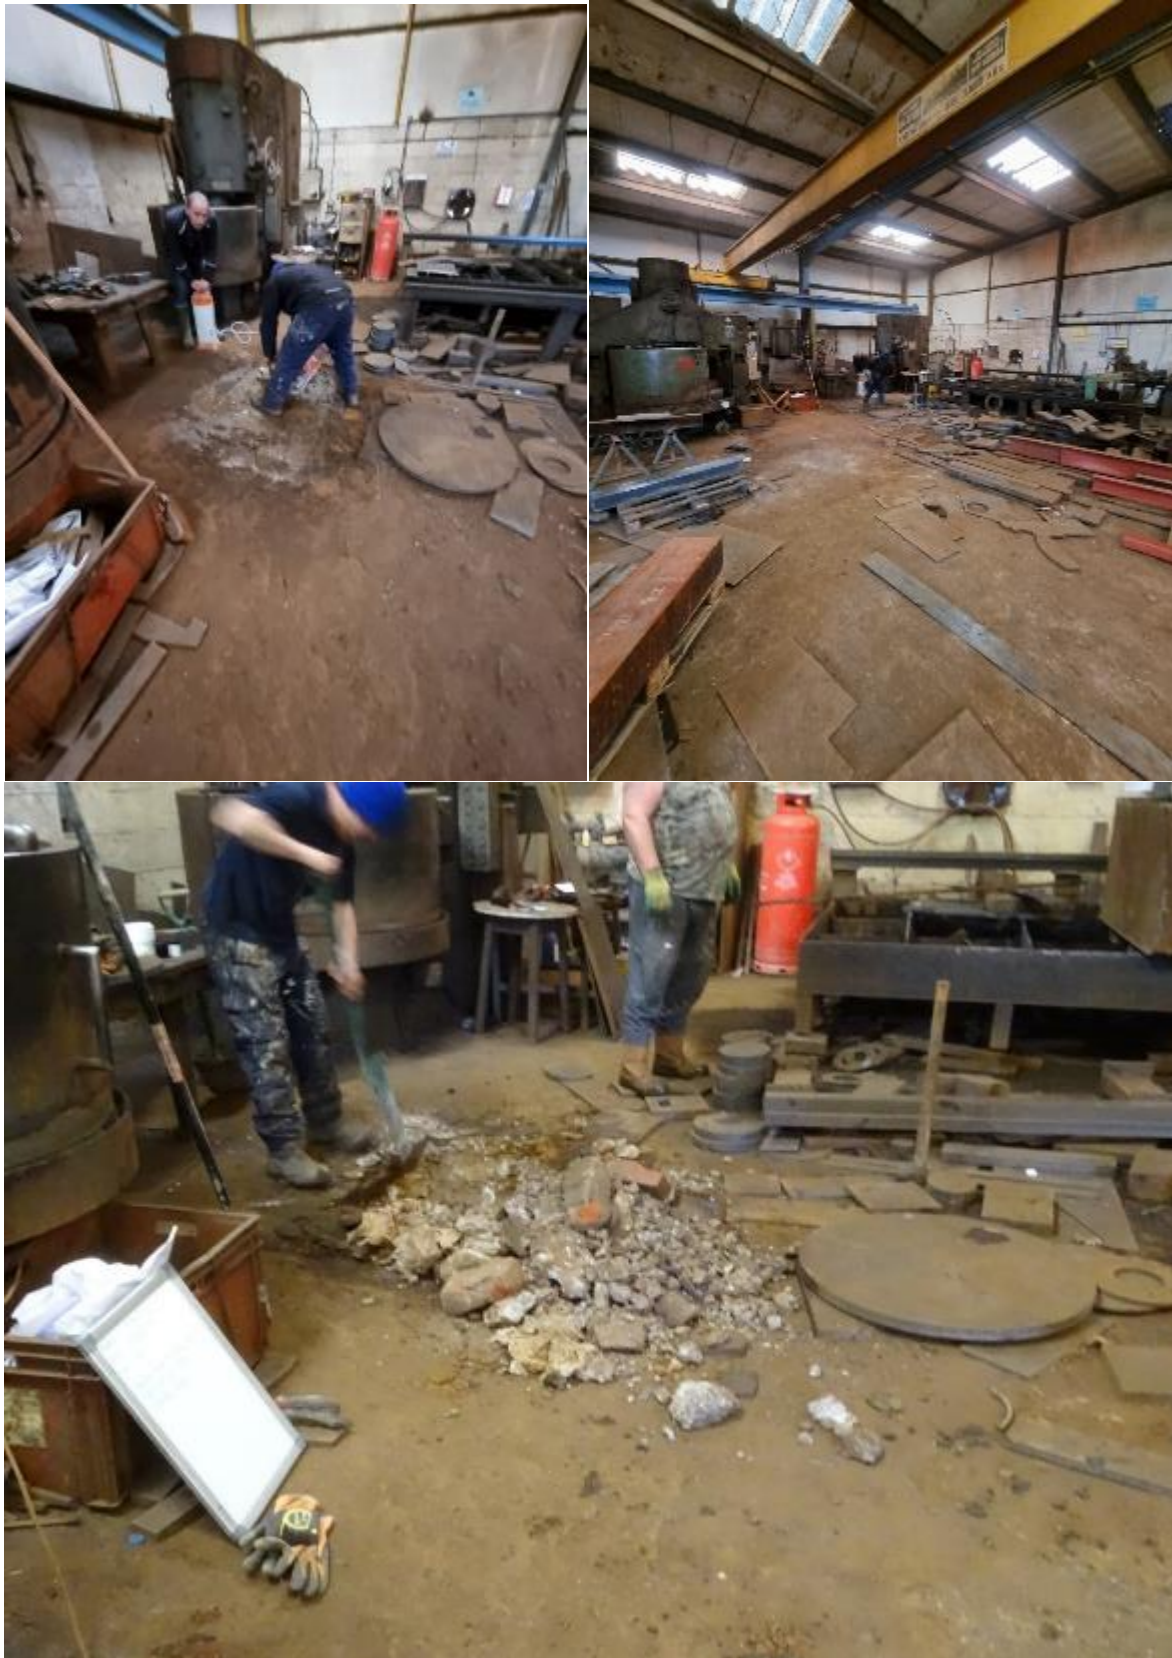
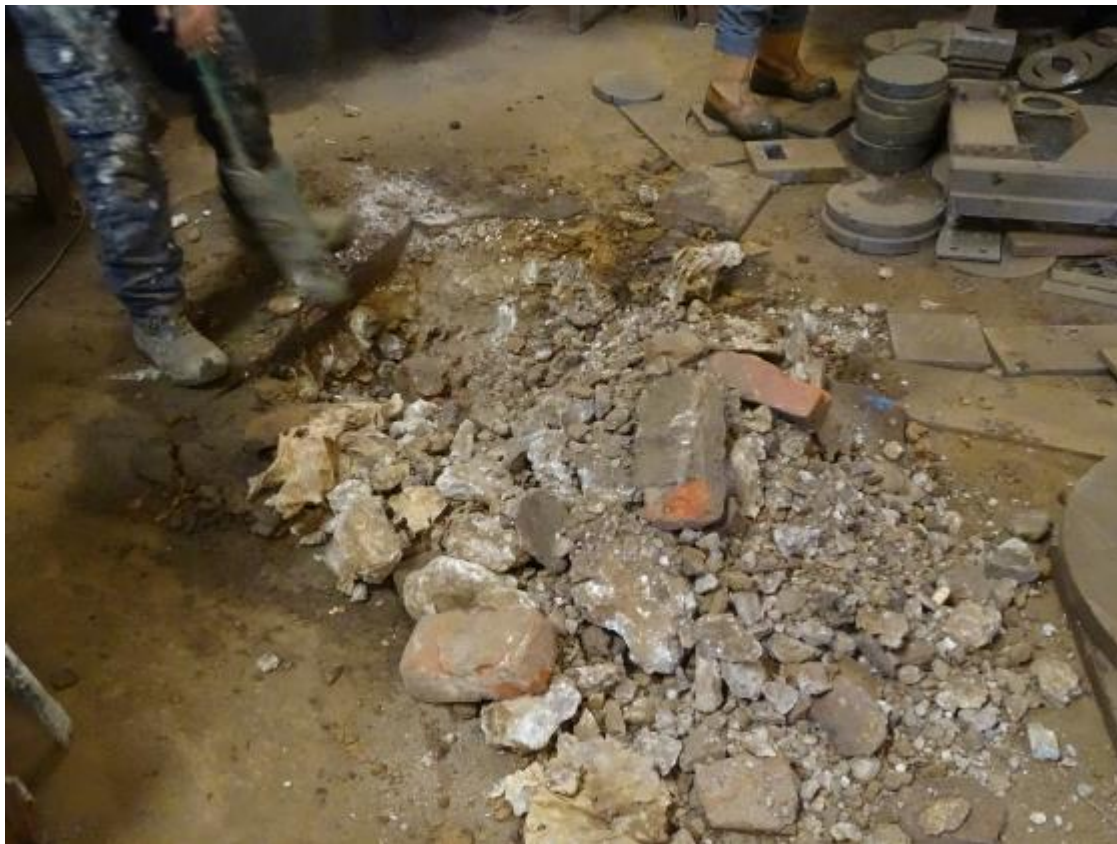
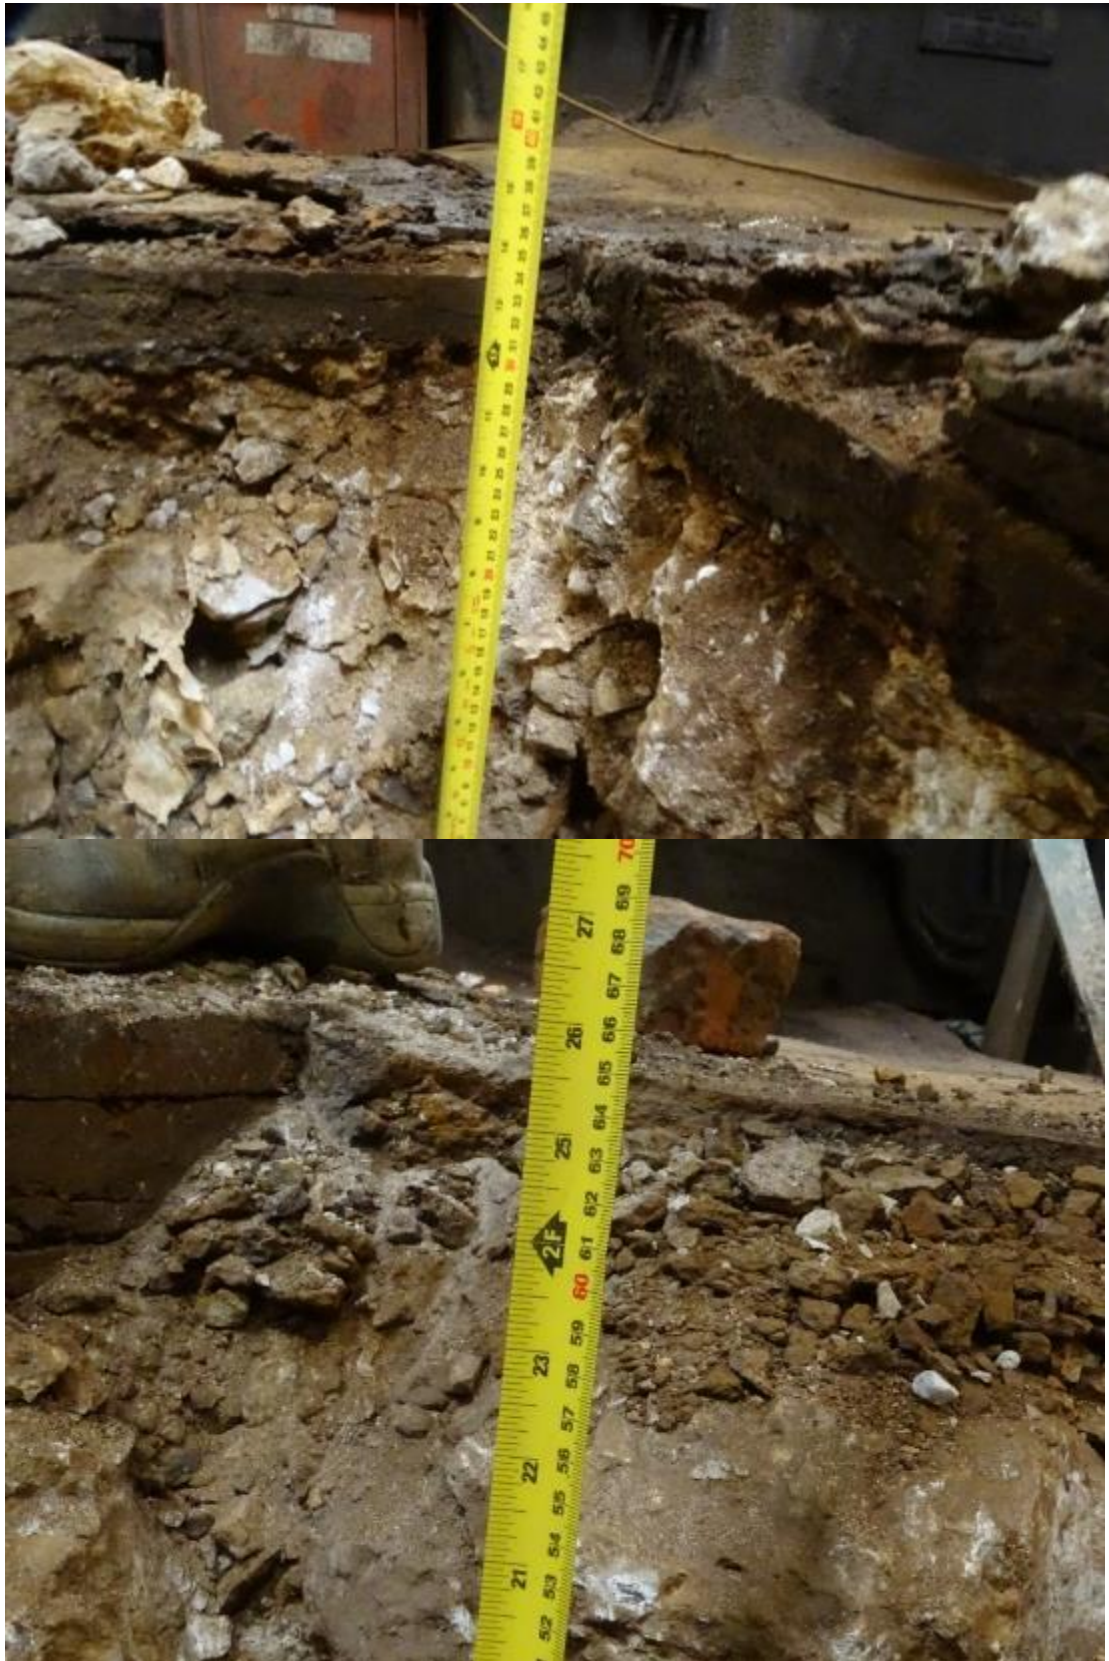
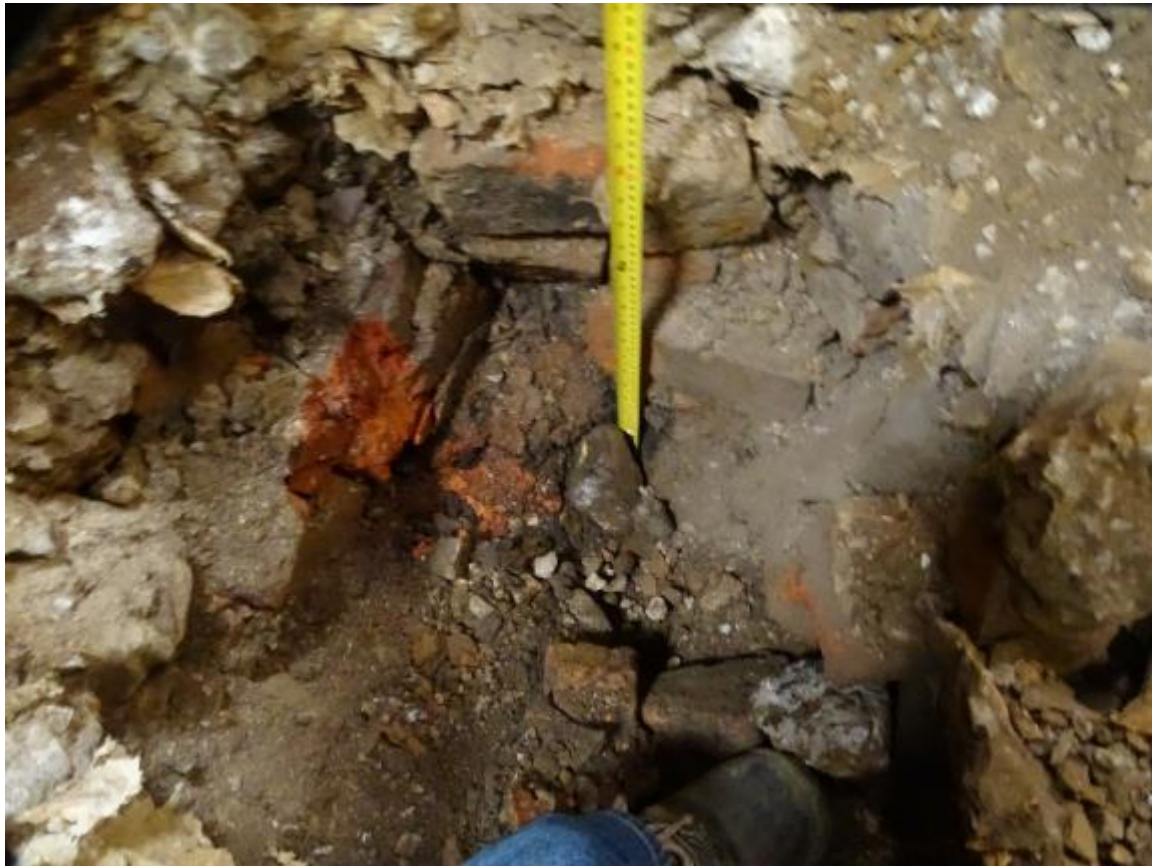
**Trail Pit 8 – Rear northwest corner of main building.**

| Trail pit 8 – | western building |
| 0.00-0.05m | concrete |
