Ref: 211108.L.003  
13 May 2022

**Re: Gas Membrane Validation – Sports Block, Belle Vue Coop Academy**

- **Belle Vue Coop Academy, Manchester M12 5AL**

Validation inspections have recently been carried out at the **Sports Block** (as shown in Enclosure 2) and details relating to the inspections are provided in the following table:

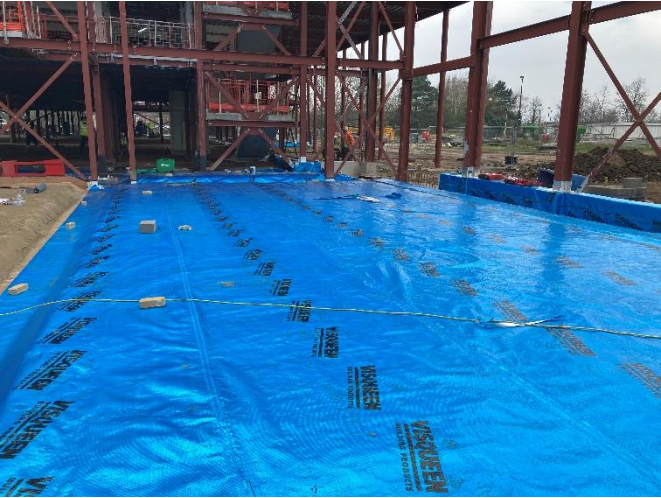
| 1. | View of area showing partial membrane installation. | |

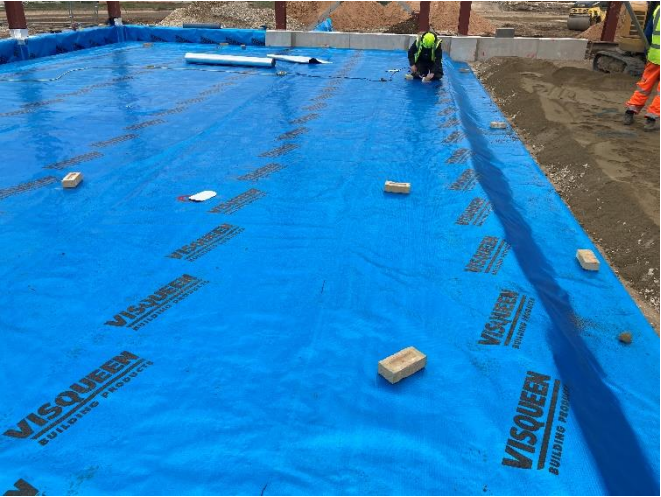
| 2. | View of area showing partial membrane installation. | |

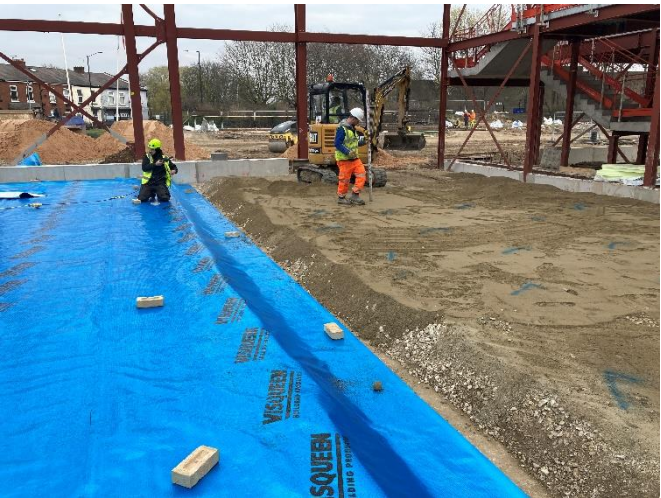
| 3. | View of area showing partial membrane installation. | |

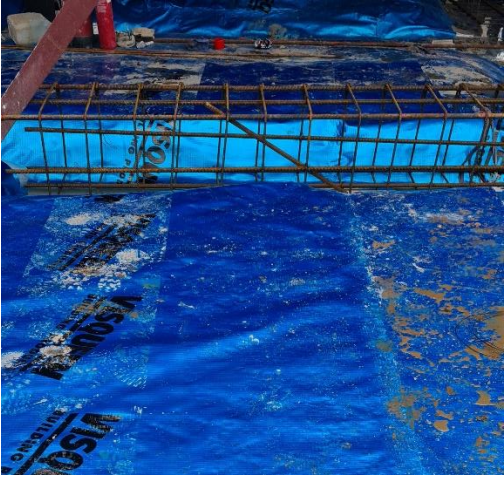
| 4. | View of the membrane installed in the remaining areas, in accordance with the Visqueen design. | |

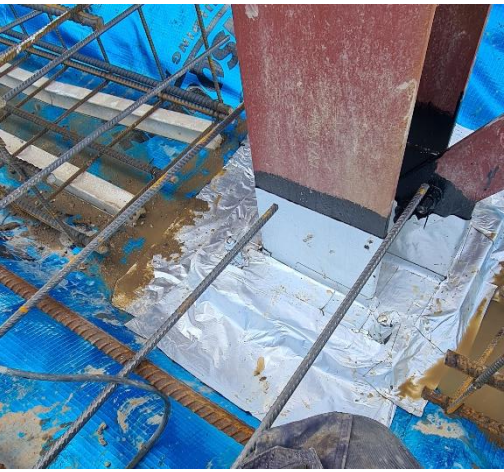
| 5. | View of a sealed stanchion, identifying the Visqueen design has been followed accordingly. | |

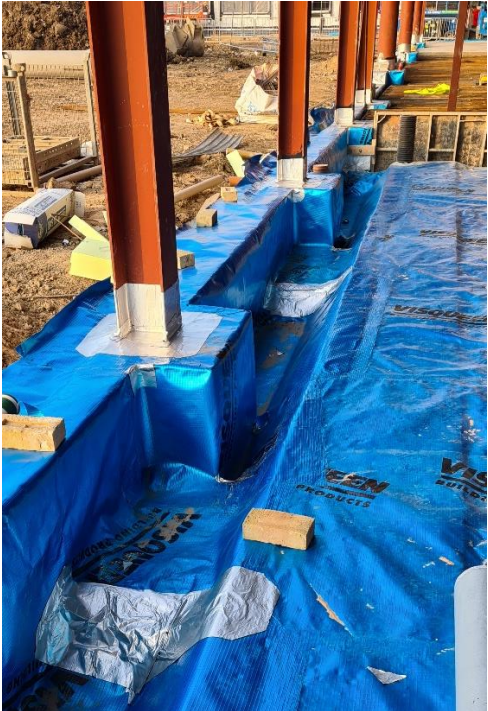
| 6. | View of the perimeter of the Sports Block showing the sealed stanchions, corners, etc. Dowel holes had not yet been sealed with Axiom in this area. | |

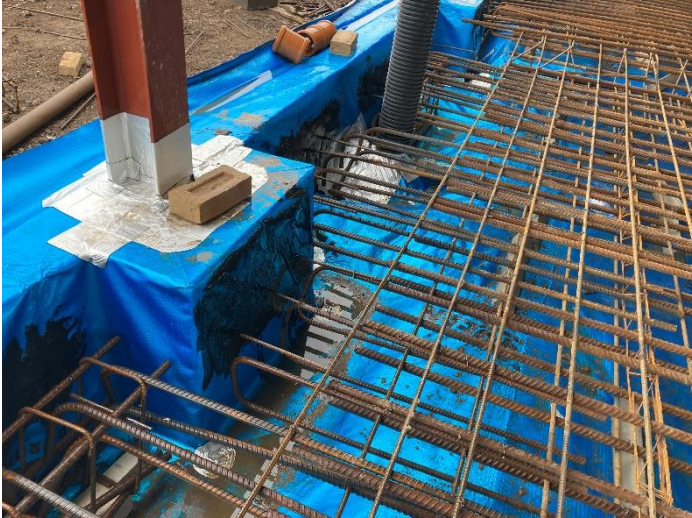
| 7. | View of the dowel holes within the gas membrane, sealed with Axiom. | |

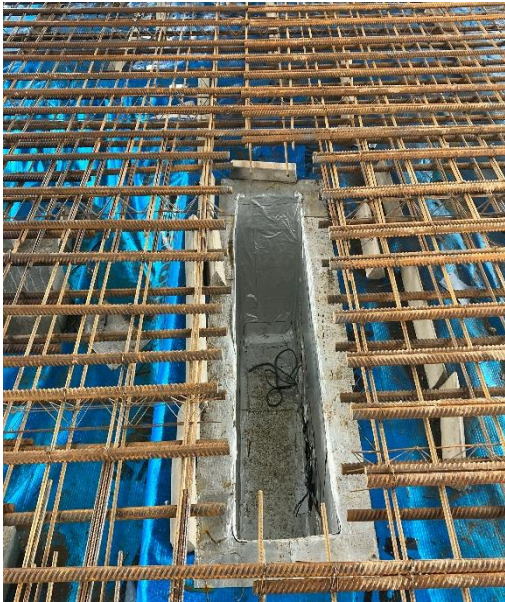
| 8. | View of the service entry pit, identifying the Visqueen design has been followed accordingly. | |

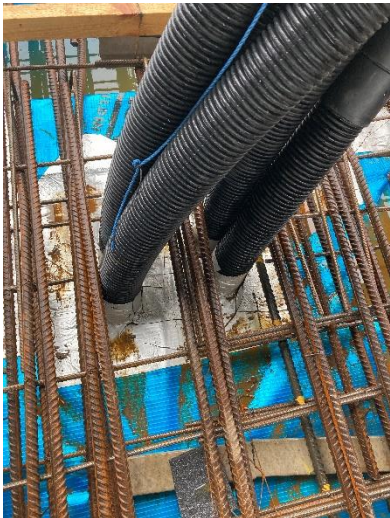
| 9. | View of sealed service entries. | |

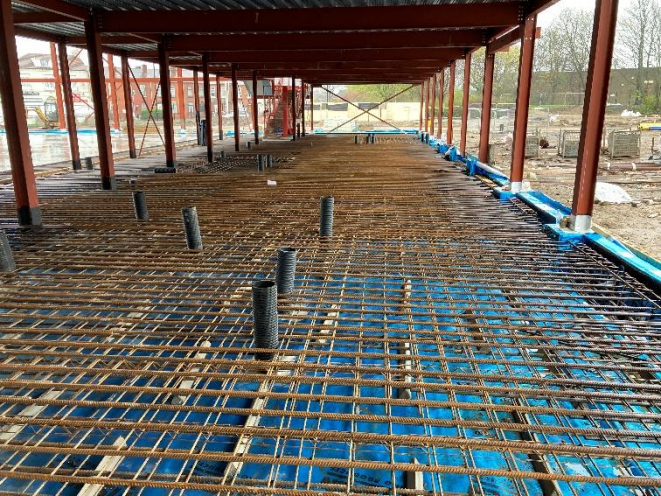
| 10. | View confirming Visqueen membrane installation across the entire footprint of the plot (beneath the steel works). | |

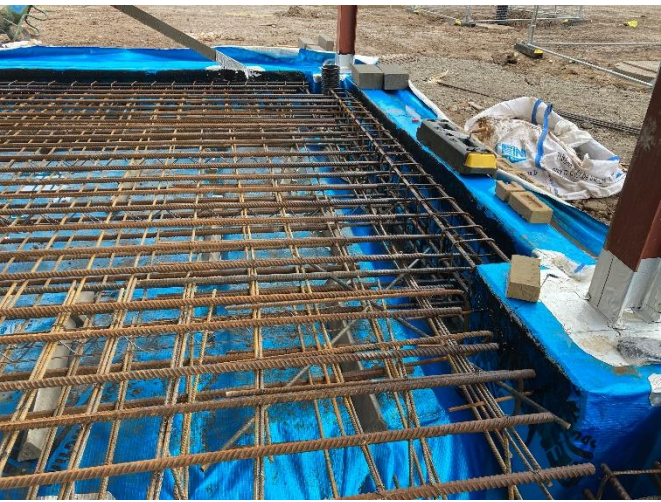
| 11. | View confirming stanchions have been sealed following the Visqueen design and dowel entries have been sealed with Axiom. | |

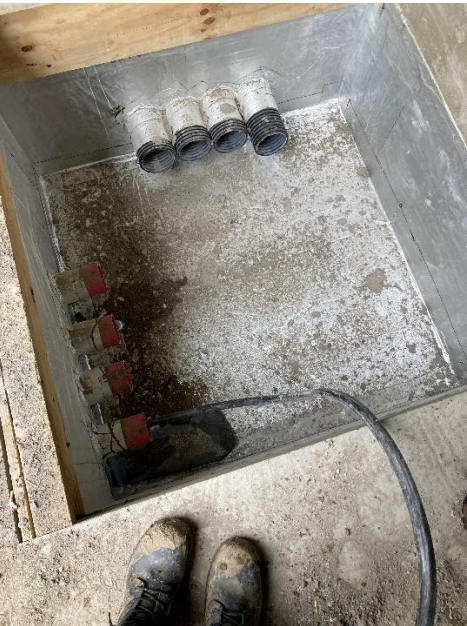
| 12. | View confirming sealing of service pit in accordance with the Visqueen design. | |

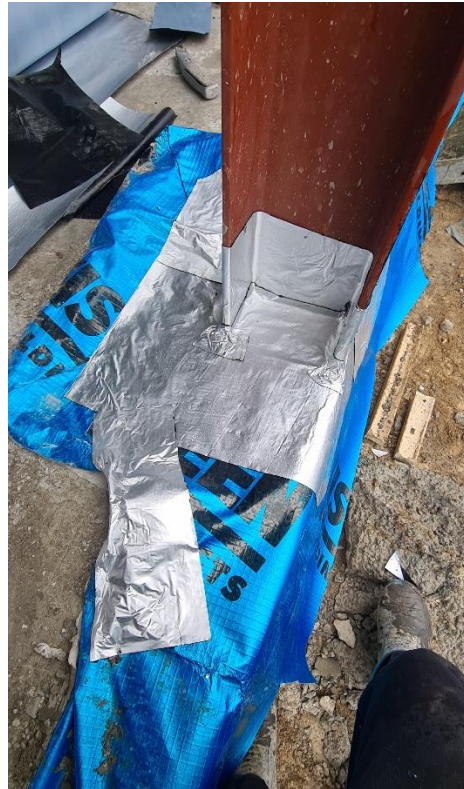
13.

View of a stanchion sealed following the site visit 5 April 2022.

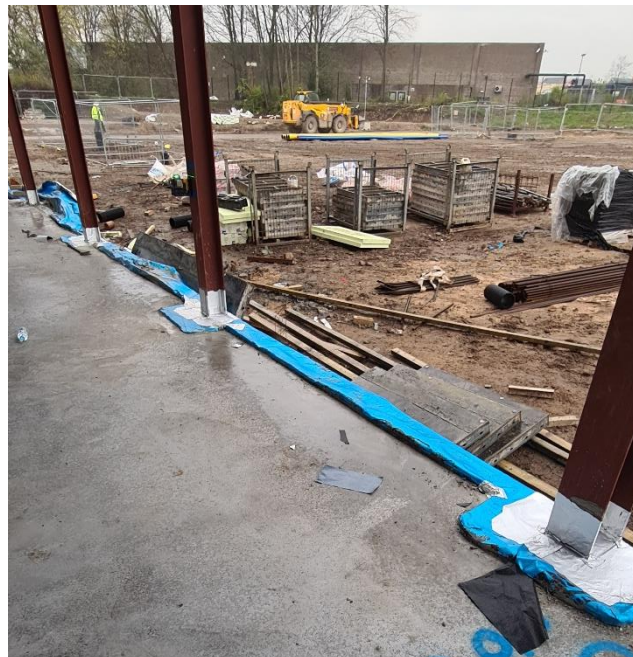
14.

View of a stanchions sealed following the site visit 5 April 2022.

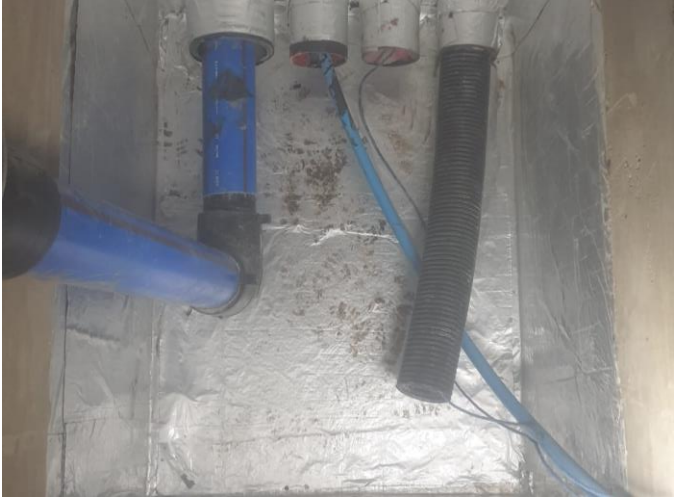
| 15. | View of the service pit sealed following the site visit on 5 April 2022. | |

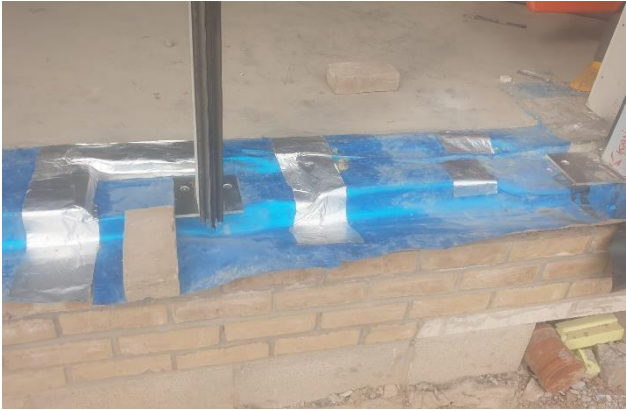
| 16. | View of repairs on the doorway of the Sports Block following the site visit on 5 April 2022. | |
