## Bituminous Interim Inspection

| <b>PROJECT NUMBER</b> | B190846/1 | <b>AREA MANAGER</b> | John Wilkinson |
| <b>PROJECT NAME</b> | Paterson Building - Christie Hospital | | |

| <b>INSPECTED BY:</b> | Anthony Symondson | <b>Date:</b> | 25-02-2022 |

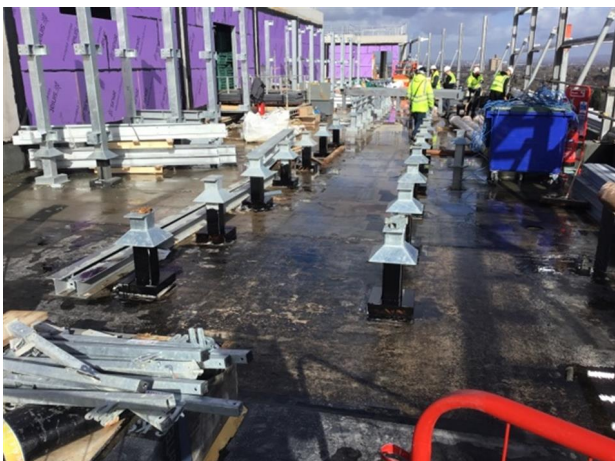
Photo 1 - View of level 9 section 2

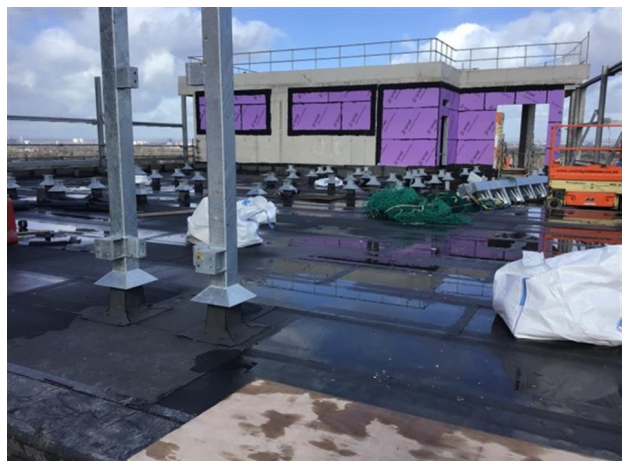
Photo 2 - View of progress to section 3

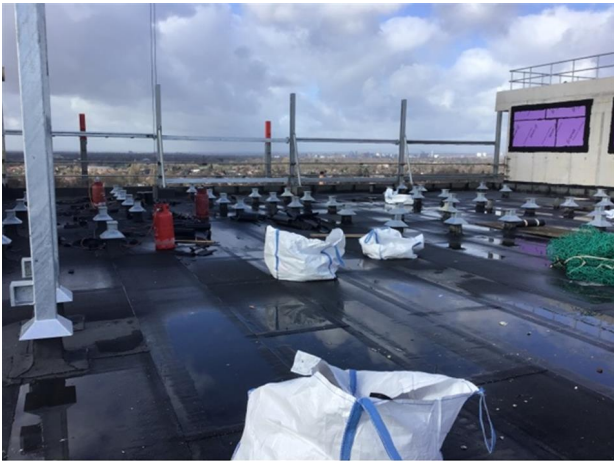
**Photo 3 - View of progress to section 3**

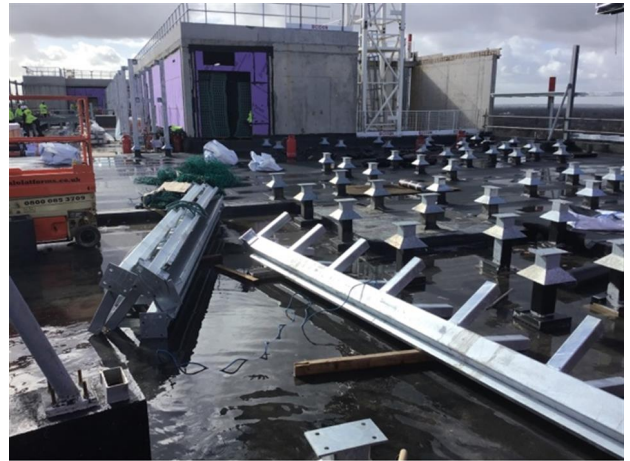
**Photo 4 - Overview of section 3**

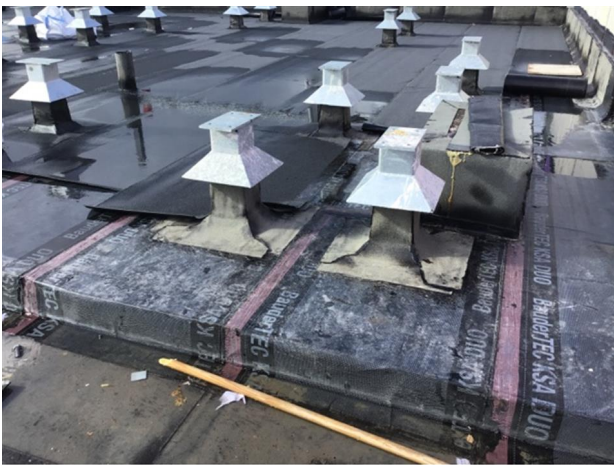
**Photo 5 - View of second underlay layer to steel posts**

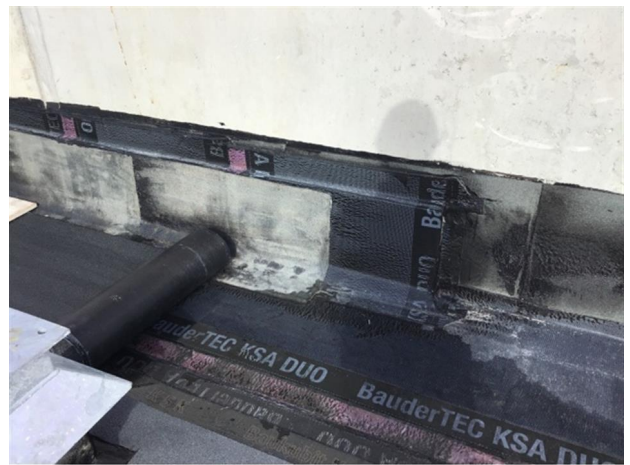
**Photo 6 - View of build up to up stands**

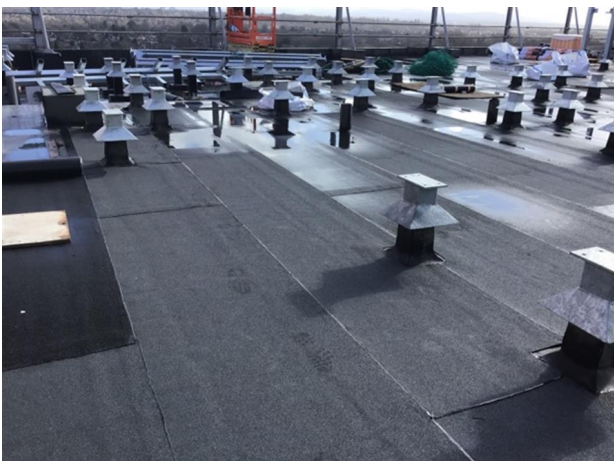
**Photo 7 - View of cap sheet to section 3**

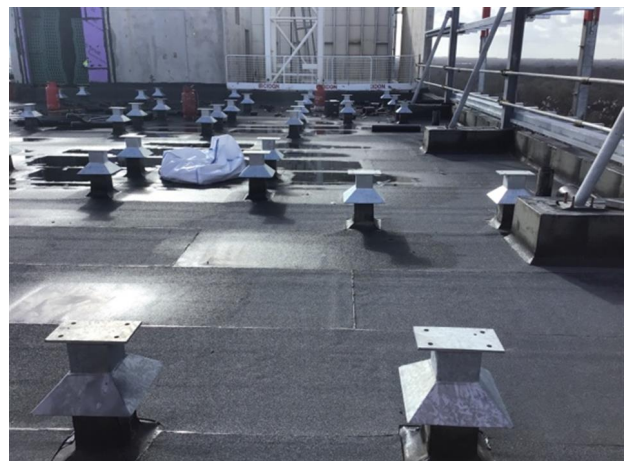
**Photo 8 - View of cap sheet to section 3**

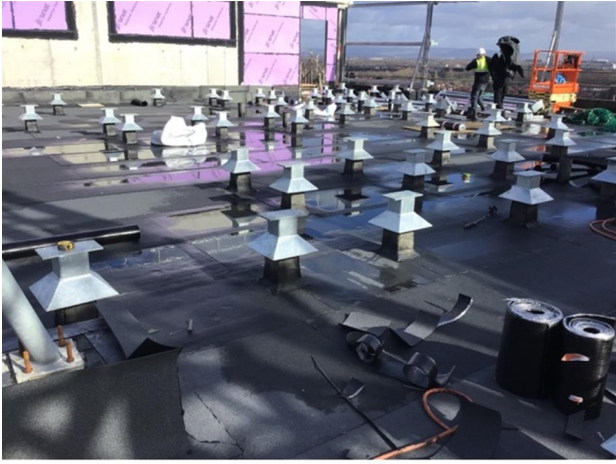
**Photo 9 - Overview of level 9 section 3**

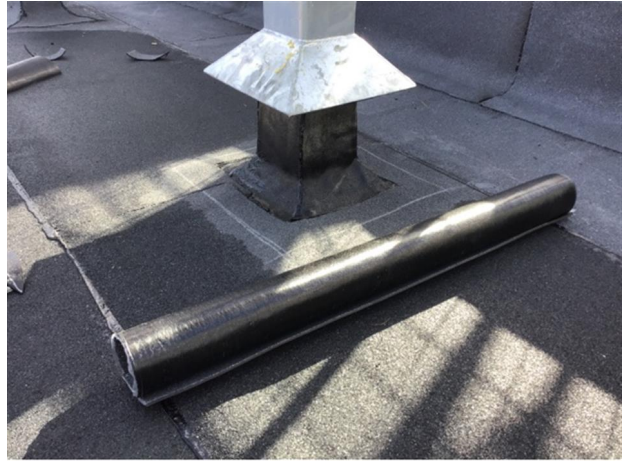
**Photo 10 - View of second underlay layer to steel posts**

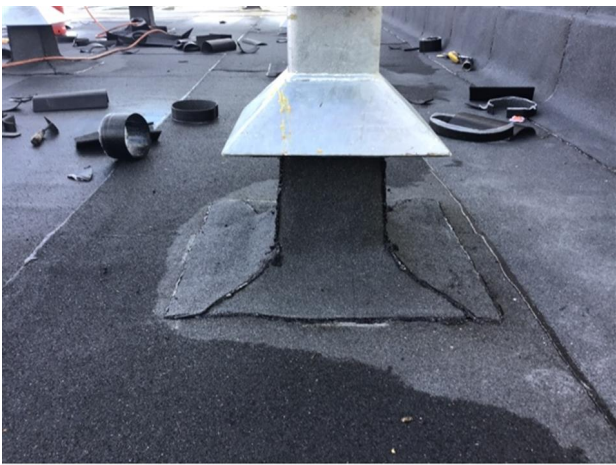
**Photo 11 - View of cap sheet to posts**

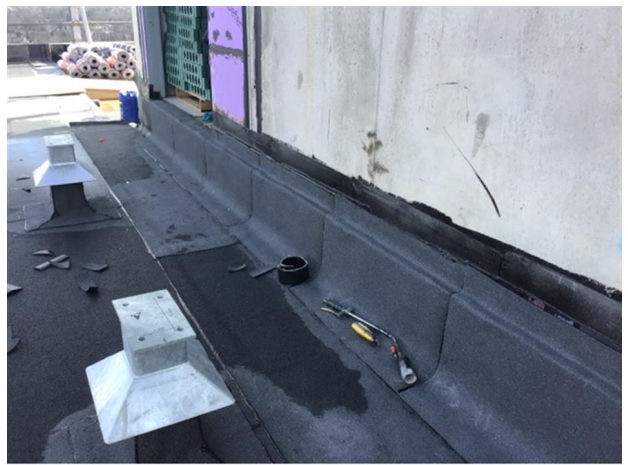
**Photo 12 - View of cap sheet to up stand**

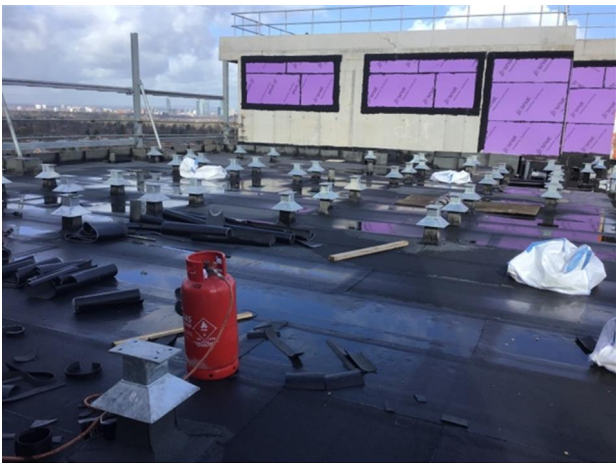
**Photo 13 - Overview of level 9 section 3**

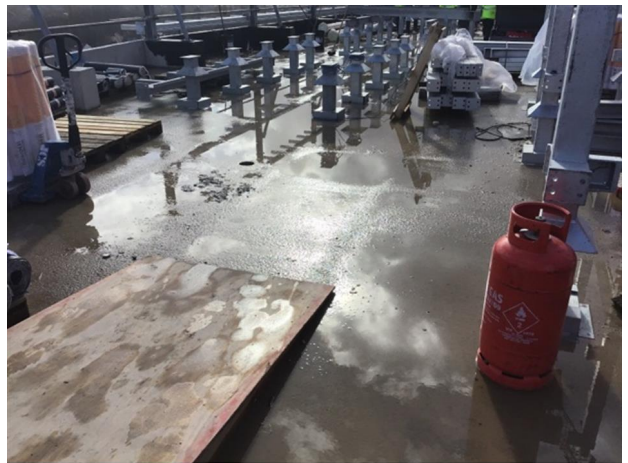
**Photo 14 - View of level 9 section 2**
