**St Margarets Chambers**  
For Charlotte Street Estates

Lightwell Elevations -  
Proposed Repairs and  
Conditions 1/2

scheme 1907  
drwg no. **P(236)**  
revision

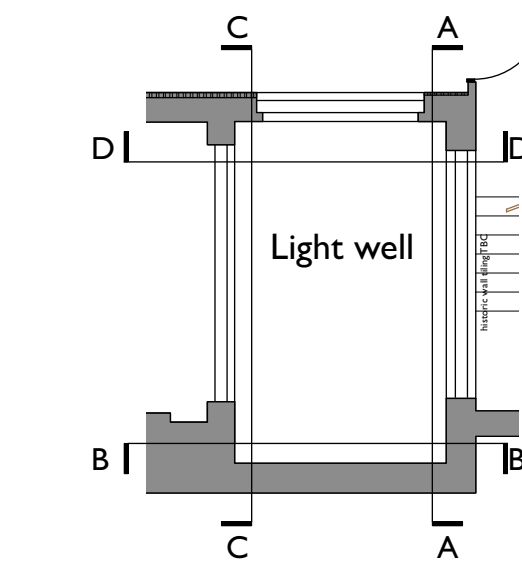
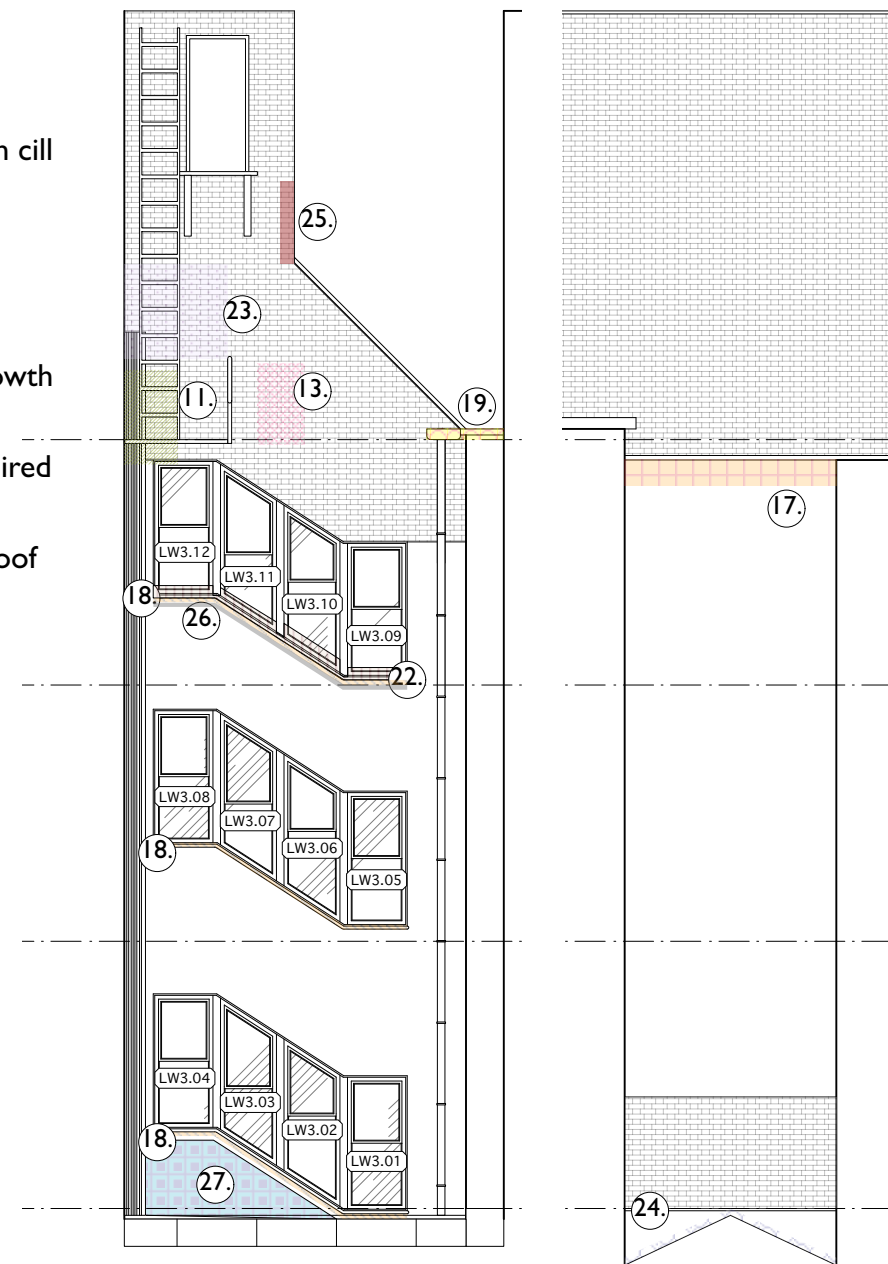
- 1 Sandstone erosion - close inspection required.
- 2 Holes left by redundant fixings - mortar fill in accordance with specification.
- 3 Gaps in brickwork. Close inspection required to inform replacement with matching material.

- 4 Missing pointing between frieze panels. Reinststate in accordance with specification.
- 5 Redundant plant equipment carefully remove and make good fabric in accordance with specification.

- 6 Eroded sandstone coping. Close inspection required. Replacement matching stone inserts may be required to prevent further deterioration.
- 7 Rusting lintels Clean off and repaint in accordance with specification.

- 8 Biological growth to be removed from roof level.
- 9 Coping water staining. May require repointing. Close inspection required.
- 10 Previous repairs to sandstone. Poorly matched aesthetic and presumed composition, but no evidence repairs are causing damage to surrounding historic fabric. Add to building maintenance plan for regular monitoring.

- 11 Biological growth to stone to be cleaned in accordance with specification.
- 12 Water staining may be caused by missing pointing. Close inspection required to inform repair strategy.

- 13 Signs of cracking. Further inspection required on site.
- 14 Redundant cables/lights/alarm box. Carefully remove
- 15 Residue from former sign to be cleaned off sandstone. Method pending site trials.

- 16 Existing timber to be carefully removed from brickwork

- 17 Clean off atmospheric dirt from glazed tiles
- 18 Redecorate cill
- 19 Clean-out gutters
- 20 Missing slate to be investigated once high level access provided
- 21 Repair and redecorate timber window frame and rotten cill
- 22 Clean concrete cill
- 23 Reinststate missing pointing
- 24 Inspect felt roof
- 25 Loose board and flashing to be repaired
- 26 inspect stone cill. Possible damage causing biological growth and staining to wall
- 27 Paint flanking and signs of damp further inspection required

Allow for the renewal of gutters and rainwater outlet to roof
