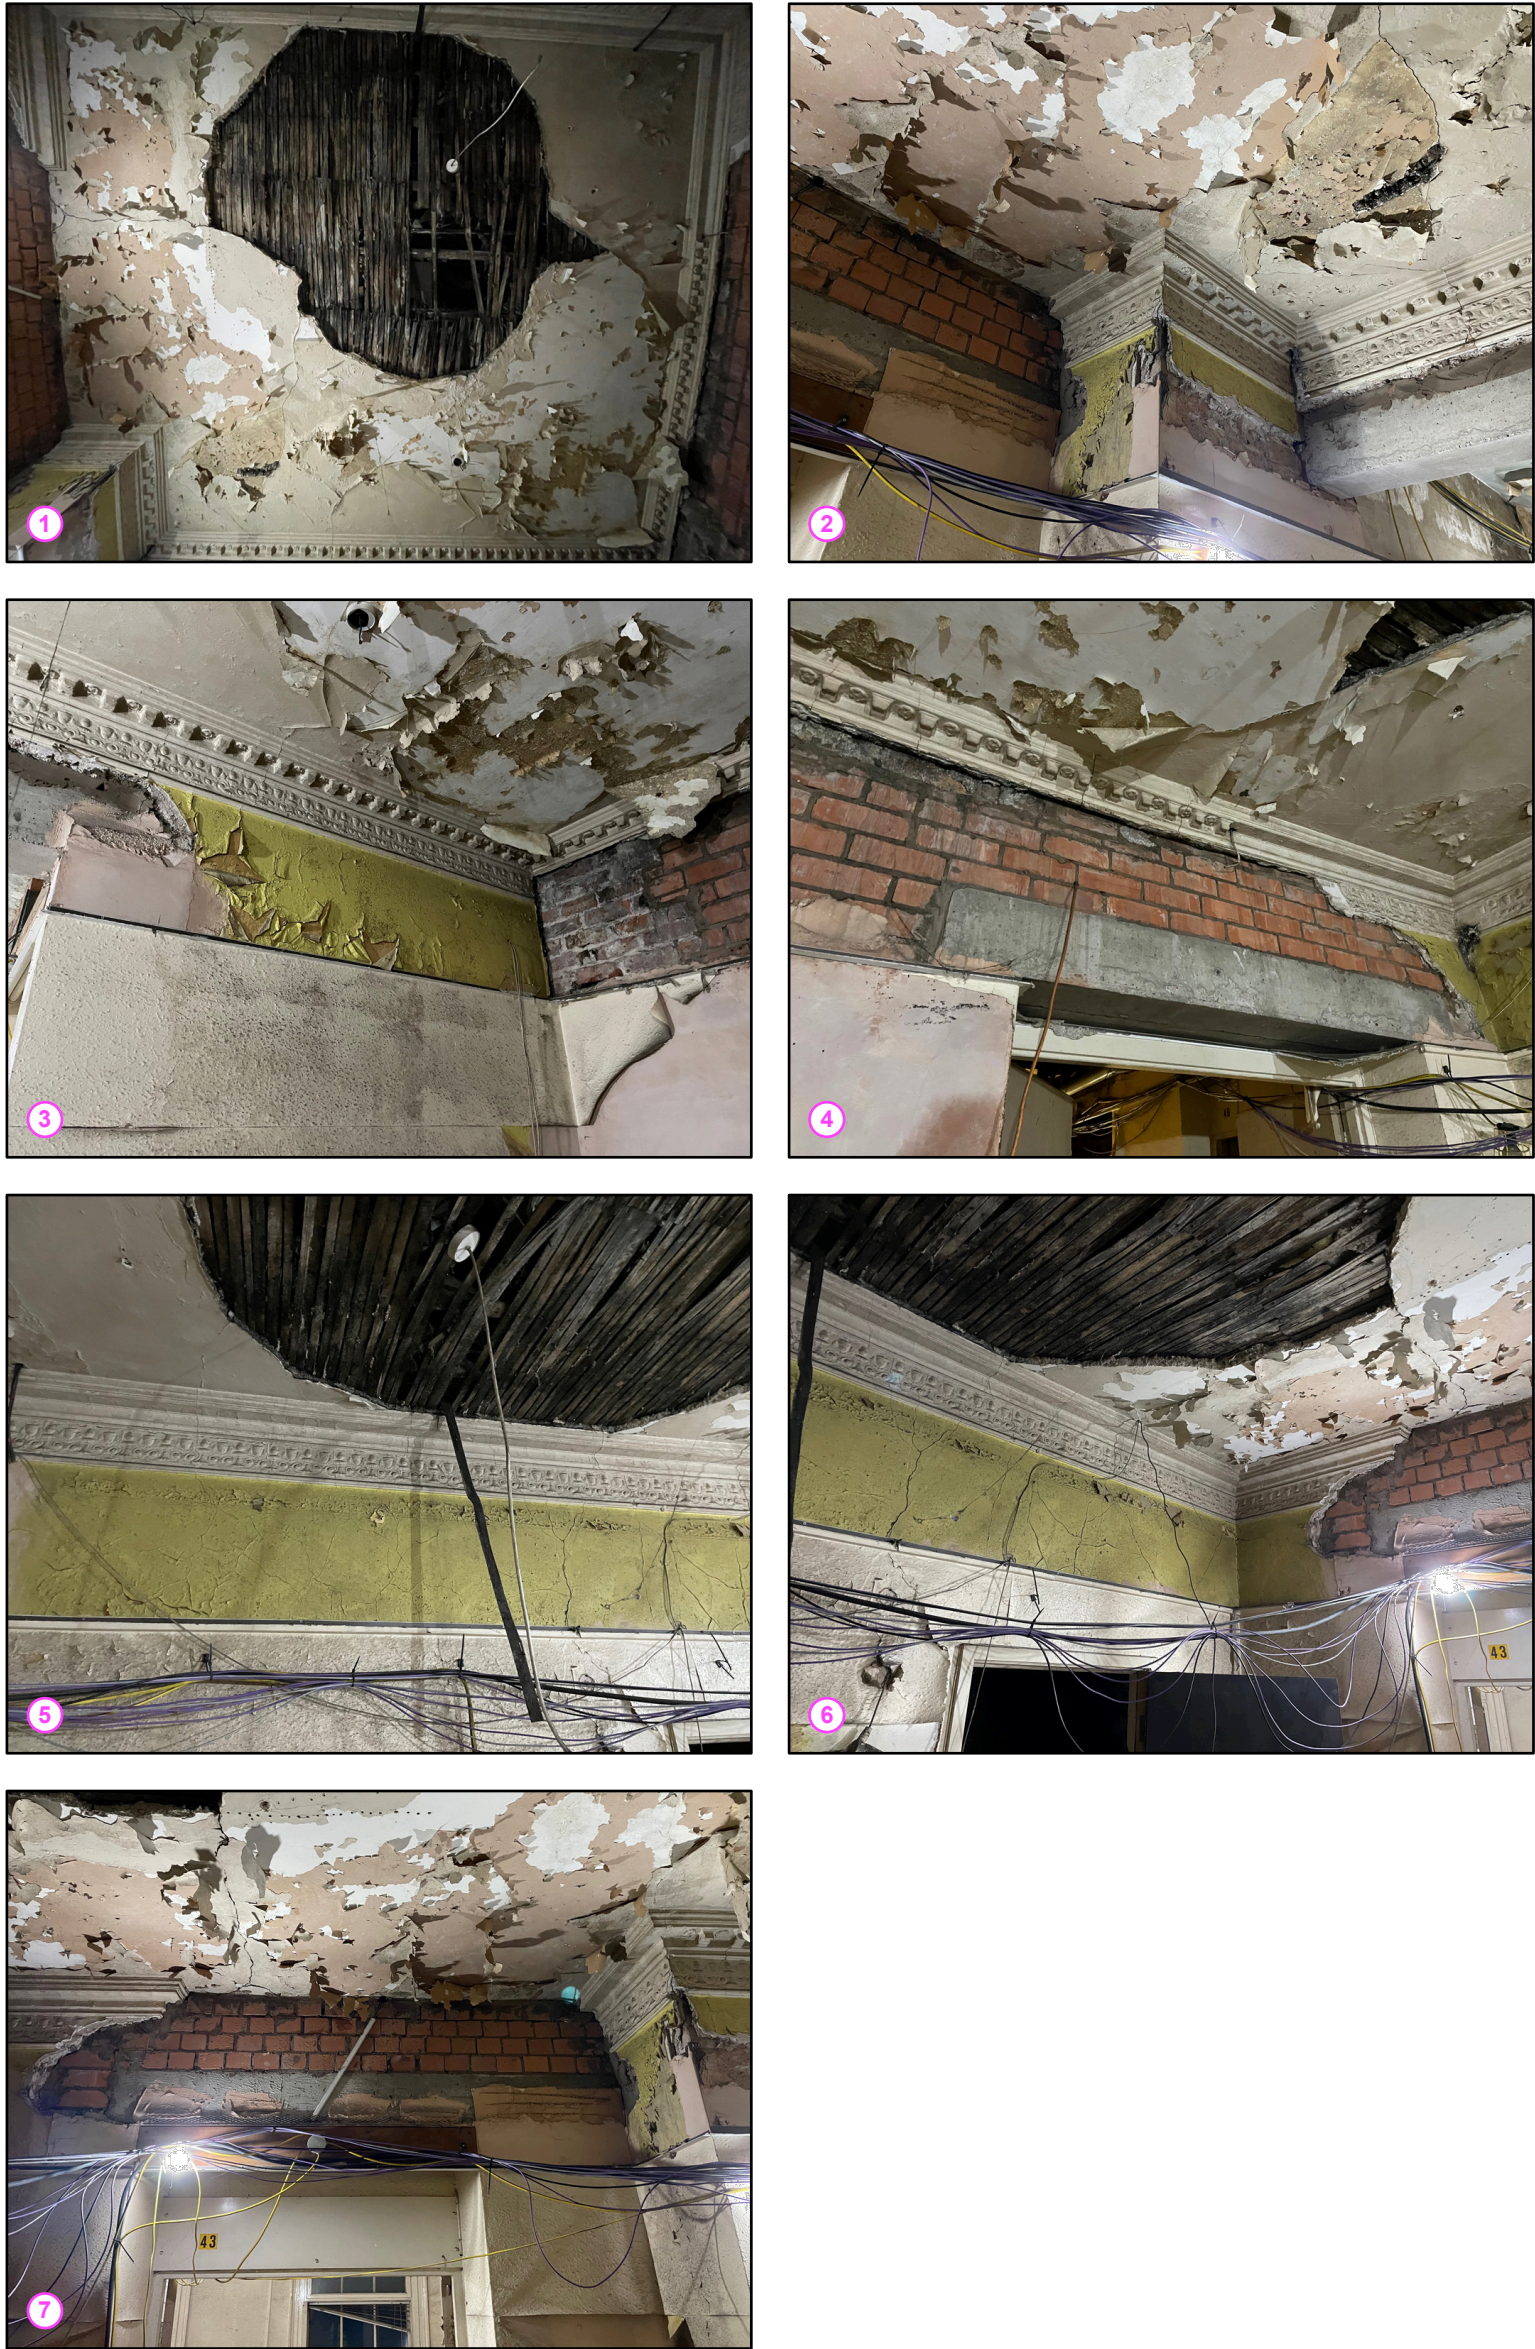
ROOM F.21

- Cornice as noted on the plan
- Some of the cornice is damaged and/or missing
- Partially collapsed ceiling as noted on the plan
- Plasterboard ceiling
- Bad water damage to ceiling

existing lathe and plaster ceiling  
to be underboarded  
[with 2 layers of fire board]  
existing cornice to be retained  
repaired as necessary  
[where cornice is missing  
remold will take place]

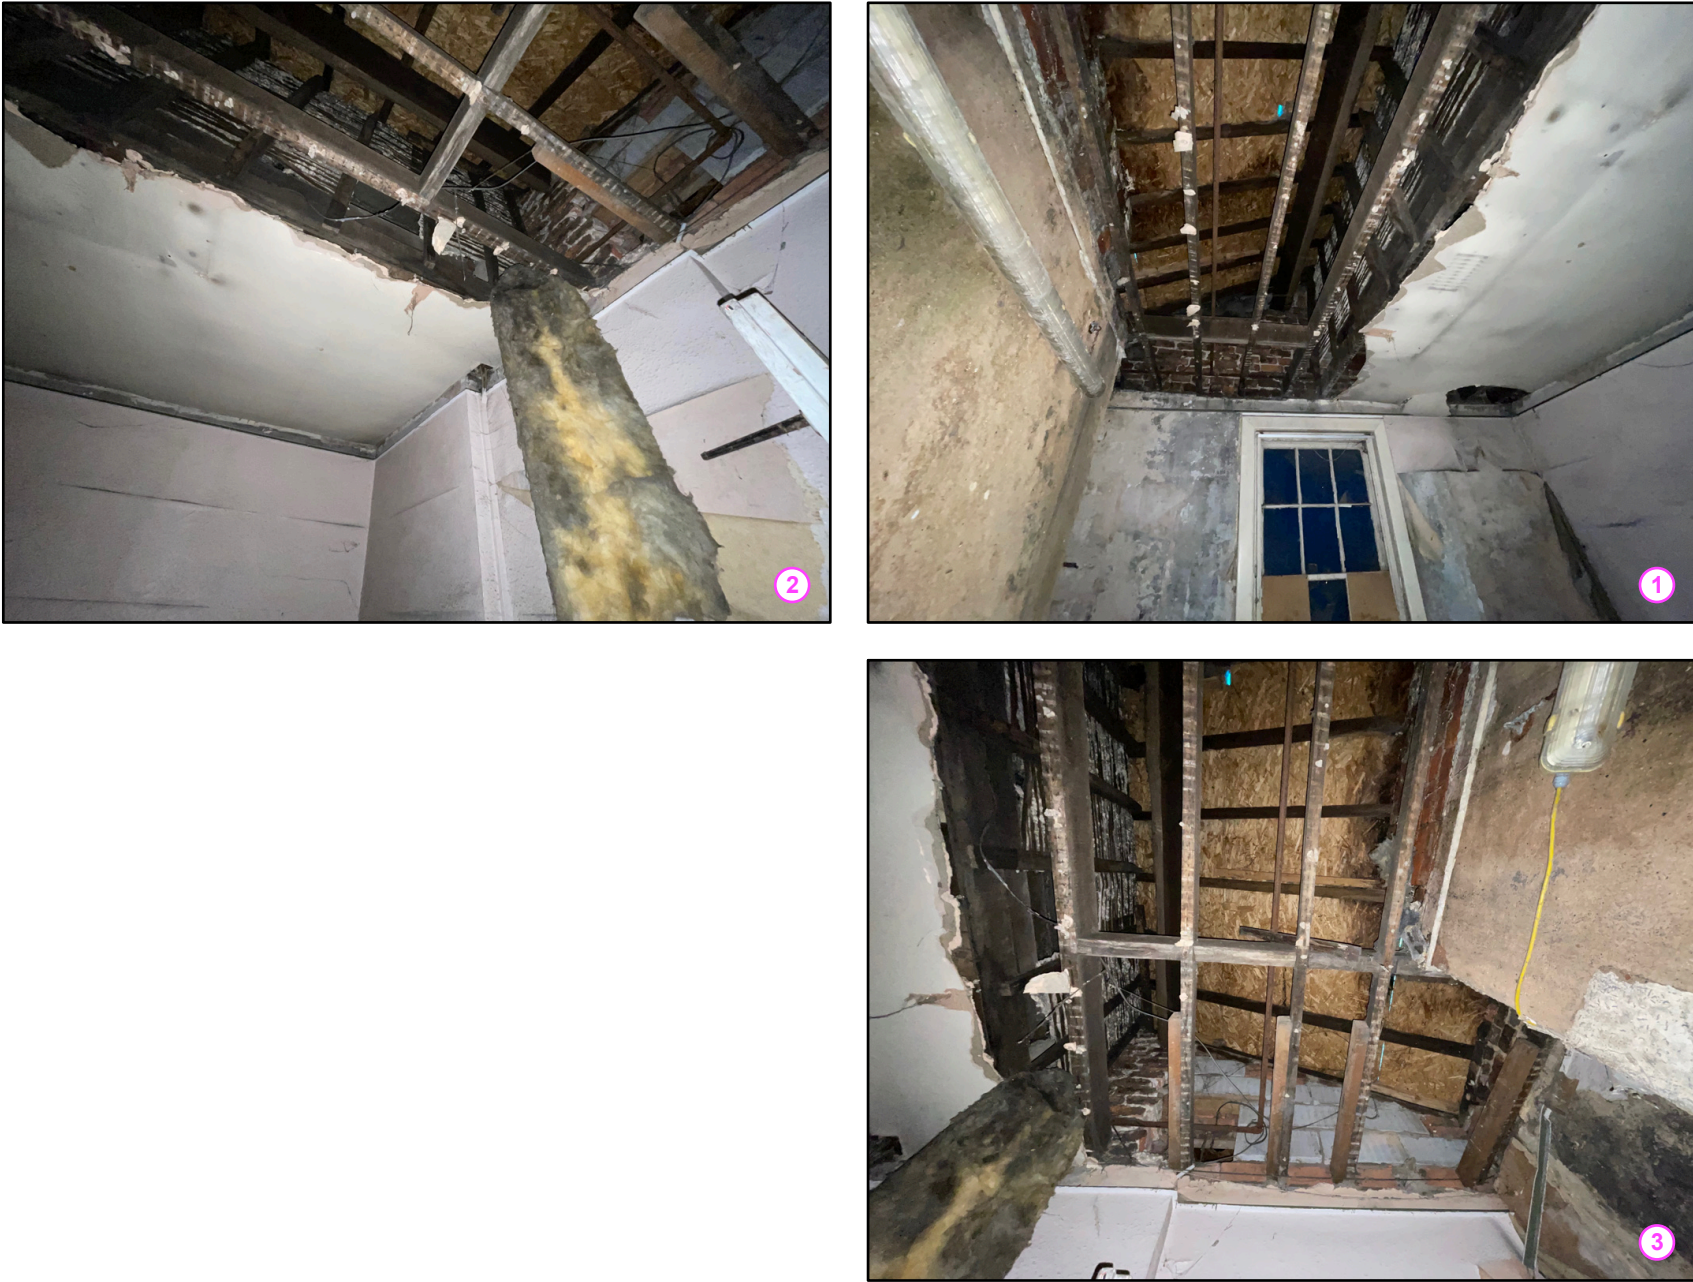
ROOM F.22

- Restricted access - Room is inaccessible due to collapsed ceiling and/or unsafe floor structure
- No cornice
- Most of the ceiling has collapsed - the rest looks damaged

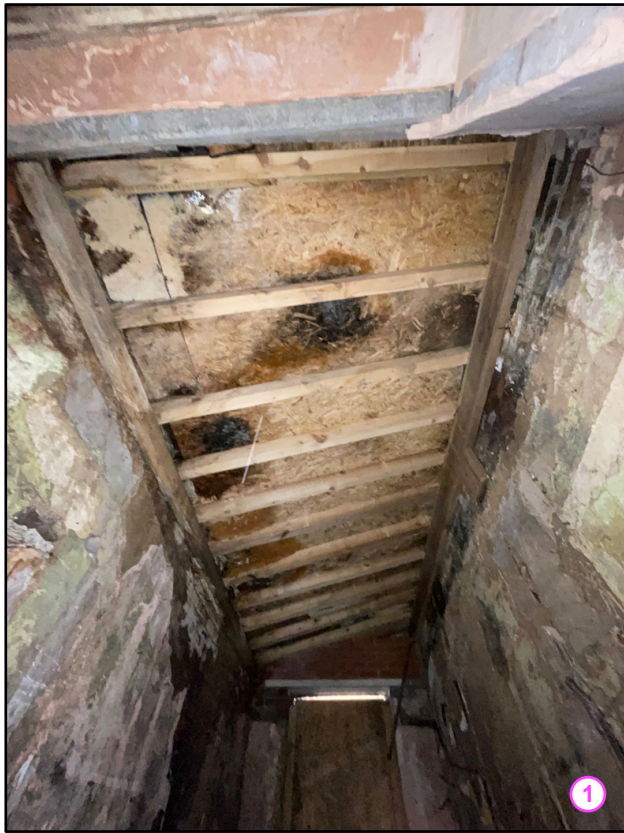
ROOM F.23

- Restricted access - Room is inaccessible due to collapsed ceiling and/or unsafe floor structure
- No cornice
- Ceiling has collapsed completely leaving exposed the timber rafters above
