# Albert Bridge House, Manchester

## Stage 1 Road Safety Audit Response Report

Curtins Ref: 080823-CUR-XX-XX-T-TP-00006  
Revision: P01  
Issue Date: 13 February 2023

### **Stage 1 Road Safety Audit**

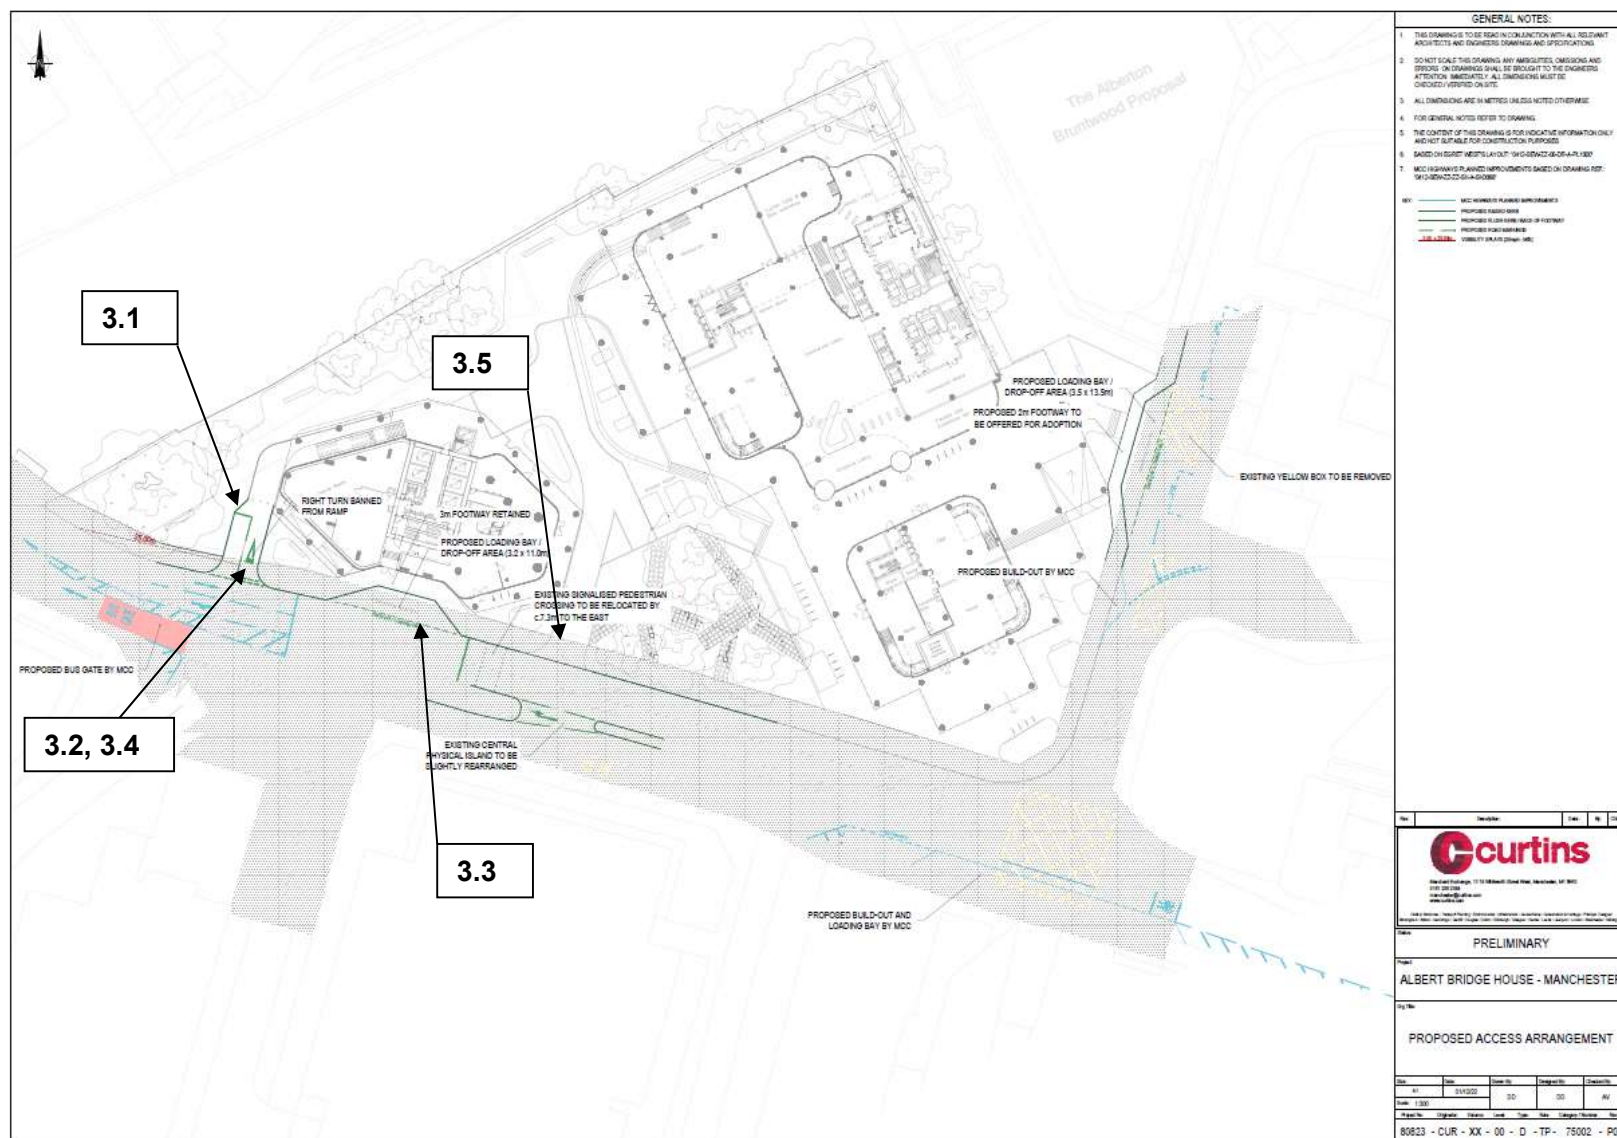
## **APPENDIX A: LOCATION PLAN**

- 1.12 All problems identified in this Road Safety Audit Report are indicated on a location plan in Appendix A

SUMMARY: Unclear whether storage capacity is adequate. Vehicles may overhang carriageway.

There appears to be signal control and a stop line for vehicles on the access ramp. Whilst the drawings state that the green light will be on default for ingress it is unclear whether there is sufficient storage space for more than one vehicle to enter and wait at the stop line should vehicles be exiting, or whether this scenario would emerge.

If this space is insufficient vehicles may overhang the carriageway of Bridge Street in possible conflict with through traffic. Waiting vehicles also may obscure the nearside traffic signal leading to possible junction conflicts, or pedestrians may cross between waiting vehicles, leading to possible conflicts with traffic exiting.

SUMMARY: Ramp may be difficult for vehicles to exit.

It is unclear the gradient of the ramped access to the development site, or whether there is a level dwell area in advance of the give-way line before vehicles enter Bridge Street. Should vehicles have to set off on a slope they may struggle to accelerate as anticipated or accept gaps in traffic safely. This could lead to emerging type conflicts.

SUMMARY: Visibility to traffic signals on exiting layby.

The signal-controlled crossing to the immediate east of the proposed service layby on Bridge Street is to be relocated. The traffic signal layout for this crossing is unclear. Whilst the stop line is shown, no signal heads are indicated. Should the driver of a vehicle exiting the bay not have visibility to a signal head they could fail to heed to pedestrians using the crossing.

SUMMARY: Visibility to / awareness of signal heads may be poor.

The proposed egress from the development car park is located very close to the signal controlled junction of Bridge Street and Gartside Street. Drivers of vehicles exiting the development may have poor visibility to / awareness of signal heads at this junction due to their proximity, alignment and the fact that drivers may be concentrating on eastbound traffic approaching on Bridge Street. This could lead to drivers failing to heed the signals and conflicting with other vehicles within the junction or pedestrians using the crossing.

SUMMARY: Vehicles may turn right.

Vehicles leaving the maintenance route may try to turn right, either through the right turn access in the central reserve, or through the signal controlled junction against

opposing traffic. These movements would be unexpected and could lead to conflict with traffic generally.

Investigate capacity of this area and examine how arrivals / departures will coincide. Ensure that there is sufficient storage space for anticipated vehicle numbers to wait upon entry to the car park when held up by vehicles exiting.

Provide a level dwell area in advance of the give way line for vehicles to set off from.

Ensure that the location of signal heads are such that they can be seen clearly for vehicles exiting the service bay.

Ensure that visibility to / awareness of the signal heads for drivers approaching the give way line on the car park egress is maximised. This could include visibility over the land to the east of the egress being available. Also traffic signal heads should be aligned towards the egress, and located in positions that offer adequate visibility from the egress.

Install left turn only signs for traffic leaving the maintenance route.
