| rev. | date | description |
|---|---|---|
| 1 | 2023 | bridgewater house |
| 4 | 2023 | GF ceilings & cornice |

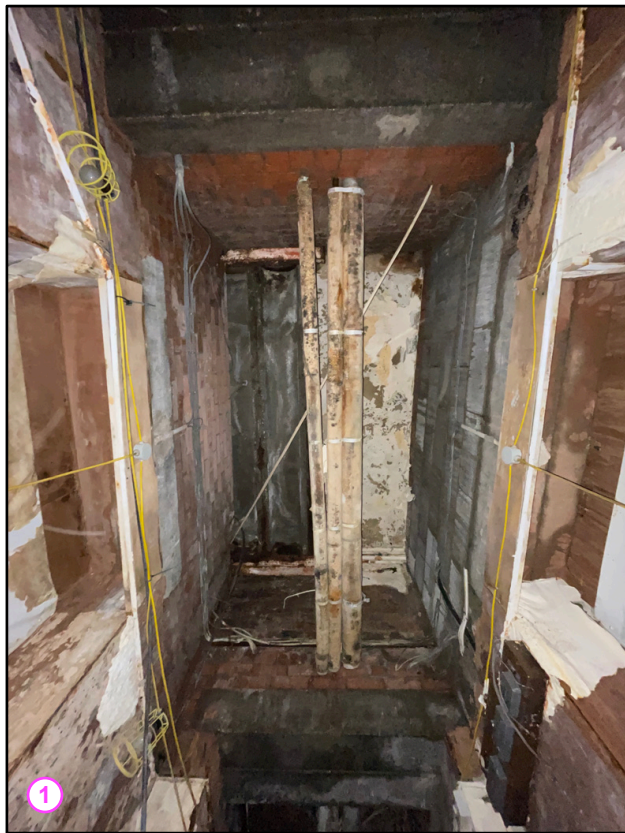
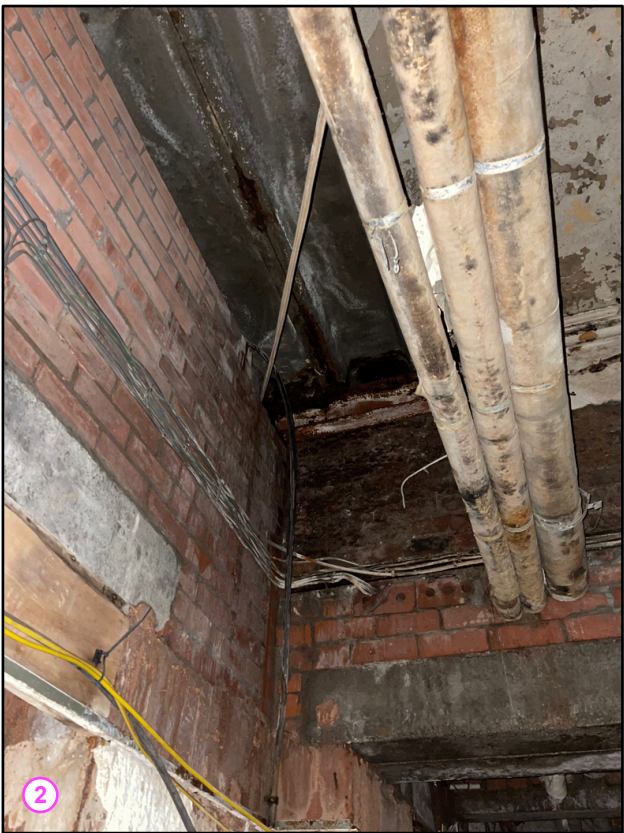
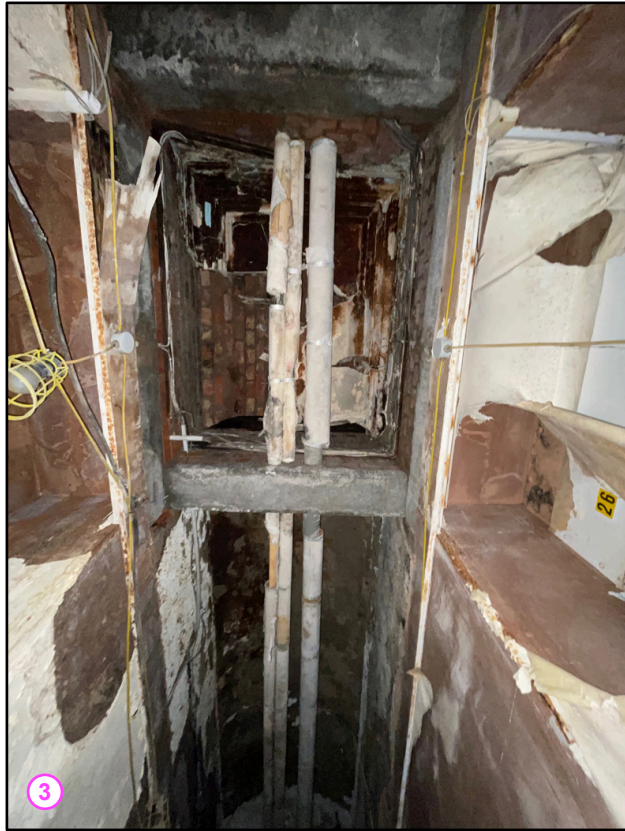
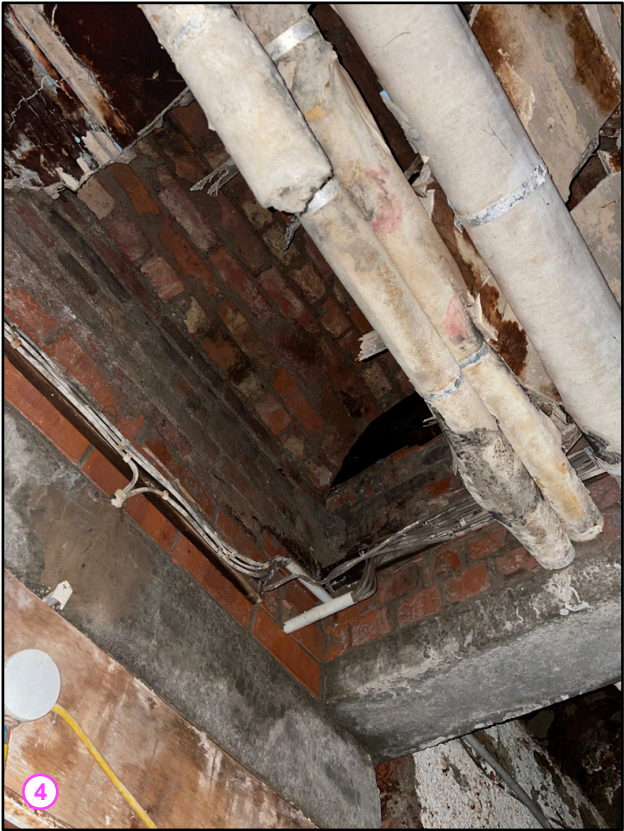
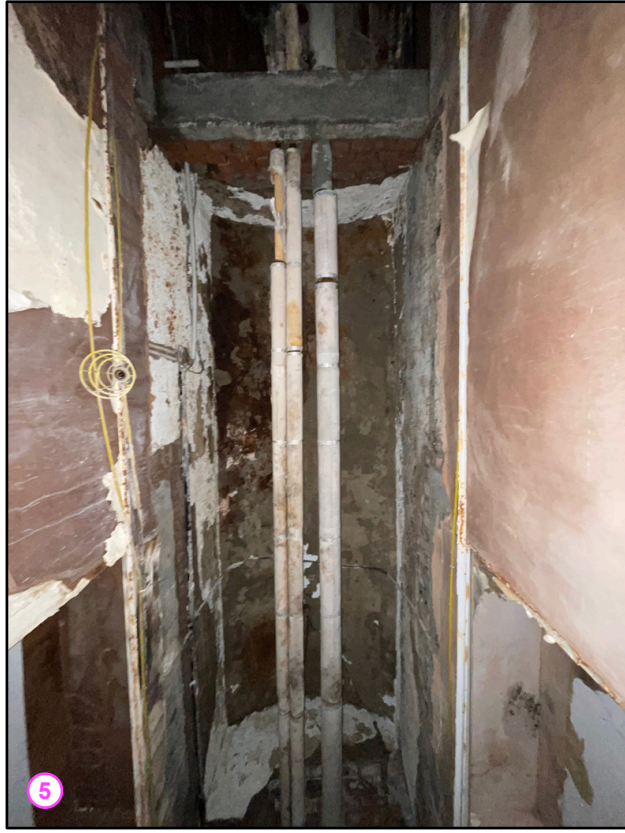
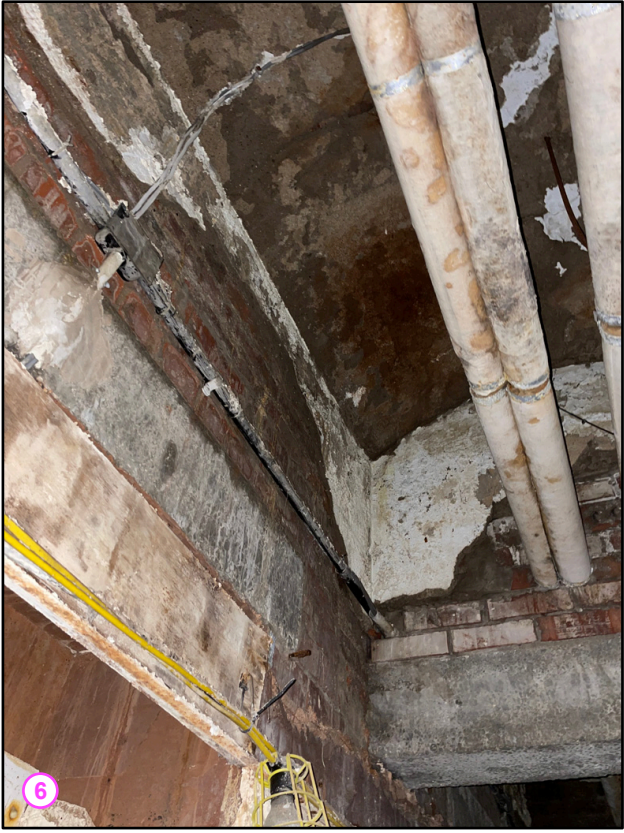
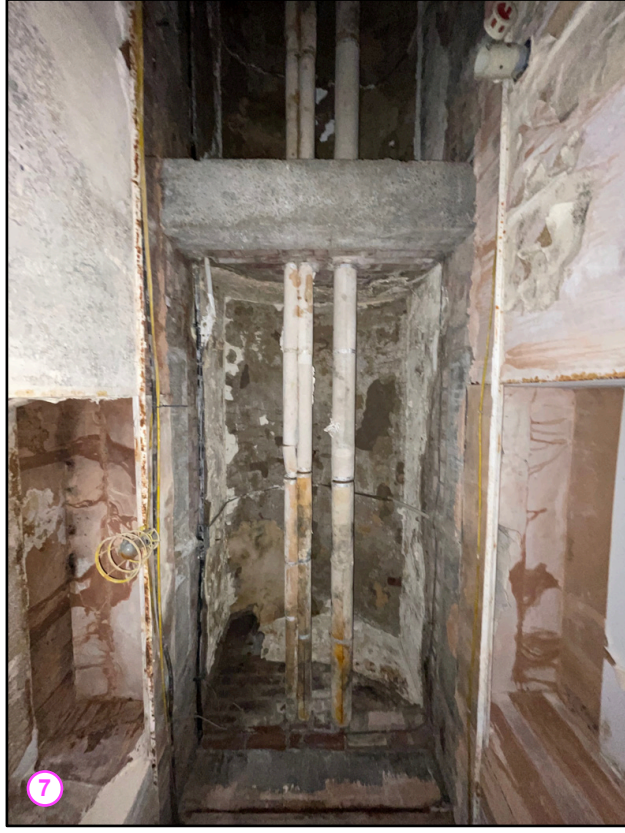
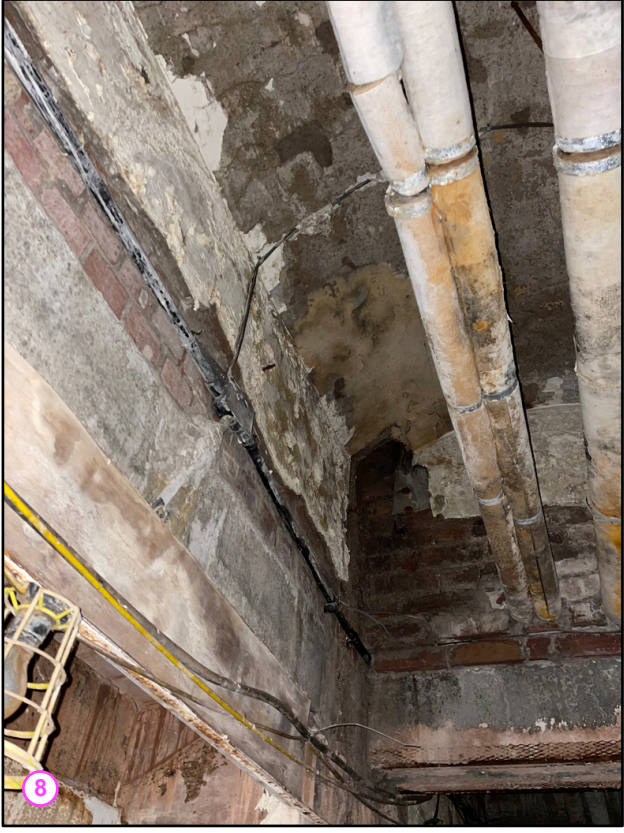
ROOM G.24

- No cornice
- Ceiling is gone completely
- Exposed pipework

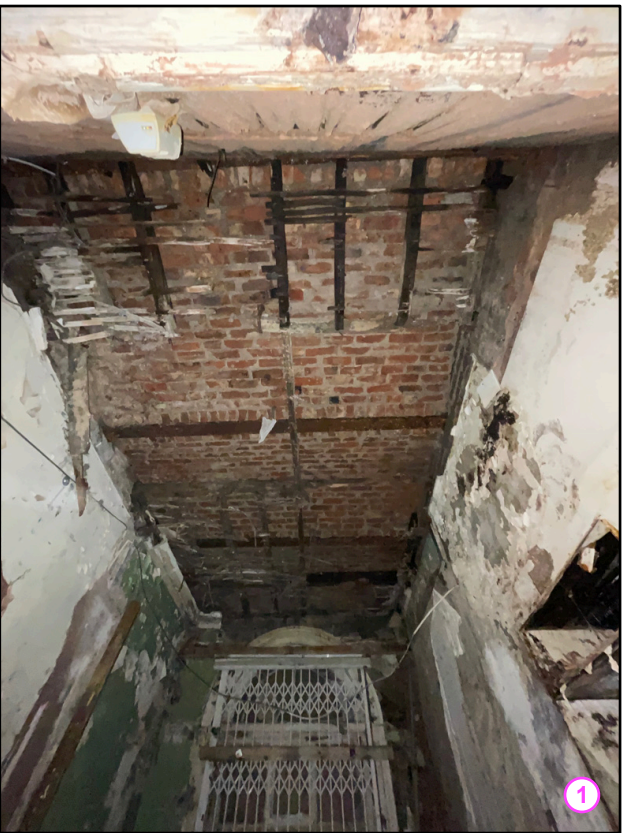
ROOM G.23

- Restricted access - Room is inaccessible due to collapsed ceiling and/or unsafe floor structure
- No cornice
- Ceiling has collapsed completely
- Vaulted ceiling has been exposed (brickwork)

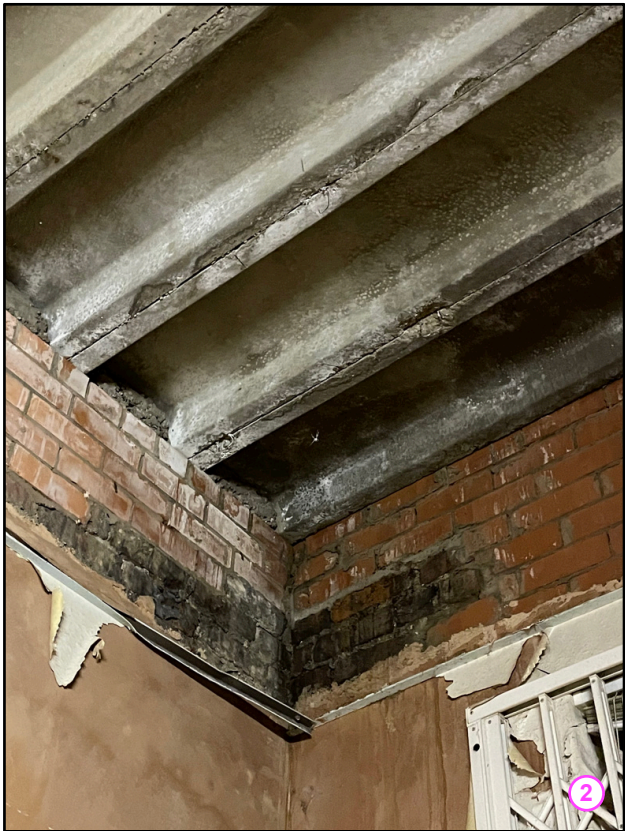
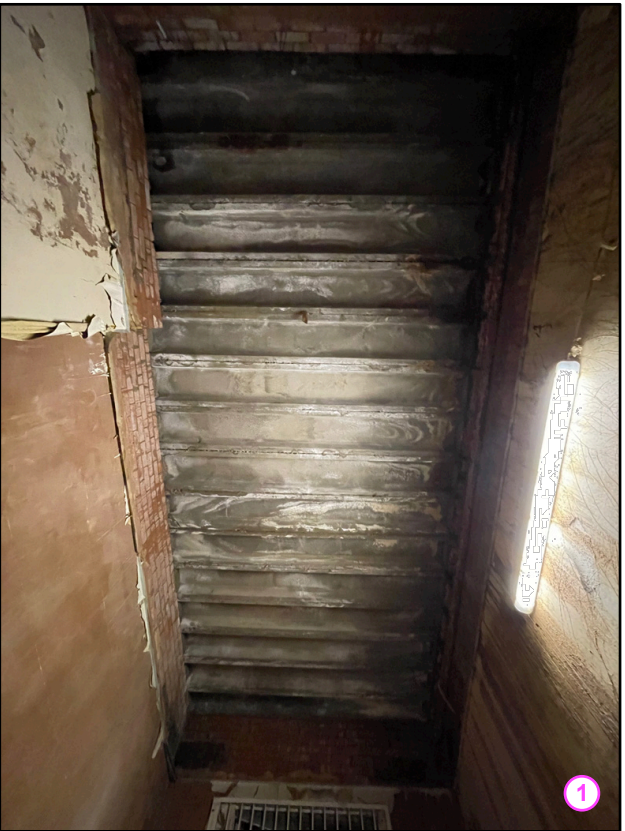
ROOM G.25

- No cornice
- Ceiling has collapsed completely
- Precast concrete ceiling has been exposed as a result

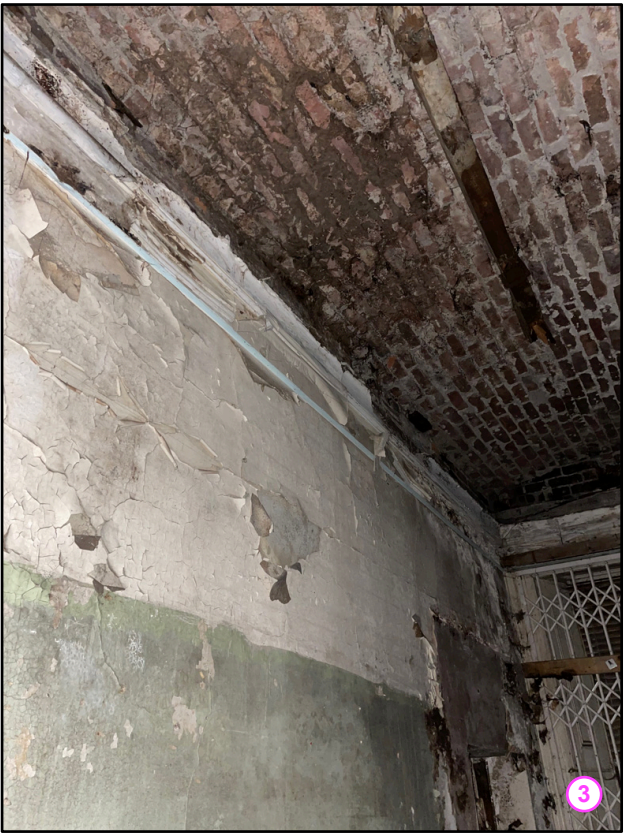
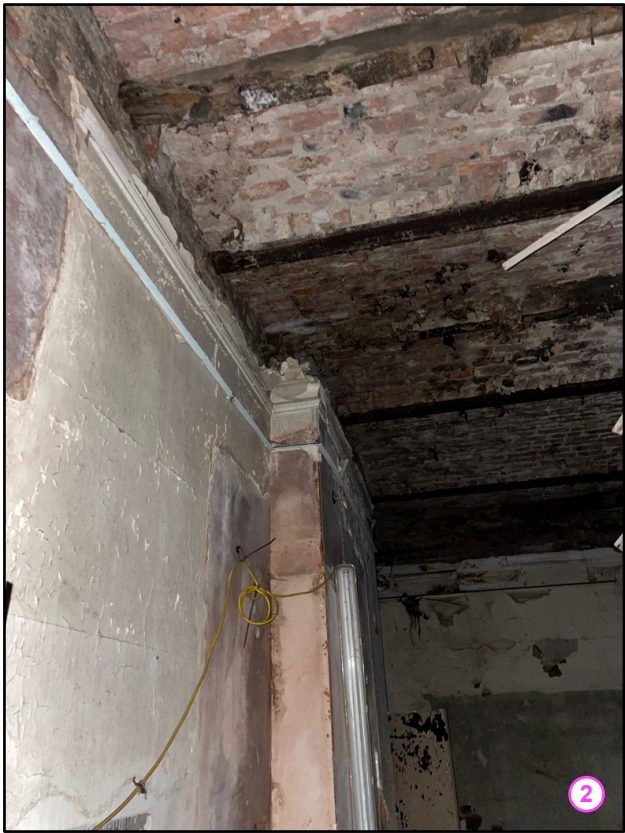
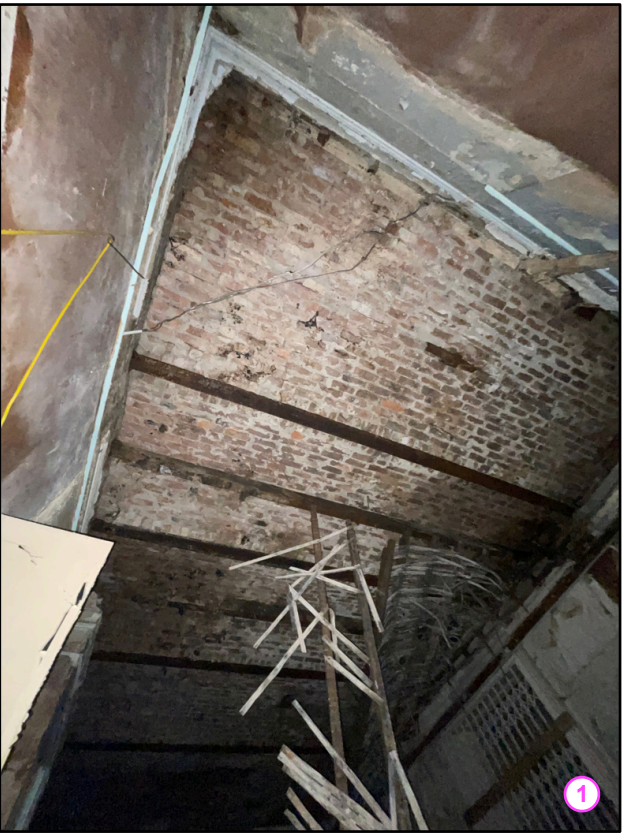
ROOM G.26

- Restricted access - Room is inaccessible due to collapsed ceiling and/or unsafe floor structure
- No cornice
- Ceiling has collapsed completely
- Vaulted ceiling has been exposed (brickwork)
