# Drainage Report

**27 Dale Street**  
**Manchester**  
**Manchester**

**Dale Street Manchester - CCTV Survey Report : 27/01/22**

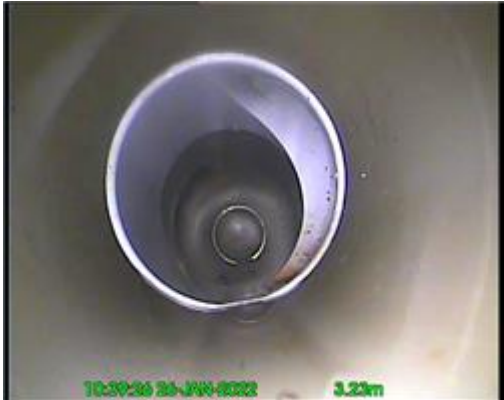
| Pos | Video Ref | Code | Description | Image |
|---|---|---|---|---|
| 03.23m | 0:00:13 | JN | Junction at 03 o'clock: 150mm Diameter | <p>Image Provided - Ref: 2_2</p> |

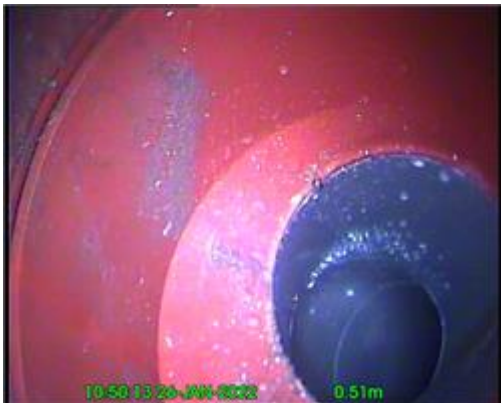
| Pos | Video Ref | Code | Description | Image |
|---|---|---|---|---|
| 00.51m | 0:00:08 | SC | Dimension of drain/sewer changes: 100mm Diameter | <p>Image Provided - Ref: 3_2</p> |

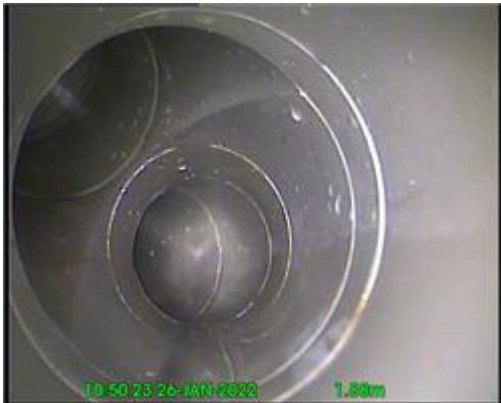
| Pos | Video Ref | Code | Description | Image |
|---|---|---|---|---|
| 01.88m | 0:00:18 | JN | Junction at 10 o'clock: 100mm Diameter | <p>Image Provided - Ref: 3_3</p> |

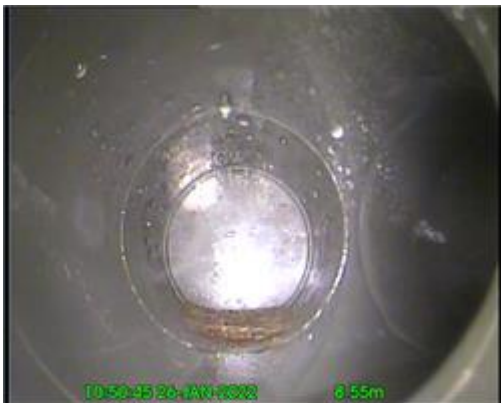
| Pos | Video Ref | Code | Description | Image |
|---|---|---|---|---|
| 08.55m | 0:00:40 | JN | Junction at 03 o'clock: 100mm Diameter | <p>Image Provided - Ref: 3_4</p> |

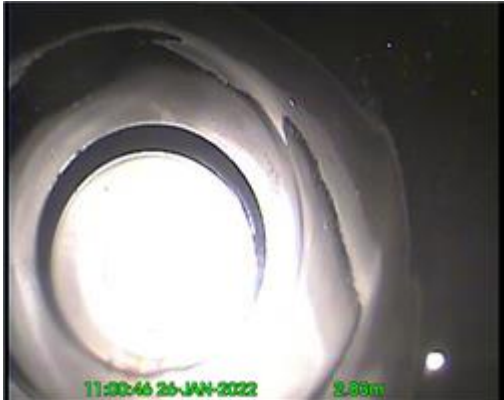
| Pos | Video Ref | Code | Description | Image |
|---|---|---|---|---|
| 00.00m | | MHF | Finish node type, manhole S1 Hydrobrake | <p>Image Provided - Ref: 5_9999</p> |

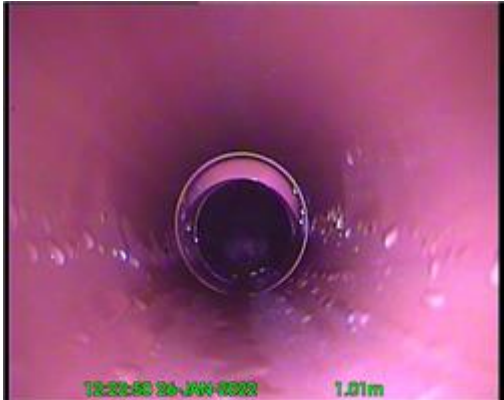
| Pos | Video Ref | Code | Description | Image |
|---|---|---|---|---|
| 01.01m | 0:00:06 | JN | Junction at 12 o'clock: 100mm<br>Diameter | Image Provided - Ref: 9_2<br> |

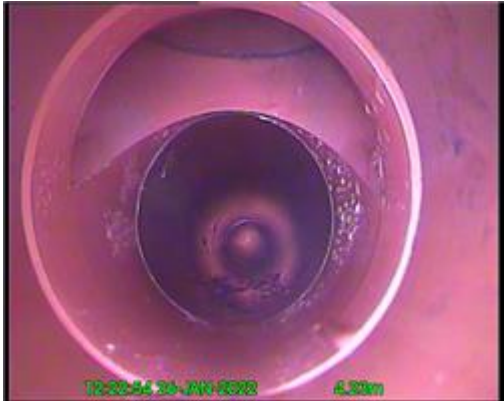
| Pos | Video Ref | Code | Description | Image |
|---|---|---|---|---|
| 04.23m | 0:00:10 | JN | Junction at 12 o'clock: 100mm<br>Diameter | Image Provided - Ref: 9_3<br> |
