## Additional Ground Investigation & Revised Remediation Strategy

LK Consult (LKC) has been retained by Torsion Construction Ltd to carry out additional ground investigation works at the proposed development at Mirabel Street, Manchester. Location and proposed development plans are provided in Appendix A.

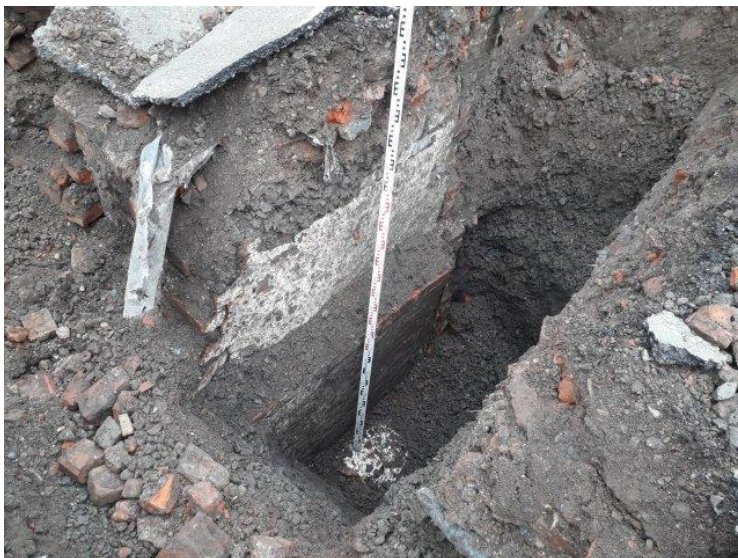
Brick wall visible in north western wall of pit and concrete floor visible.

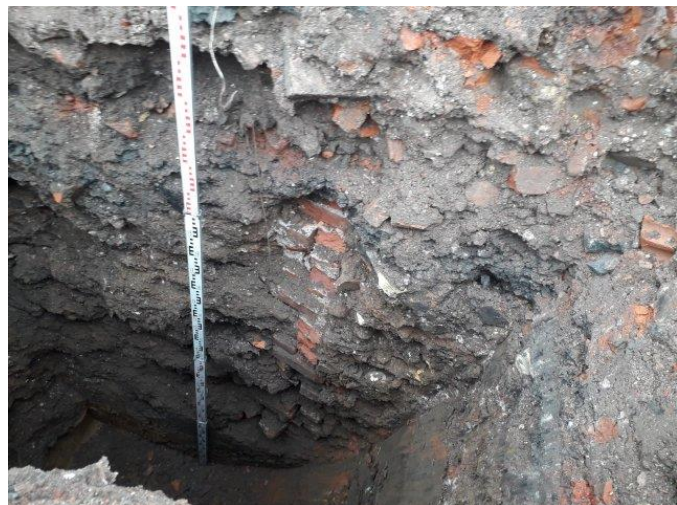
Brick wall visible on south eastern wall of TP204.

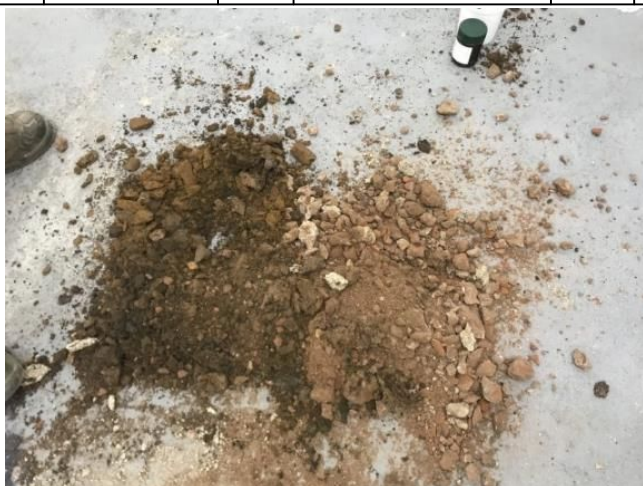
Trial hole stable and dry.

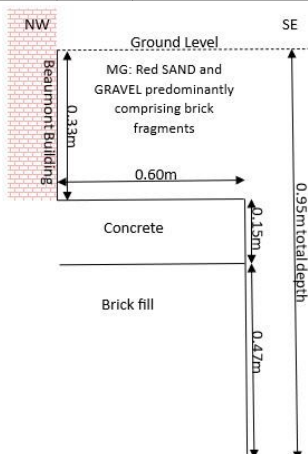
Trial hole stable and dry.

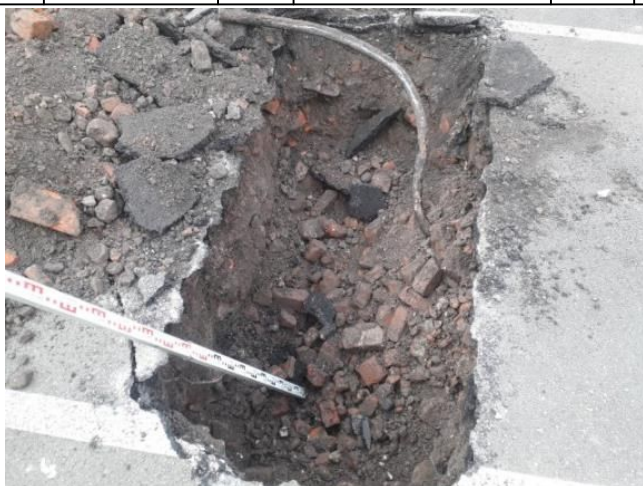
Trial pit unstable, made ground collapsing between 0.10-1.20mbgl.  
Pit dry.  
No brick foundations / walls encountered.

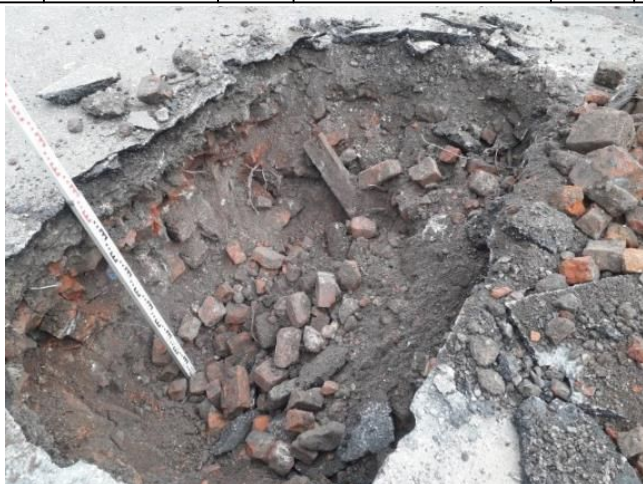
Trial pit unstable, made ground collapsing between 0.10-1.10mbgl.  
Pit dry.  
No brick foundations / walls encountered.

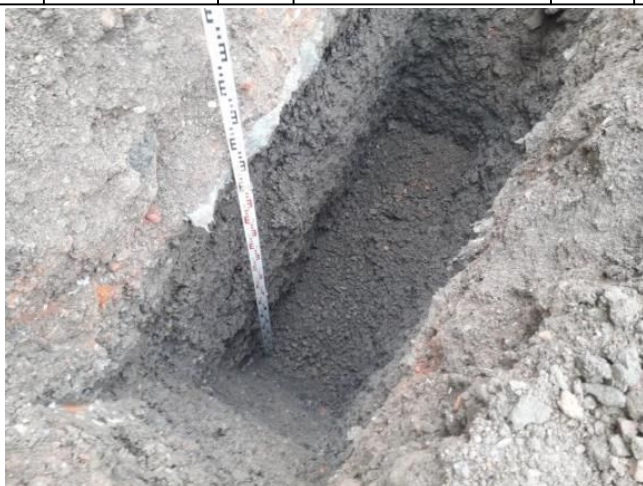
Trial pit unstable, made ground collapsing from 0.80mbgl.  
Strata between 0.80-3.20mbgl slightly damp.  
No brick foundations / walls encountered.
