**86 Princess St**  
Water Ingress

Condition Survey 2 Of 2

| drwg no. | <b>E(402)</b> |

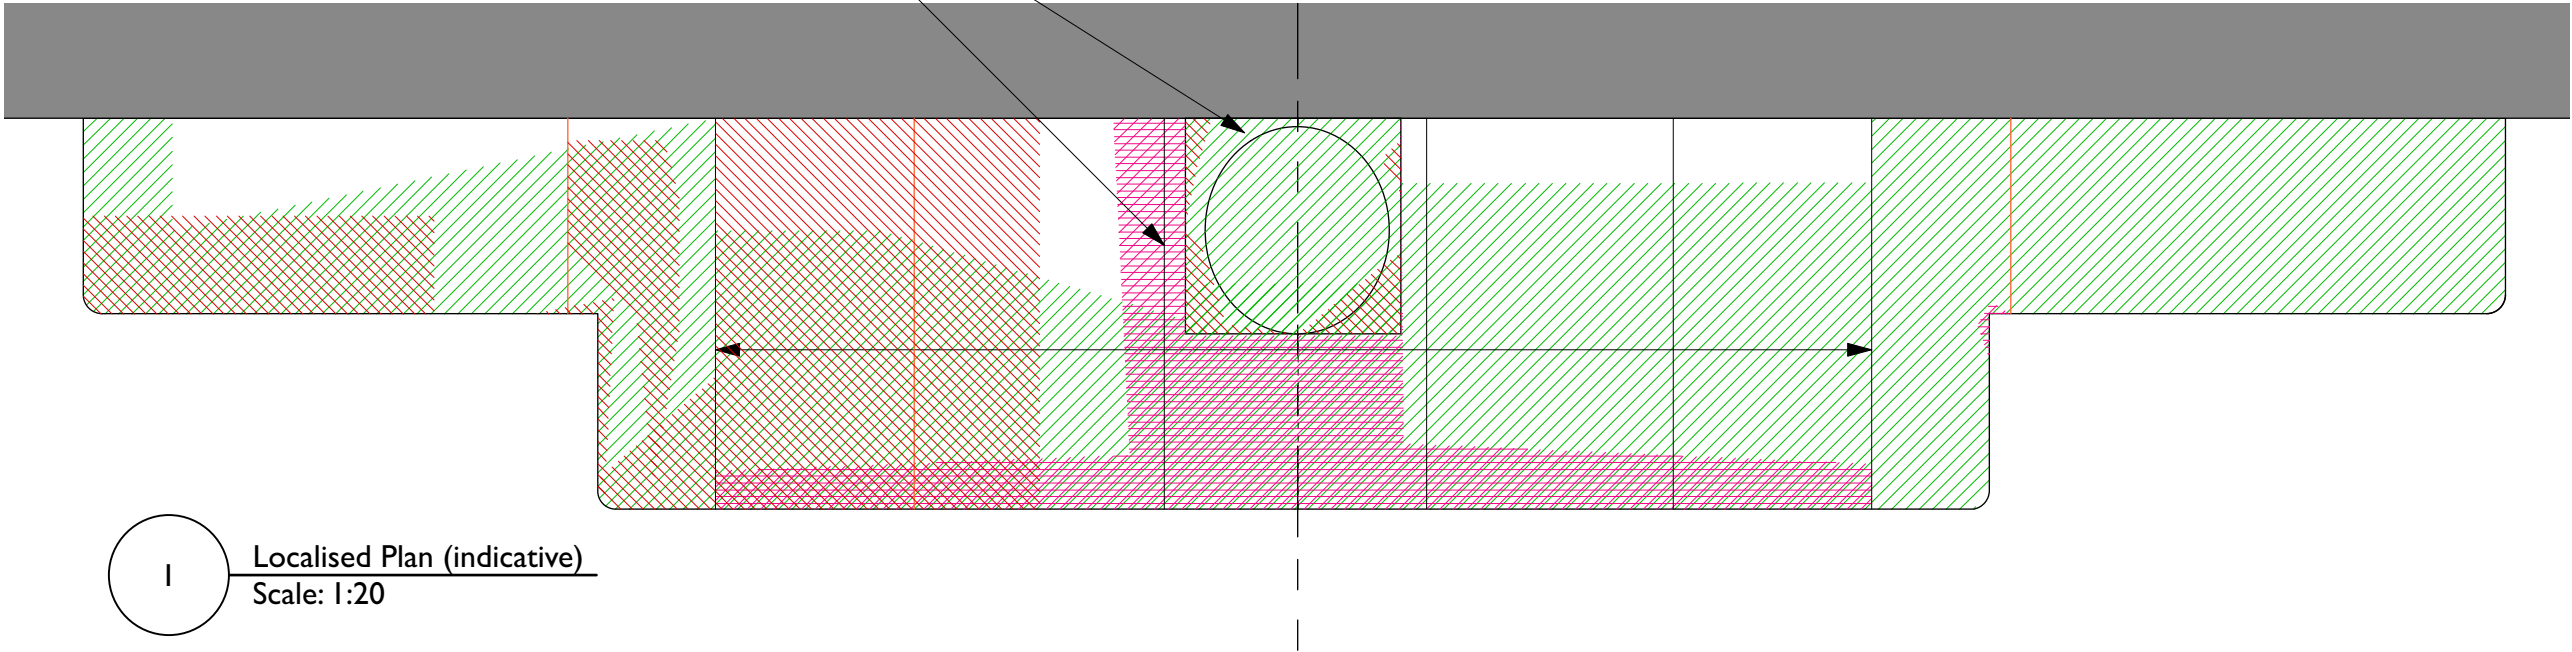
1 Localised Plan (indicative)  
Scale: 1:20

- AtMB-Biological Growth
- AtMB-Eroded or missing pointing
- AtMB-Eroded Stone
- AtMB-Previous Cement Repairs
- AtMB-Water Staining
