## 1830 Warehouse

## Museum of Science & Industry, Manchester

### Internal Structural Inspection Report

05 December 2022

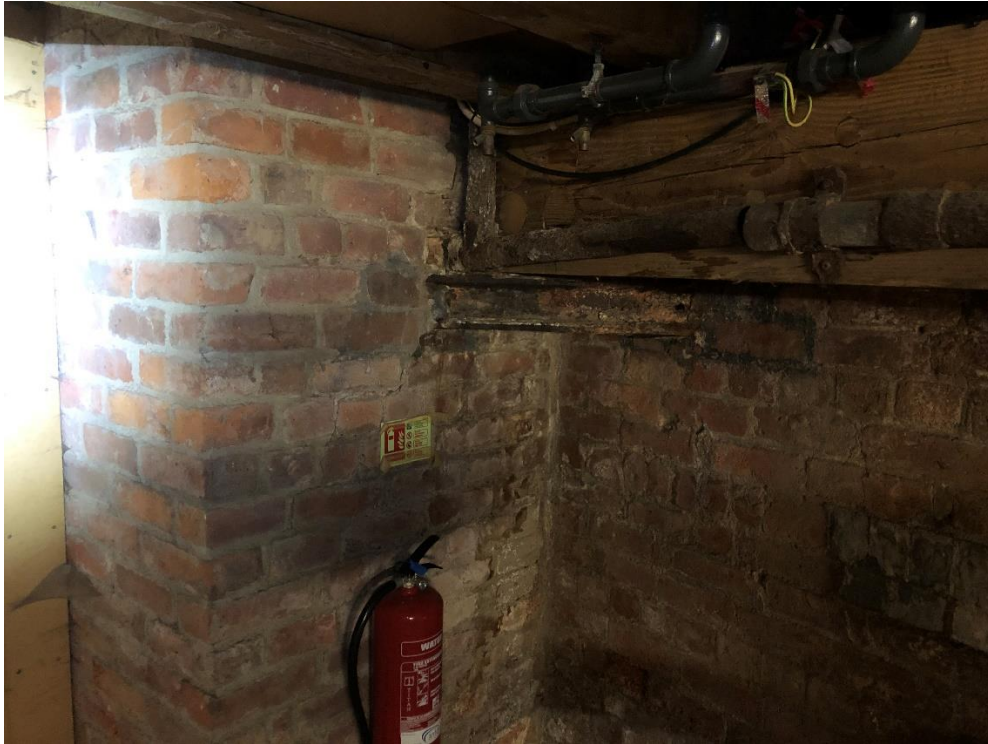
- 4.4.2 At basement level, there was moderate surface corrosion noted in Bay 1 where diagonal iron beams are embedded in the corners to support the primary timber floor beams (see photo 1). This has resulted in some minor spalling of brick faces in these areas. No significant section loss was evident.

- 5.11 At basement level, there was moderate corrosion noted in Bay 1 where diagonal iron beams are embedded in the corners to support the primary timber floor beams. This corrosion is to be expected as the masonry at this level retains the damp earth beyond. This has resulted in some minor spalling of brick faces in these areas. It appears that no significant section loss was evident, however this should be cleaned down to expose the degree of corrosion.

Photograph 01: Looking at the southwest corner. corrosion in corner support to ground floor timber floor beam

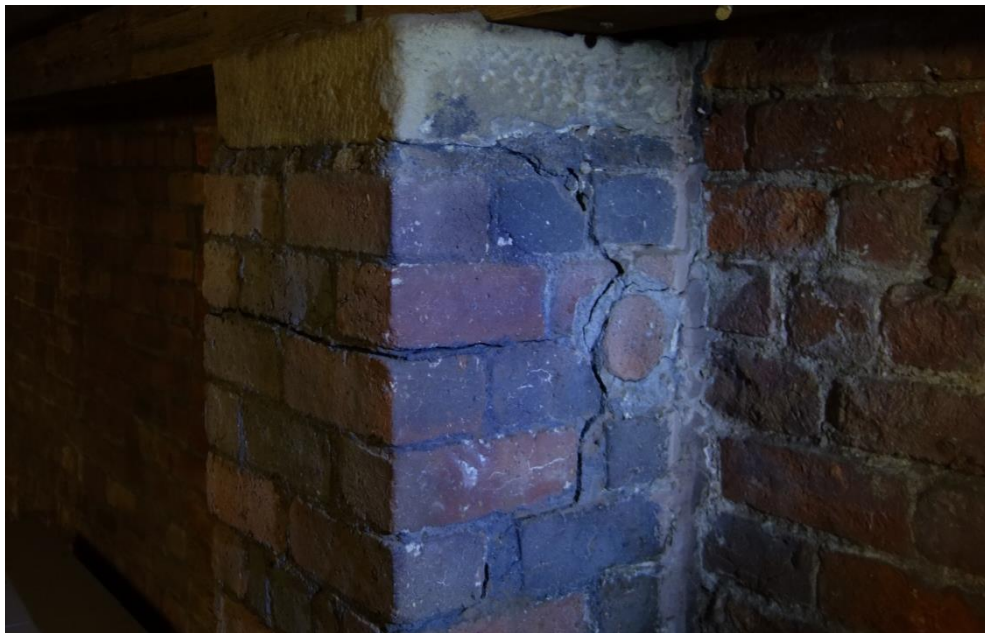
- 5.10 Various brick piers at basement level displayed vertical cracking adjacent to timber beam bearing, which possibly suggests high localised stresses. Historic crack filling is evident in some locations. Whilst the brick piers do not appear to be at risk of failing, providing re pointing and reinforcement across the cracks will tie the piers into the perimeter walls re-establishing the robustness of the structure.

Photograph 02 – Vertical cracking through a primary beam support pier at the South wall at basement level.

- Whilst the brick piers do not appear to be progressively failing, diagonal and vertical cracking reduces the robustness of the structure and bearing capacity.
- Install monitoring devices across the cracks,
- Where additional capacity is needed in the floor structure, providing horizontal bed joint reinforcement and re-pointing should be carried out in the brick piers.

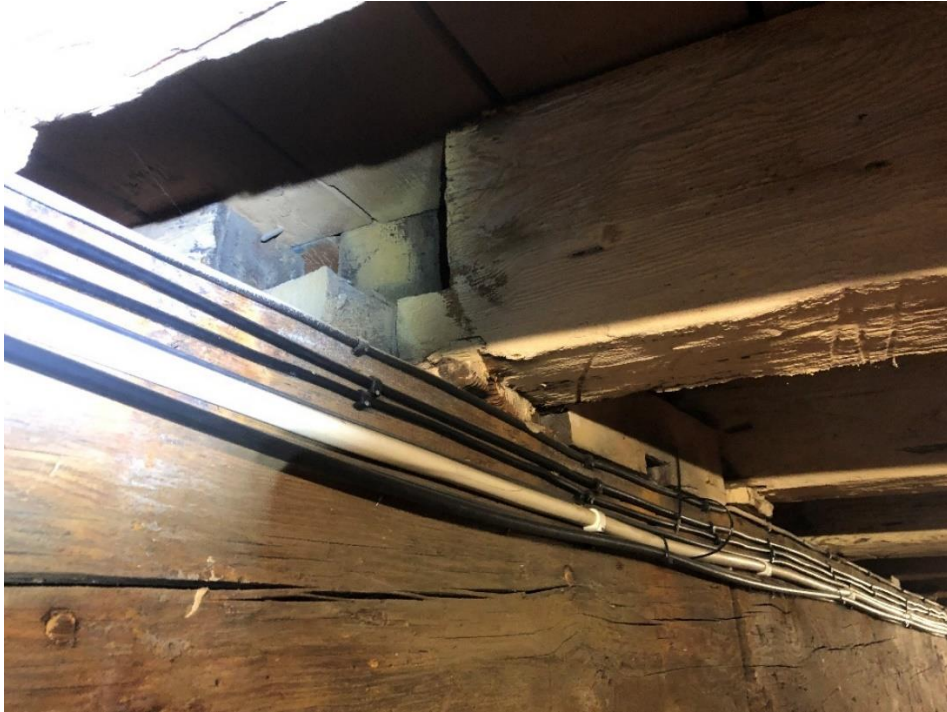
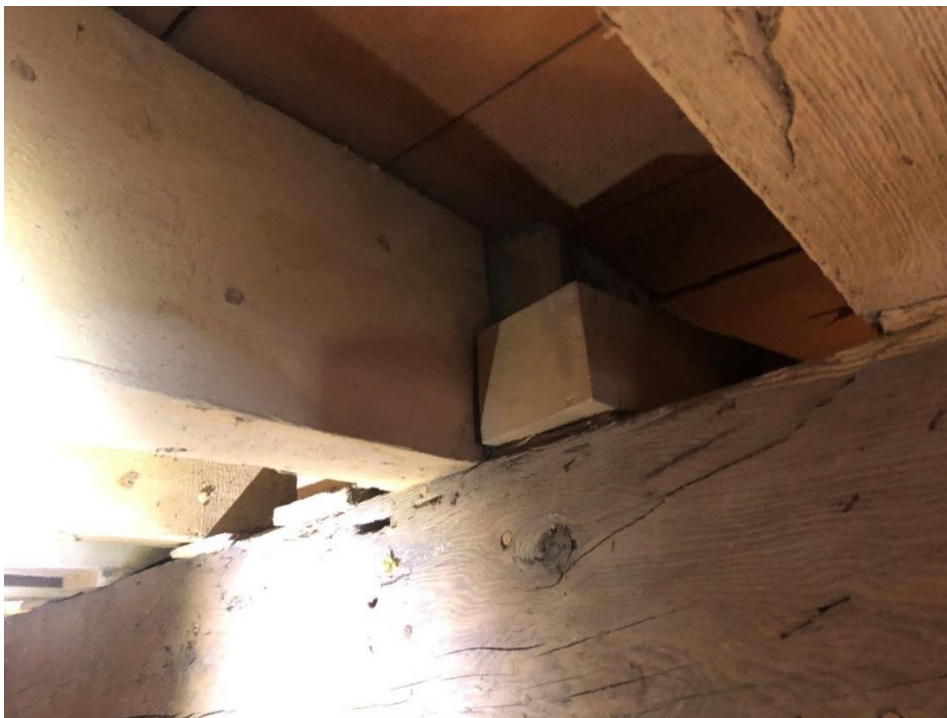
**Photograph 03, 04: limited bearing of timber floor joist.**

**Note base of timber column above floor beam. This limited bearing has been addressed in various areas of the building, however, there remains floor joists which are at increased risk of end bearing / dynamic failure**

- Ground floor structure (observed from basement) - Bay 1, 3 and 4. Floor joists have reduced bearing length on the floor beams in multiple locations. Continue to monitor the locations and avoid overloading the floor structure.

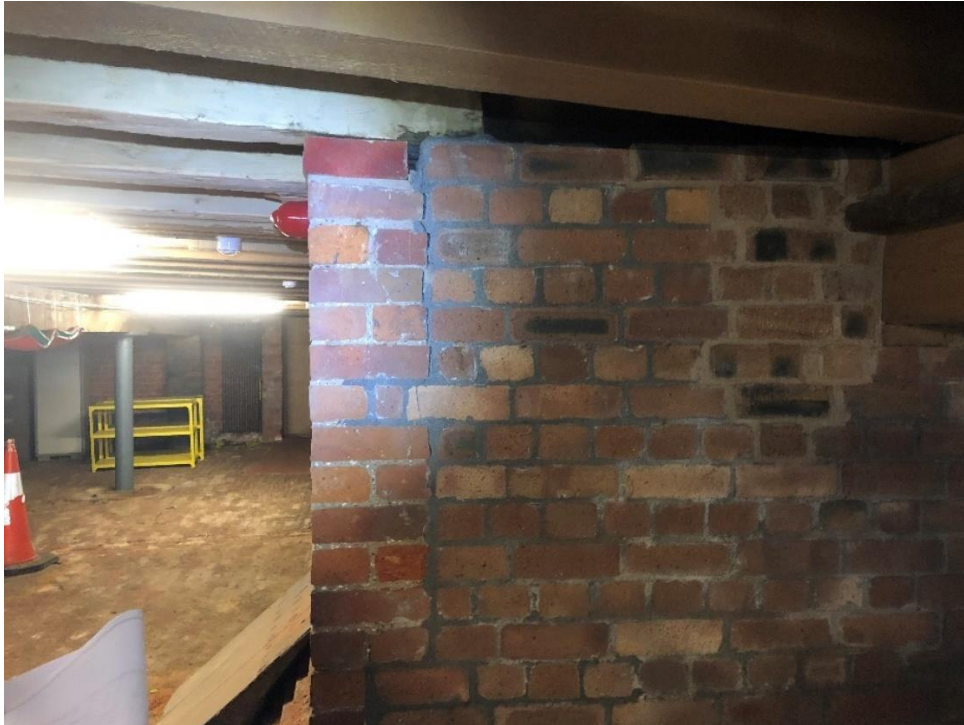
**Photographs 05 - Stepped cracking, mortar loss and historic re-pointing at the face and return of the piers.**

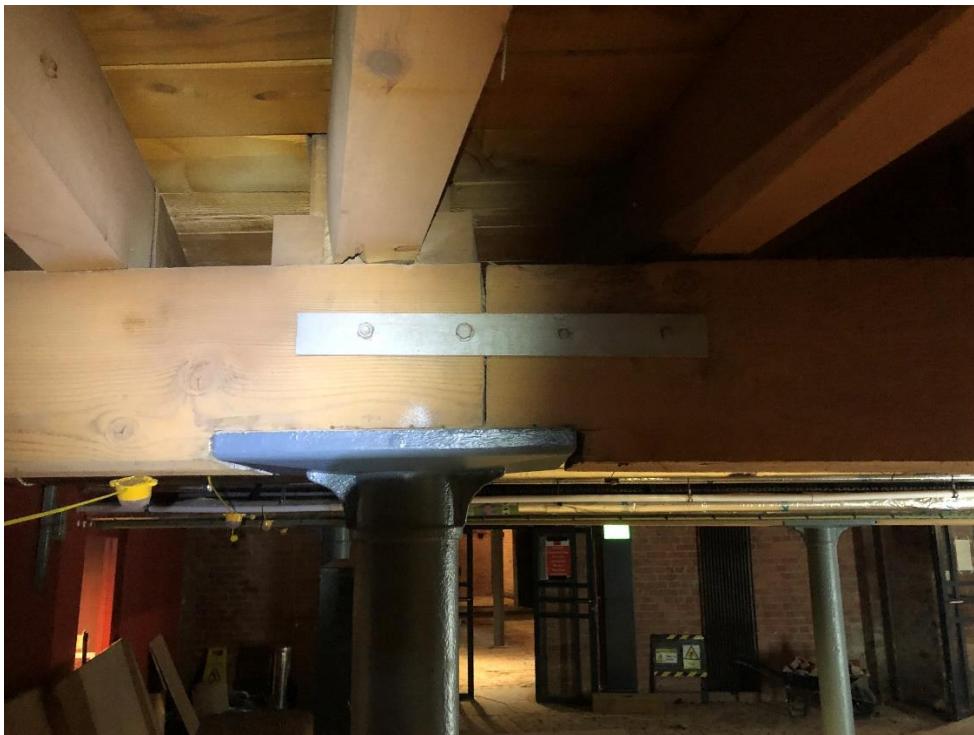
**Photograph 06 - Floor beam 'but' connection off centre overcast iron column. s. floor beam eccentrically loading cast iron plate.**

- 7.3 Our outline remedial recommendations are as follows:
- 7.3.1 Minimal bearing –
- Ground floor (observed from basement). A primary beam splice is positioned at the edge of a cast iron column head plate. The connection should be reinforced to reduce eccentric loading of the cast iron column.

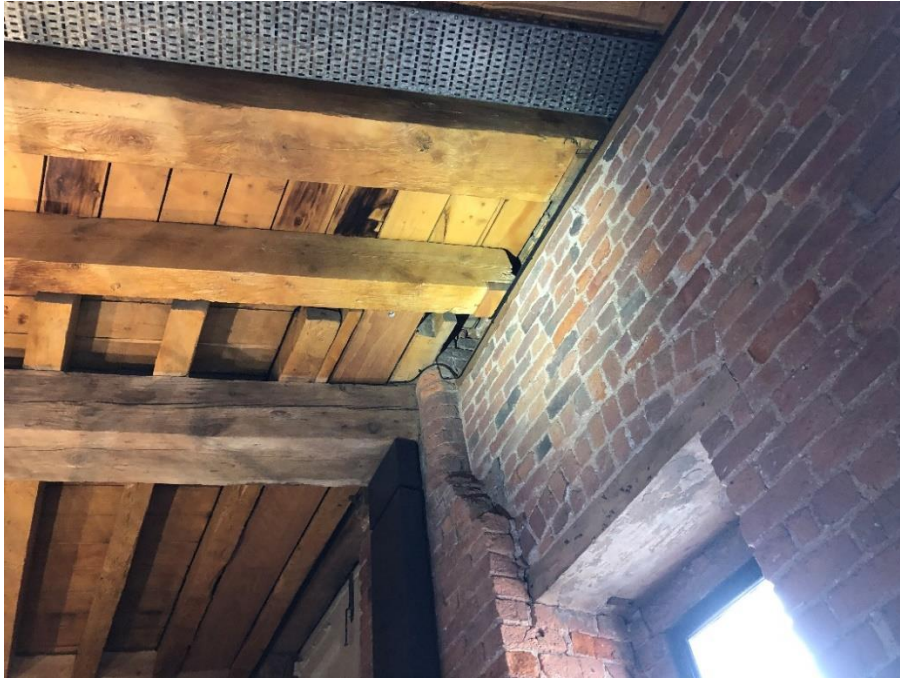
4.2.4 Vertical and diagonal cracking was noted at various locations up the inside face of the piers (see photo 7 & 8) either side of the tall doors at the North elevation, which possibly suggests high localised stresses. Historic crack filling was evident suggesting that the issue may be ongoing.

**Photograph 07 – A full height photo of a ground floor pier at the inside of the Northern elevation, showing the extent of vertical cracking evident through bricks.**

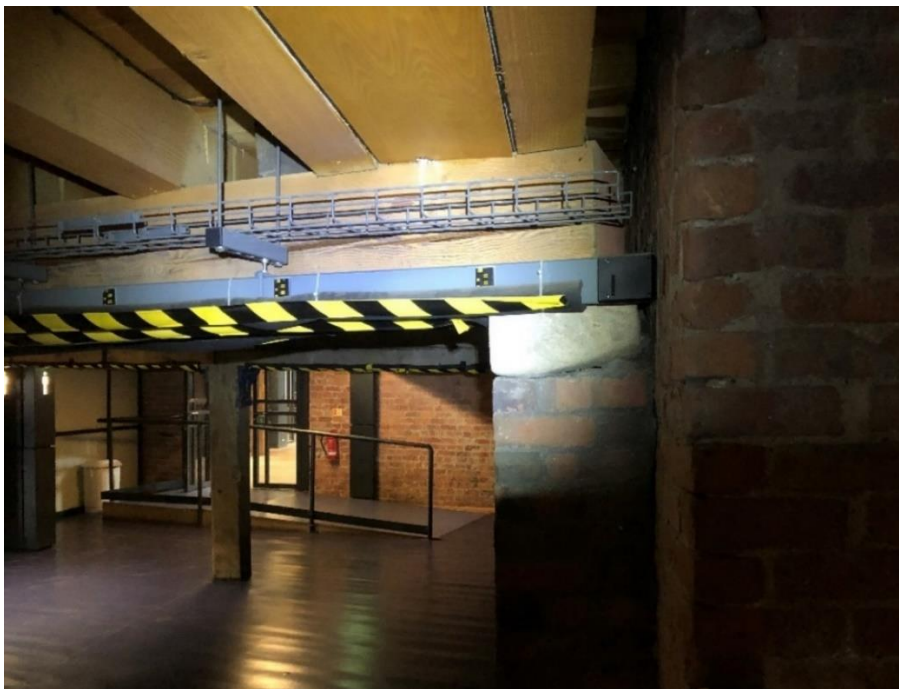
**Photograph 08 – A photo of a ground floor pier at the inside of the Southern elevation, providing limited lateral restraint to the head of the wall.**

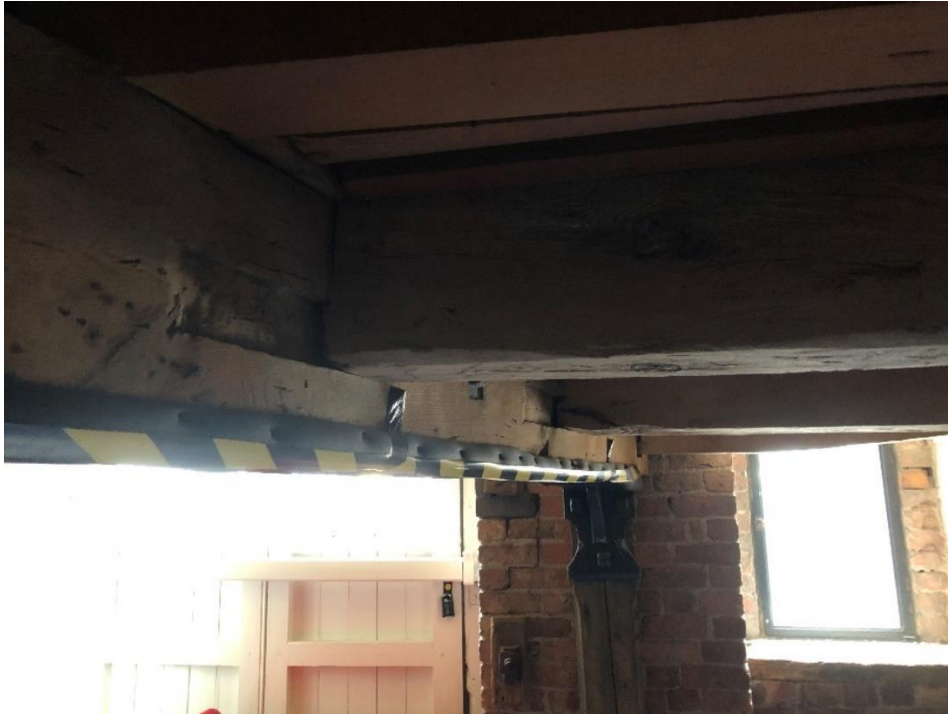
- 6.4 The analysis of the individual members determined that the capacity of a typical grid of timber joist, beams, and columns (sizes taken from the smallest observed on site) was limited by the primary timber beams (see photo 9) which ranged from 330mm x 340mm to 360mm x 380mm. The maximum allowable imposed load capacity assessed for the general floor grid is 2.5kN/m<sup>2</sup>.

**Photograph 09 – View of limited bearing of floor joist on floor beam, and brick cracking beyond.**

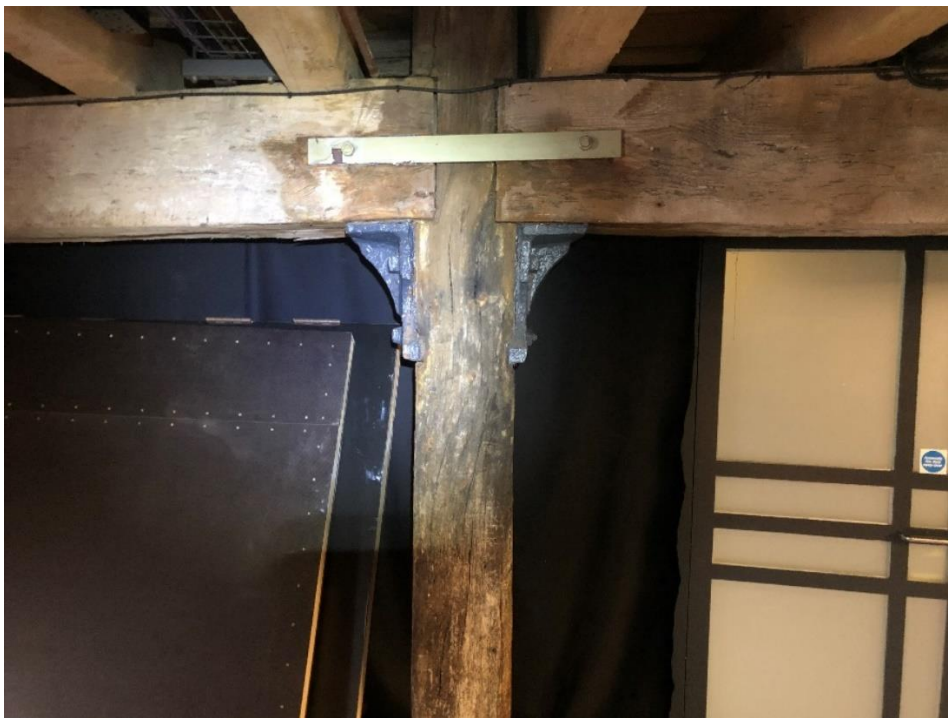
- 4.3.4 The majority of the timber throughout the structure appears to be dry and without substantial historic or current decay – the majority of these issues were addressed in the early 1990s and then subsequently in the most recent works. There are a small number of locations at ground, mezzanine and first floor level where some deterioration is apparent that has not been previously addressed. These areas are currently dry but the extent of any loss of structural integrity can't be visually confirmed. Photo 10 shows a typical location in Bay 1 as viewed at ground floor.

**Photograph 10 – View from ground floor level of degraded timber post and beam, H&R to review level of rot.**

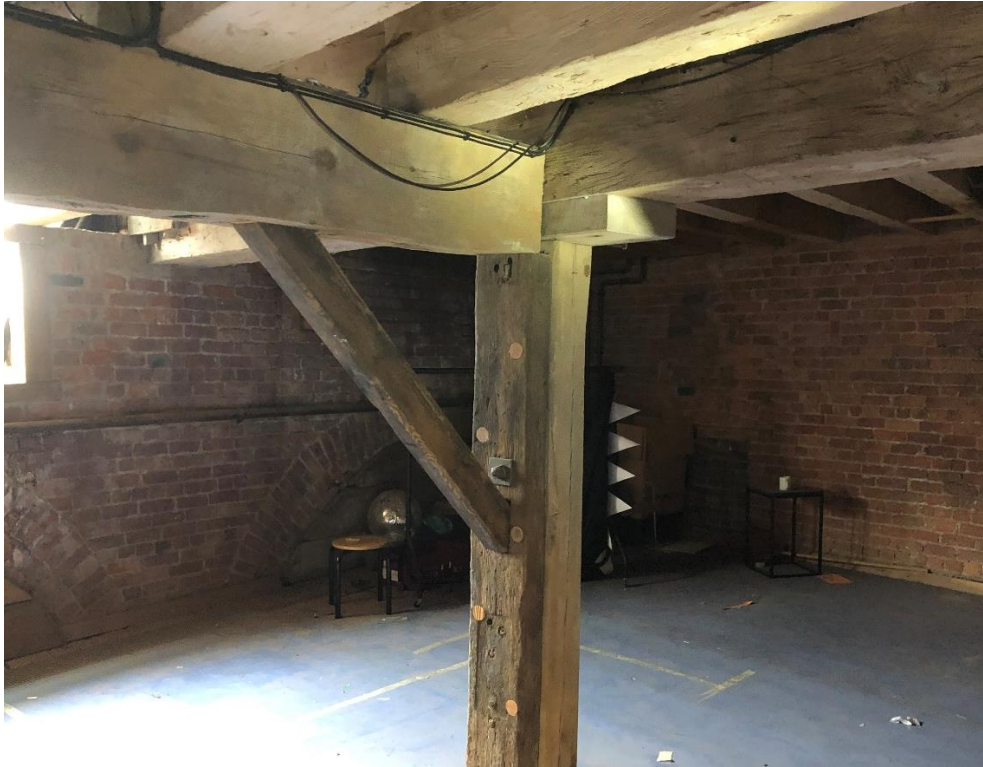
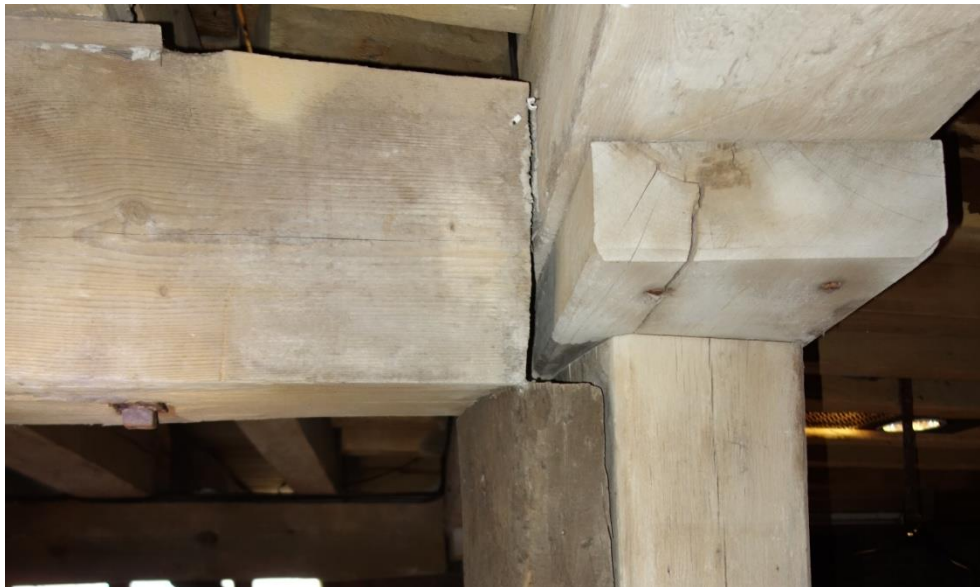
**Photograph 11, 12 – View from ground floor (11) mezzanine (12) of east west beams with limited bearing on vertical plate. Vertical plate bolted to column using single M20 bolt. Shrinkage and frame racking has pulled the timber off this bearing and it now very little contact remains.**

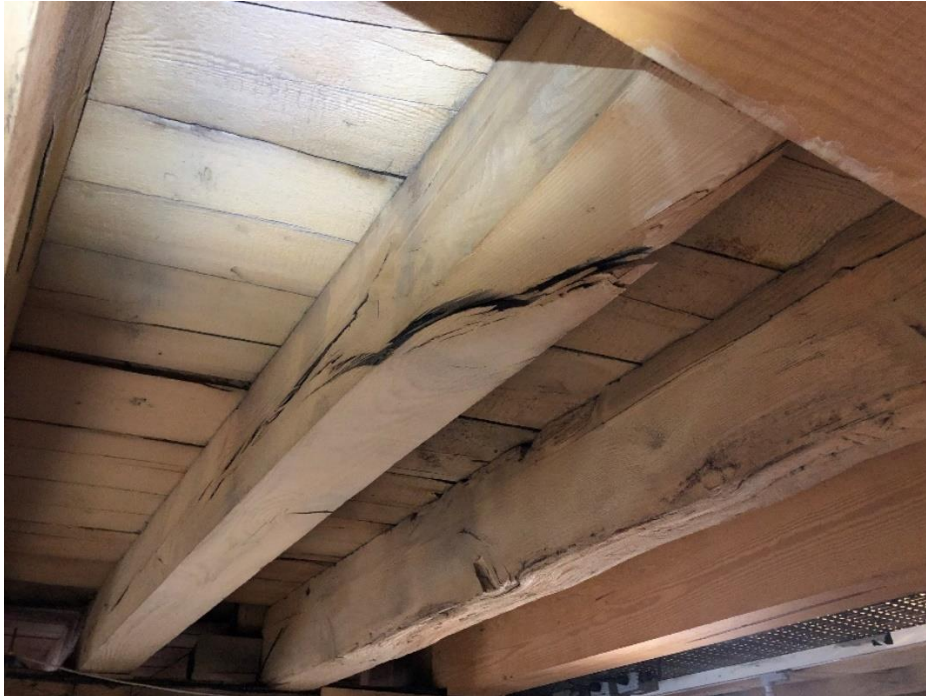
- 4.1.7 Various timber joists and isolated timber beams are noted to show cracking (both longitudinal and shear), at ground, mezzanine and first floor level (see photo 13). The majority of locations the beams do not appear to be at risk of progressive failure, however the capacity of the beam remains limited by the reduced cross section.

**Photograph 13 – View from mezzanine floor level of cracking in floor joist.**

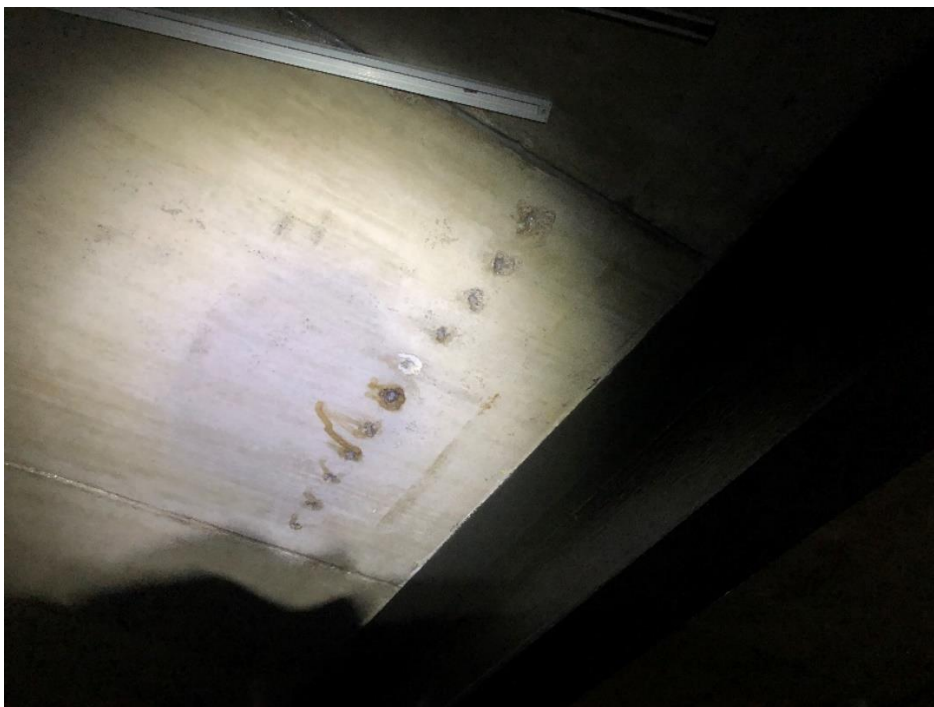
**Photograph 14 – Service penetrations in precast concrete planks observed from first floor. locally filled using resin / mastic, however minimal corrosion assumed based on staining.**

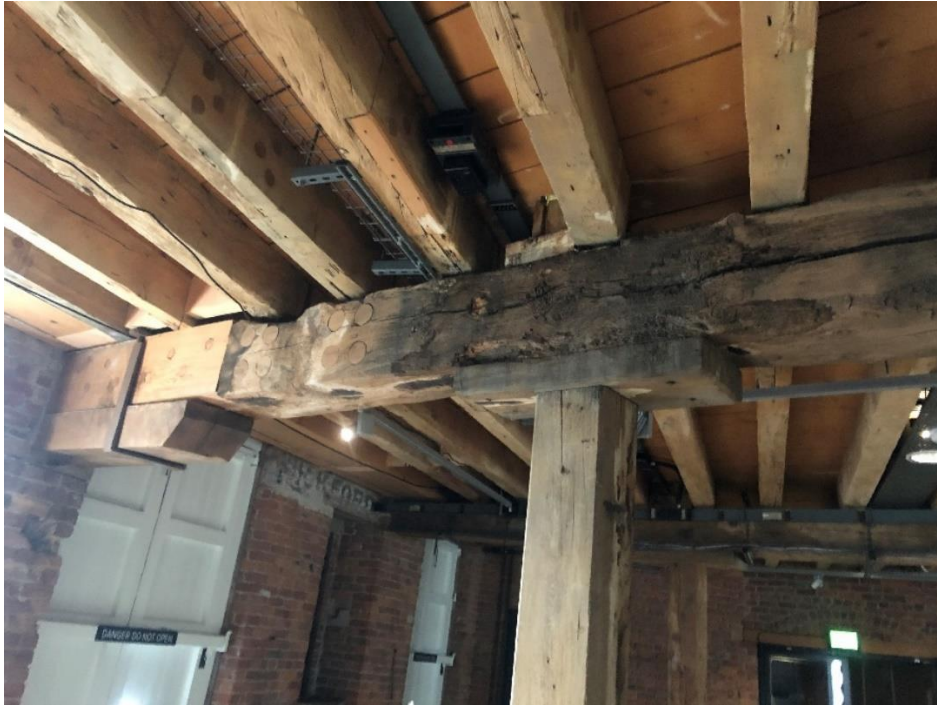
**Photograph 15 – View from first floor level of degraded timber post and beam, H&R to review condition of timber.**

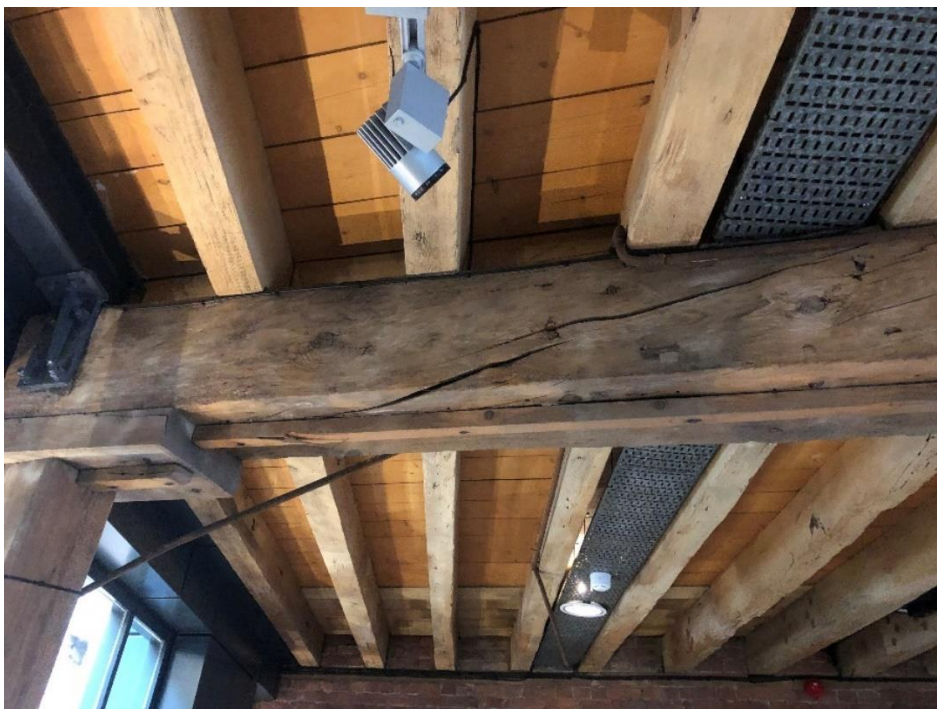
**Photograph 16 – View from first floor level of diagonal cracking in floor beam.**

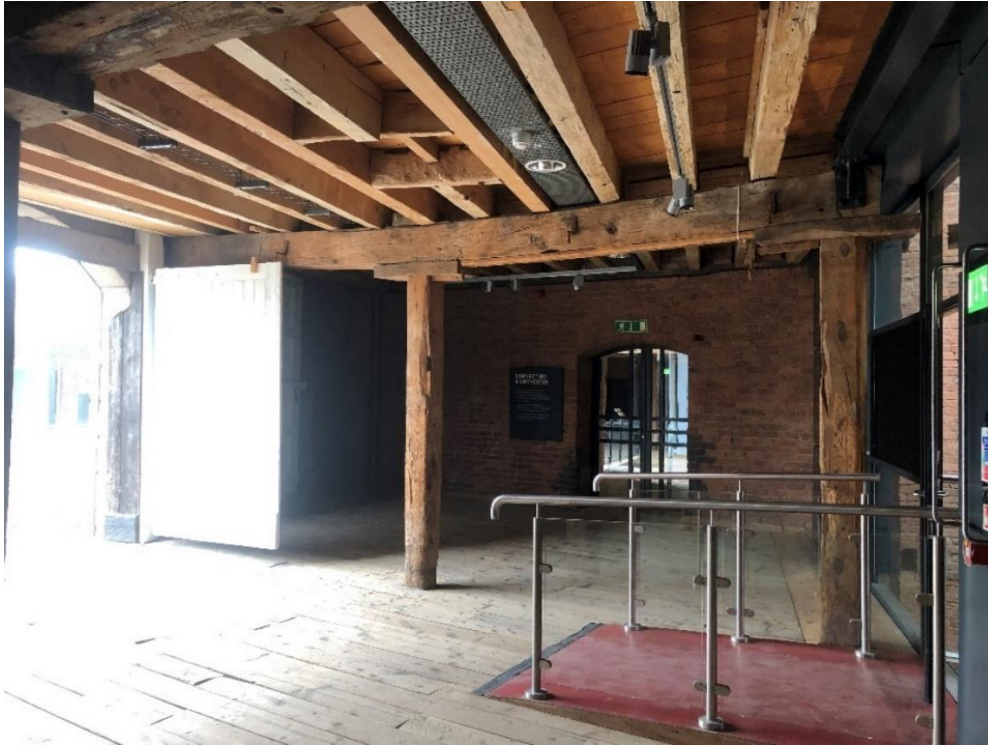
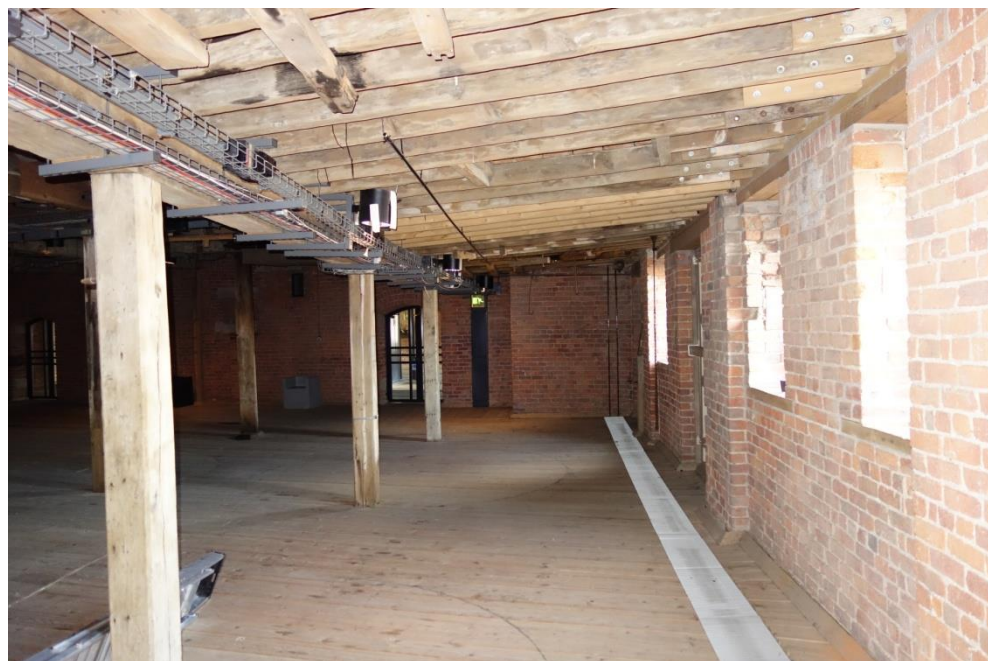
- 4.1.4 The floor levels vary within each bay, with distortions in the plane of the floor easily visible to the naked eye (see photos 17 & 18), as well as noted from the spot levels on the measured survey. This local change in floor joist level is dictated by the level of their bearings at cross beams and ultimately, the level of the column supports. The magnitude of this variation shows a higher depression in the upper levels, notably in two locations the south side of Bay 2 & 3.

**Photograph 17, 18 – View from first (16) and second (17) floor level of general depression in floor level**

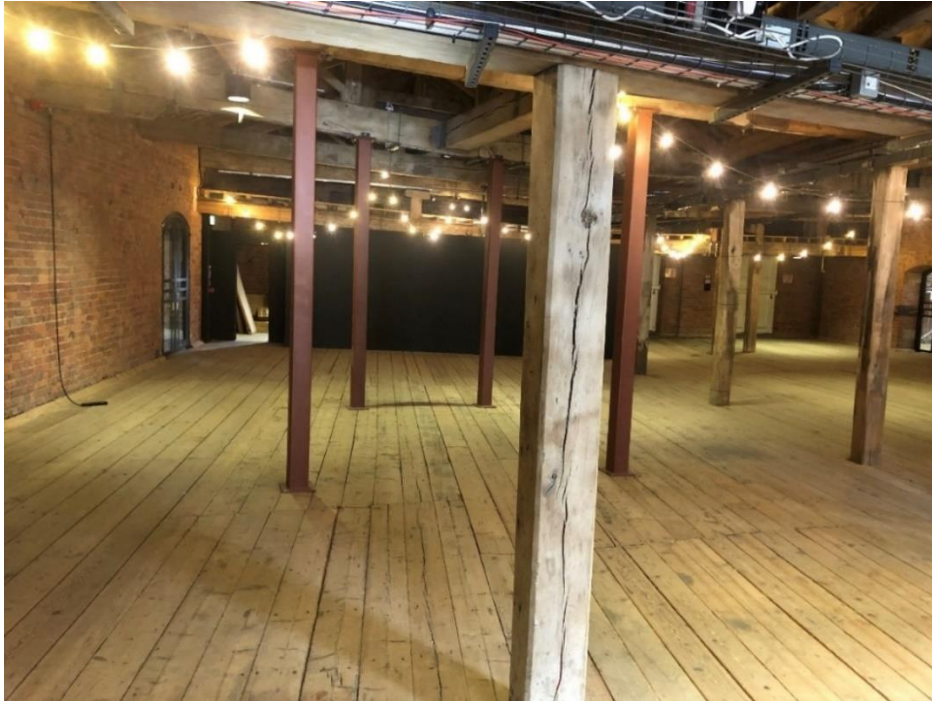
- 4.1.2 Square Hollow Section (SHS) steel columns (4No) have been installed in recent times to prop the failed trusses as well as the adjacent truss to the North, which receives the other end of the old lifting beam. Tracking the location of these SHS props through the floor, it was noted that the columns are sat on the boards between joists, and away from primary North-South beams.

**Photograph 19 – Steel props at second floor beneath roof truss ties.  
Note props load onto second floor beams below (i.e., they are not over columns)**

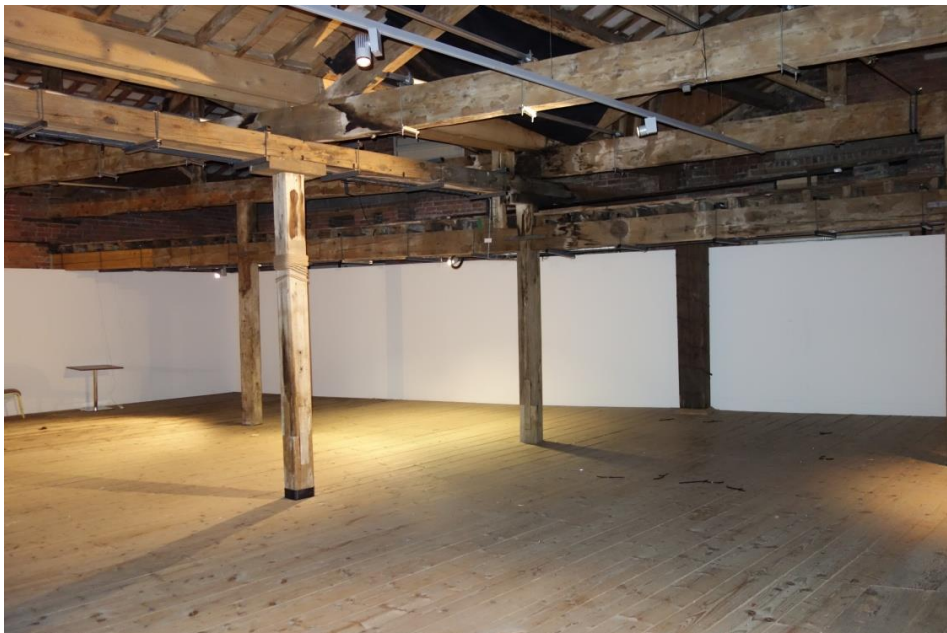
**Photograph 20 – A general view of the top floor of the building, showing typical arrangement of regularly spaced timber columns, block corbel heads and primary valley beams onto which the timber Queen post trusses sit.**

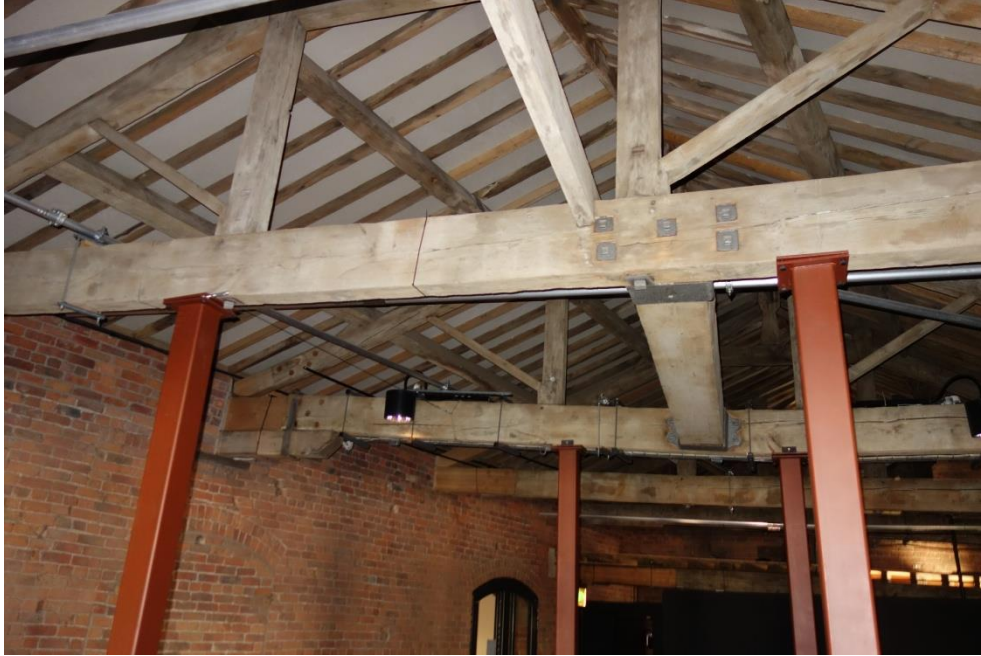
- 4.1.1 Deflection of the bottom chord of the primary longitudinal roof trusses was noted in multiple locations, suggestive of under-sizing and/or overloading. The deflection is most pronounced at Bay 2, where there has been historic overloading of the trusses during goods movement into and out the warehouse. Significantly sized lifting beams are secured to the side of these tie beams and running north-south between trusses. In 2 No. locations, the tie beam (bottom chord) has actually snapped (see photos 21 & 22).

- 5.6 It is evident that historic local overloading of the truss bottom chords in second floor Bay 2 is the cause of the additional, more pronounced deflection and tie beam failure. Semi-permanent propping in the form of SHS posts have been installed (likely in 1992) and serve to transfer the roof load to the floorboards and joists of the 2<sup>nd</sup> floor, and away from primary structure. The failure of the tie beam in this Bay 2 truss means that the post at this location will be receiving the majority of the roof load, and it is our opinion that the floorboards and joists under are not suitable to receive such loading in the long term. Whilst no failure is evident in the boarding, minor stress fractures were seen in the joist directly below the prop that is beneath the failed truss A repair should be implemented to re-establish the structural integrity of this tie beam thereby re-instating the original load path down the primary timber posts.

**Photograph 21 – Square Hollow Section columns (4No), serve to prop failed trusses at the East side of Bay 2.**

- Discuss with the Science Museum Group regarding their options for removing the propping.
- To facilitate removing the propping, the bottom chord of the truss should be strengthened across the length of the failed chord using new steel plate details. A repair detail would likely involve plates bolted either side of the bottom chord to span from primary valley beam to wall. Failure and significant bowing of existing bottom chords makes member recovery difficult. Careful consideration of temporary works would be required for all remediation options.
- The failure of the bottom chord of the southern truss in Bay 2 should be addressed using localised plate repairs.

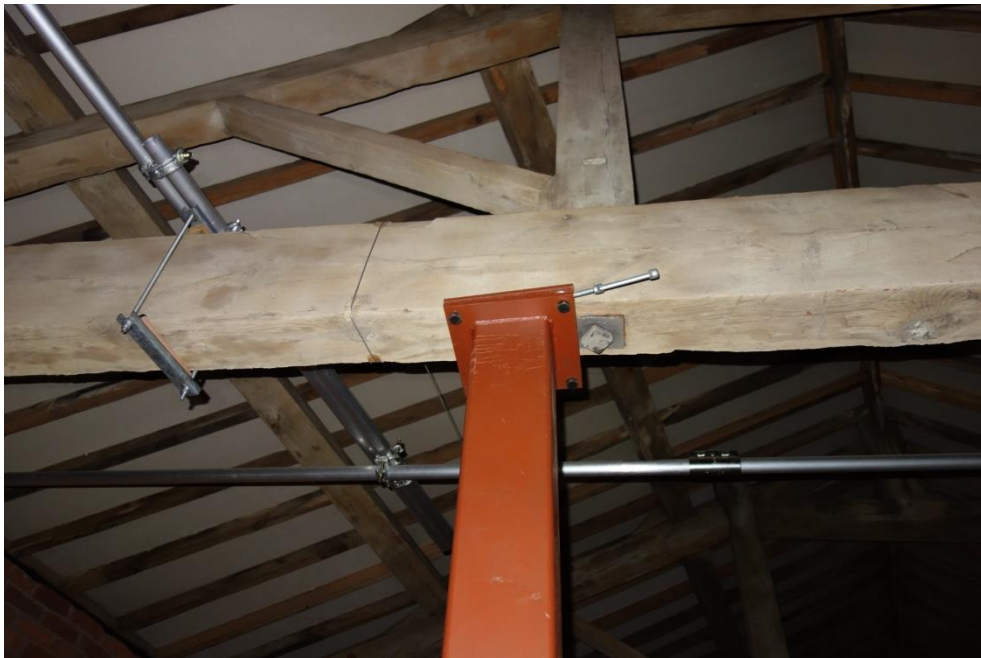
**Photograph 22 – The column head plates are pressed firmly to the underside of the trusses using a threaded plate separation system.**

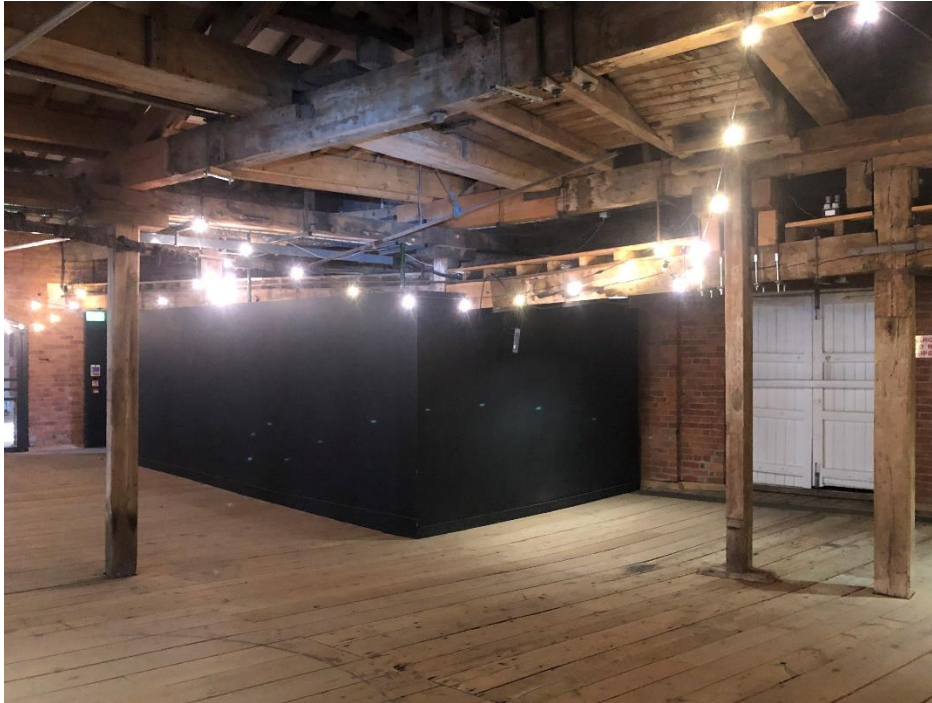
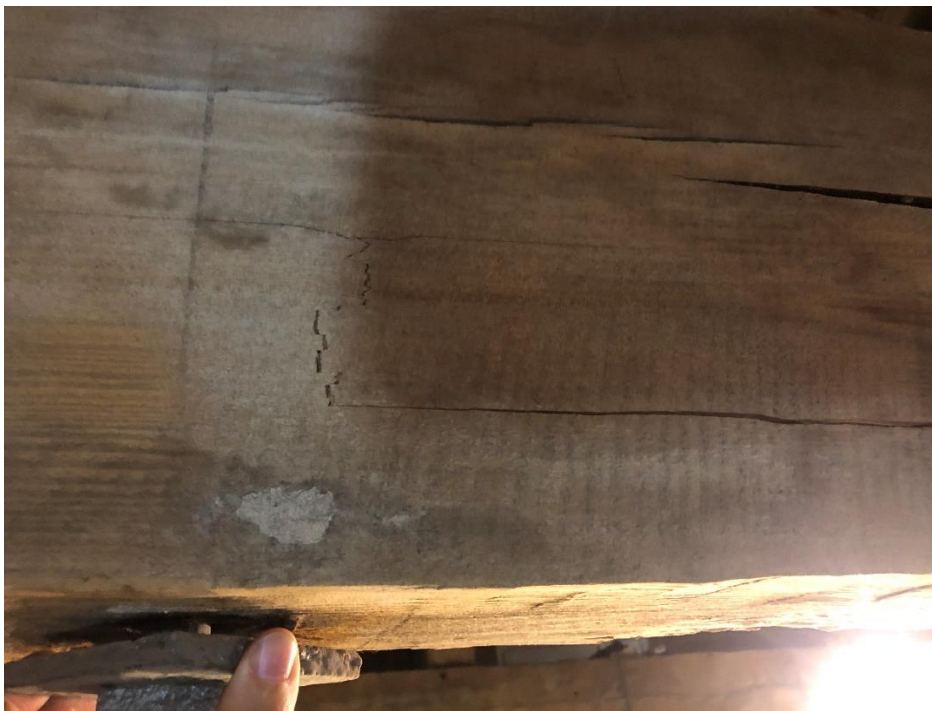
- 4.1.3 The tie beam of a primary truss to the south of the two locations noted above has also failed (see photos 23 & 24). The failure in the southern truss is close to the position of a knot which is a natural weak point, as well as being close to the king post tension rod, from which the tie beam is effectively hung.

- 5.7 The truss bottom chord immediately to the south of the propped trusses has also failed with vertical cracking observed. The failure in the tie beam is close to the king post tension rod, which is the location of the greatest vertical load in the truss. As such a repair should be implemented to enhance the shear capacity of the tie beam and enhance the robustness of the truss.

**Photograph 23 – Roof truss to the south of propped trusses in Bay 2, with cracking of main tie.**

**Photograph 24 – Close up of roof truss cracking, to the south of propped trusses in Bay 2, with cracking of main tie.**

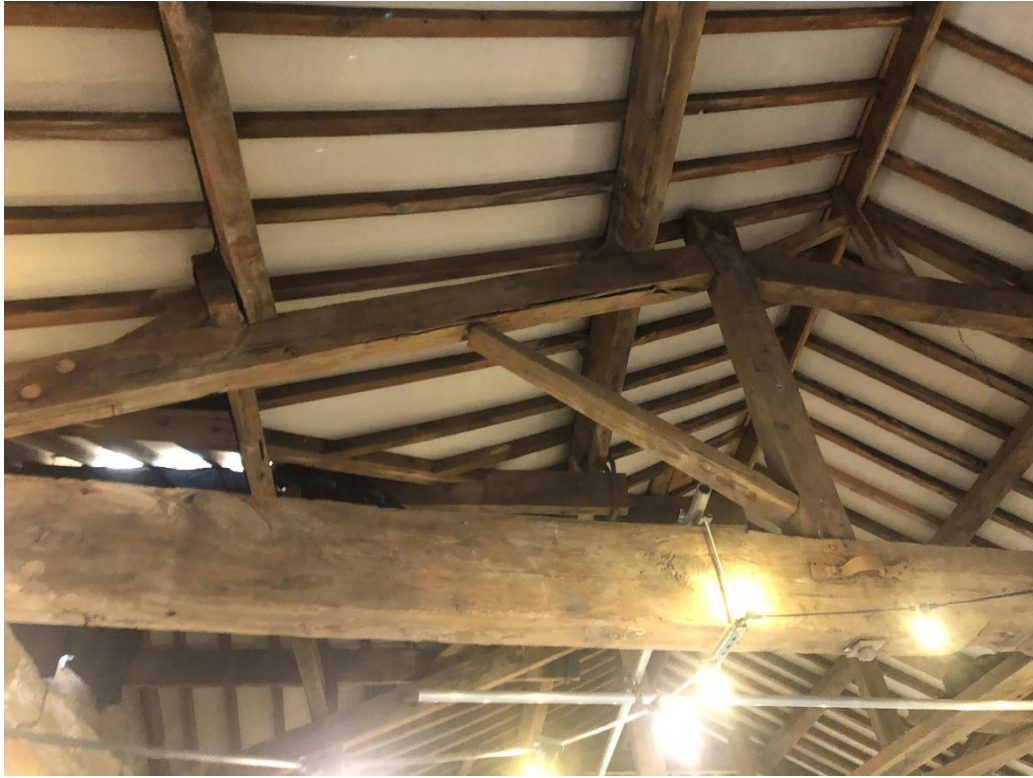
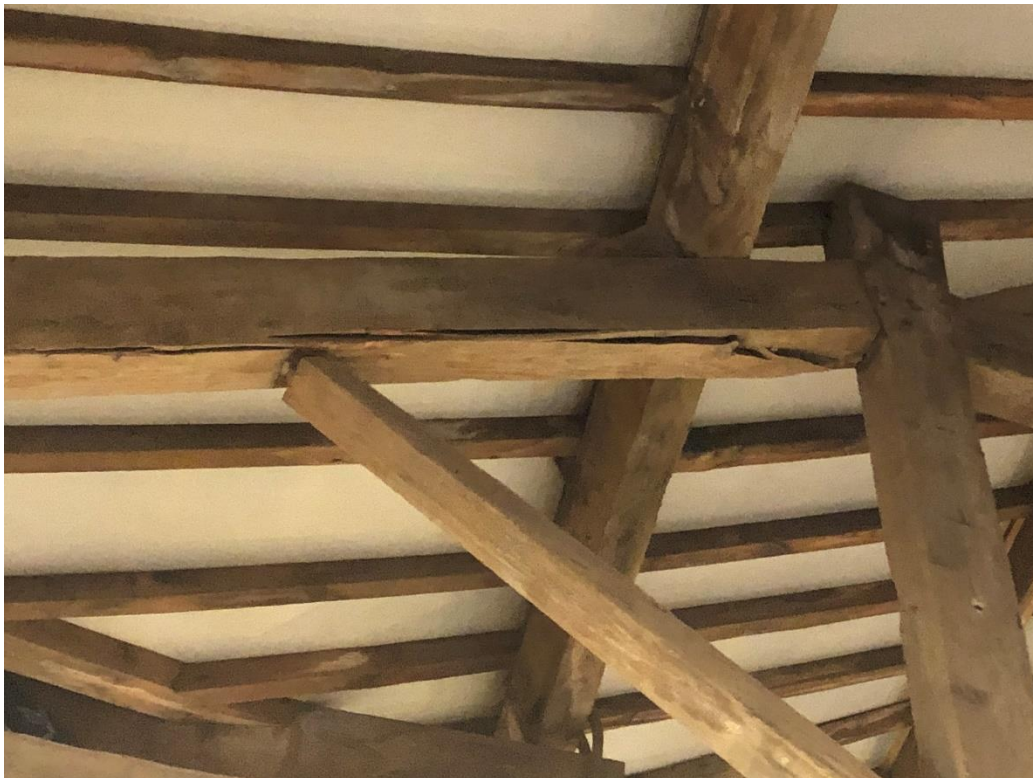
**Photograph 25 & 26 – Roof truss in Bay 1 showing high level splitting in principal rafter.**
