## Bituminous Interim Inspection

| <b>PROJECT NUMBER</b> | B190846/1 | <b>AREA MANAGER</b> | John Wilkinson |
| <b>PROJECT NAME</b> | Paterson Building - Christie Hospital | | |

| <b>INSPECTED BY:</b> | Anthony Symondson | <b>Date:</b> | 26-01-2022 |

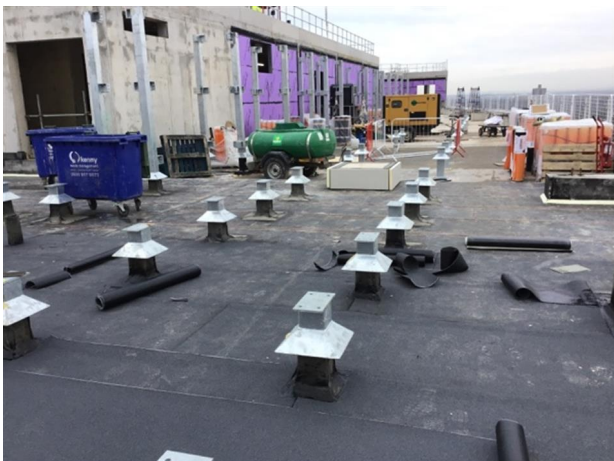
Photo 1 - View of progress to section 1

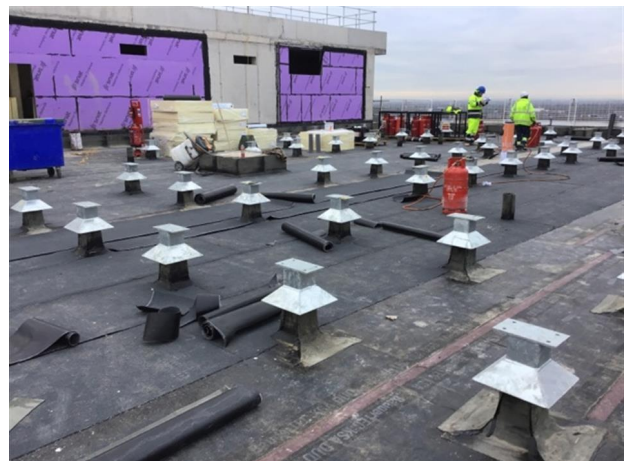
Photo 2 - Overview of section 1

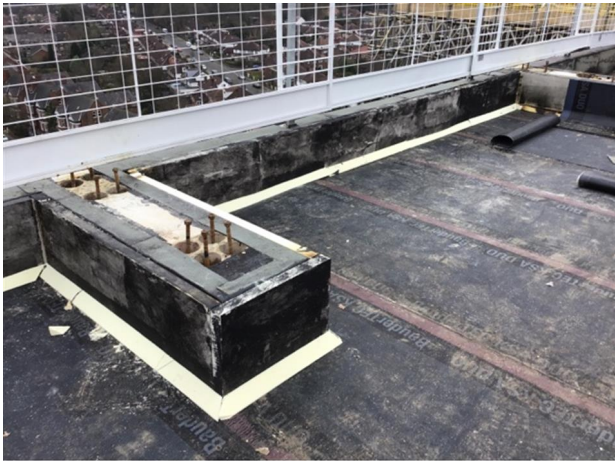
**Photo 3 - View of up stand to section 1**

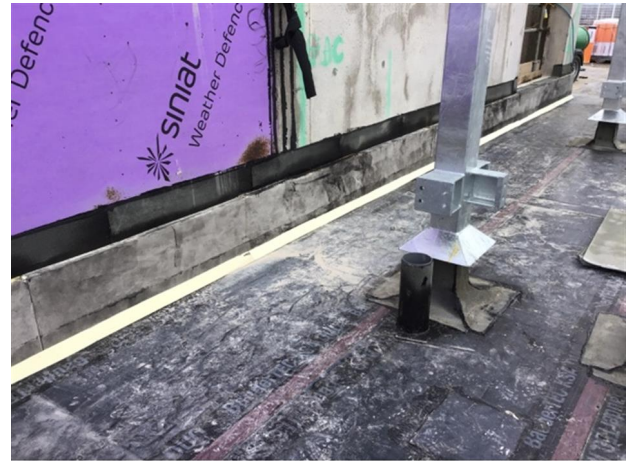
**Photo 4 - View of up stand to level 9**

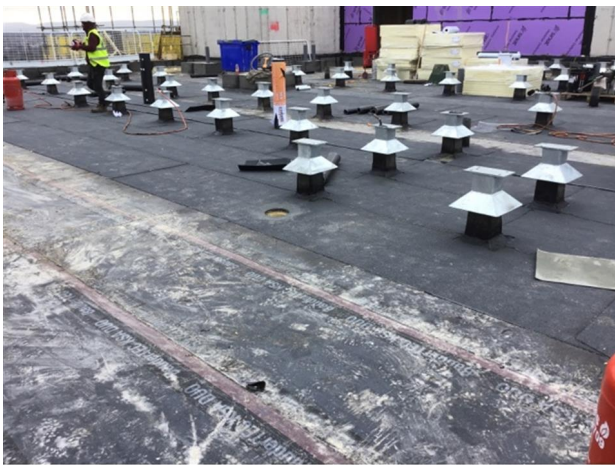
**Photo 5 - View of progress to level 9**

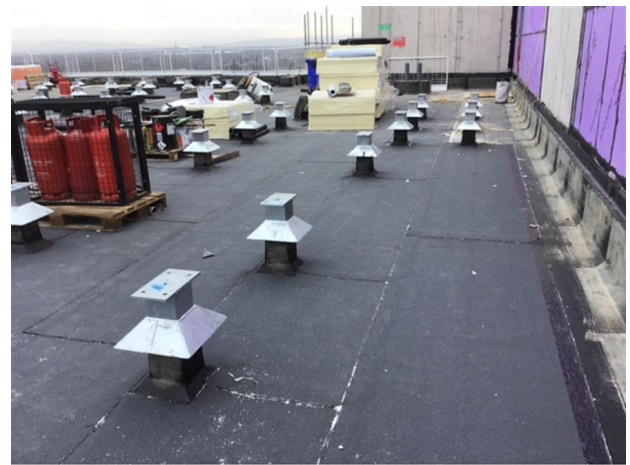
**Photo 6 - View of cap sheet to level 9**

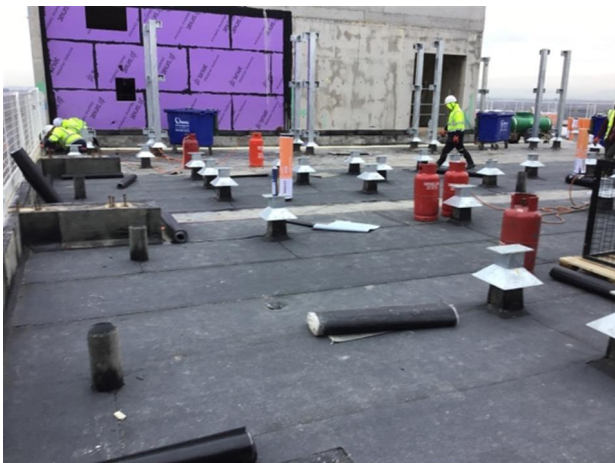
**Photo 7 - View of level 9**

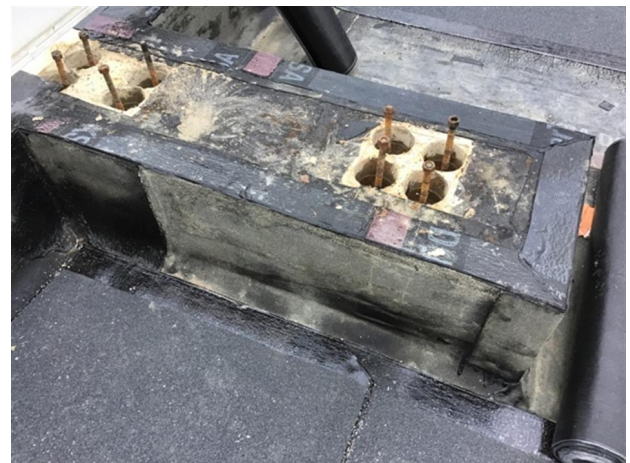
**Photo 8 - View of two layer underlay up stand**

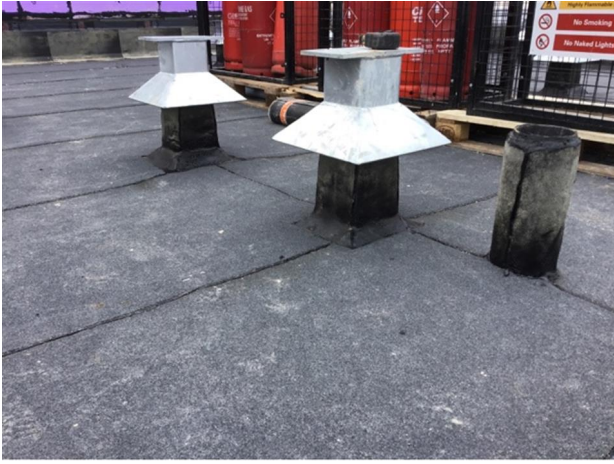
**Photo 9 - View of steel support**

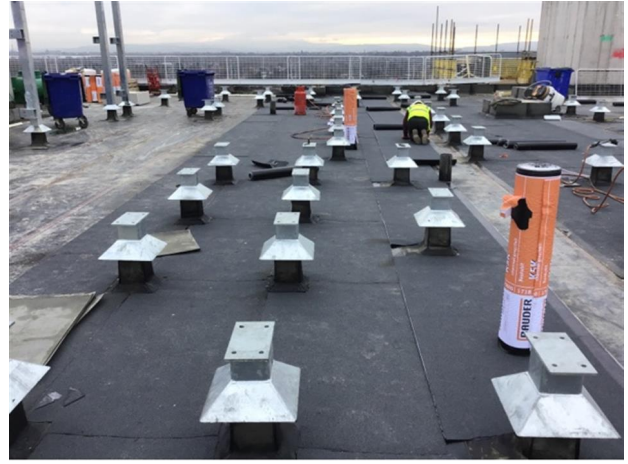
**Photo 10 - View of cap sheet to level 9**

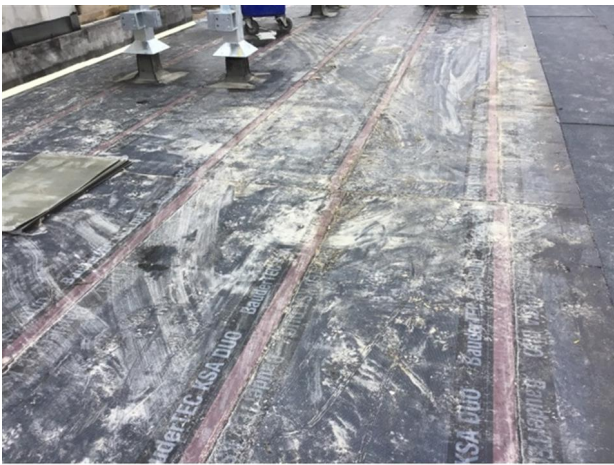
Discussed with operatives that underlay will need cleaning prior to cap sheet being installed due to dust and dirt build up from trafficking

**Photo 11 - View of underlay as comments**

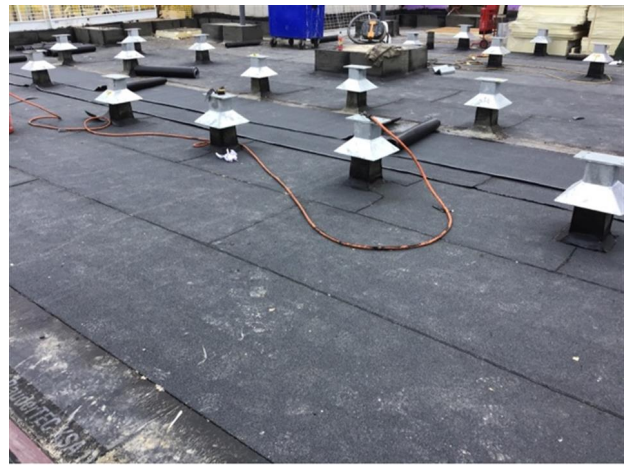
**Photo 12 - View of cap sheet to level 9**
