Ref: 211108.L.002  
24 March 2022

**Re: Gas Membrane Validation – Drama Block, Belle Vue Coop Academy**

- **Belle Vue Coop Academy, Manchester M12 5AL**

## **Enclosure 2 – Photographs**

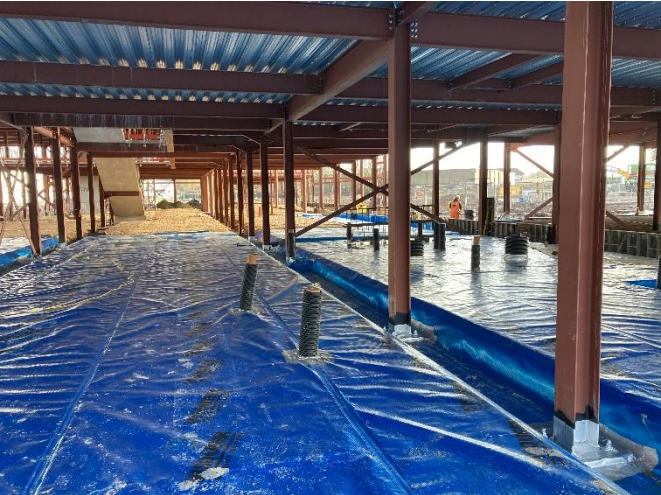
Failed inspections were due to unsealed penetrations in the membrane and/or incomplete membrane coverage. This letter report confirms the final validation of the Drama Block after Visit 3.

| 1. | View of area showing partial membrane installation. | |

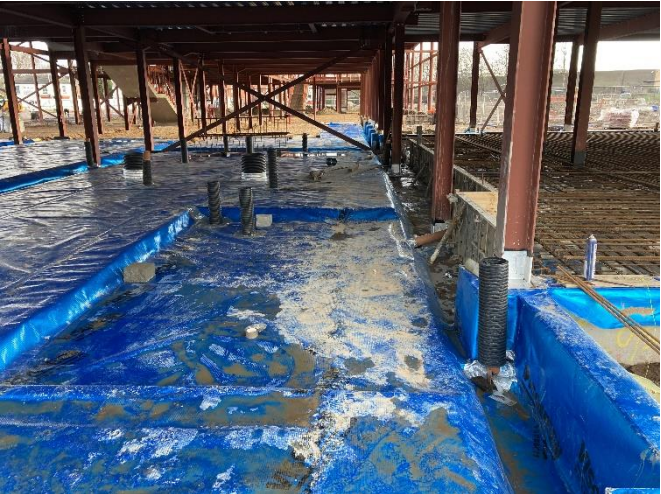
| 2. | View of area showing partial membrane installation. | |

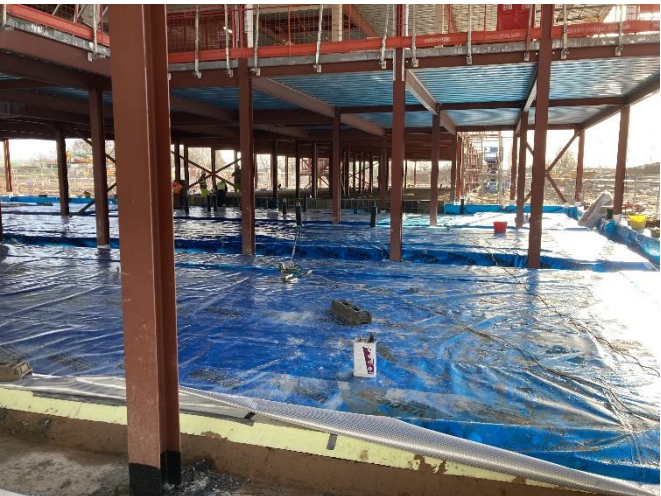
| 3. | View of area showing partial membrane installation. | |

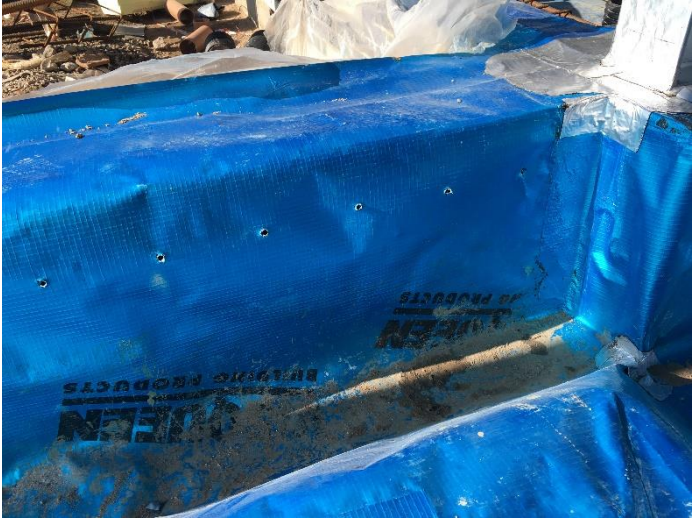
| 4. | View of the dowel holes within the gas membrane, awaiting sealing with Axiom. | |

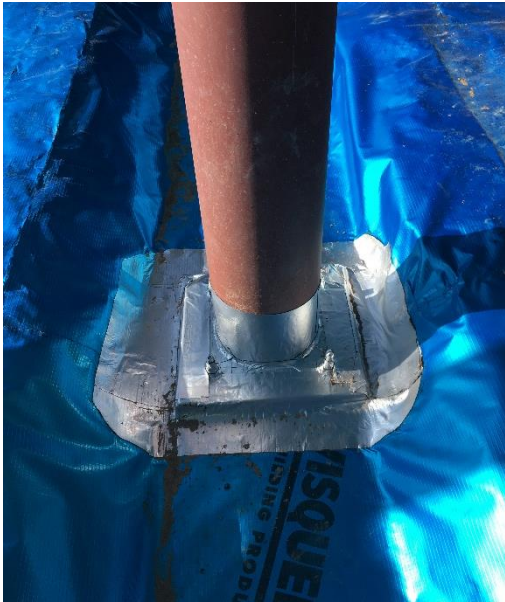
| 5. | View of the stanchions confirming the Visqueen design has been followed accordingly. | |

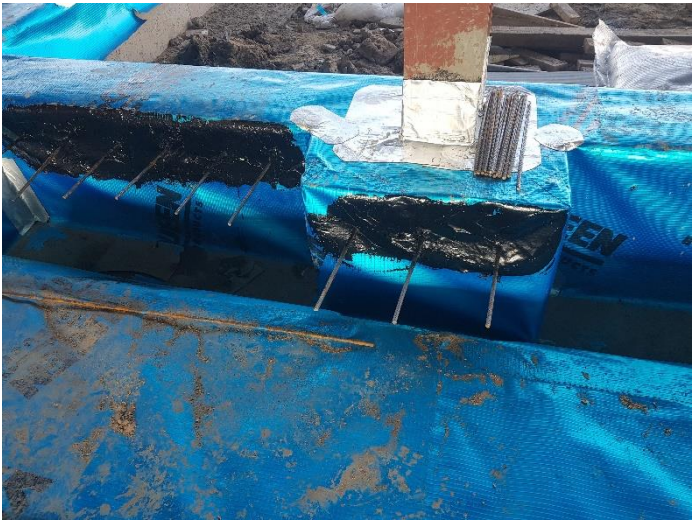
| 6. | View of ongoing work, showing sealed dowel entries on the left and centre of the site and to be sealed entries on the right. | |

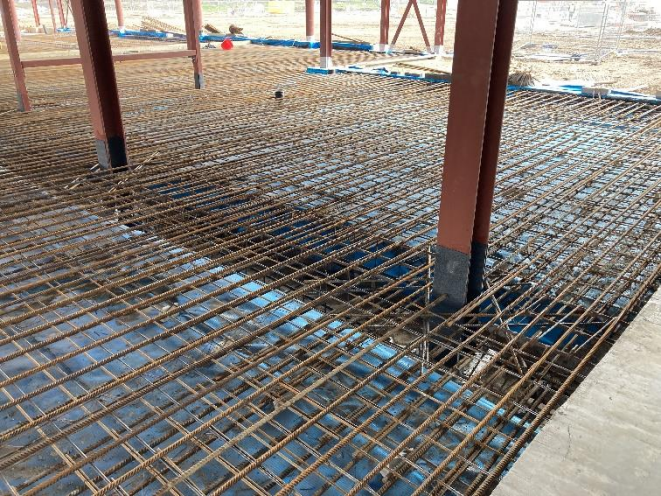
| 7. | View confirming Visqueen membrane installation across the entire footprint of the plot (beneath the steel works). | |

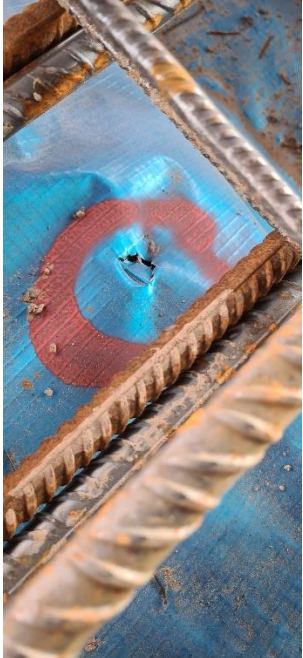
| 8. | Damage caused to membrane (1 of 59 identified during the site visit). | |

The membrane should be protected from any follow-on work, any damage must be repaired prior to concrete pouring.

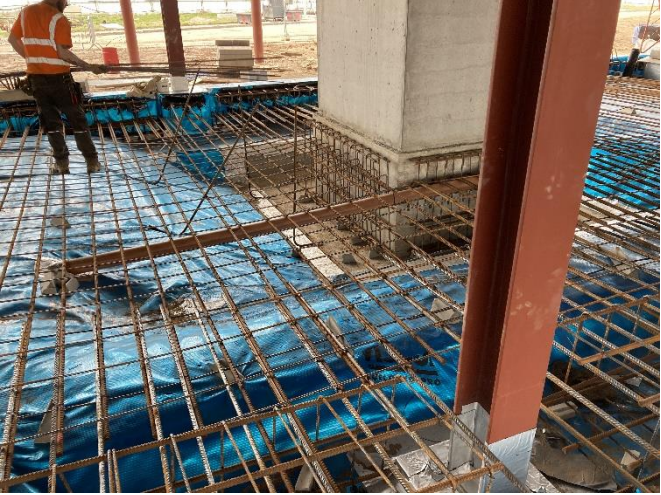
| 9. | View confirming Visqueen membrane installation across the entire footprint of the plot (beneath the steel works). | |

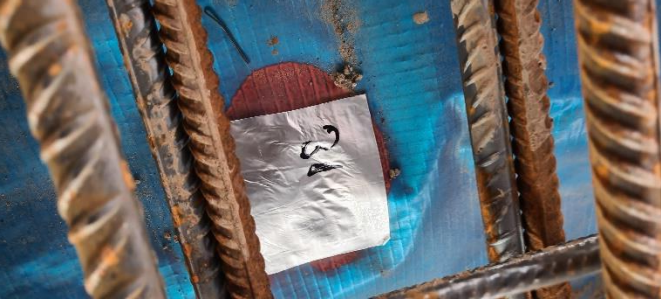
| 10. | Repair of damage caused by follow-on steel works (31 of 59). | |

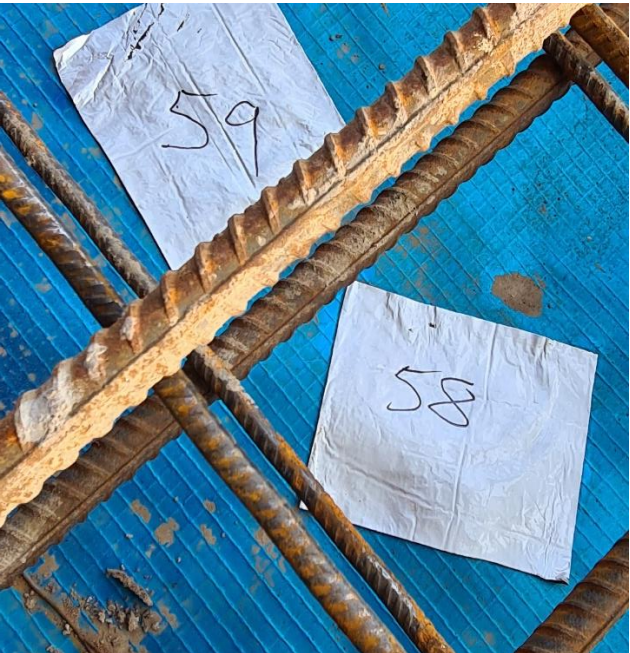
| 11. | Repair of damage caused by follow-on steel works (58 and 59 of 59). | |

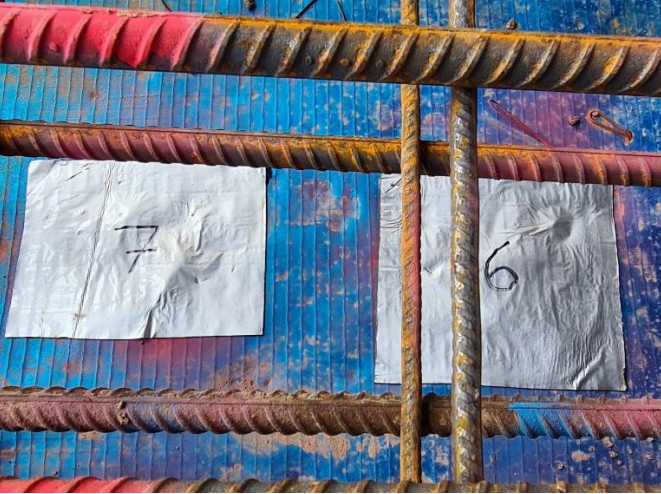
| 12. | Repair of damage caused by follow-on steel works (16 and 17 of 59) | |

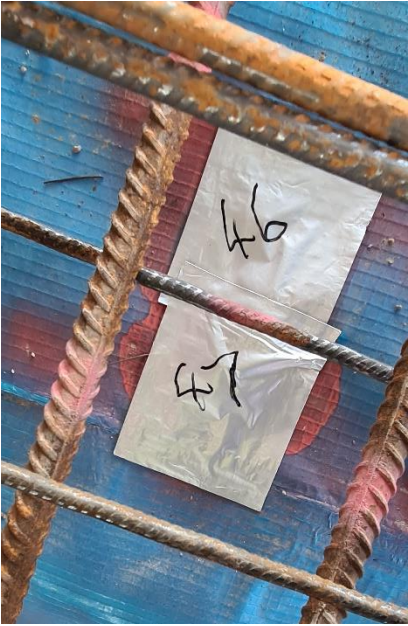
| 13. | Repair of damage caused by follow-on steel works (46 and 47 of 59) | |

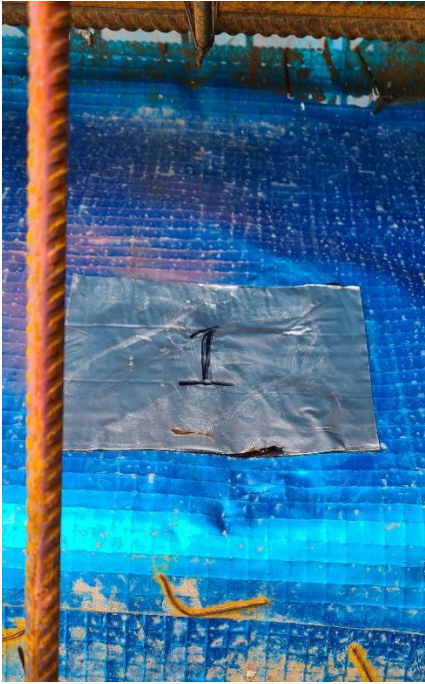
| 14. | Repair of damage caused by follow-on steel works (1 of 59) | |

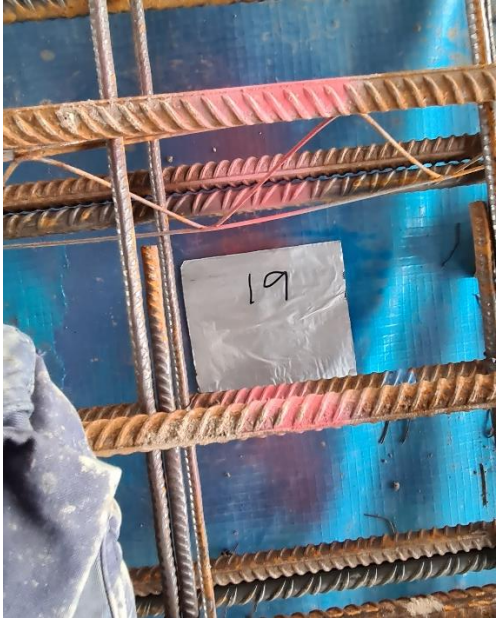
| 15. | Repair of damage caused by follow-on steel works (19 of 59) | |

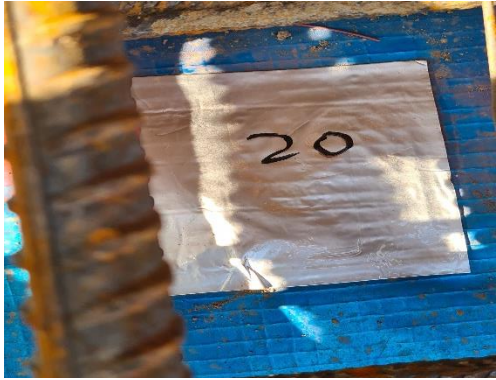
| 16. | View of damage caused by follow-on steel works (20 of 59) | |

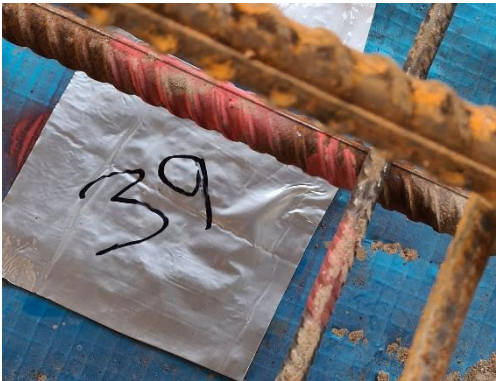
| 17. | View of damage caused by follow-on steel works (39 of 59) | |
