# Site Investigation Report

97980.1.USI

| Brief | Auger were commissioned by Crawford & Co to undertake a site investigation and CCTV inspection of the underground drainage within the area of concern at the property. |

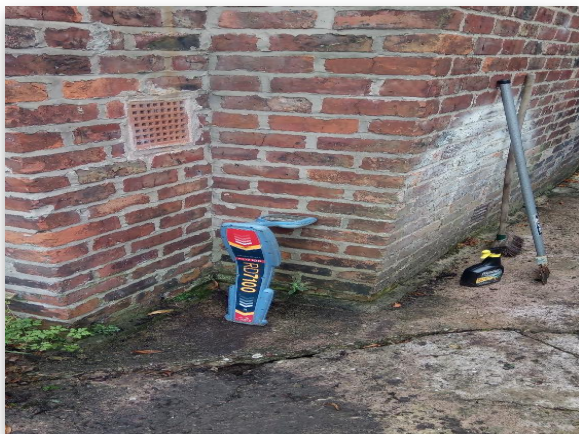
Fig 2.1: Trial Hole 2 Location

| Trial Hole Findings | We were unable to collect root samples from TH2 because no roots were located within the trial hole. |

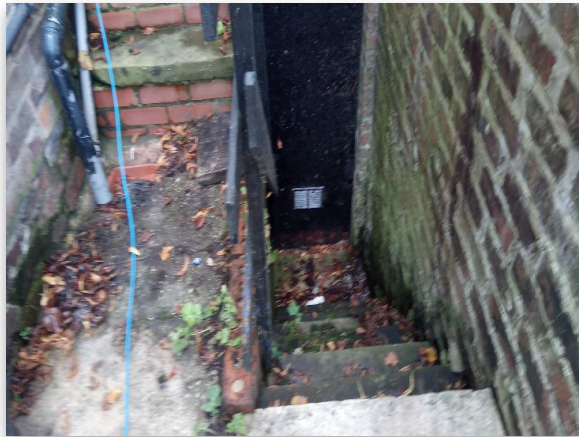
| Visual Inspection | <p>A visual inspection of the site revealed that WG2 at the base of the cellar steps has cracked and is allowing the escape of water.</p> <p>We carried out a water mains listening test whilst on site which revealed that there was no evidence of a leak on the incoming water supply serving the property.</p> <p>The RWP to the front of the property was also found to be expelling directly to ground. We would advise that this is re routed into a soakaway or the nearest drainage system on a private basis.</p> |

Fig 7.1: WG and steps to cellar.

On line 2, excavate and replace WG2 and 1.5m of 100 mm pipework including a branch connection at a depth no greater than 1m. This will require excavating through 2 of the cellar steps.

*It will be necessary to remove and re-build part of the steps to facilitate the recommended repairs. We have allocated a half day in the quotation to undertake this work, however currently the make up of the steps are unknown, if any complications arise with these works then additional cost will be incurred.*

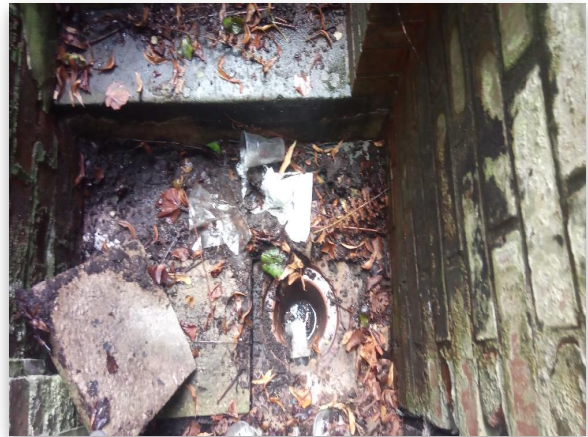
Fig 7.2: WG2.

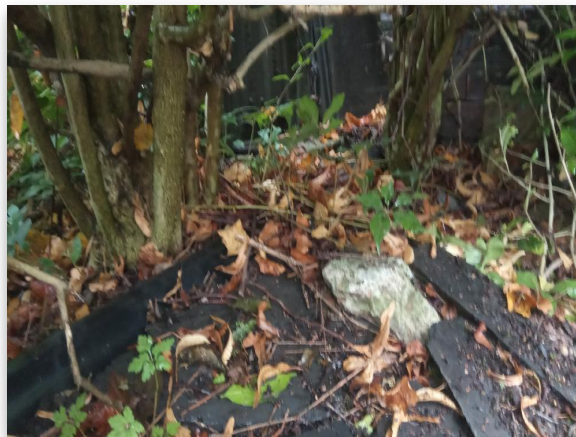
Fig 7.3: RWP at front to ground
