Ref: 211108.L.001  
11 February 2022

**Re: Gas Membrane Validation – Teaching Block, Belle Vue Coop Academy**

- **Belle Vue Coop Academy, Manchester M12 5AL**

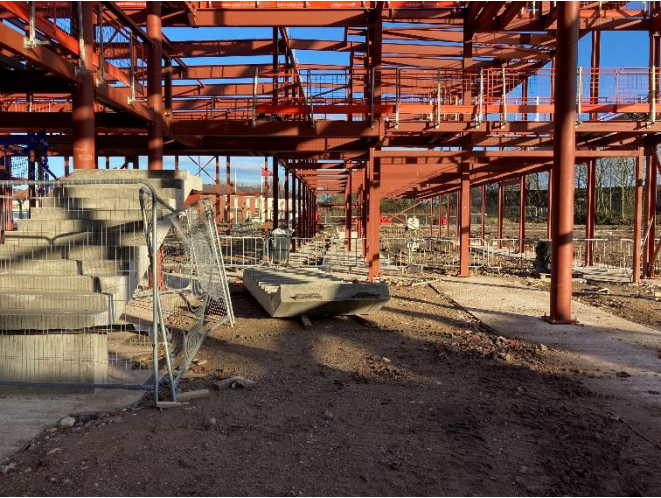
| 1. | View of area where membrane is to be laid. | |

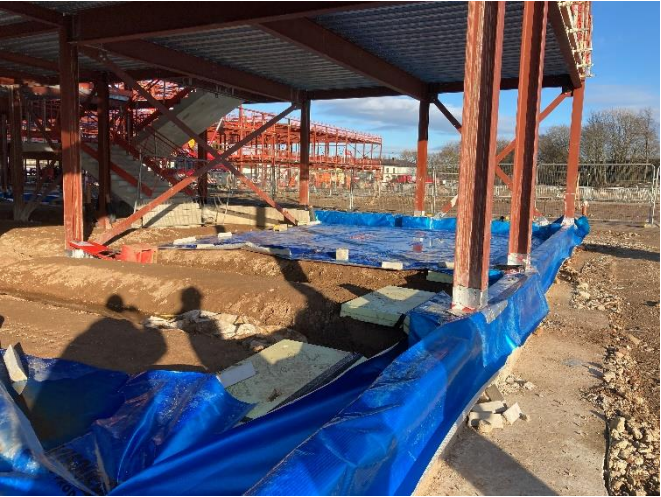
| 2. | View of the first portion of membrane installed, on southern edge of Teaching Block. | |

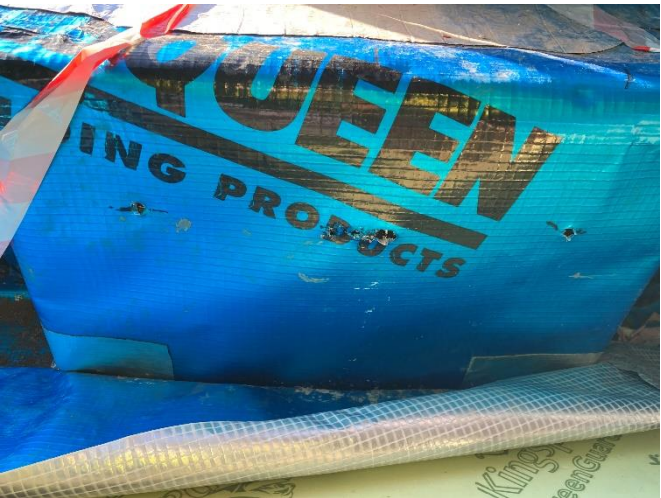
| 3. | Penetrations within the membrane prior to insertion of dowels for steel works. | |

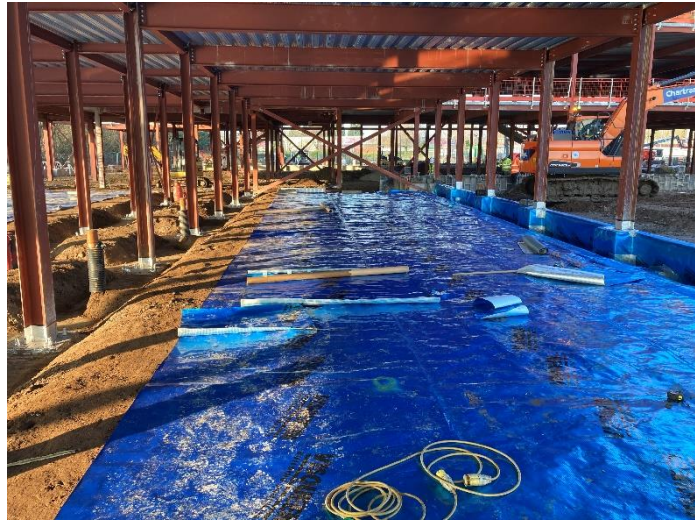
4.

View of the gas membrane confirming the joint was heat welded and suitably installed with a 150mm overlap present.

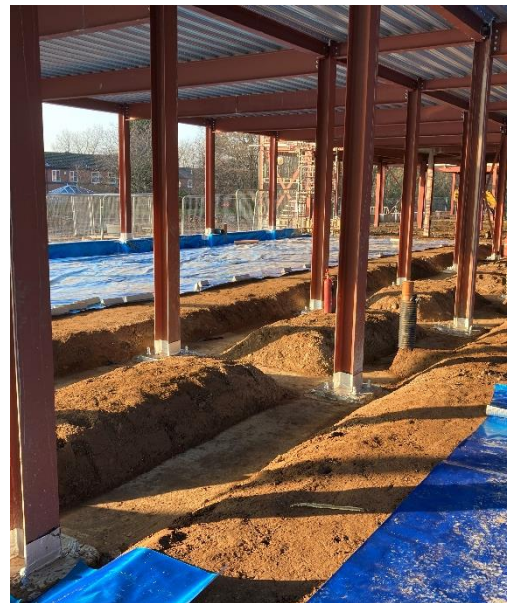
5.

View of the stanchions confirming the Visqueen design has been followed accordingly.

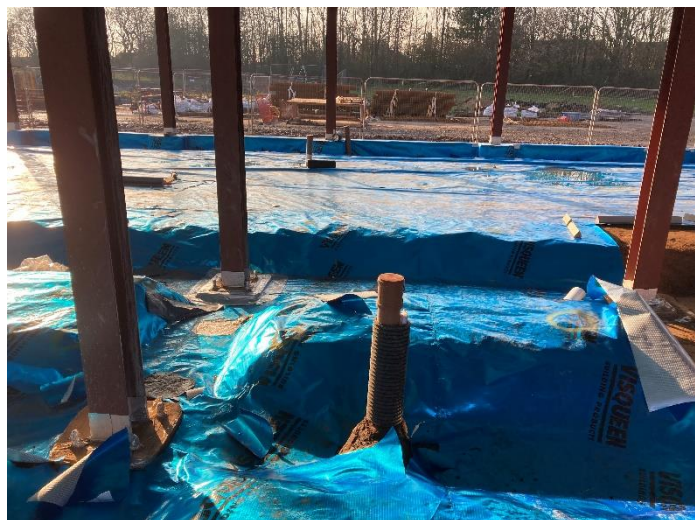
6.

View of ongoing work, with stanchion shown on the left and service entry on the centre of the photograph.

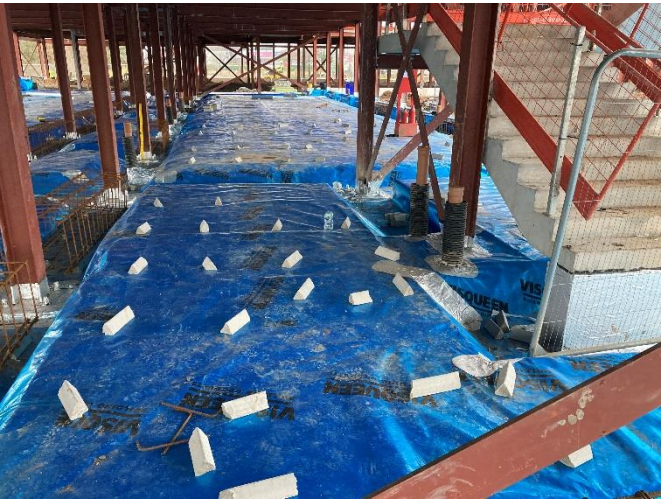
| 7. | <p>View confirming Visqueen membrane installation across the entire footprint of the plot. The membrane was installed to a suitable standard.</p> <p>Concrete blocks were placed on the surface, with the potential to cause damage. This was discussed with Chartrange (Enclosure 3).</p> | |

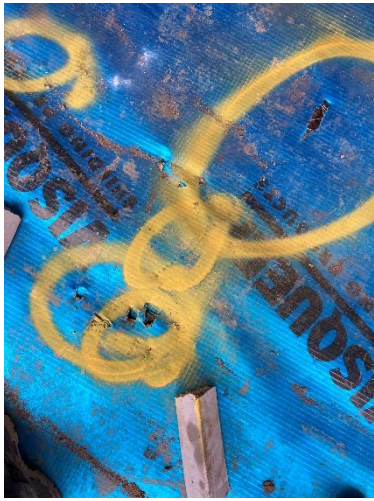
| 8. | <p>Damage caused to membrane.</p> | |

I can confirm the full area excluding the dowels of the Teaching Block has now been validated. As discussed while I was on site, damage has been caused to the membrane by follow on works. As agreed, these locations are to be repaired by Water8 Solutions with a photographic record of repairs provided following completion of the works.

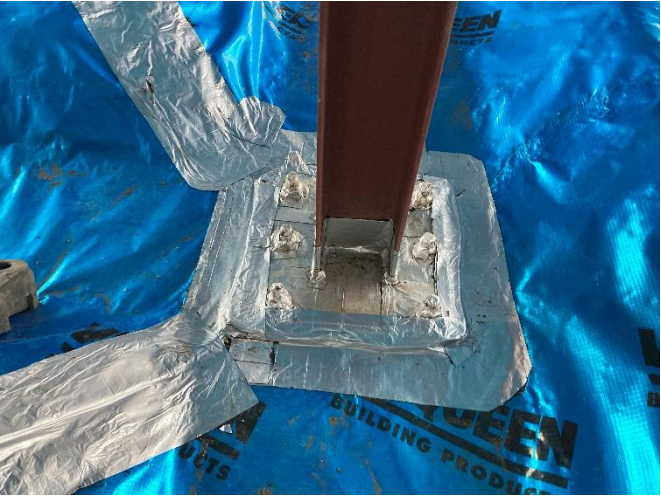
| 9. | <p>View of gas membrane and black single-sided bituminous tape used to form, seal and reinforce corners. The tape is also used, as per the Visqueen design, to seal the membrane to the stanchions.</p> | |

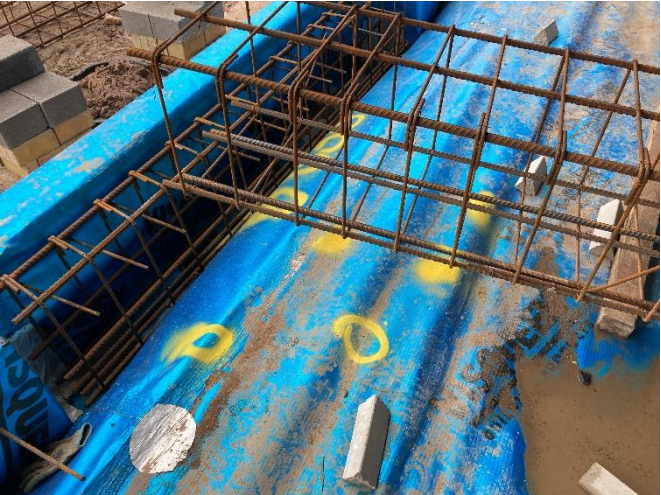
| 10. | View of damage caused by follow-on steel works. | |

Going forward, as discussed, protection is required to be used by the follow-on works to prevent any further damage, with plastic boarding used to protect the membrane from the steel works.

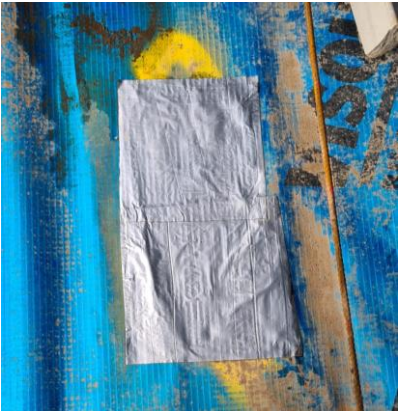
| 11. | View of repairs to membrane, undertaken after visit. Validated by photographs and on following visit. | |

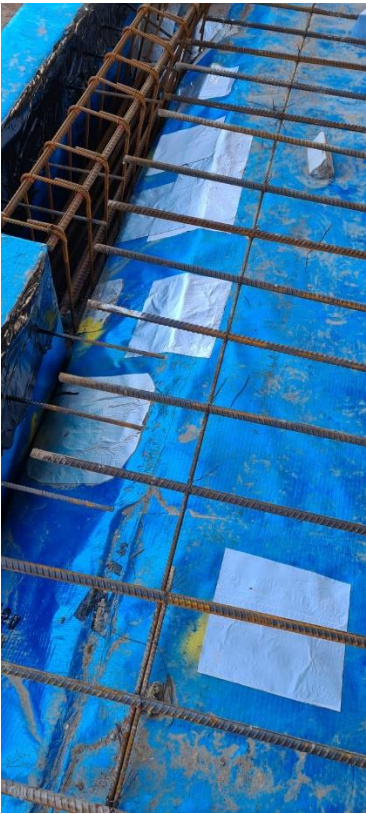
| 12. | View of repairs to membrane, undertaken after visit. Validated by photographs and on following visit. | |

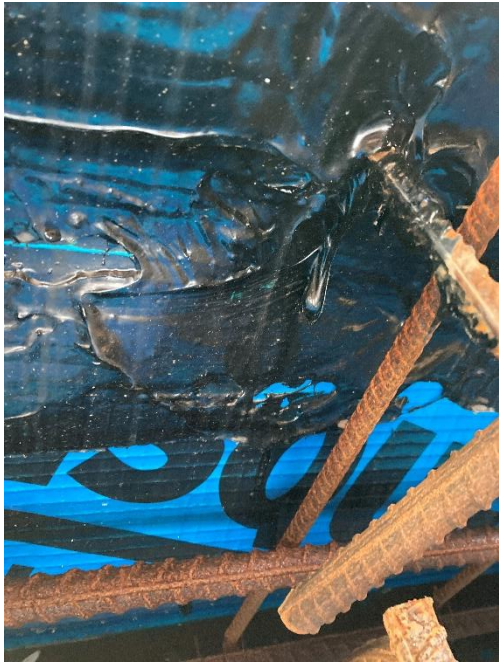
| 13. | View confirming the dowels have been sealed using Liquid Axiom, as detailed by Visqueen. | |

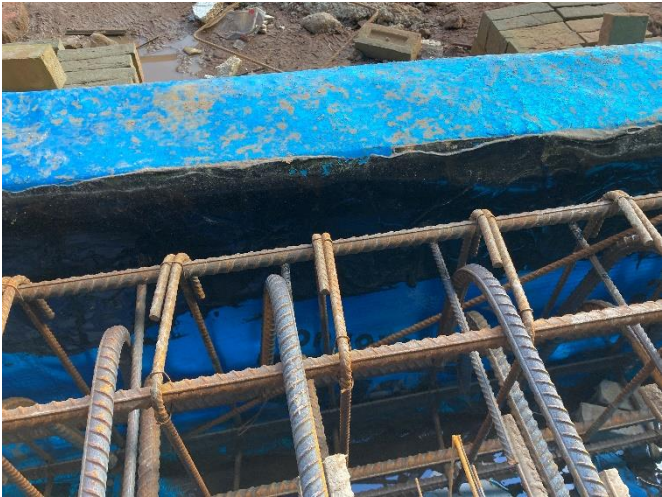
| 14. | View confirming the dowels have been sealed using Liquid Axiom, as detailed by Visqueen. | |

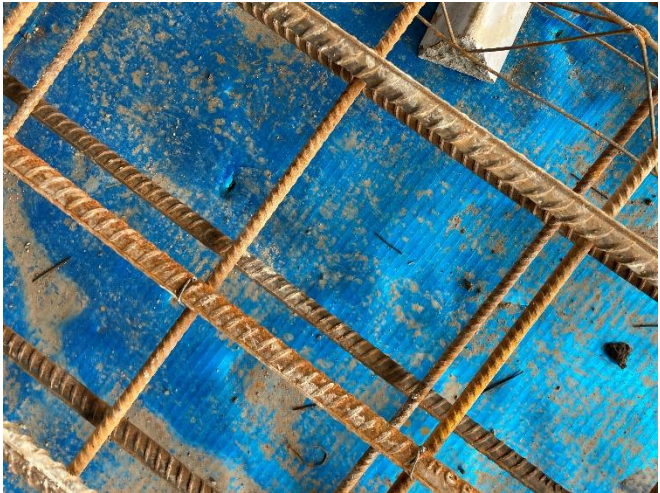
| 15. | Damage to membrane beneath the steel rebar installed prior to concrete pour. Repaired during visit to site as confirmed by RJ. | |

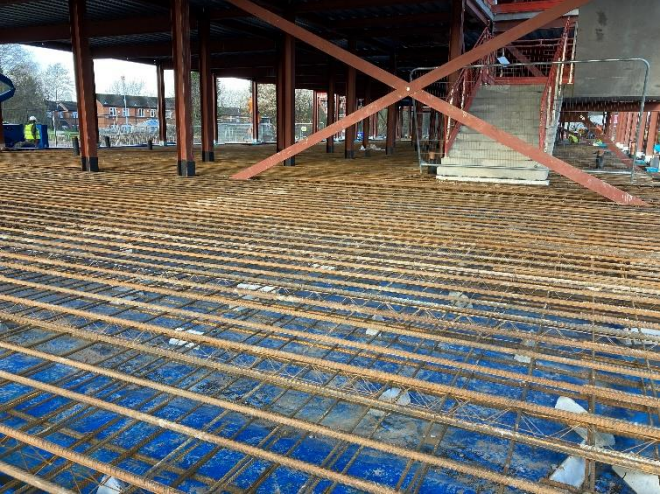
| 16. | View of gas membrane beneath the steel rebar. | |

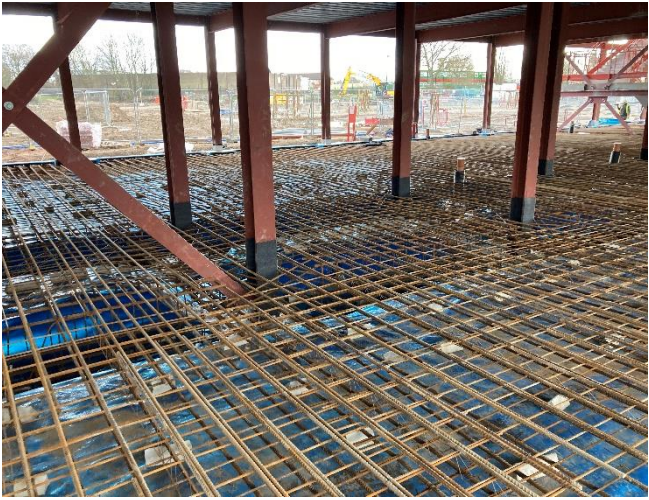
| 17. | View of gas membrane beneath the steel rebar. | |

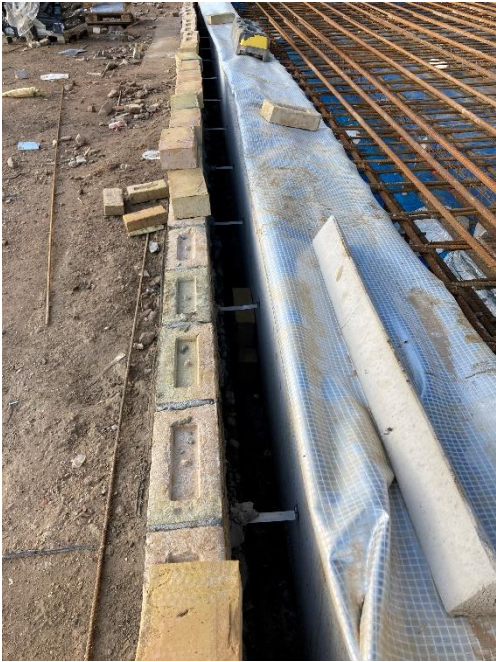
| 18. | Wall cavity confirmed as being free of debris. | |
