## Technical Note 3

| Document No: | LM21346-DYSE-XX-ZZ-TN-S-0003 |
| Content: | Sustainable Urban Drainage Strategy |

CCTV DRAINAGE SURVEY REPORT

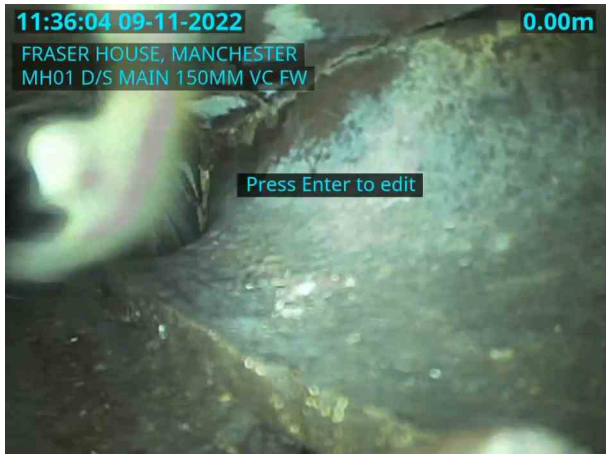
| Scale: | 1:50 | Position [m] | Code | Observation | MPEG | Photo | Grade |
|---|---|---|---|---|---|---|---|
| | | 0.01 | B | Broken pipe from 2 o'clock to 6 o'clock | 00:00:05 | MH 01X_9495520f-13f5- | 4 |

MH  
01X\_9495520f-13f5-4970-9f07-6edb2390ad7b\_20221126\_10  
5153\_408.jpg, 00:00:05, 0.01 m  
Broken pipe from 2 o'clock to 6 o'clock

Grade 4: Best practice suggests consideration should be given to repairs to avoid a potential collapse.

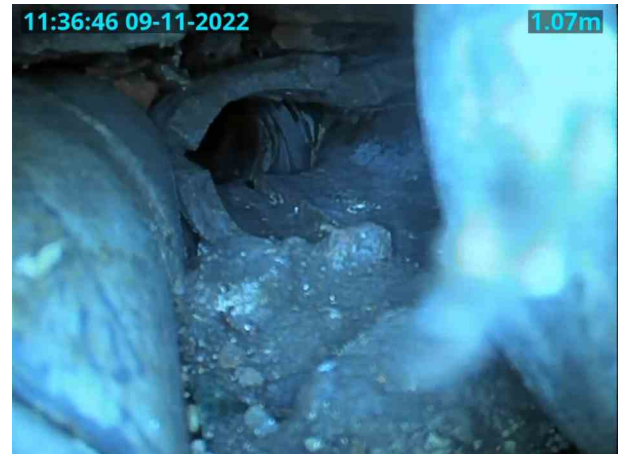
| Scale: | 1:50 | Position [m] | Code | Observation | MPEG | Photo | Grade |
|---|---|---|---|---|---|---|---|
| | | 1.07 | B | Broken pipe from 12 o'clock to 12 o'clock | 00:00:47 | MH 01X_801bd1fc-71e2- | 4 |

MH  
01X\_801bd1fc-71e2-480f-a4d8-c5f6b2f04110\_20221126\_105  
307\_415.jpg, 00:00:47, 1.07 m  
Broken pipe from 12 o'clock to 12 o'clock

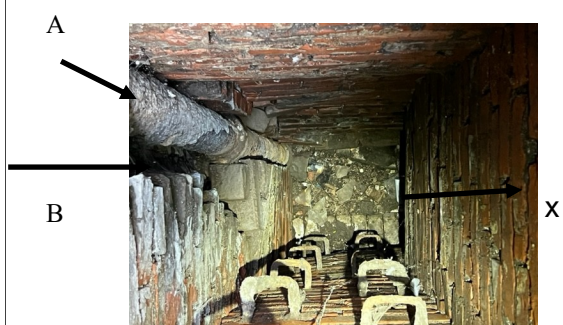
Remarks: Cover broken Step irons poor  
Chamber full of debris- requires cleaning

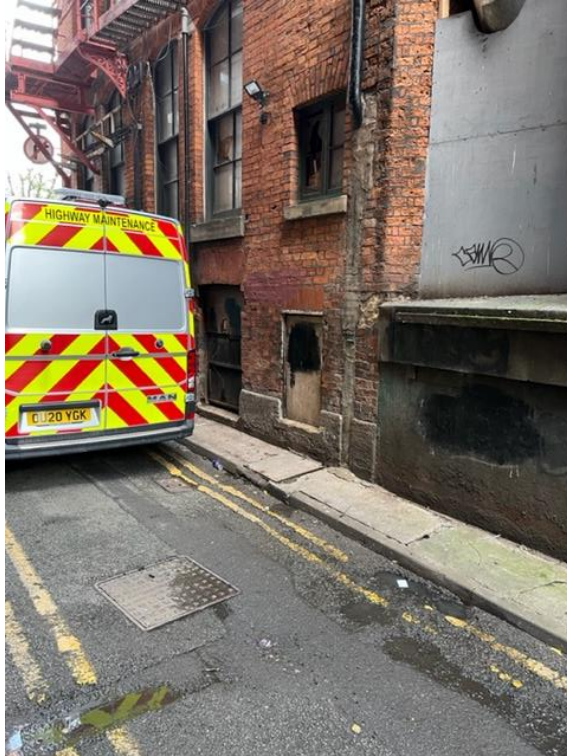
Photo 9, Public sewer manhole location
