# AquaSPEED

**RE: RENAISSANCE HOTEL, BLACKFRIARS STREET, MANCHESTER, M3 2EQ**

### **CCTV SURVEY**

## BLACKFRIARS STREET MANCHESTER - CCTV Survey Report : 15/06/21

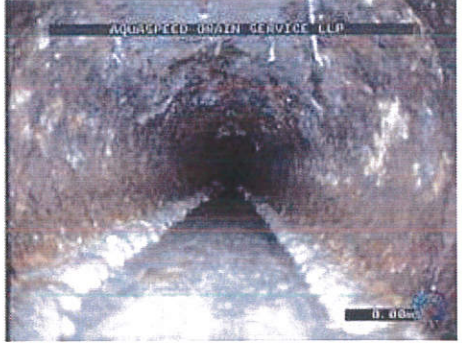
| <b>Section: 1</b><br><br>From: 6507<br>To: DOWNSTREAM | LINE HAS 5 % GREASE WOULD RECCOMEND CLEANING AND FOLLOW UP CCTV APPROX 1HR THIS WOULD BE OOHS | DRB Grade: <b>B</b><br>Pipe Size: 225<br>Material: Cast Iron<br>Use: Combined |

| Pos | Video Ref | Code | Description | Image |
|---|---|---|---|---|
| 00.00m | 0:00:00 | S1 DEG | Attached deposits, grease 0m - 16.61m from 04 o'clock to 06 o'clock: 5% Cross sectional area loss - Severity 3 | Image Provided - Ref: 0_3<br> |

Survey 1, 6507 downstream 225mm – this line contains grease deposits. The tanker unit is now required to attempt to remove the grease & resurvey on completion to check. The cost would be:

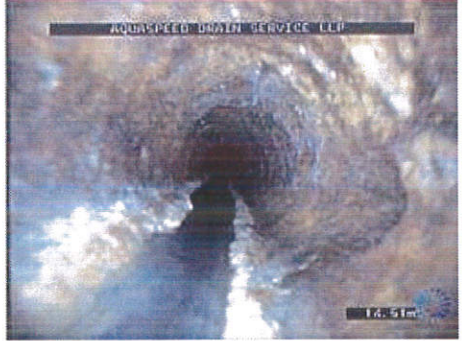
| Pos | Video Ref | Code | Description | Image |
|---|---|---|---|---|
| 14.51m | 0:01:51 | JN | Junction at 03 o'clock: 100mm Diameter | Image Provided - Ref: 0_4<br> |

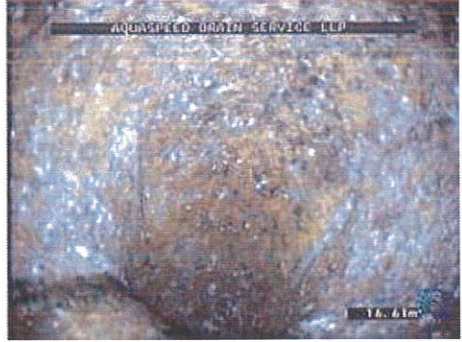
| Pos | Video Ref | Code | Description | Image |
|---|---|---|---|---|
| 16.61m | 0:02:09 | LDF | Line of drain/sewer deviates down [full] | Image Provided - Ref: 0_2<br> |

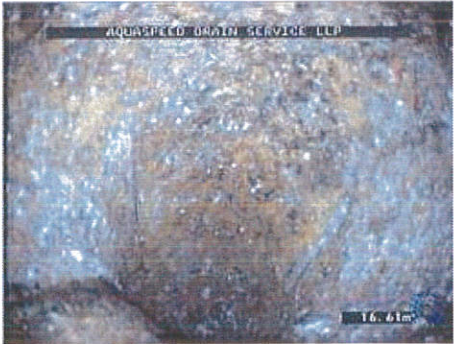
| Pos | Video Ref | Code | Description | Image |
|---|---|---|---|---|
| 16.61m | | SA | Survey abandoned<br>SHAFT DOWN | Image Provided - Ref: 0_9999<br> |

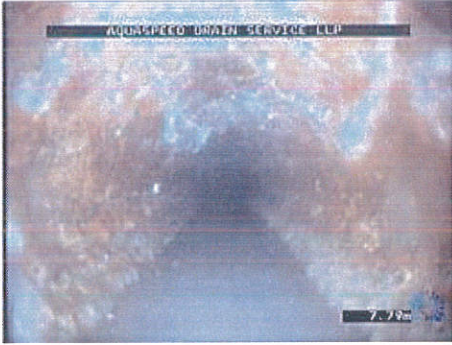
| <b>Section: 2</b><br><br>From: 6507<br>To: MH1 | LINE HAS 5 % GREASE REQ CLEANING AND RESURVEY APPROX 1HR OOHS | DRB Grade: <b>B</b><br>Pipe Size: 150<br>Material: Cast Iron<br>Use: Combined |

| Pos | Video Ref | Code | Description | Image |
|---|---|---|---|---|
| 07.80m | 0:00:57 | S1 DEG | Attached deposits, grease 7.8m - 26.21m from 05 o'clock to 06 o'clock: 5% Cross sectional area loss - Severity 3 | Image Provided - Ref: 1_3<br> |

Survey 2, 6507 to MH1 150mm – requires extensive warthog jetting to attempt to remove grease deposits & resurvey on completion to check. The cost is included in survey 1 above.

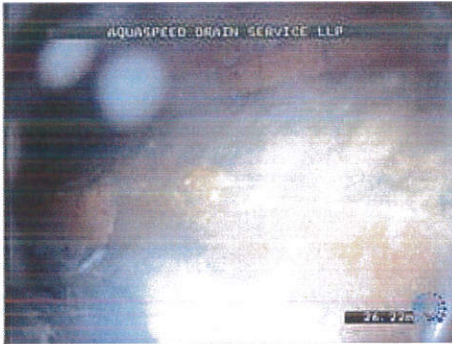
| Pos | Video Ref | Code | Description | Image |
|---|---|---|---|---|
| 26.21m | | MHF | Finish node type, manhole UPSTREAM | Image Provided - Ref: 1_9999<br> |

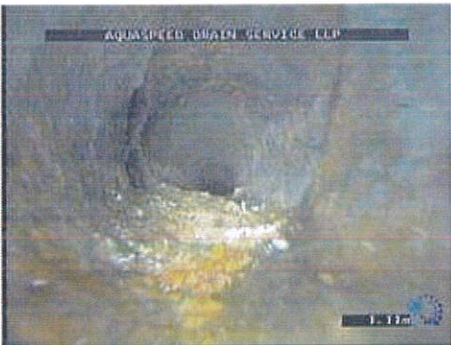
| Pos | Video Ref | Code | Description | Image |
|---|---|---|---|---|
| 01.11m | 0:00:15 | DEE | Attached deposits, encrustation from 05 o'clock to 07 o'clock: 5% Cross sectional area loss - Severity 3 | Image Provided - Ref: 2_2<br> |

Survey 3, 6507 to upstream 1 150mm – this line is encrusted & requires chain flail jetting to attempt to remove the encrustation. To enable the CCTV crawler to access the pipe, this will require confined space entry equipment [there is a gas alarm on entry of this drain]. The cost to carry out the flail jetting & CCTV crawler work is included in survey 1. The cost for the confined space equipment would be:

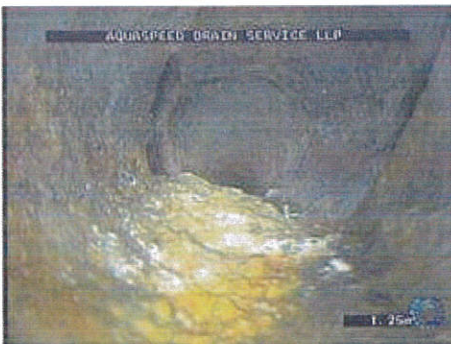
| Pos | Video Ref | Code | Description | Image |
|---|---|---|---|---|
| 01.25m | 0:00:16 | JN | Junction at 09 o'clock: 100mm Diameter | Image Provided - Ref: 2_3<br> |

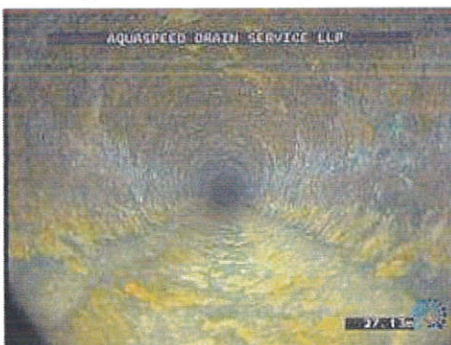
| <b>Section: 3</b><br><br>From: 6507<br>To: UPSTREAM 1 | UNABLE TO PUSH FURTHER AND GAS ALARM ON ENTRY WILL REQ CHAIN FLAIL AND CLEANING TO ALLOW CRAWLER TO ACCESS PIPE DUE TO DISTANCE APPROX 2 HR OOHS | DRB Grade: <b>B</b><br>Pipe Size: 150<br>Material: Cast Iron<br>Use: Combined |

| Pos | Video Ref | Code | Description | Image |
|---|---|---|---|---|
| 27.13m | | SA | Survey abandoned<br>UNABLE TO PUSH FURTHER<br>AND GAS ALARM ON ENTRY | Image Provided - Ref: 2_9999<br> |

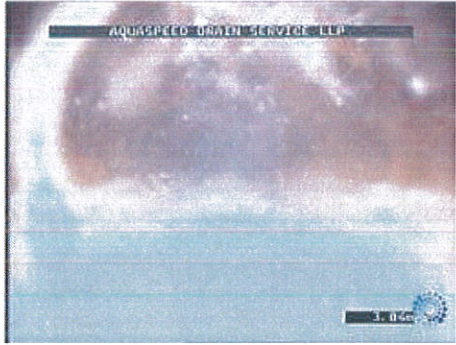
| Pos | Video Ref | Code | Description | Image |
|---|---|---|---|---|
| 03.05m | 0:00:29 | WL | Water level: 10% Height/Diameter | Image Provided - Ref: 3_2<br> |

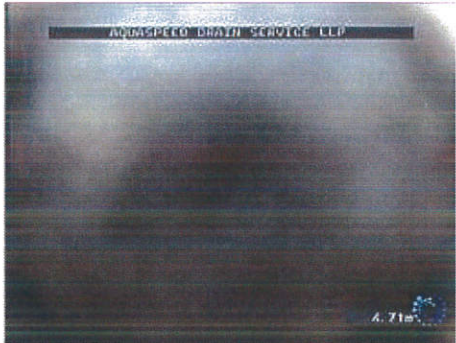
| <b>Section: 4</b><br><br>From: MH2<br>To: MH1 | LINE HAS BELLY THIS REQ JETTING TO REMOVE WATER FROM LINE AND FOLLOW UP CCTV APPROX 1 HR OOHS | DRB Grade: <b>A</b><br>Pipe Size: 150<br>Material: Cast Iron<br>Use: Combined |

| Pos | Video Ref | Code | Description | Image |
|---|---|---|---|---|
| 04.71m | 0:00:39 | WL | Water level: 50% Height/Diameter | Image Provided - Ref: 3_3<br> |

Survey 4, MH2 to MH1 150mm – there is a dip in this line which requires further jetting to remove the holding water & resurvey on completion to check. Cost included in survey 1.

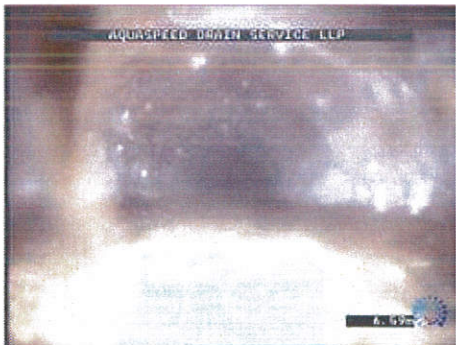
| Pos | Video Ref | Code | Description | Image |
|---|---|---|---|---|
| 06.59m | 0:00:52 | WL | Water level: 10% Height/Diameter | Image Provided - Ref: 3_4<br> |

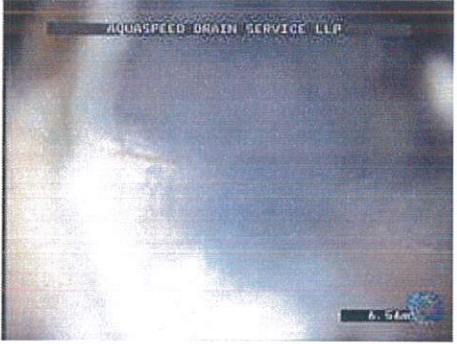
| Pos | Video Ref | Code | Description | Image |
|---|---|---|---|---|
| 06.59m | | MHF | Finish node type, manhole MH1 | <p>Image Provided - Ref: 3_9999</p> |

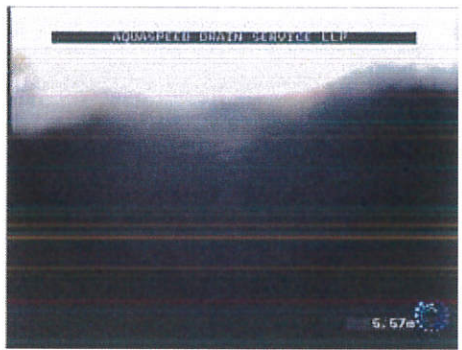
| Pos | Video Ref | Code | Description | Image |
|---|---|---|---|---|
| 05.56m | 0:00:00 | DES | Settled deposits fine: 40% Cross sectional area loss - Severity 3 | Image Provided - Ref: 4_2<br> |

Survey 5, MH2 upstream 150mm – this requires manhole / confined space entry to allow the line to be cleaned & surveyed. Cost included in survey 1.

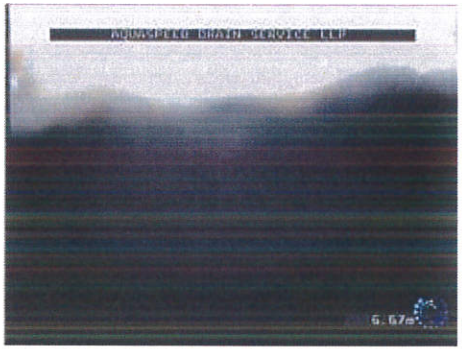
| <b>Section: 5</b><br><br>From: MH2<br>To: UPSTREAM | REQ MH ENTRY TO ACCESS TO CLEAN LINE AND FOLLOW UP CCTV APPROX 1 HR OOHS | DRB Grade: <b>B</b><br>Pipe Size: 150<br>Material: Cast Iron<br>Use: Combined |

| Pos | Video Ref | Code | Description | Image |
|---|---|---|---|---|
| 05.57m | | SA | Survey abandoned DEBRIS AND STOPPED LINE TAKES ACO | Image Provided - Ref: 4_9999<br> |

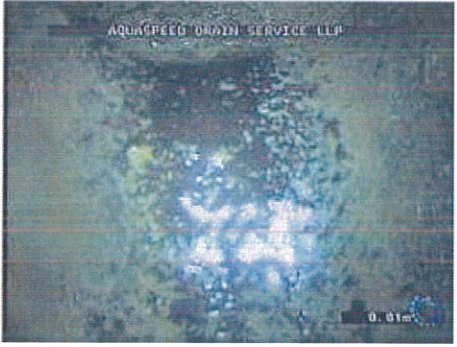
| <b>Section: 6</b><br><br>From: MH2<br>To: UPSTREAM 1 | REQ MH ENTRY TO ACCESS DROP SHAFT TO CCTV APPROX 1 HR OOHS | DRB Grade: <b>A</b><br>Pipe Size: 150<br>Material: Cast Iron<br>Use: Combined |

| Pos | Video Ref | Code | Description | Image |
|---|---|---|---|---|
| 00.80m | | SA | Survey abandoned<br>LINE STEPS UP OVER DROP<br>SHAFT REQ MH ENTRY | <p>Image Provided - Ref: 5_9999</p> |

Survey 6, MH2 upstream 1 150mm – this requires manhole / confined space entry to access the drop shaft. This can then be jetted & surveyed. Cost included in survey 1.
