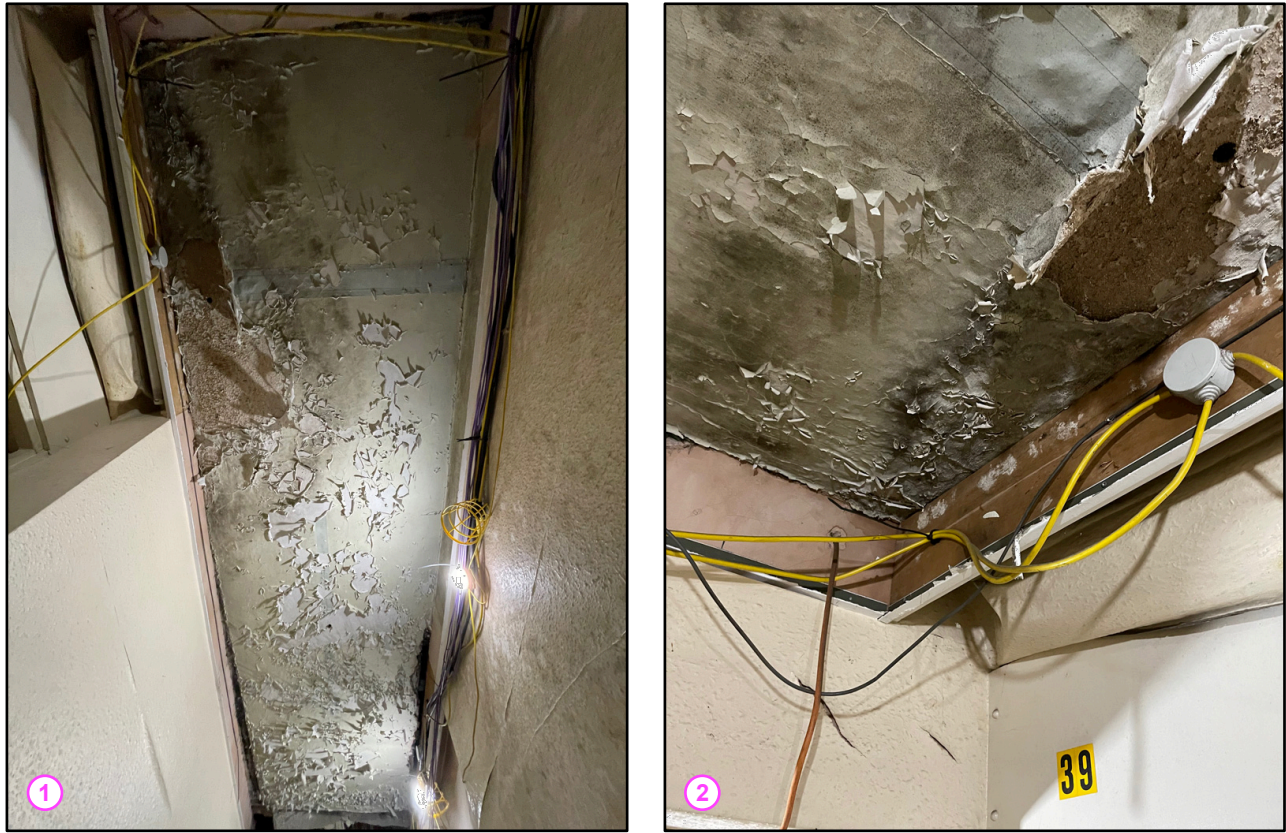
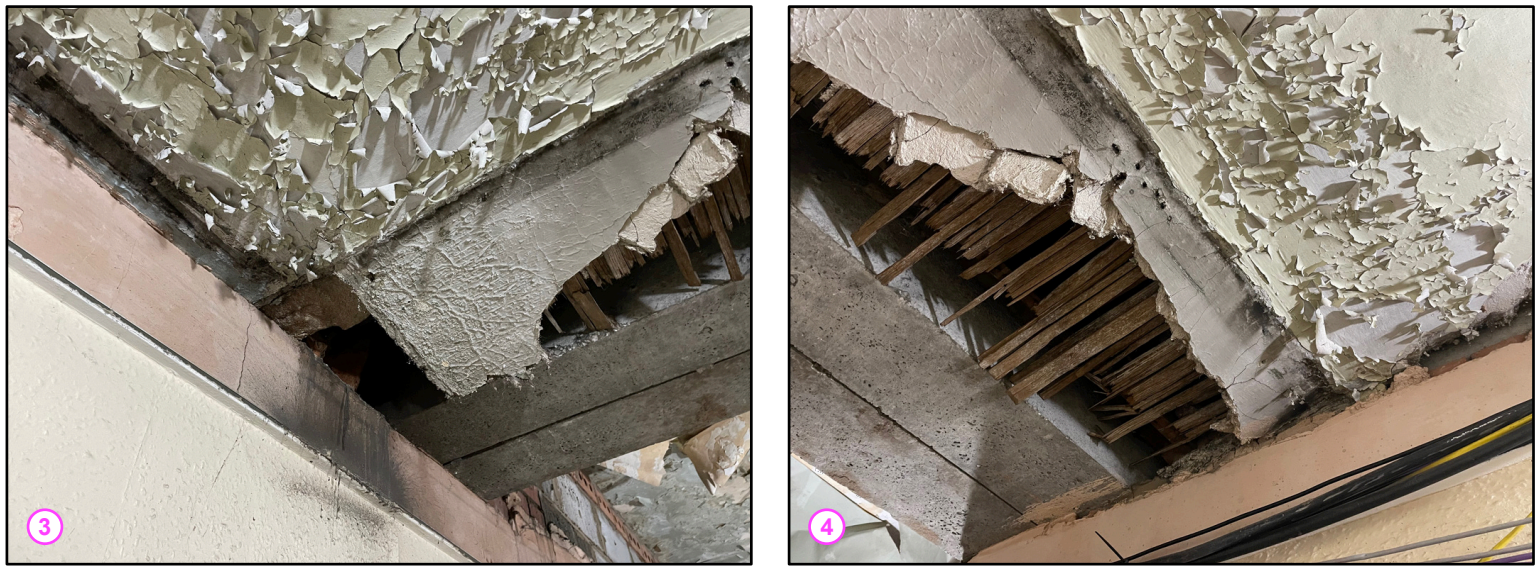
ROOM F.13

- No cornice
- Plasterboard ceiling
- Partially collapsed ceiling as noted on the plan
- Ceiling is damaged in various areas

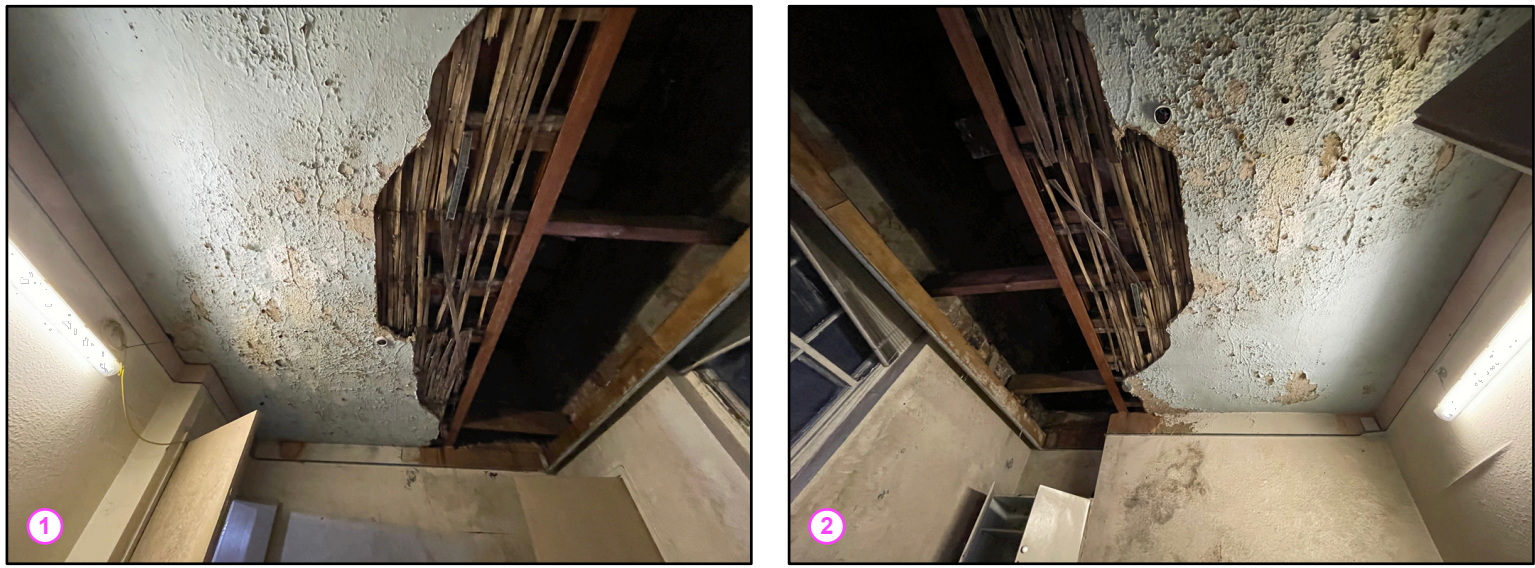
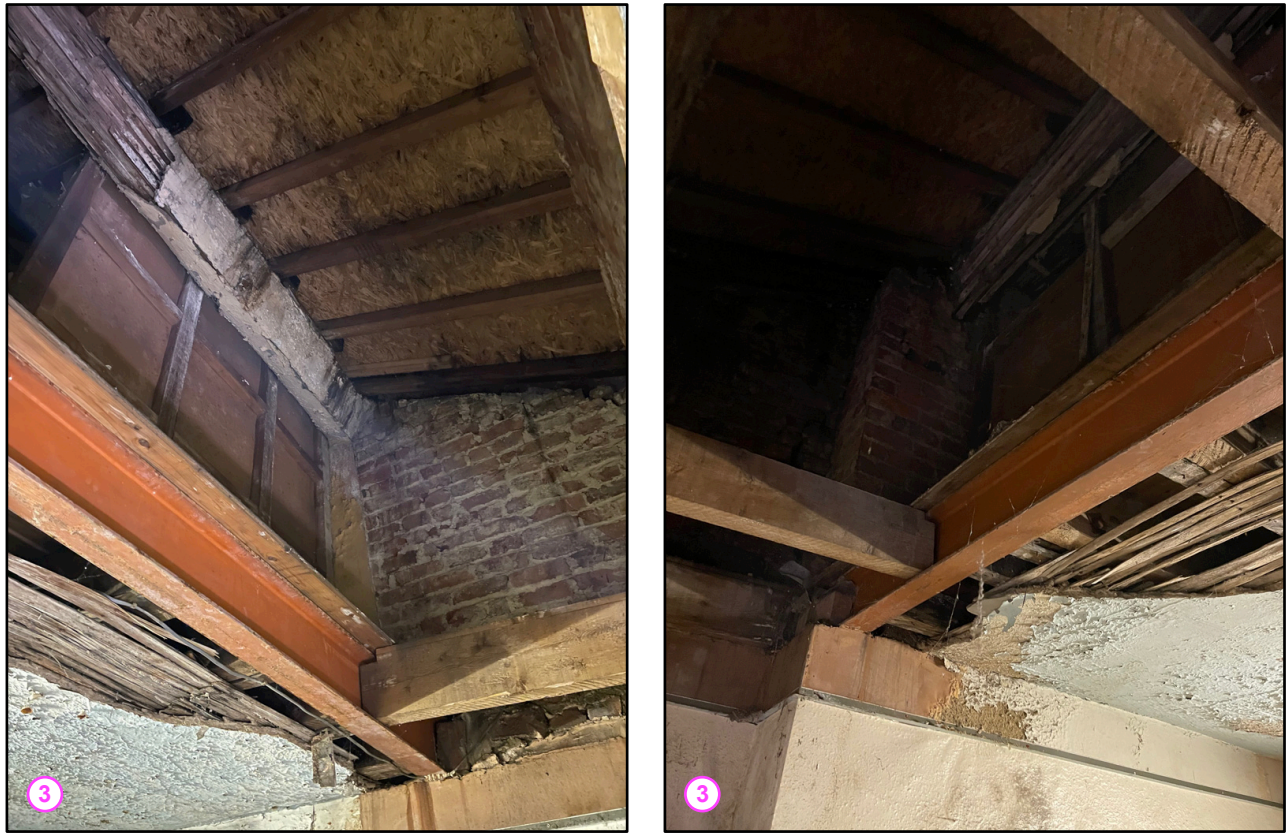
ROOM F.14

- No cornice
- Plasterboard ceiling
- Half of the ceiling has collapsed revealing floor joists and the floor above
- Ceiling is severely damaged

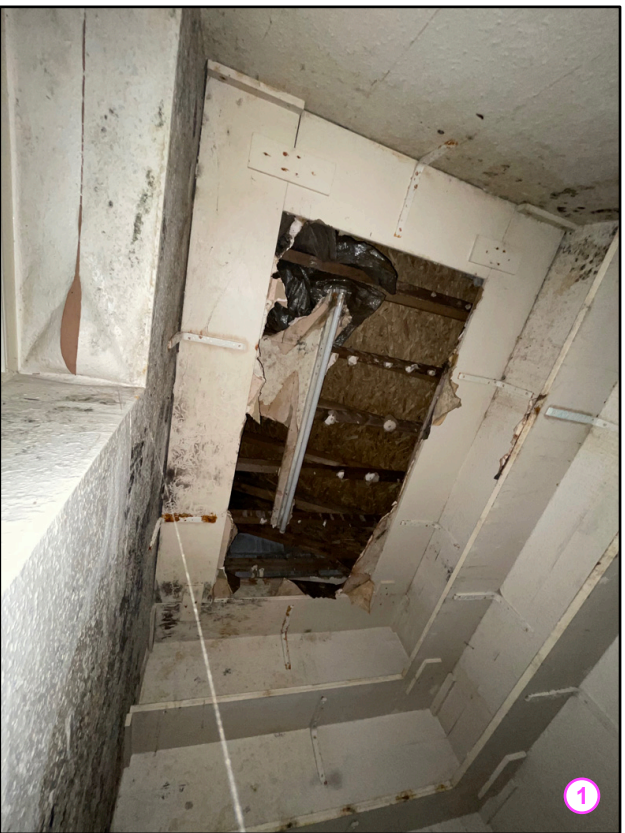
ROOM F.15

- No cornice
- Half of the ceiling has collapsed

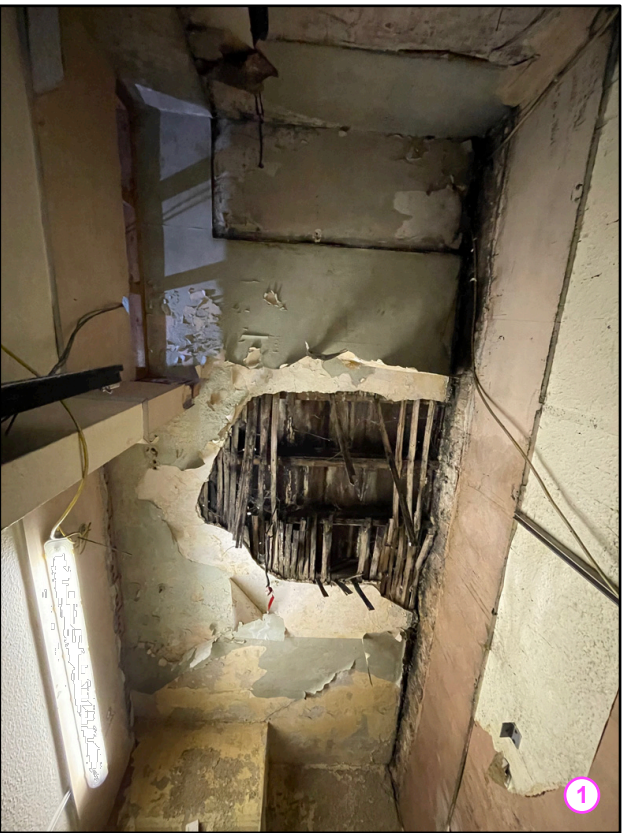
ROOM F.16

- No cornice
- Partially collapsed ceiling as noted on the plan
- Ceiling is damaged in various areas
- Bad water damage to ceiling

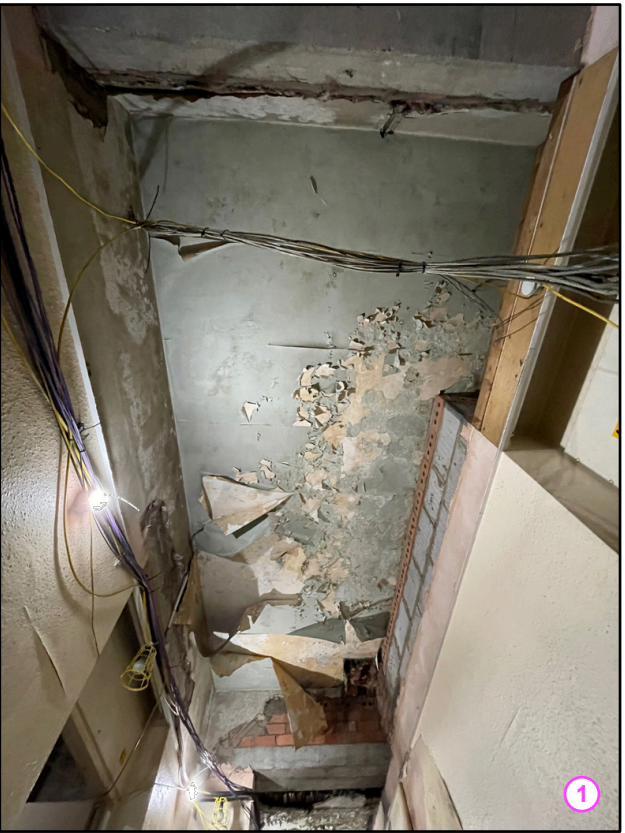
ROOM F.17

- No cornice
- Partially collapsed ceiling as noted on the plan
- Ceiling is damaged in various areas
- Bad water damage to ceiling
