# London Road Fire Station

## Courtyard Metal Stair

### Condition Appraisal

Curtins Ref: 060270-CUR-00-XX-RP-S-00040

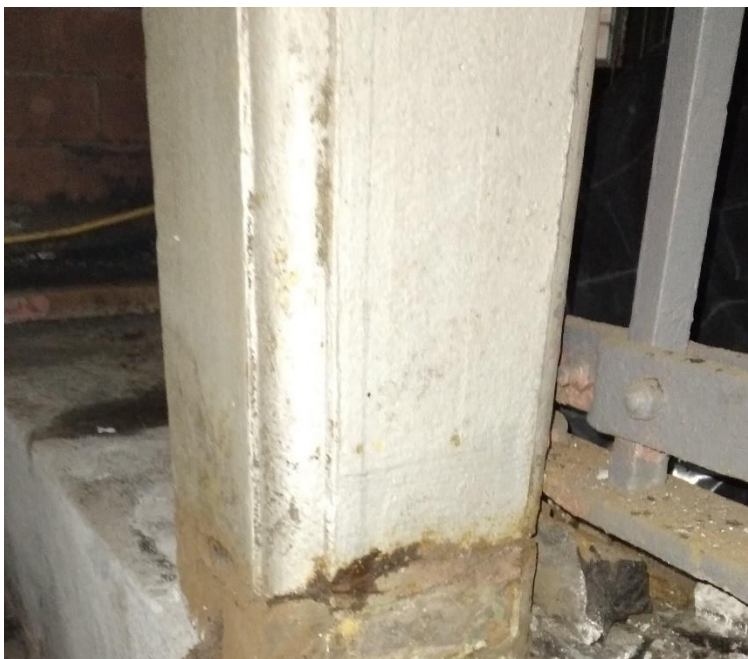
Iron columns with bevelled corners.

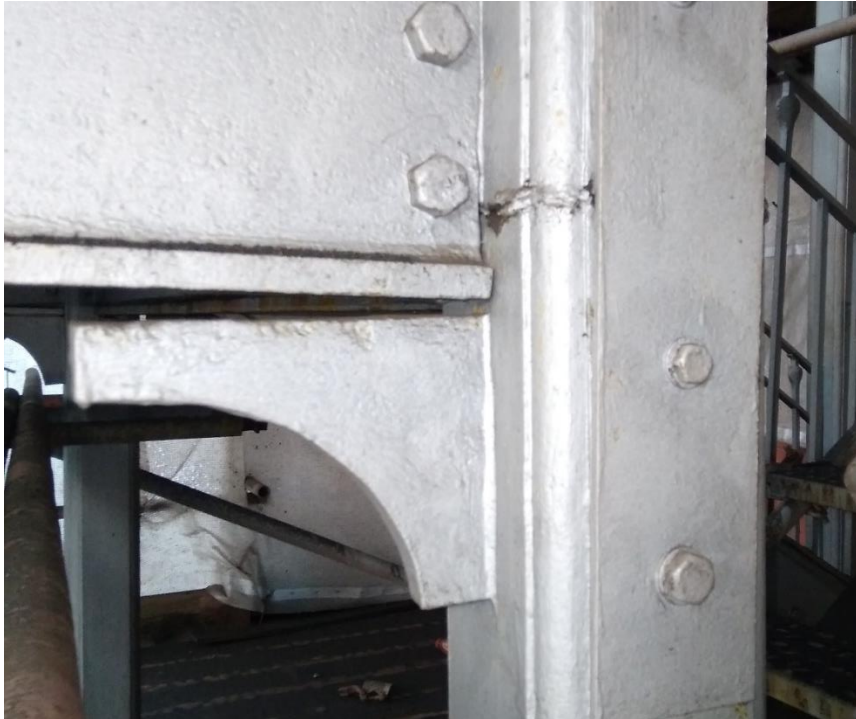
Columns showing welded brackets for supporting landing beams / stair stringers. Ineffective.

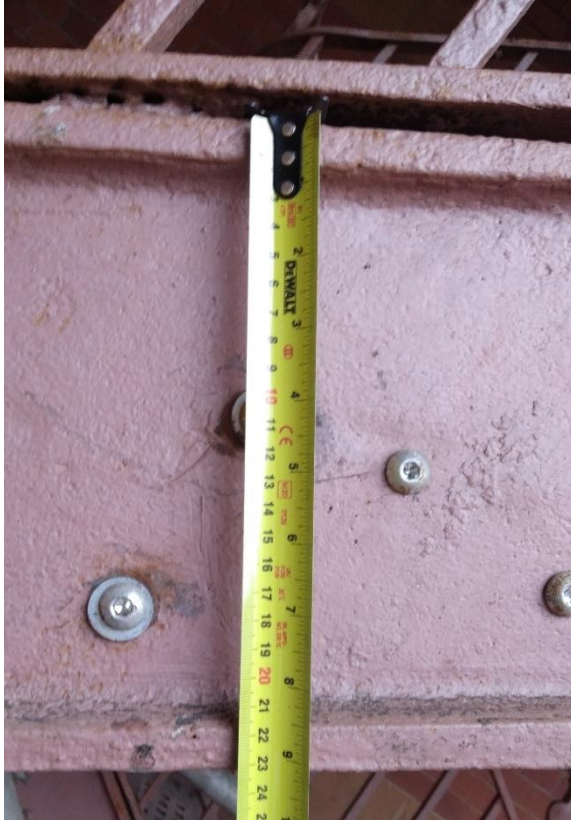
Stair stringers (supporting handrails)

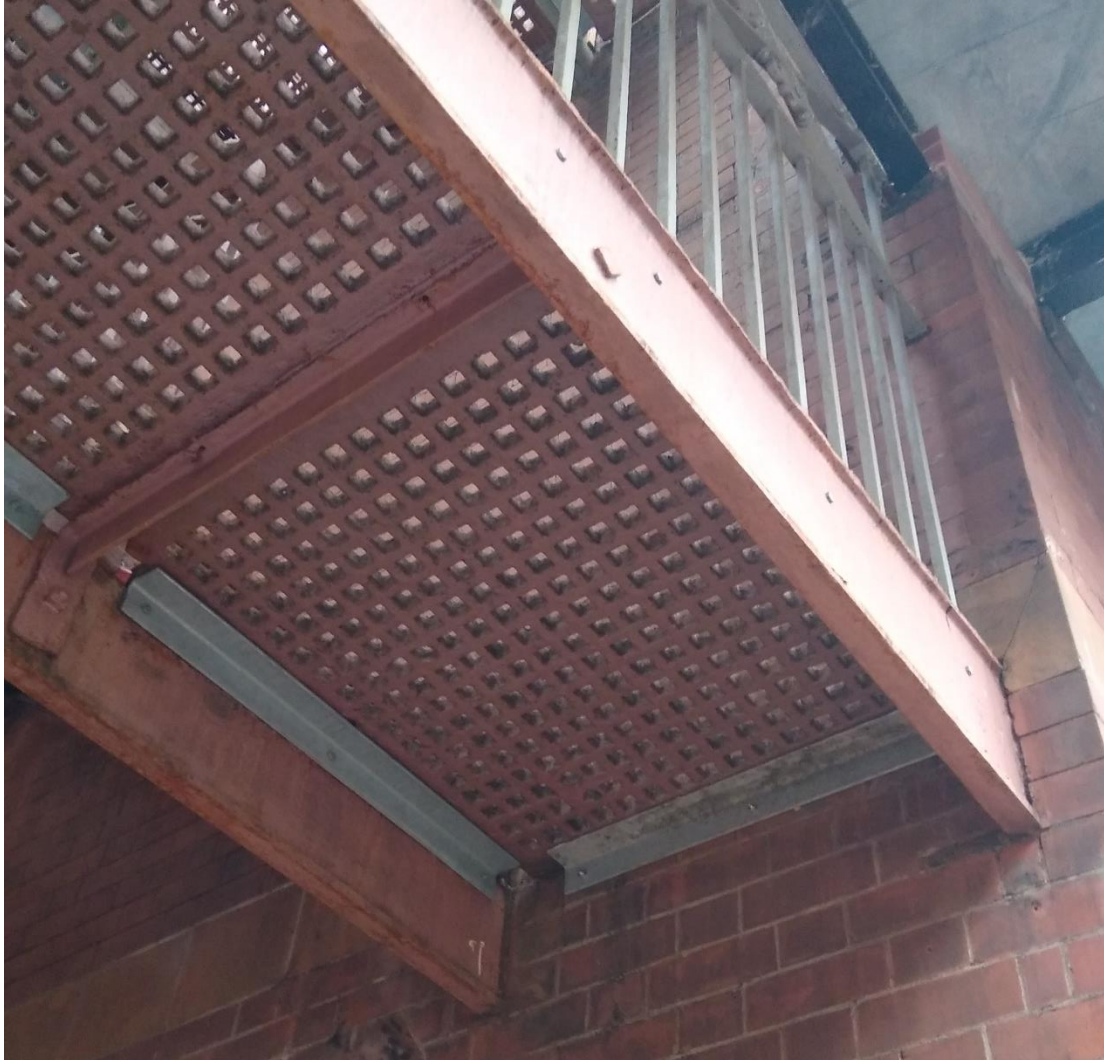
Original cast iron landing beams (bearing into wall), historic mild steel additions and some 2021 replacements.

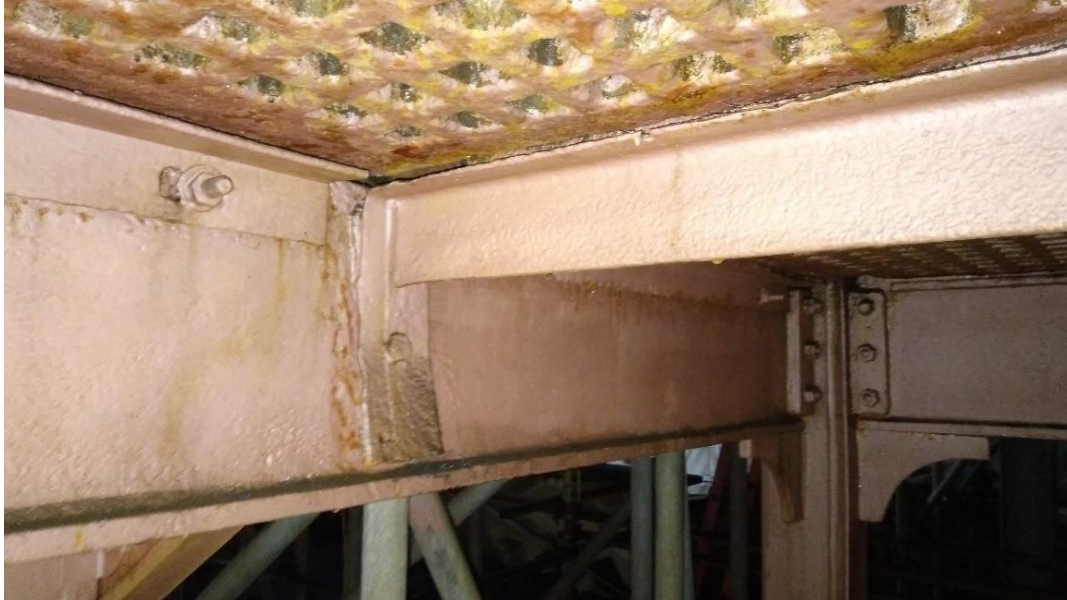
Half

landing 0.33 showing compromised ledger angles / deck supports. Added at later date to poor standard.

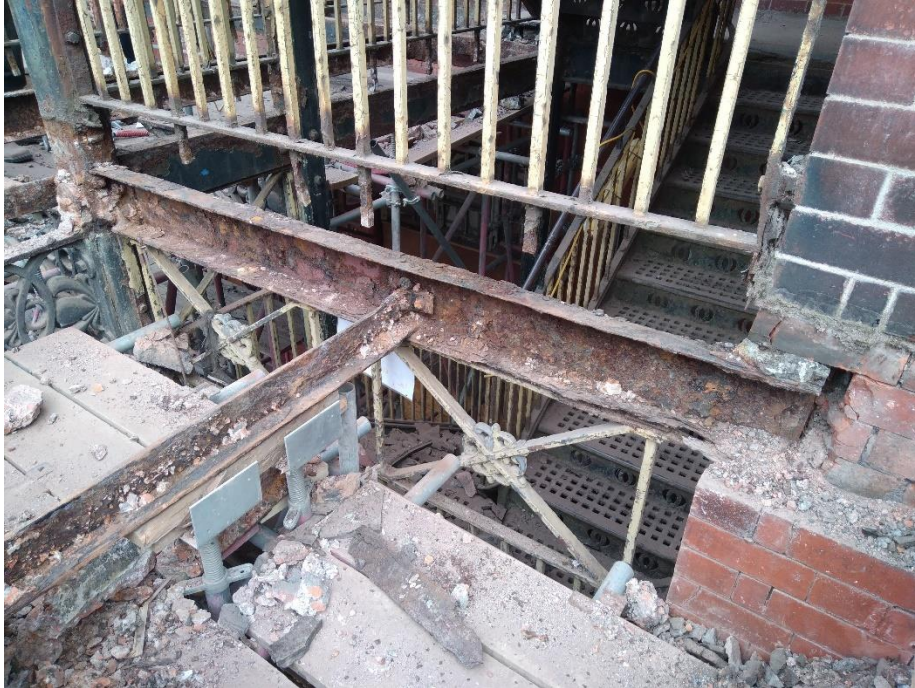
Level 1 showing severely corroded mild steel beam. Replaced as part of Balcony works.

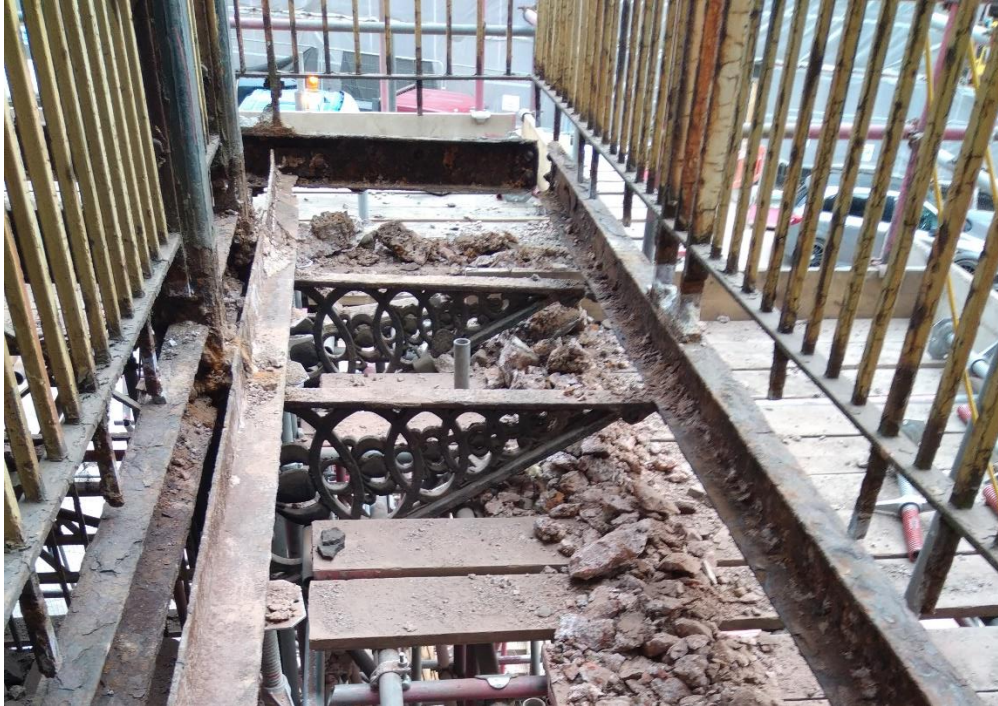
Level 1 showing  
cast iron corbels (cracked). Defects not shown.

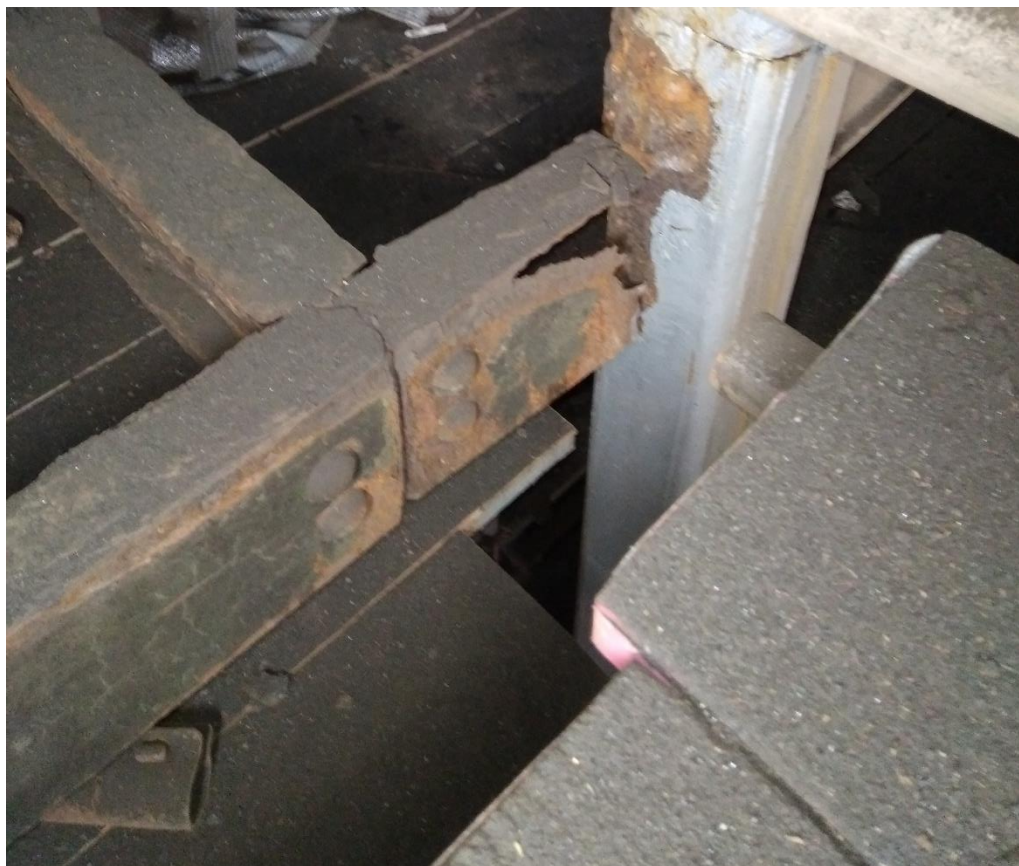
Level

Balcony-Column beams severely corroded: Replacement PFC required.

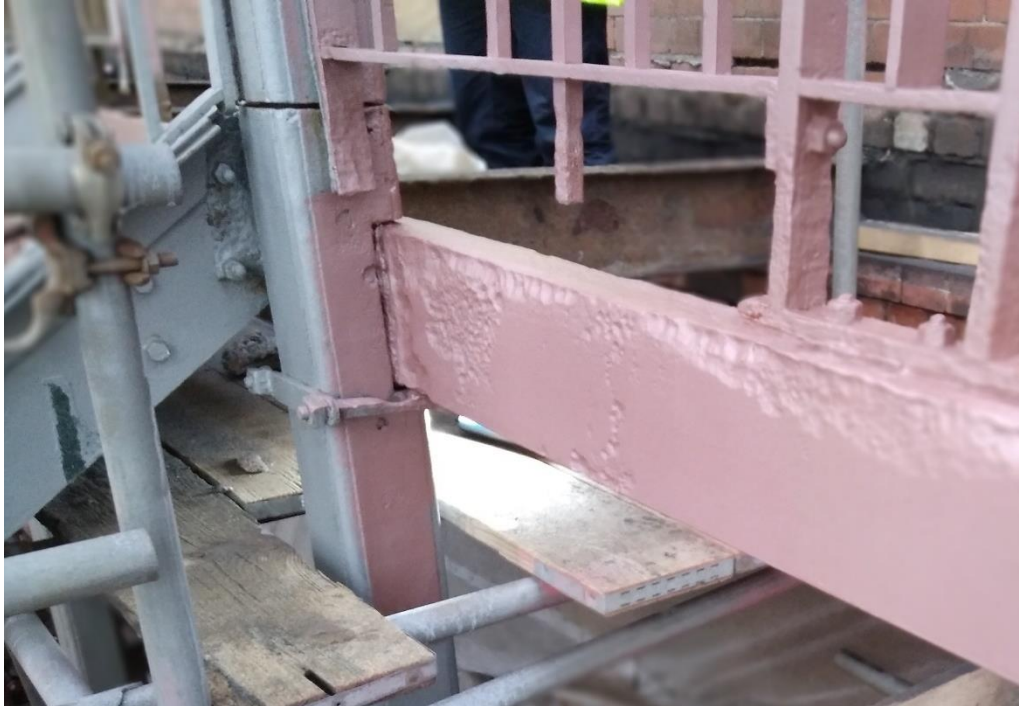
Level 3

showing pitted beams & notched cast iron (poor detail) which lead to complete cracked columns (crack obscured behind bracket).

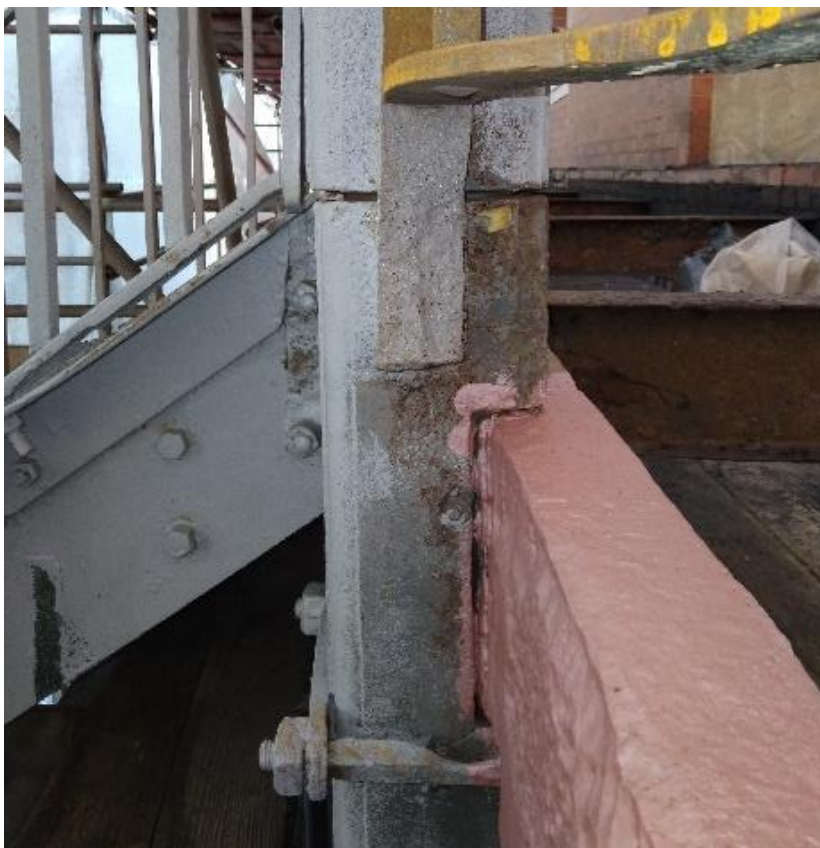
Columns are notched-out for incoming PFC beams. This is a very poor detail which has led to complete column cracking at level 3.

Column notching at Level 3: Cracking (lower half of column) not visible (obscured behind bracket).

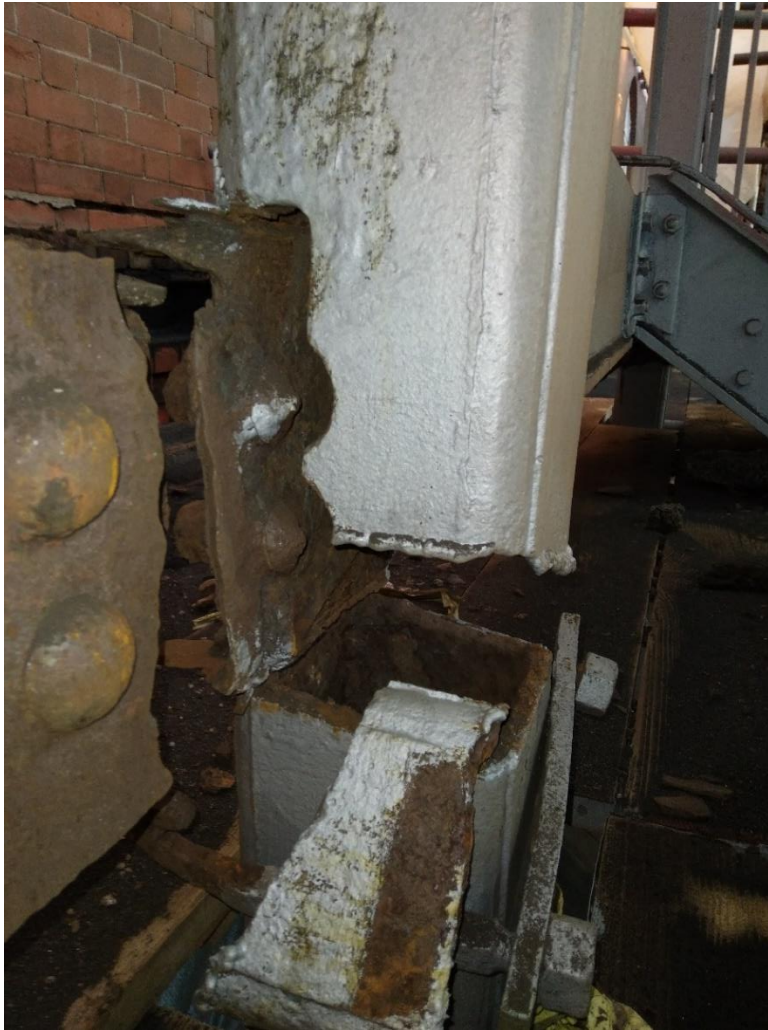
Column notching at Level 3: Fully-cracked section. Column replacement required.

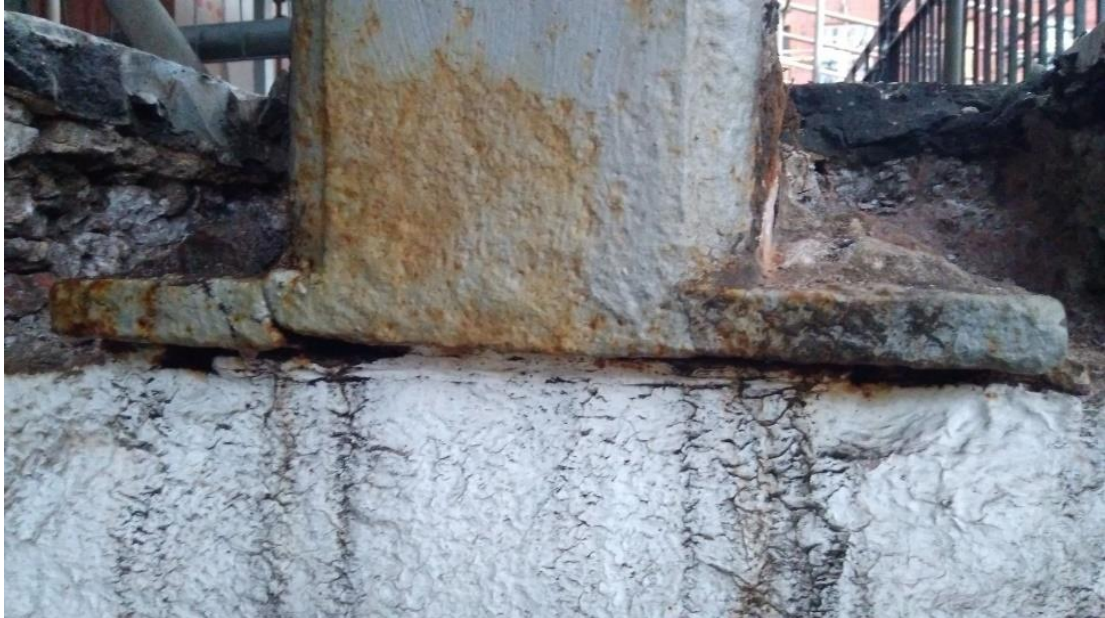
Cast iron column cracked baseplate. Also oversailing side of wall.

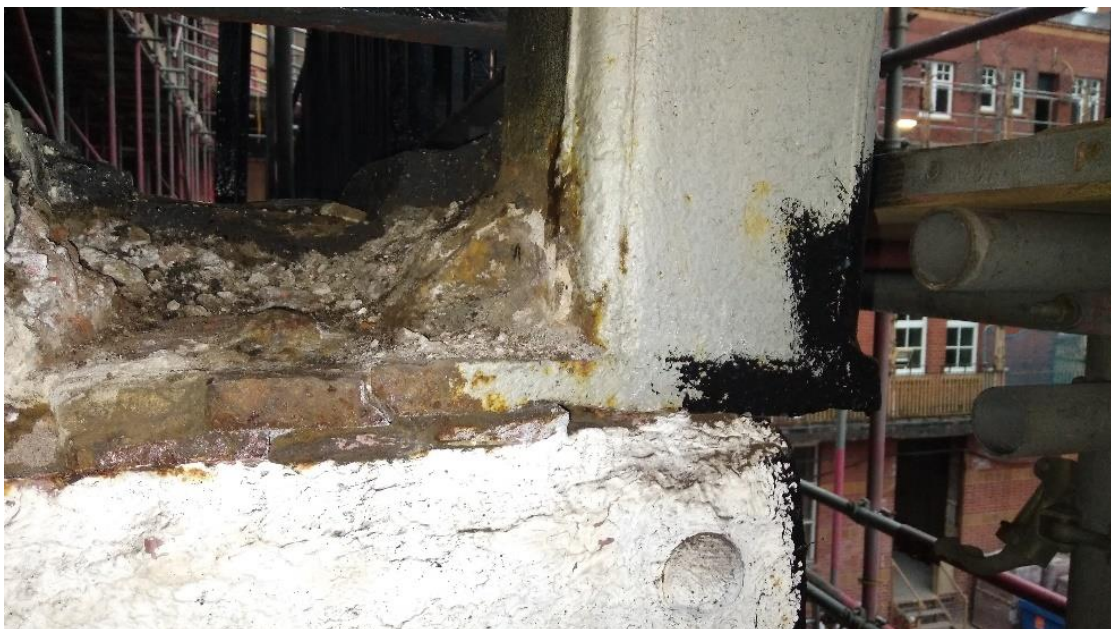
Cast iron column cracked baseplate. Column also oversailing both directions.

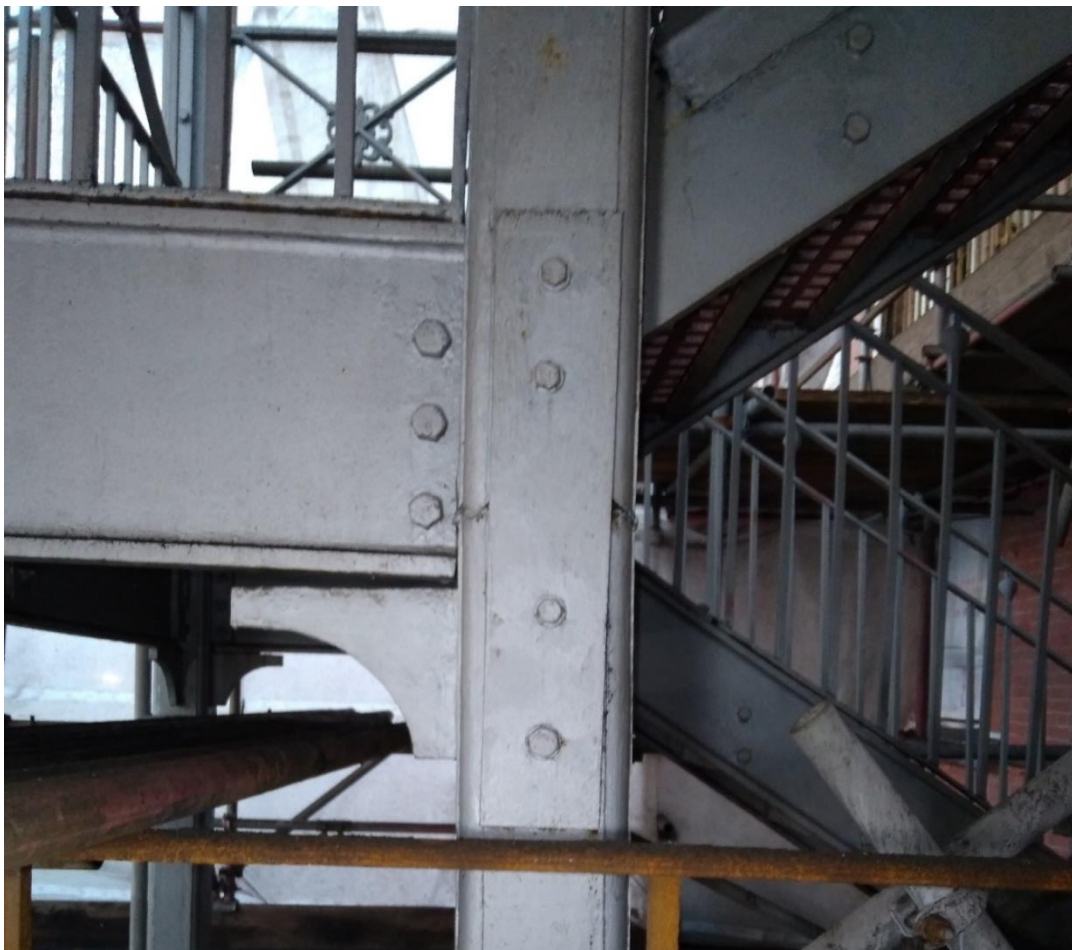
Half

landing level 2.5 showing cracked column (historic repair attempt) and inactive spandrels providing no stability bracing.

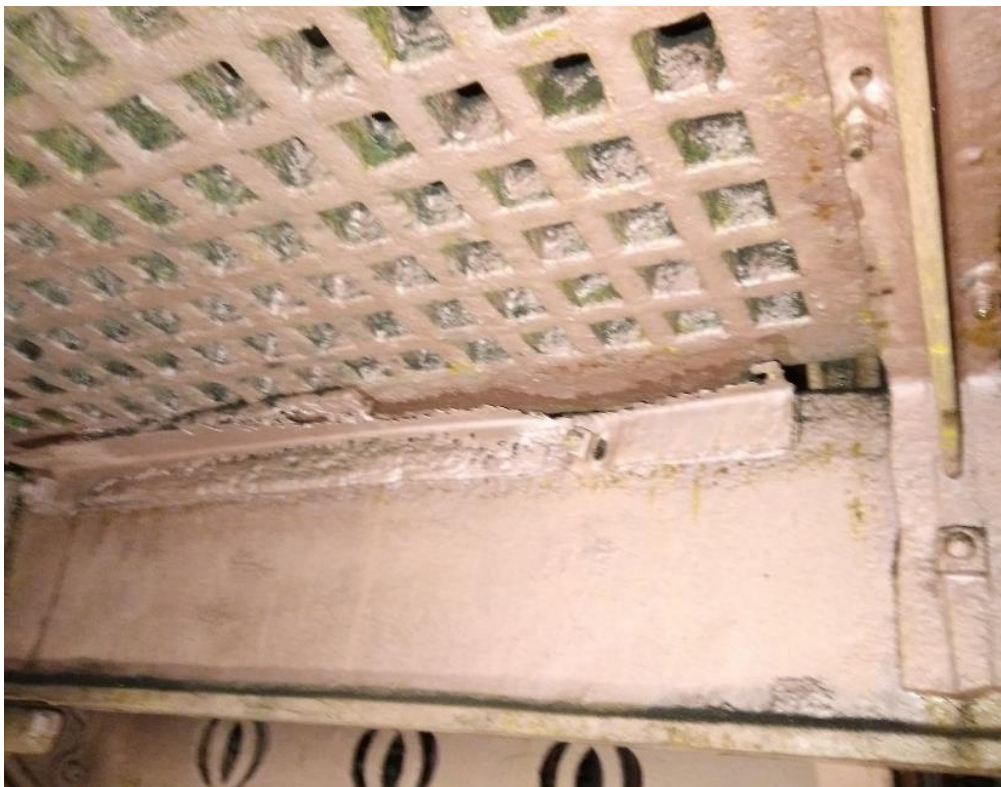
Historic additions of mild steel to replace lost Iron have corroded.

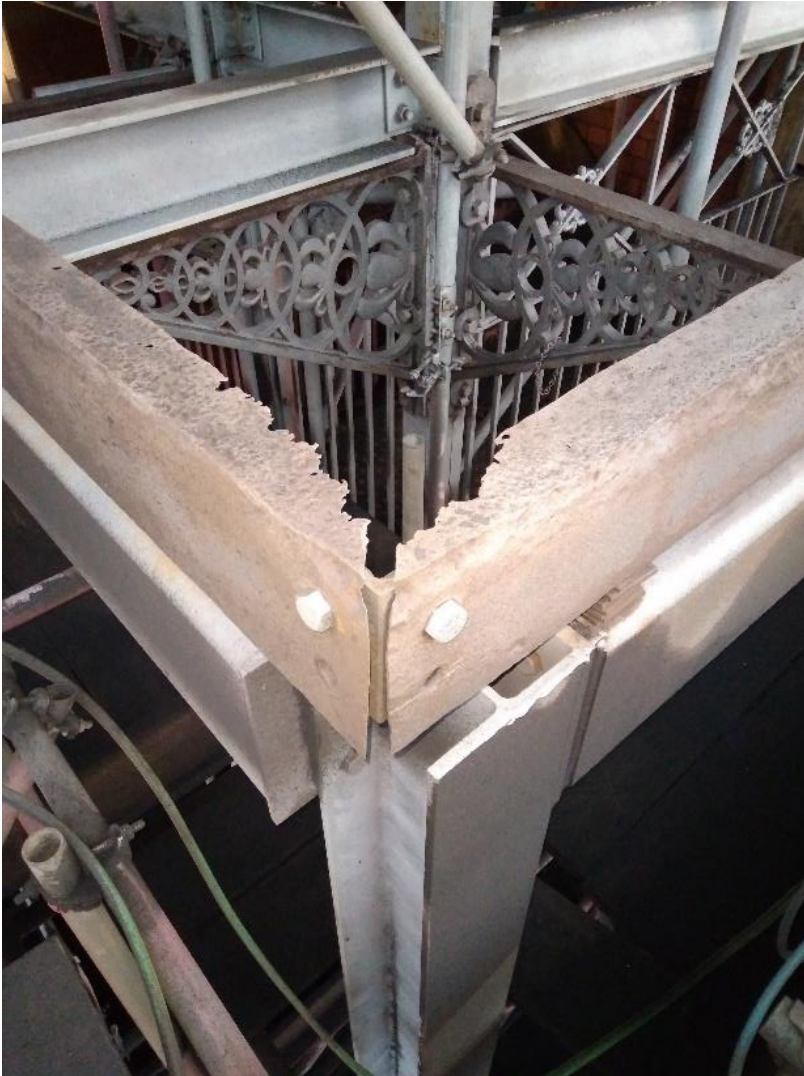
Beam-beam corrosion (supported by additional steelwork to avoid replacement).

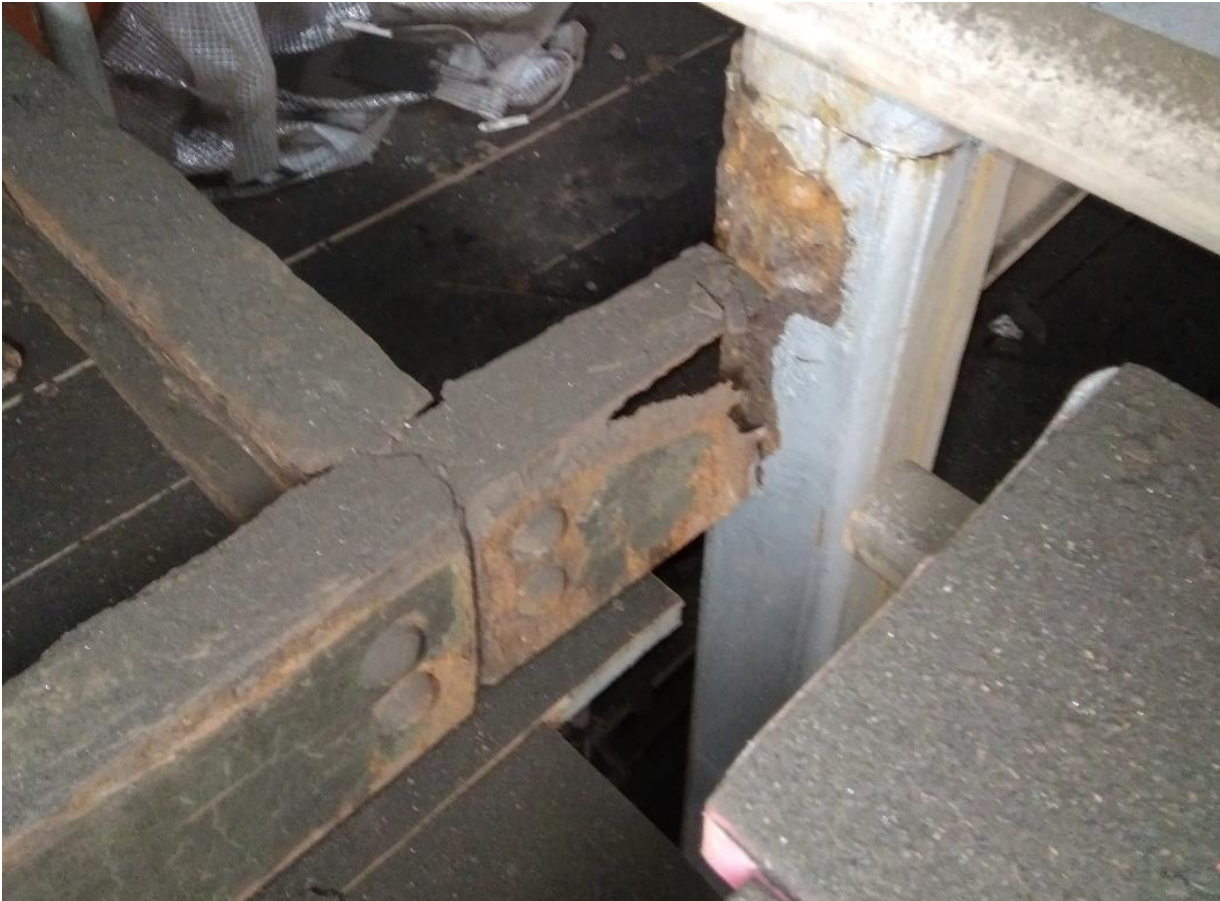
Beam-column corrosion and connection failure.

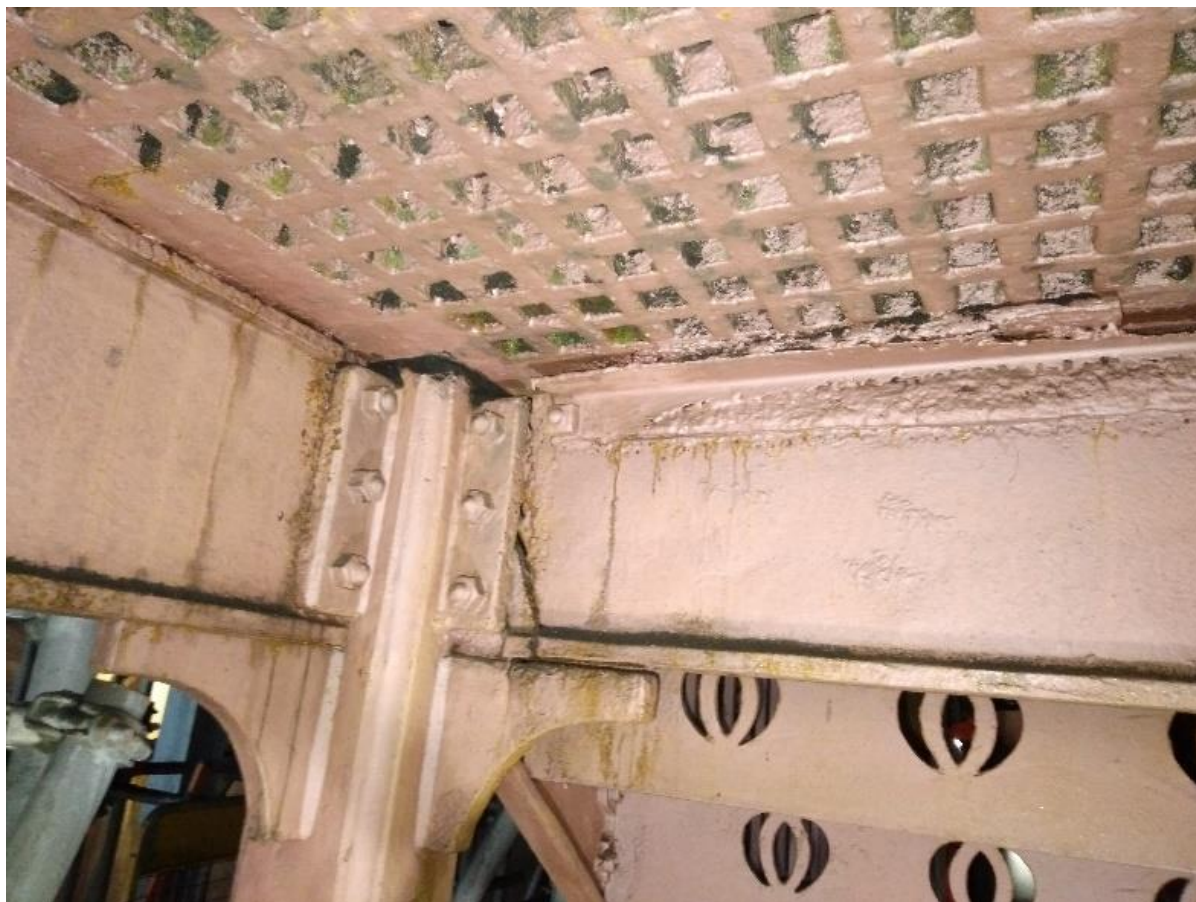
Cracked landing beam at connection.

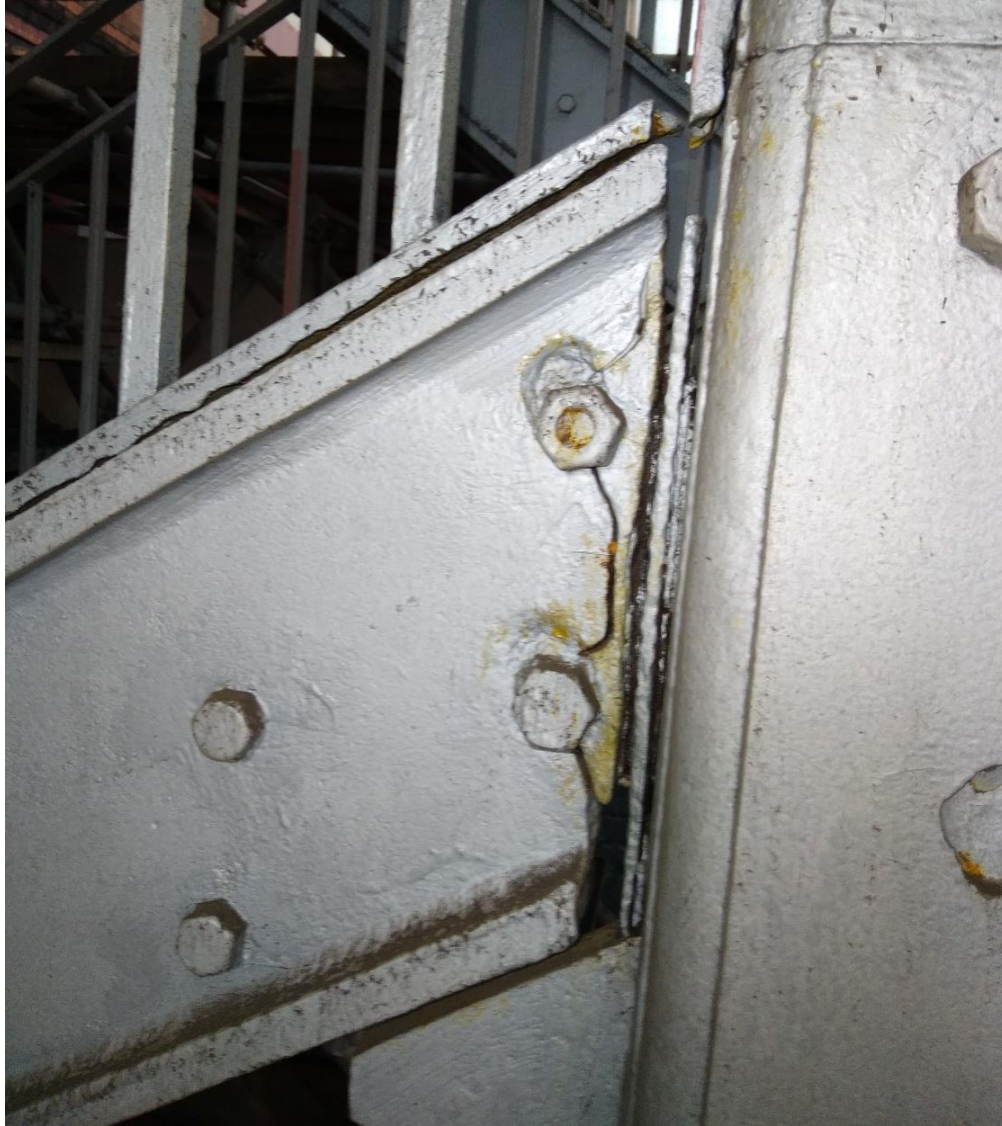
Cracked stringers with what appears historic repairs (bolt replacement).

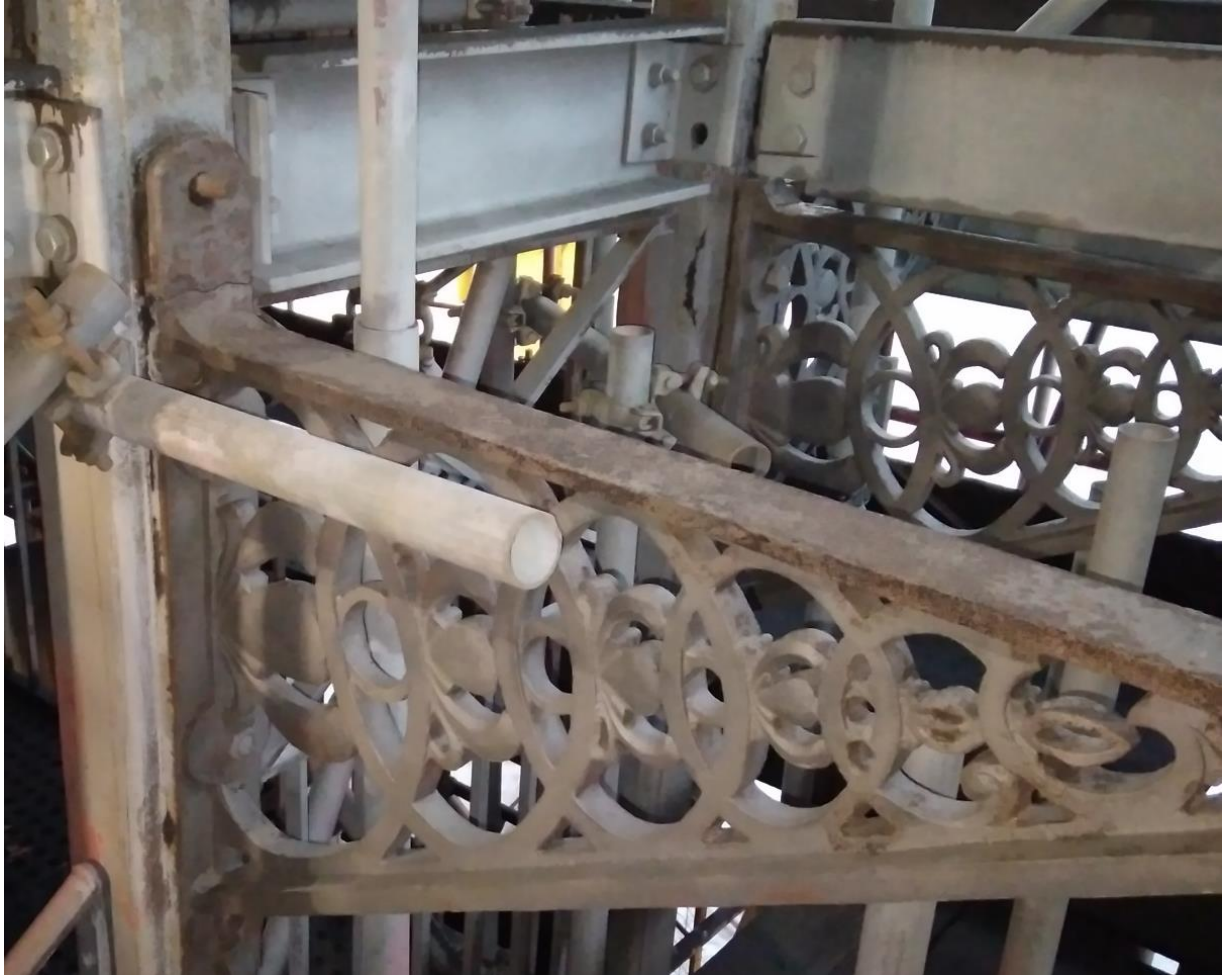
Cracked corbel at bolted connection.

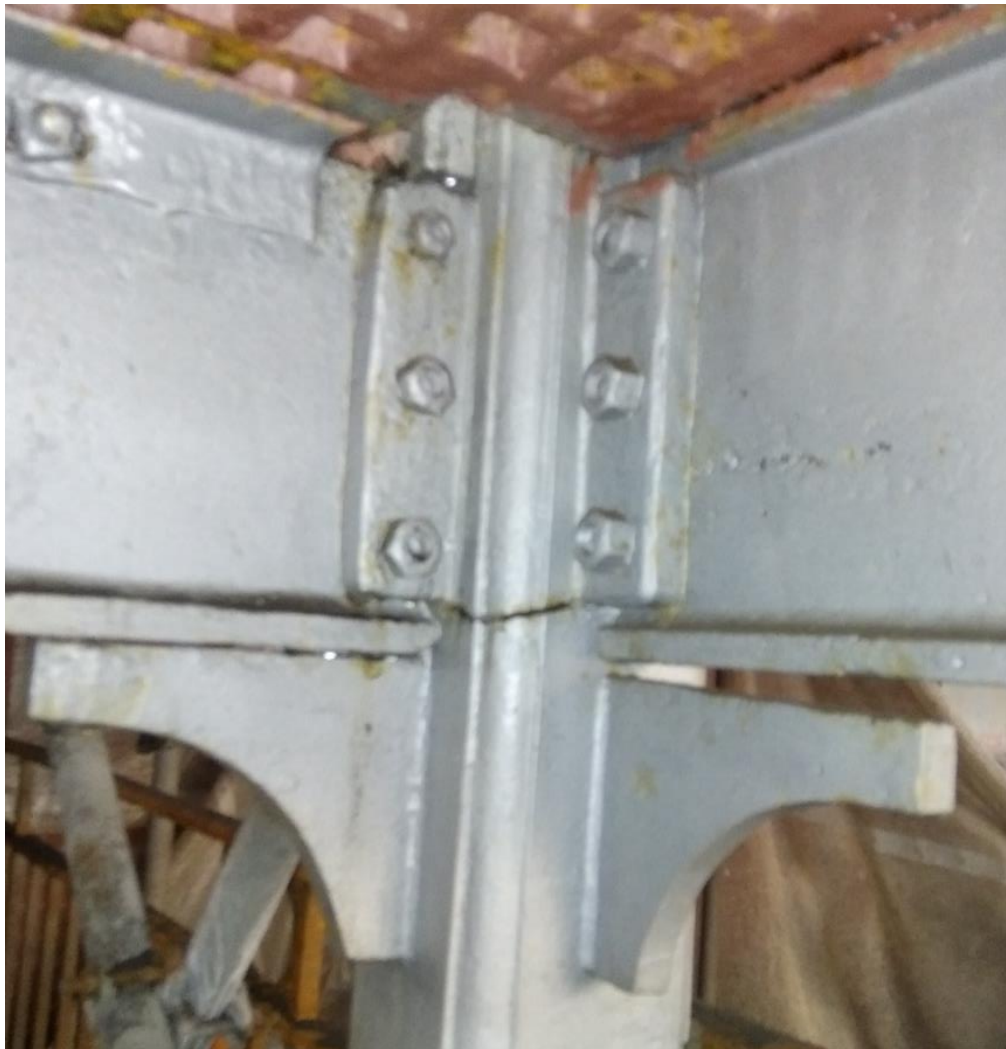
Column cracking

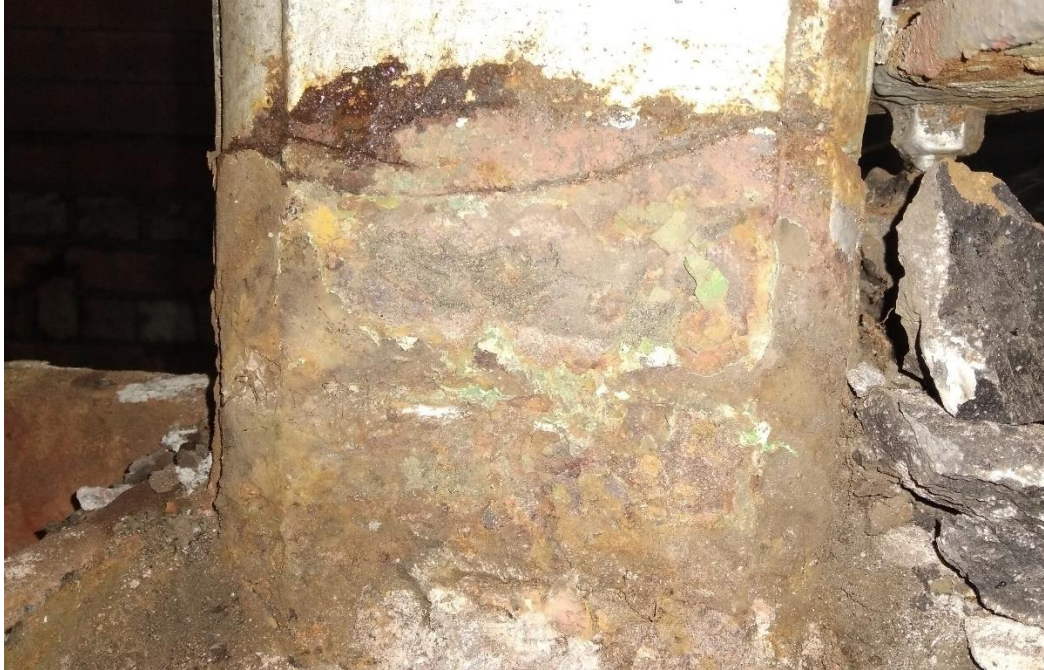
Column cracking (level 2 flat roof)

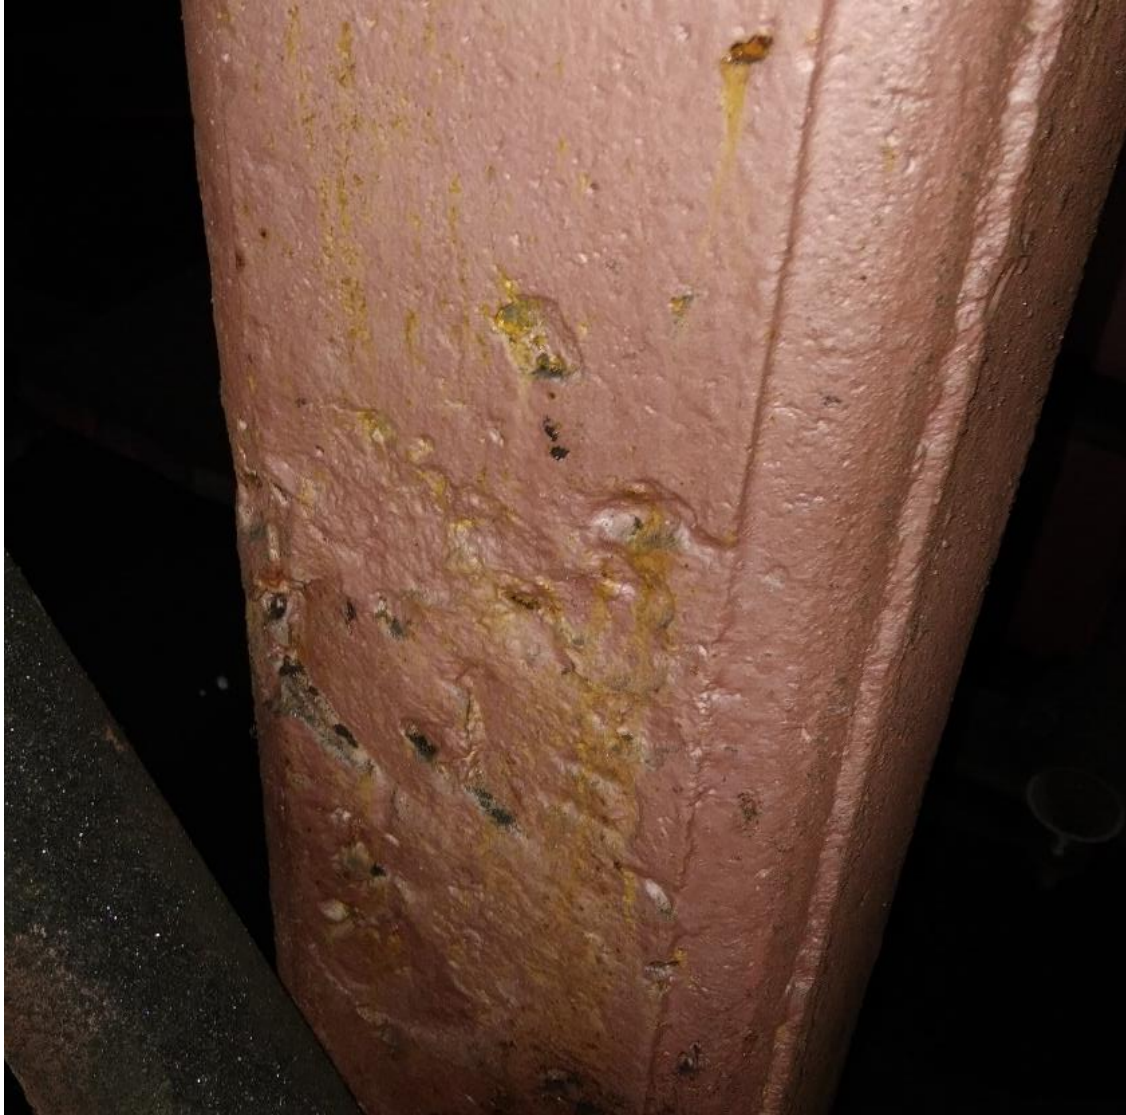
Iron Column corrosion (pitting)

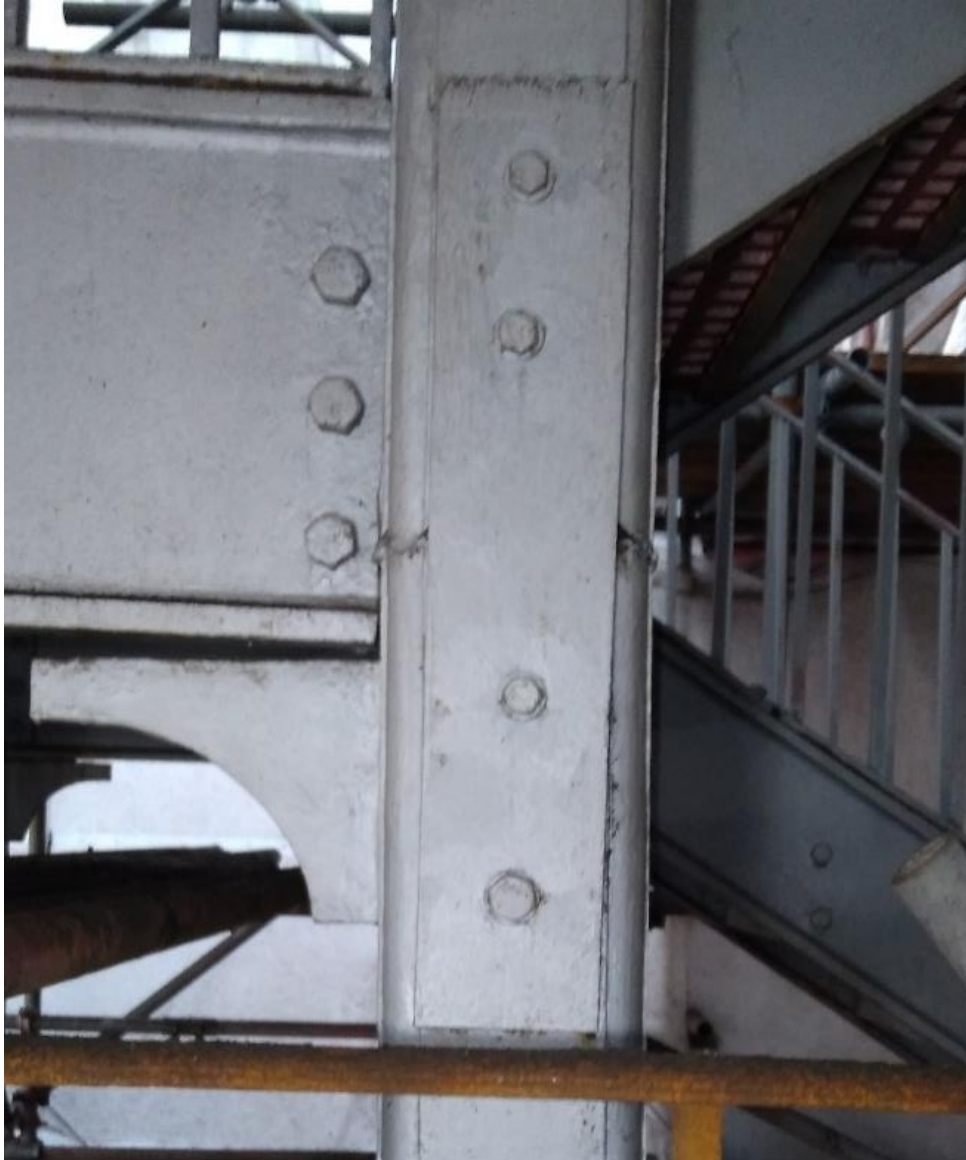
Historic bolted splice (to 1 face only).

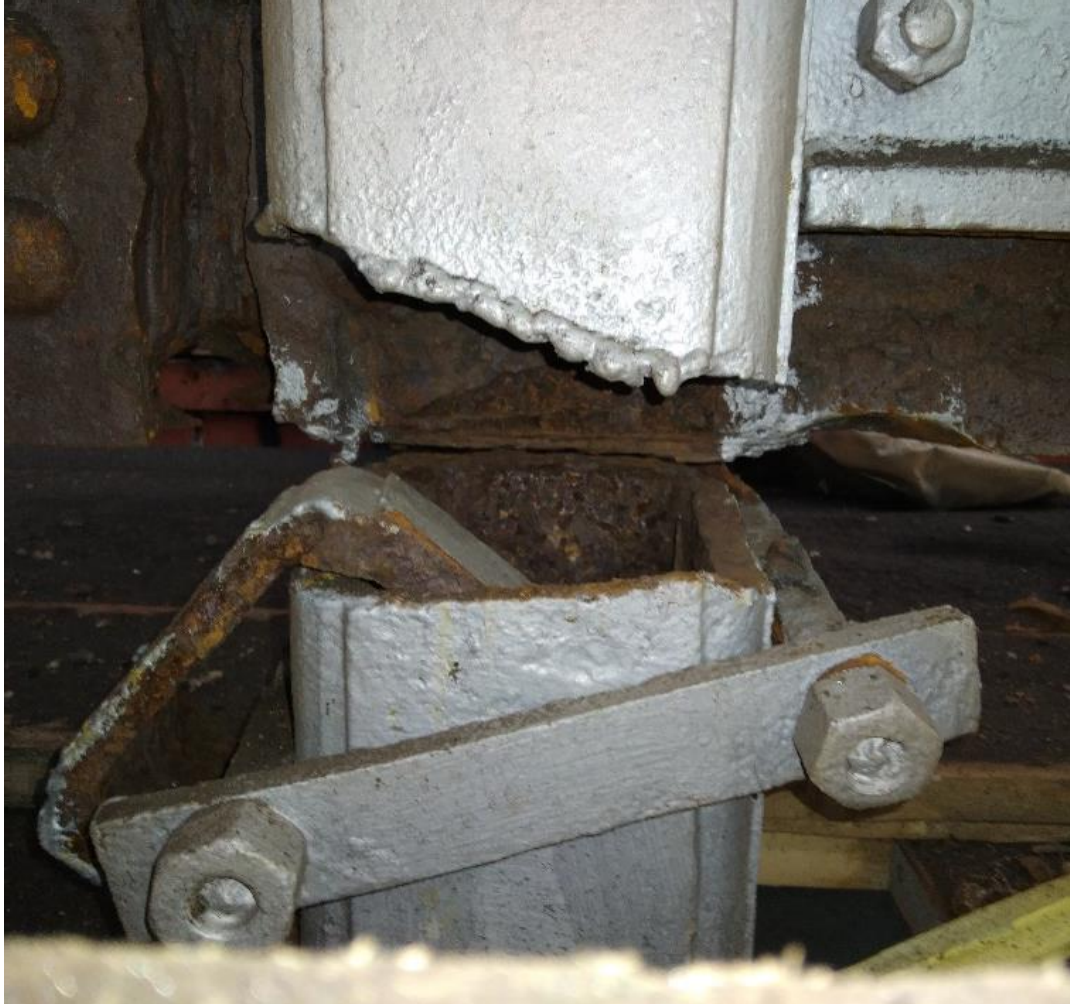
It is clear from visual inspection (see image below), some attempts to site-weld cast iron columns has occurred which has been unsuccessful and may have made the column worse

Completely disconnected column with signs of historic welded repair (unsuccessful).

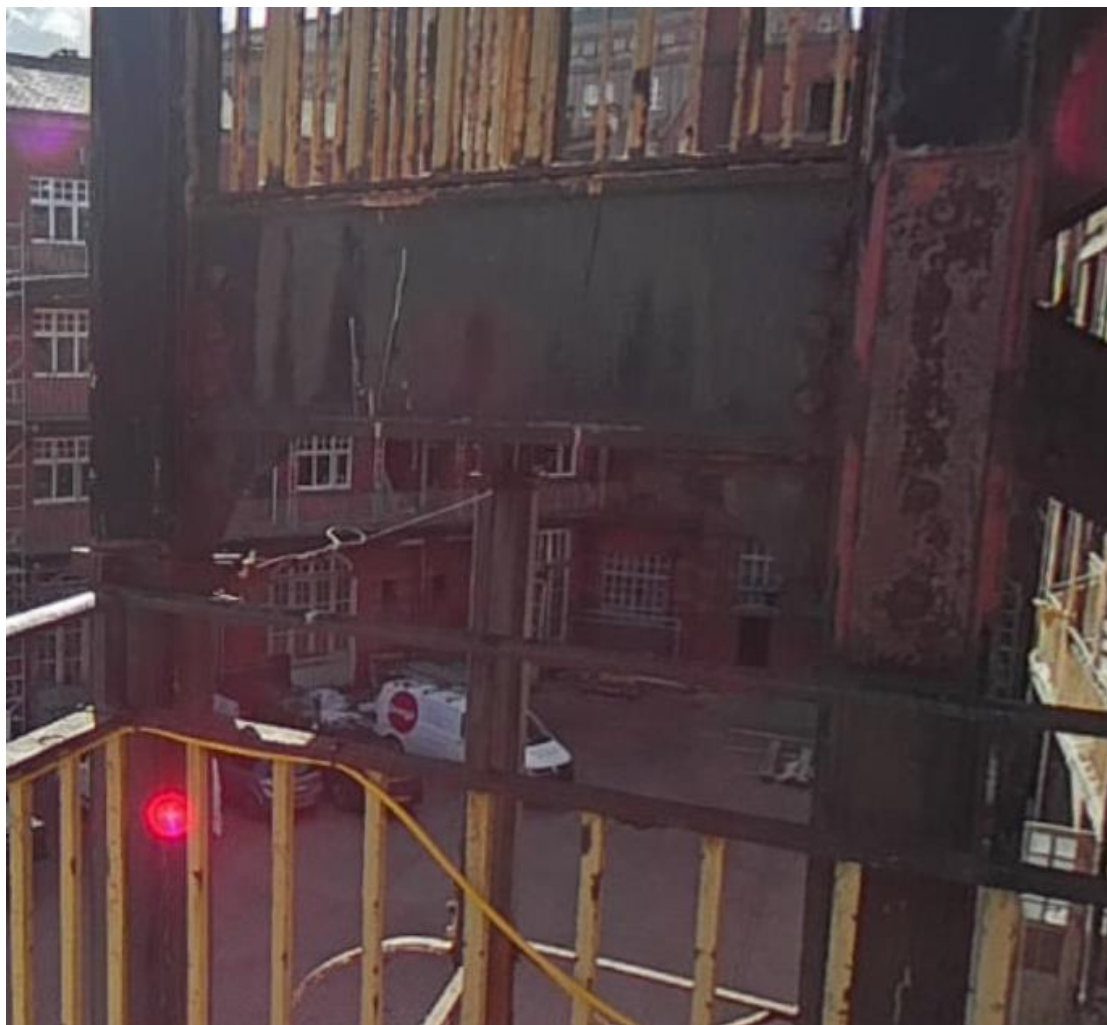
Historically there have been attempts to add stability bracing with tension cables (see image below), which have not been successful or failed in intervening years.

Tension cables added in 20<sup>th</sup> century. Ineffective repair. Now removed.
