# London Road Fire Station

## Courtyard Metal Stair

### Condition Appraisal

Curtins Ref: 060270-CUR-00-XX-RP-S-00040

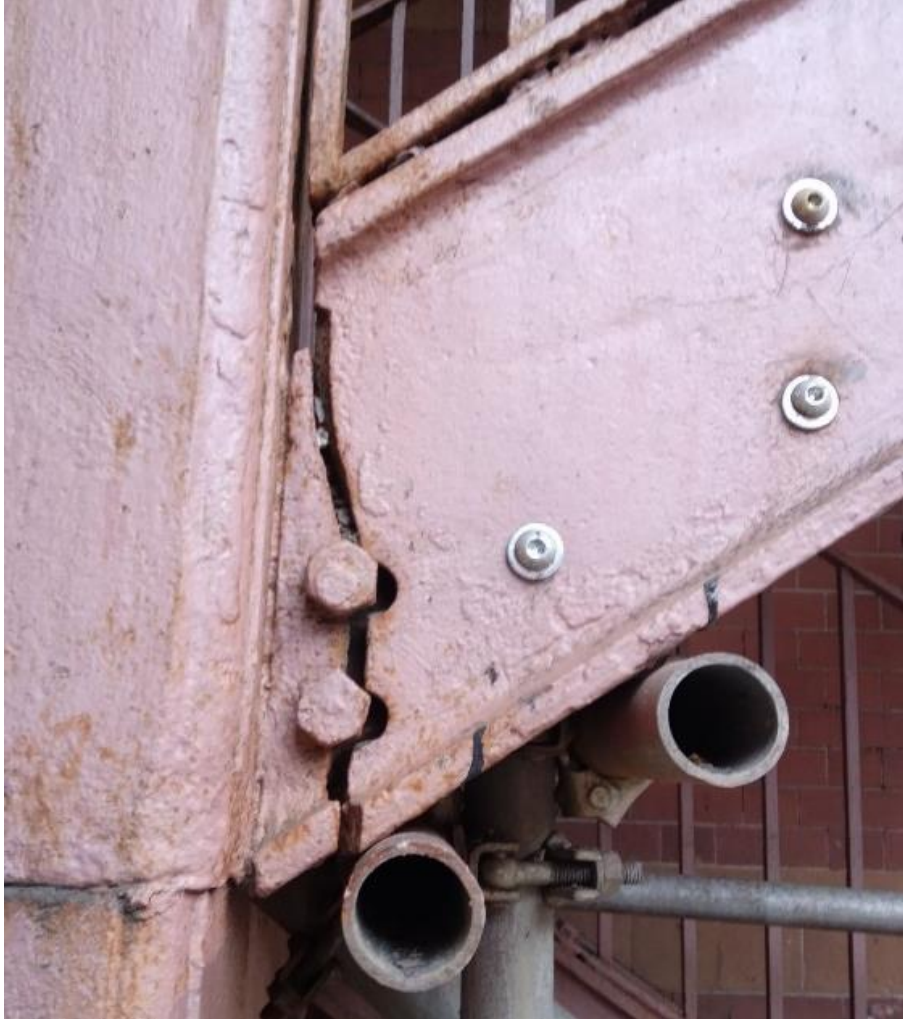
Recent stringer connection failure due to stress in beam.

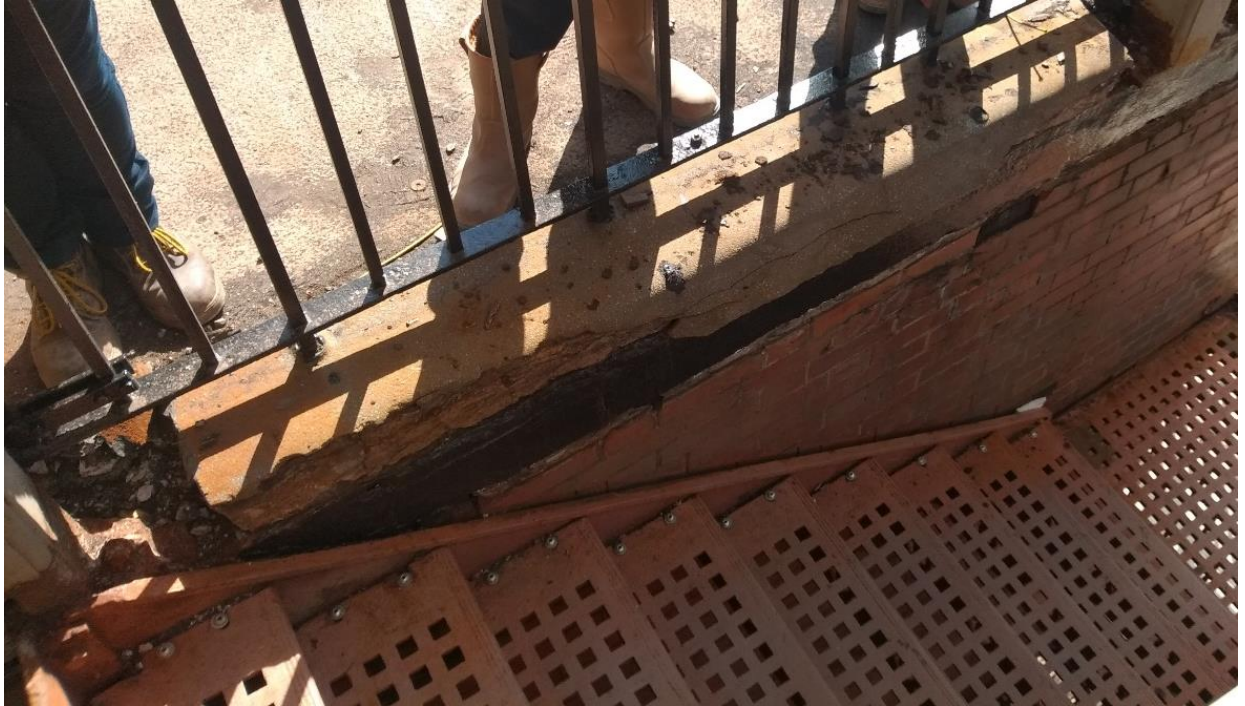
Stringer lateral movement (on plan) away from existing masonry wall (level 2). (Not visible on image).

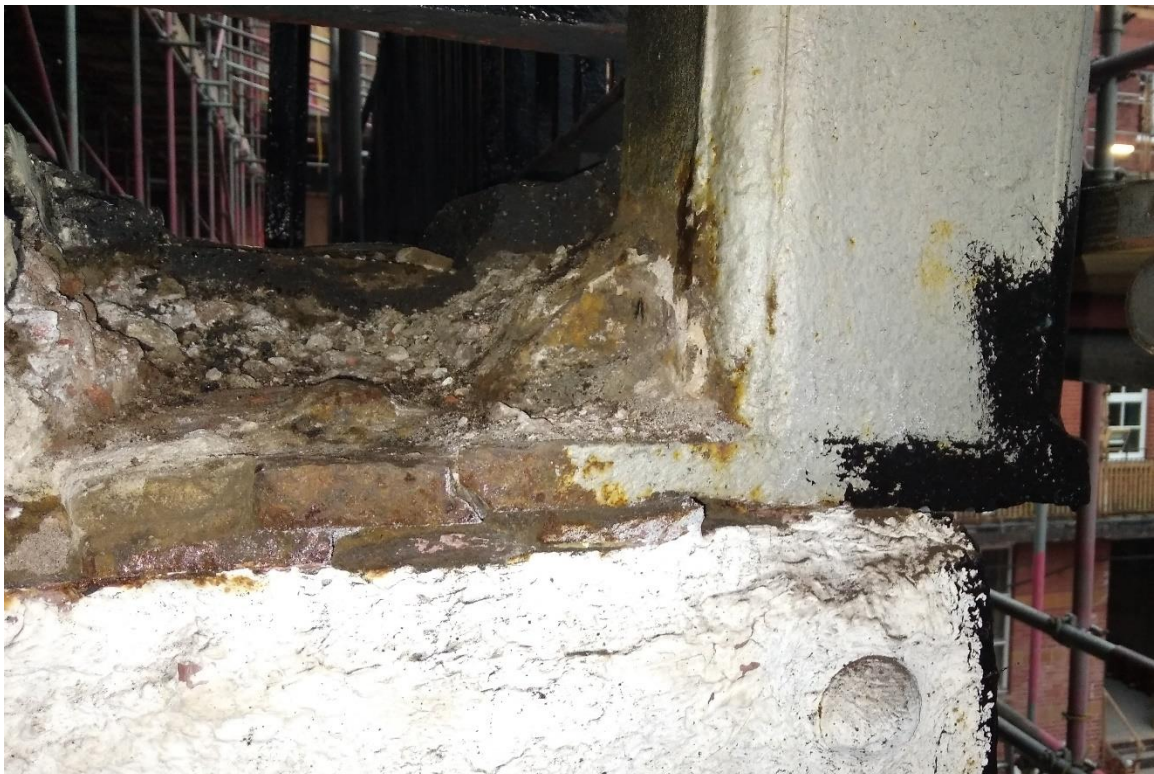
Further historic column cracking encountered to column bases / baseplates at Level 2 flat roof.

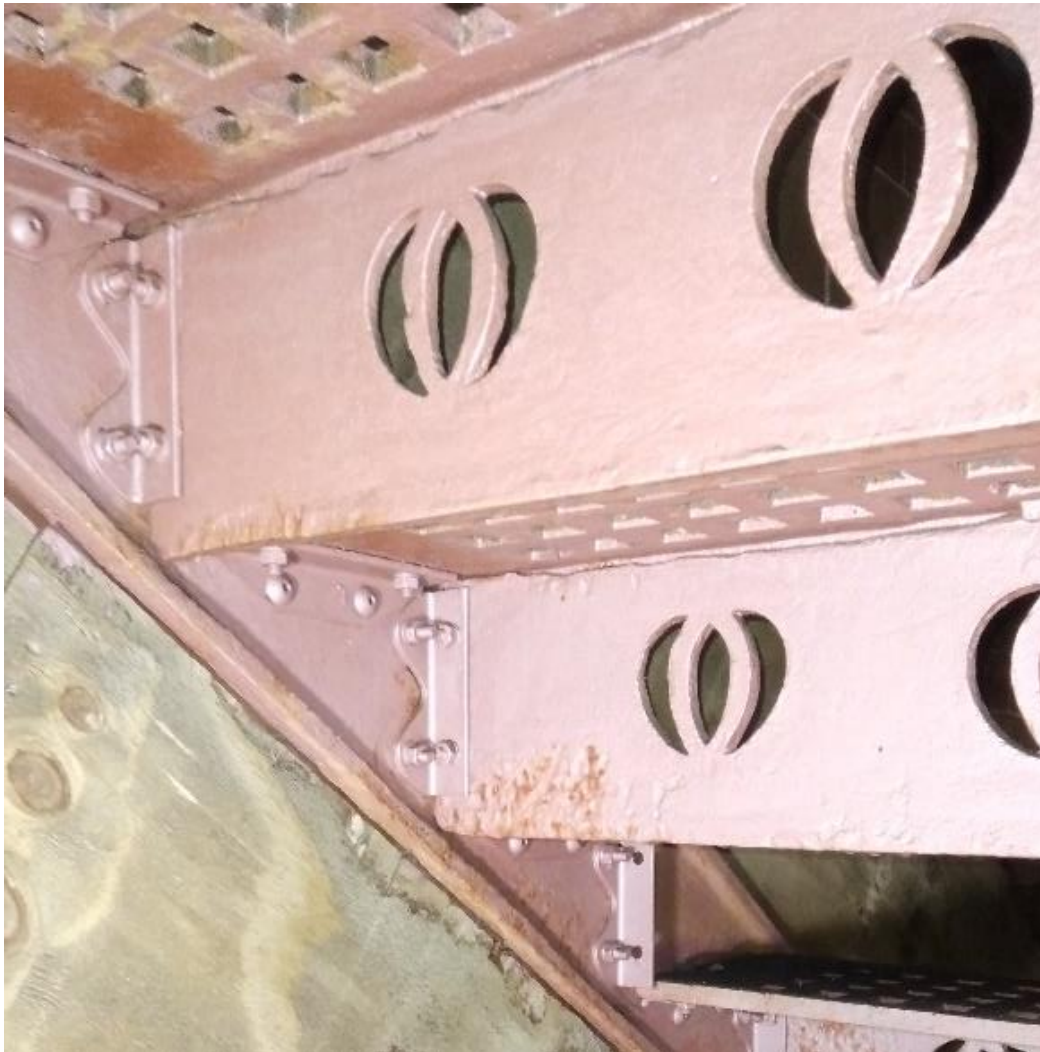
Replacement

tread support brackets (curved metalwork).
