INVESTIGATION OF LIME TORCHING TO THE UNDERSIDE OF THE ROOF IN  
BAY 04 OF THE 1830 WAREHOUSE

SCIENCE AND INDUSTRY MUSEUM, MANCHESTER (SIM)

JOB NO. 210.58

11 OCTOBER 2018

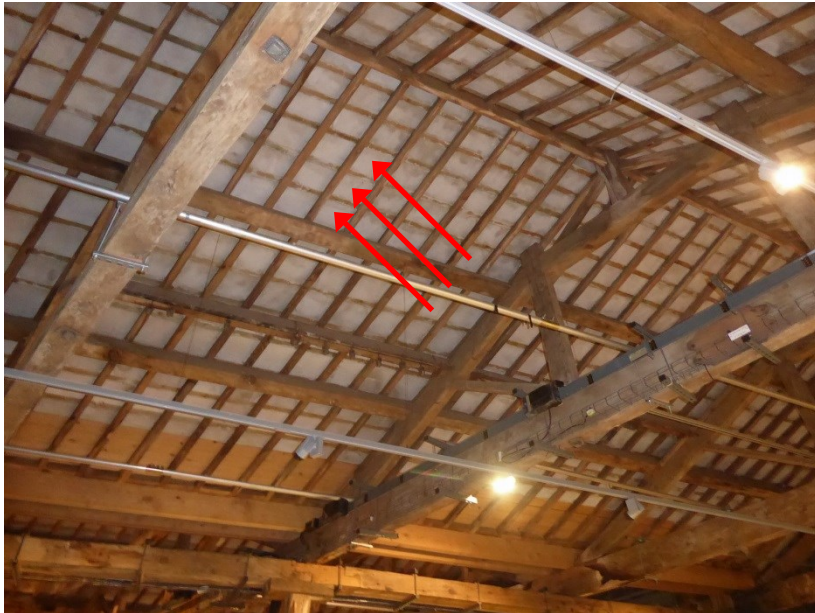
**Fig 1:**

Bay no. 4; showing a general view of the roof structure with lime torching applied to the underside of the slates between the slate battens

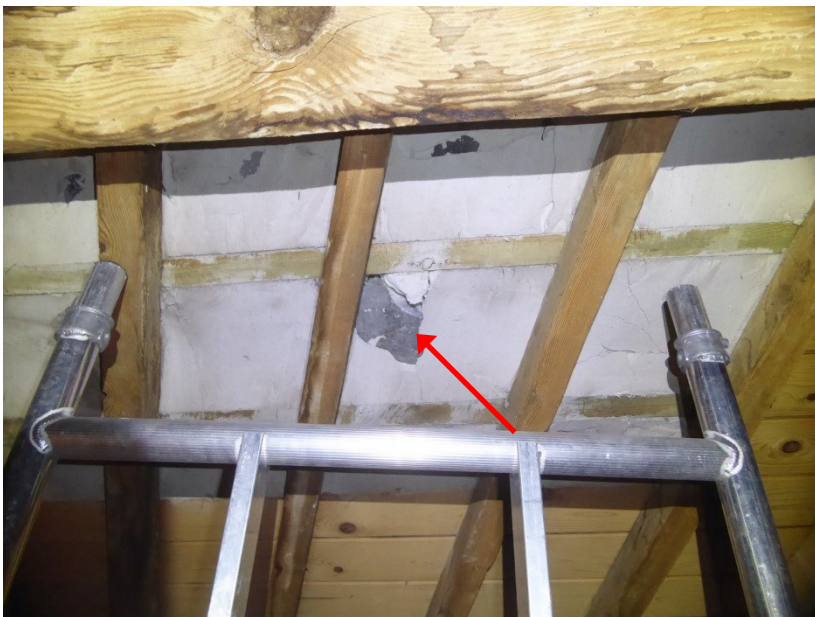
**Fig 2:**

Location no.1; showing area of damaged torching prior to tactile inspection. Torching has fallen in the past exposing the underside of the slate above

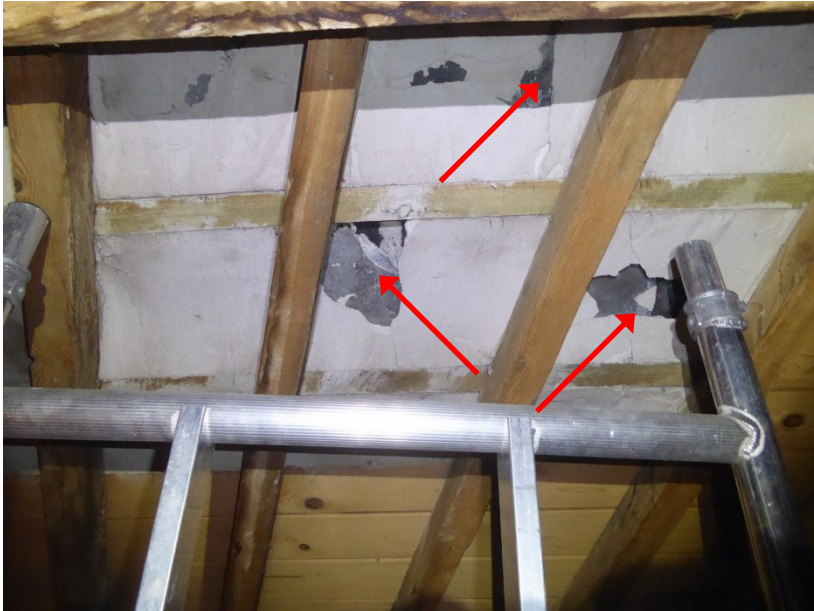
**Fig 3:**

Location no.1; showing area of damaged torching following tactile inspection and removal of particularly loose material

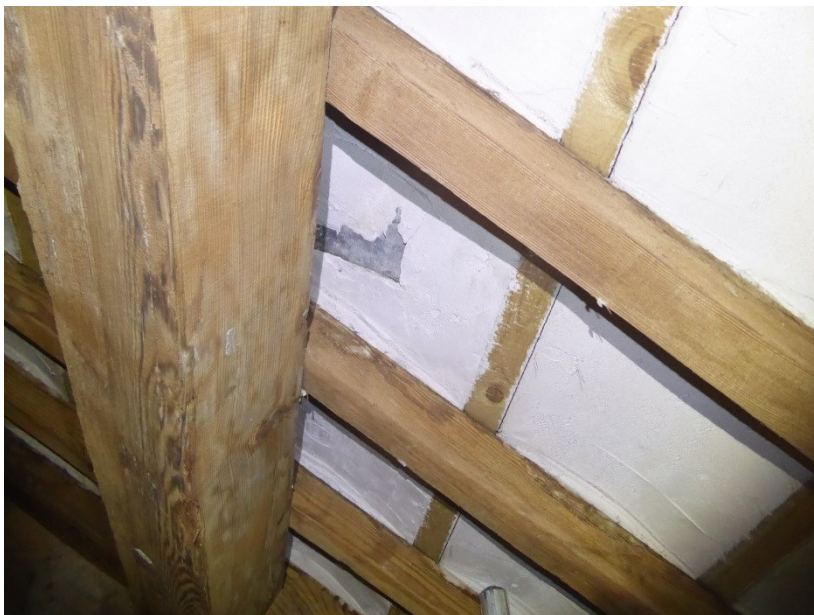
**Fig 4:**

Location no. 2; showing slate visible above an area of missing torching. There was no loose material and it appears that this small area was missed during original application

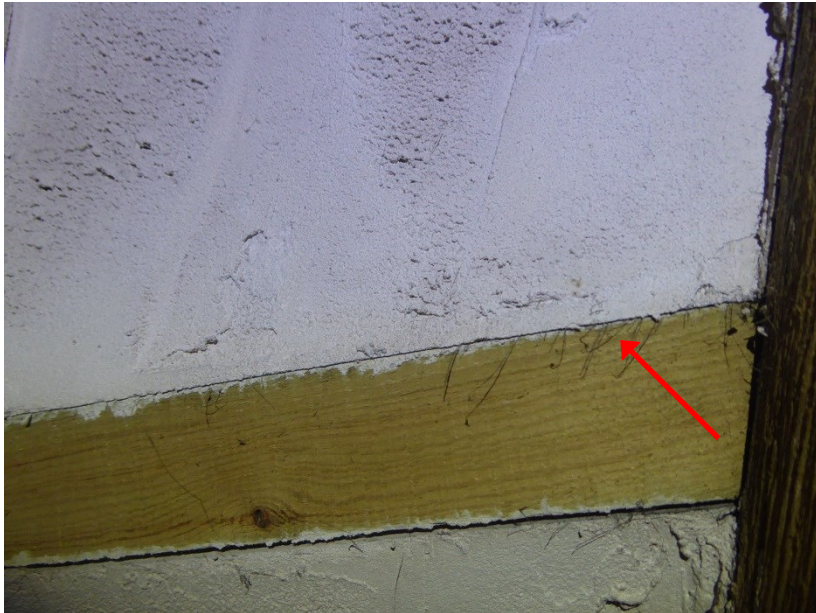
**Fig 5:**

Location no. 2; showing visible horse/  
goats hair above the slate batten

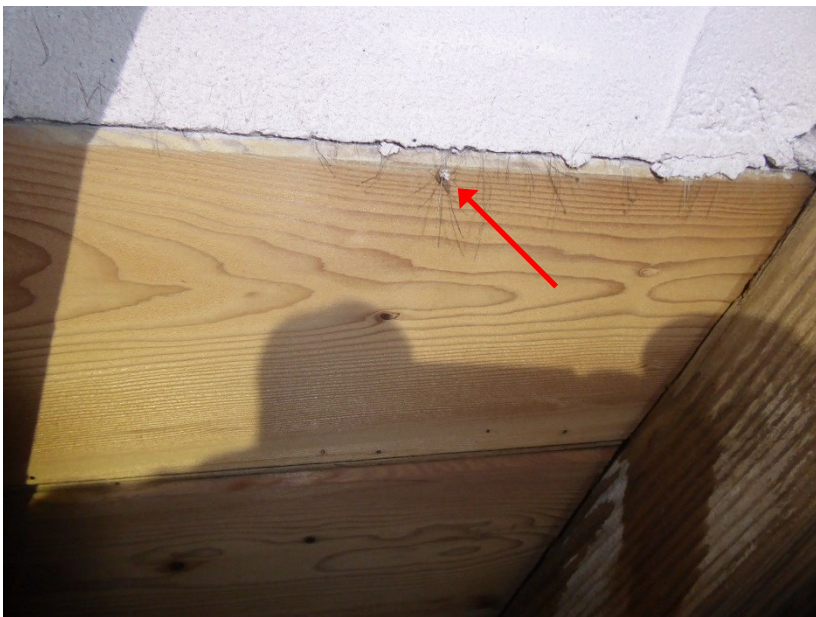
**Fig 6:**

Location no. 2; showing visible horse/  
goats hair above valley gutter timbers

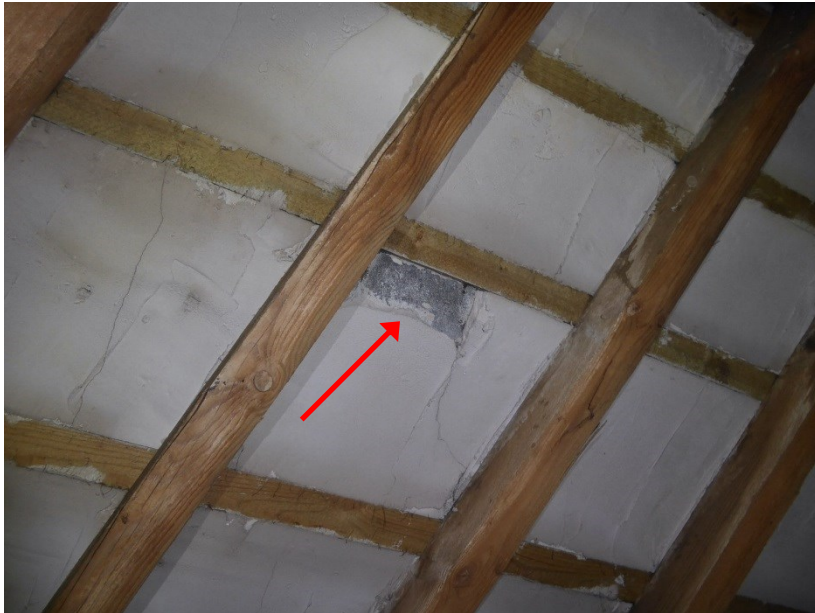
**Fig 7:**

Location no.3; showing area of damaged torching prior to tactile inspection. The torching here had recently fallen and that had instigated the need for this emergency inspection

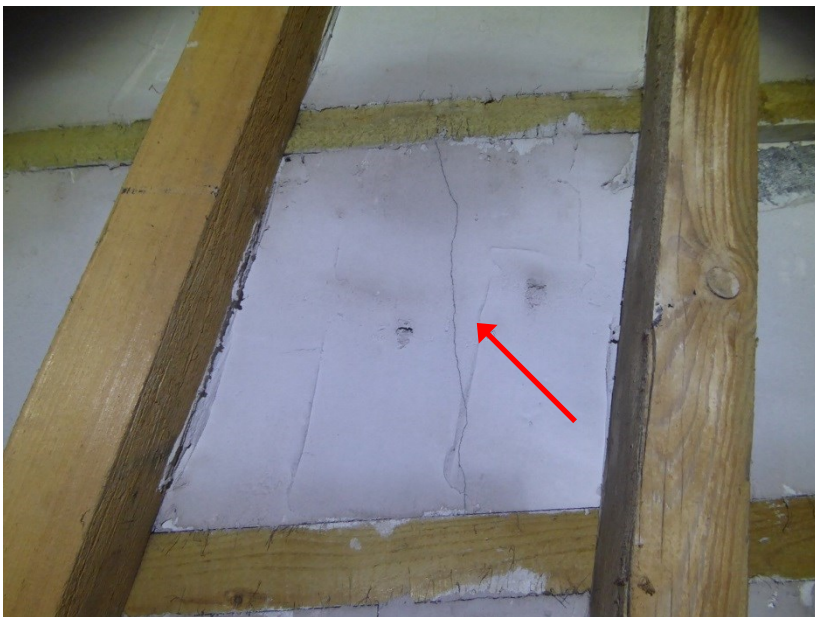
**Fig 8:**

Location no.3; showing example of cracking failure through the torching

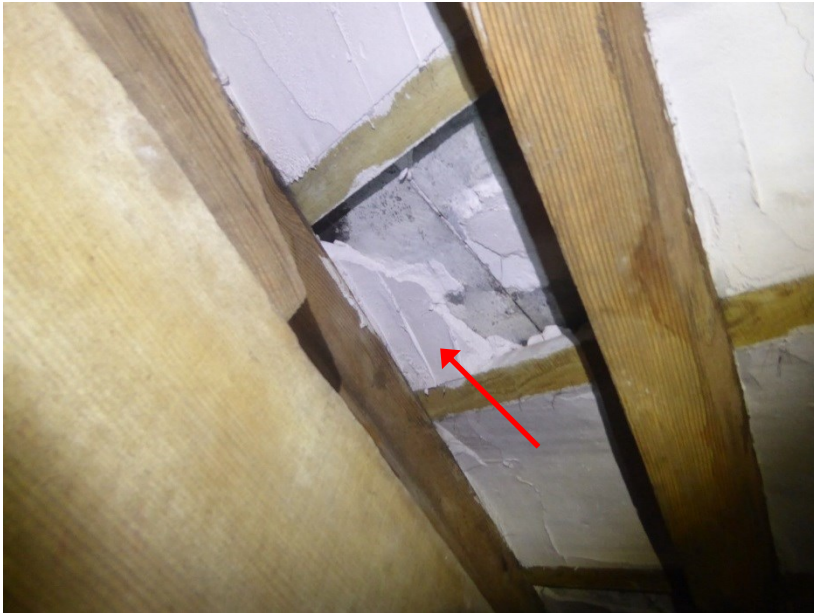
**Fig 9:**

Location no.4; showing area of damaged torching prior to tactile inspection

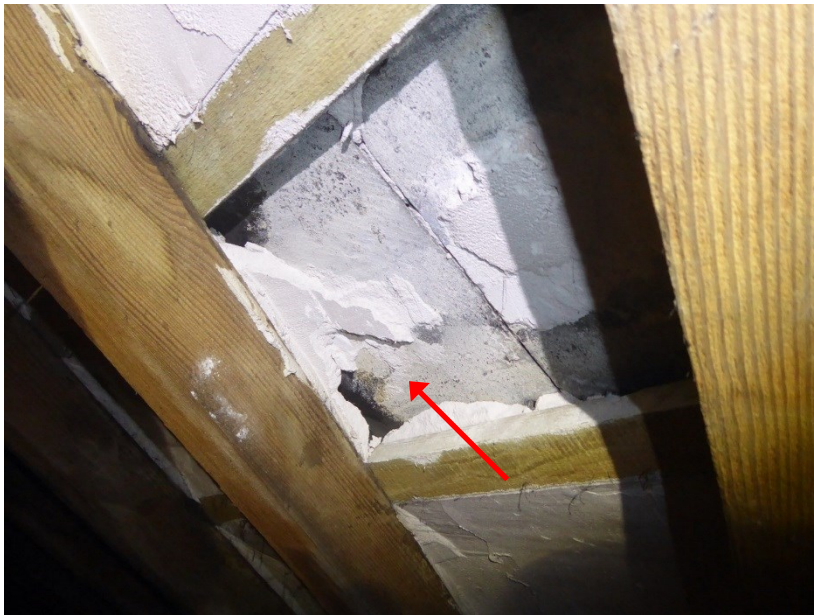
**Fig 10:**

Location no.4; showing area of damaged torching following tactile inspection and removal of particularly loose material

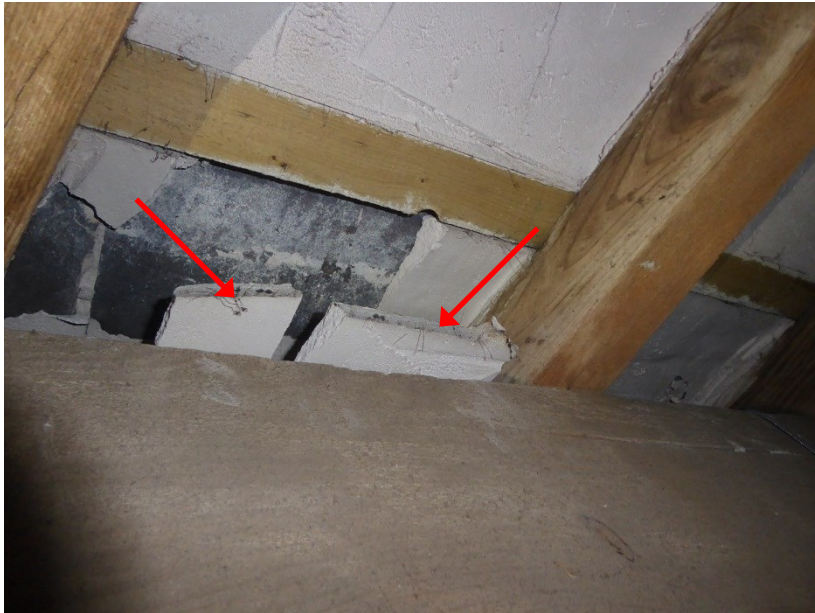
**Fig 11:**

Location no.5; showing area of damaged torching prior to tactile inspection. The torching had fallen and collected above the timber purlin

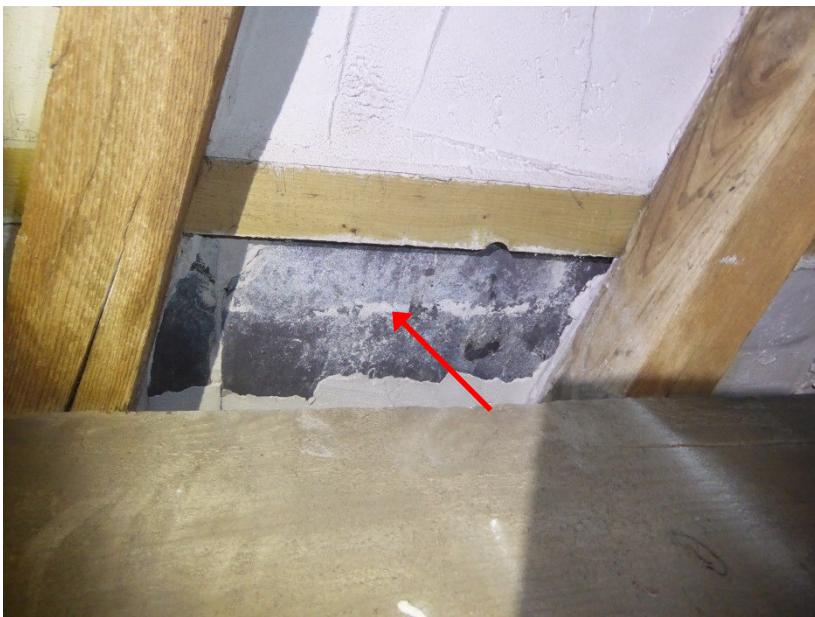
**Fig 12:**

Location no.5; showing area of damaged torching following tactile inspection and removal of particularly loose material

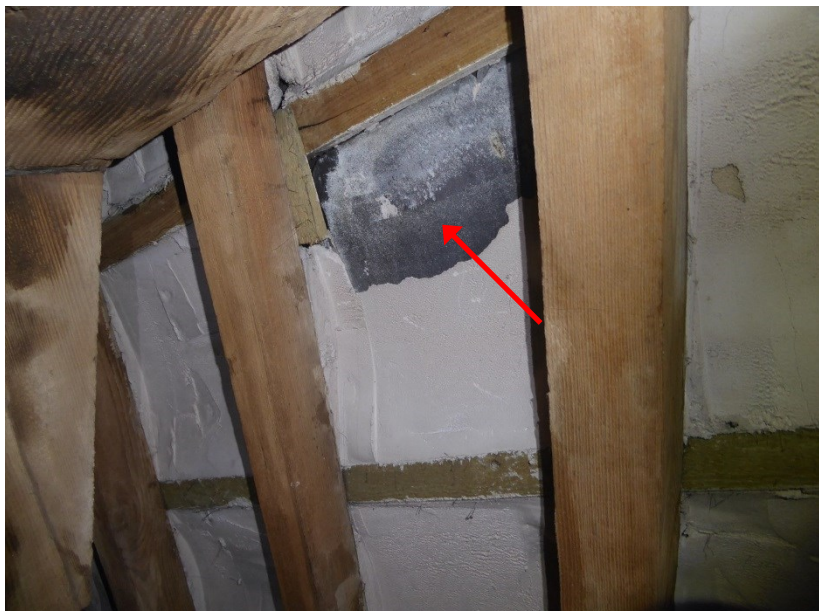
**Fig 13:**

Location no.6; showing area of damaged torching following tactile inspection and removal of particularly loose material

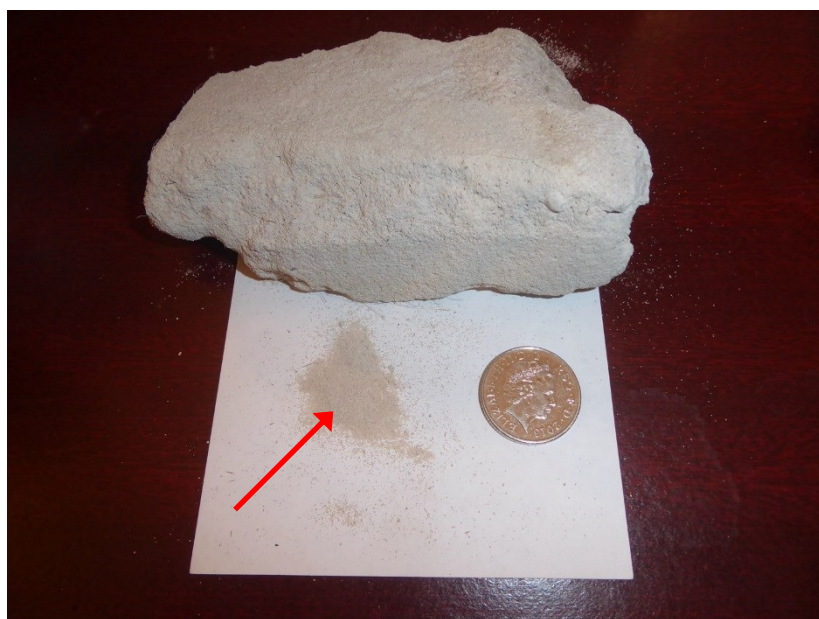
**Fig 14:**

- 2 Aggregates: When viewed under a microscope it was evident that the aggregate/sand was very fine and homogenous. The inclusion of larger aggregate particles was only rarely found. In good practice, aggregate used for mortars and body plasters should be comprised of a variety of particle sizes, graded to improve the bulk density. It also appeared that the torching had been applied with successive coats. However, it could not be determined whether a 'key' had been made in the 'scratch' coat to aid bonding between coats. In conclusion, this all made for a very weak mortar and provides a cause for the failure observed

Sample no.1 taken from location no.6; showing a representative example of loose torching that was removed. Note the lack of horse/goats hair and very fine, poorly graded mineral aggregate

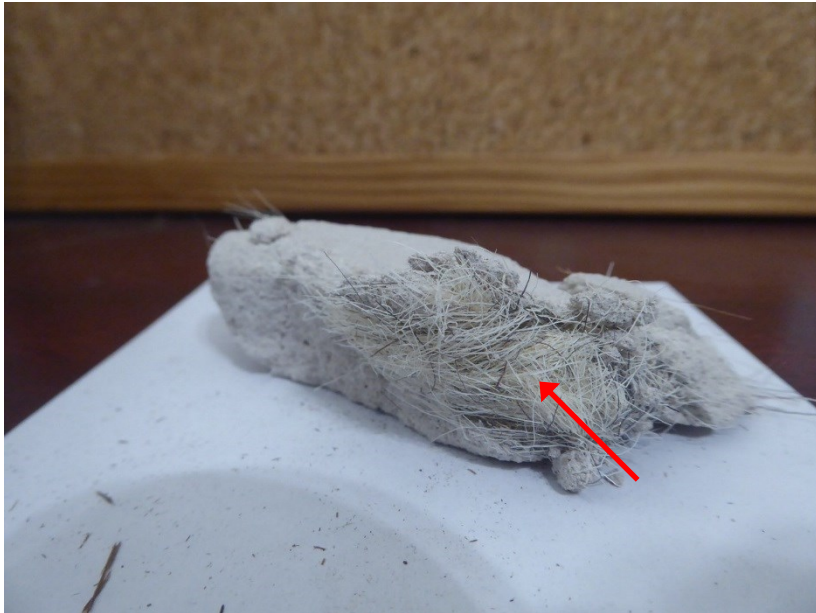
**Fig 15:**

- 1 Fibre inclusion: Examinations of fragments of loose mortar showed that although natural hair was used, it was very poorly distributed in the mortar. The hair has been inadequately distributed through the mortar and in the samples taken there were examples of both an insufficient quantity of hair and a 'clumped' inclusion of hair. Hair (or in recent years synthetic fiber) is added to the lime mortar to give the mix additional tensile strength and act as reinforcement in the bonding key. In best practice for lime mortar, hair is 'teased-out' of a bundle by hand into a forced-action type mixer

Sample no.2 taken from location no.4; showing a representative example of loose torching that was removed. Note the 'clumped' distribution of animal hair

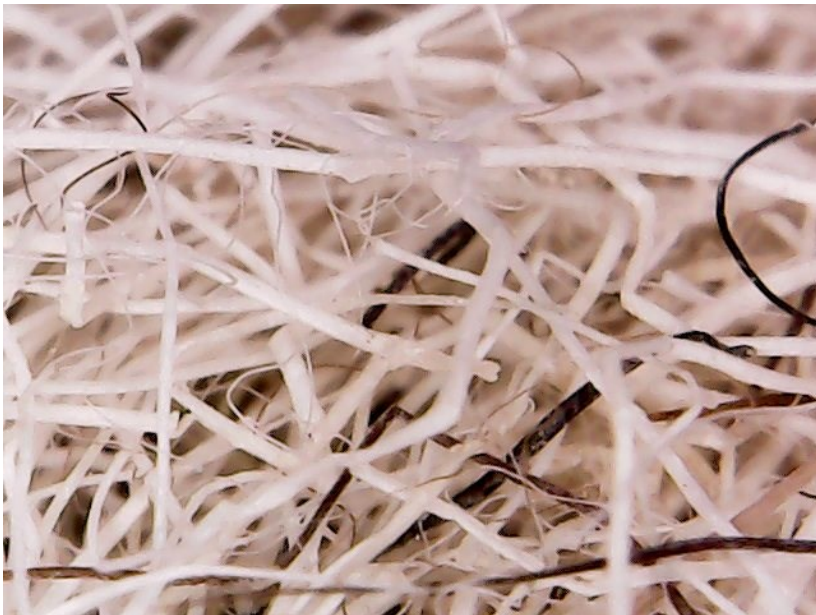
**Fig 16:**

Sample no. 2; showing micro view of animal hair. This may be a goat hair product

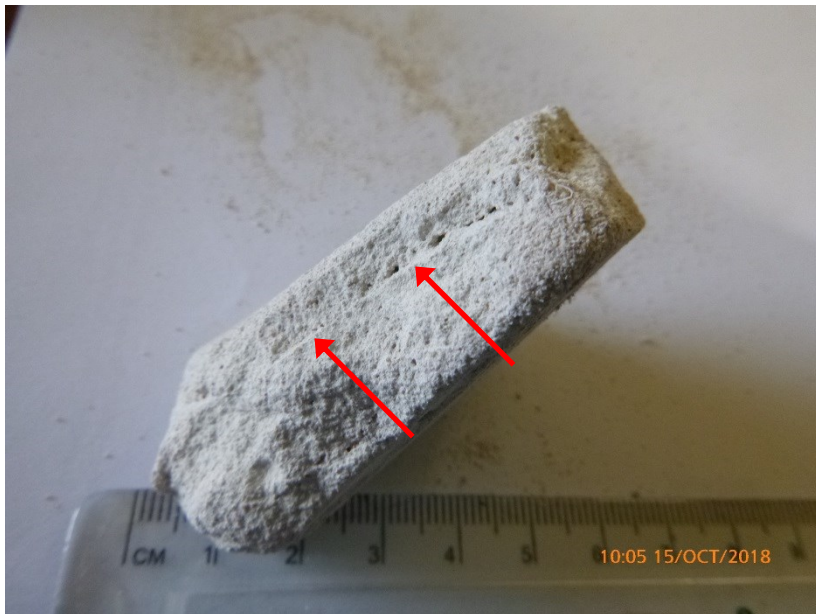
**Fig 17:**

Sample no.3 taken from location no.5; showing what appears to be a multi-coat build up. Historic use of torching mortar is only in a single coat and the additional coats is likely an intention to 'plaster' the soffit to a smooth surface

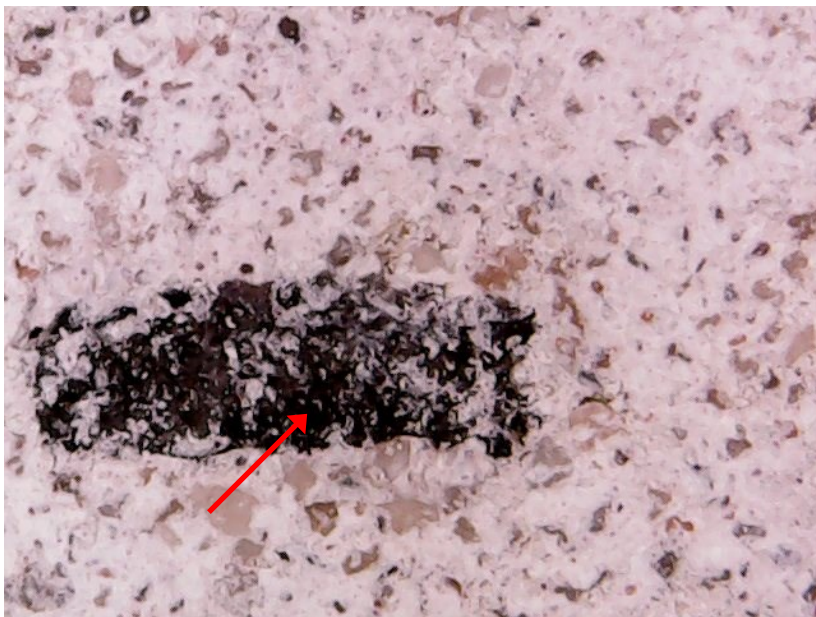
**Fig 18:**

Sample no.3; showing micro view. Note the very fine and homogenous aggregate which made for a very weak mortar. Larger inclusions were only found very rarely

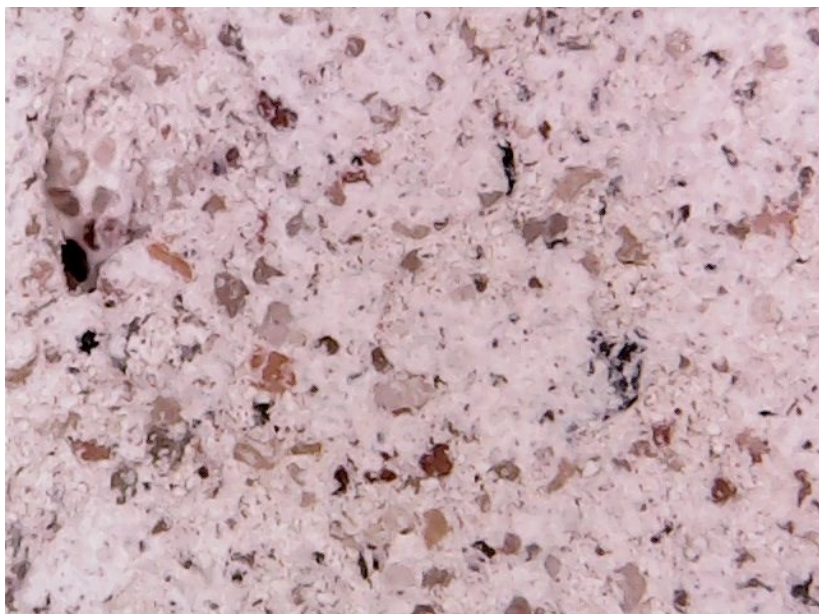
**Fig 19:**

Sample no.3; showing micro view.  
Note the very fine and homogenous aggregate

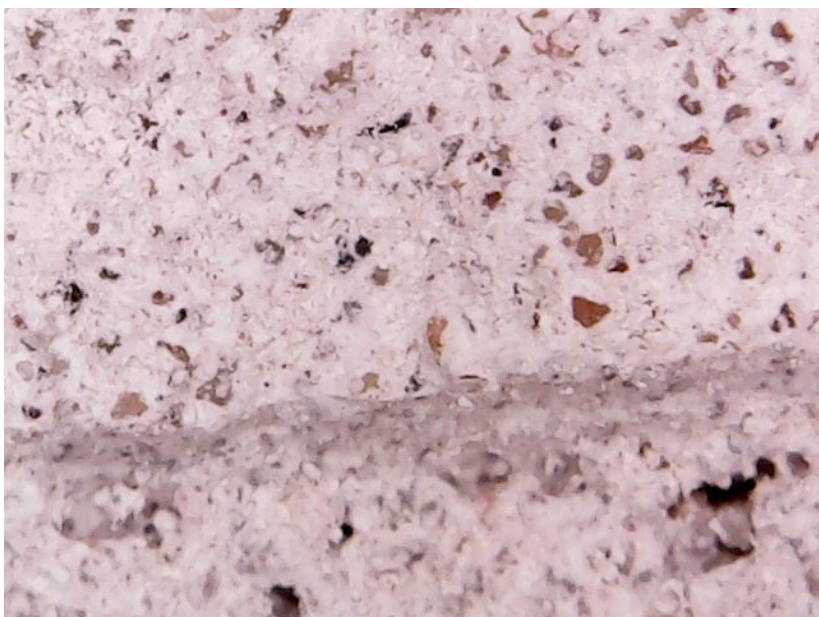
**Fig 20:**

Sample no.3; showing micro view.  
Showing apparent interface between successive coats. From the sample view, it could not be determined if there had been any 'scratch'/'key' to aid bonding between coats

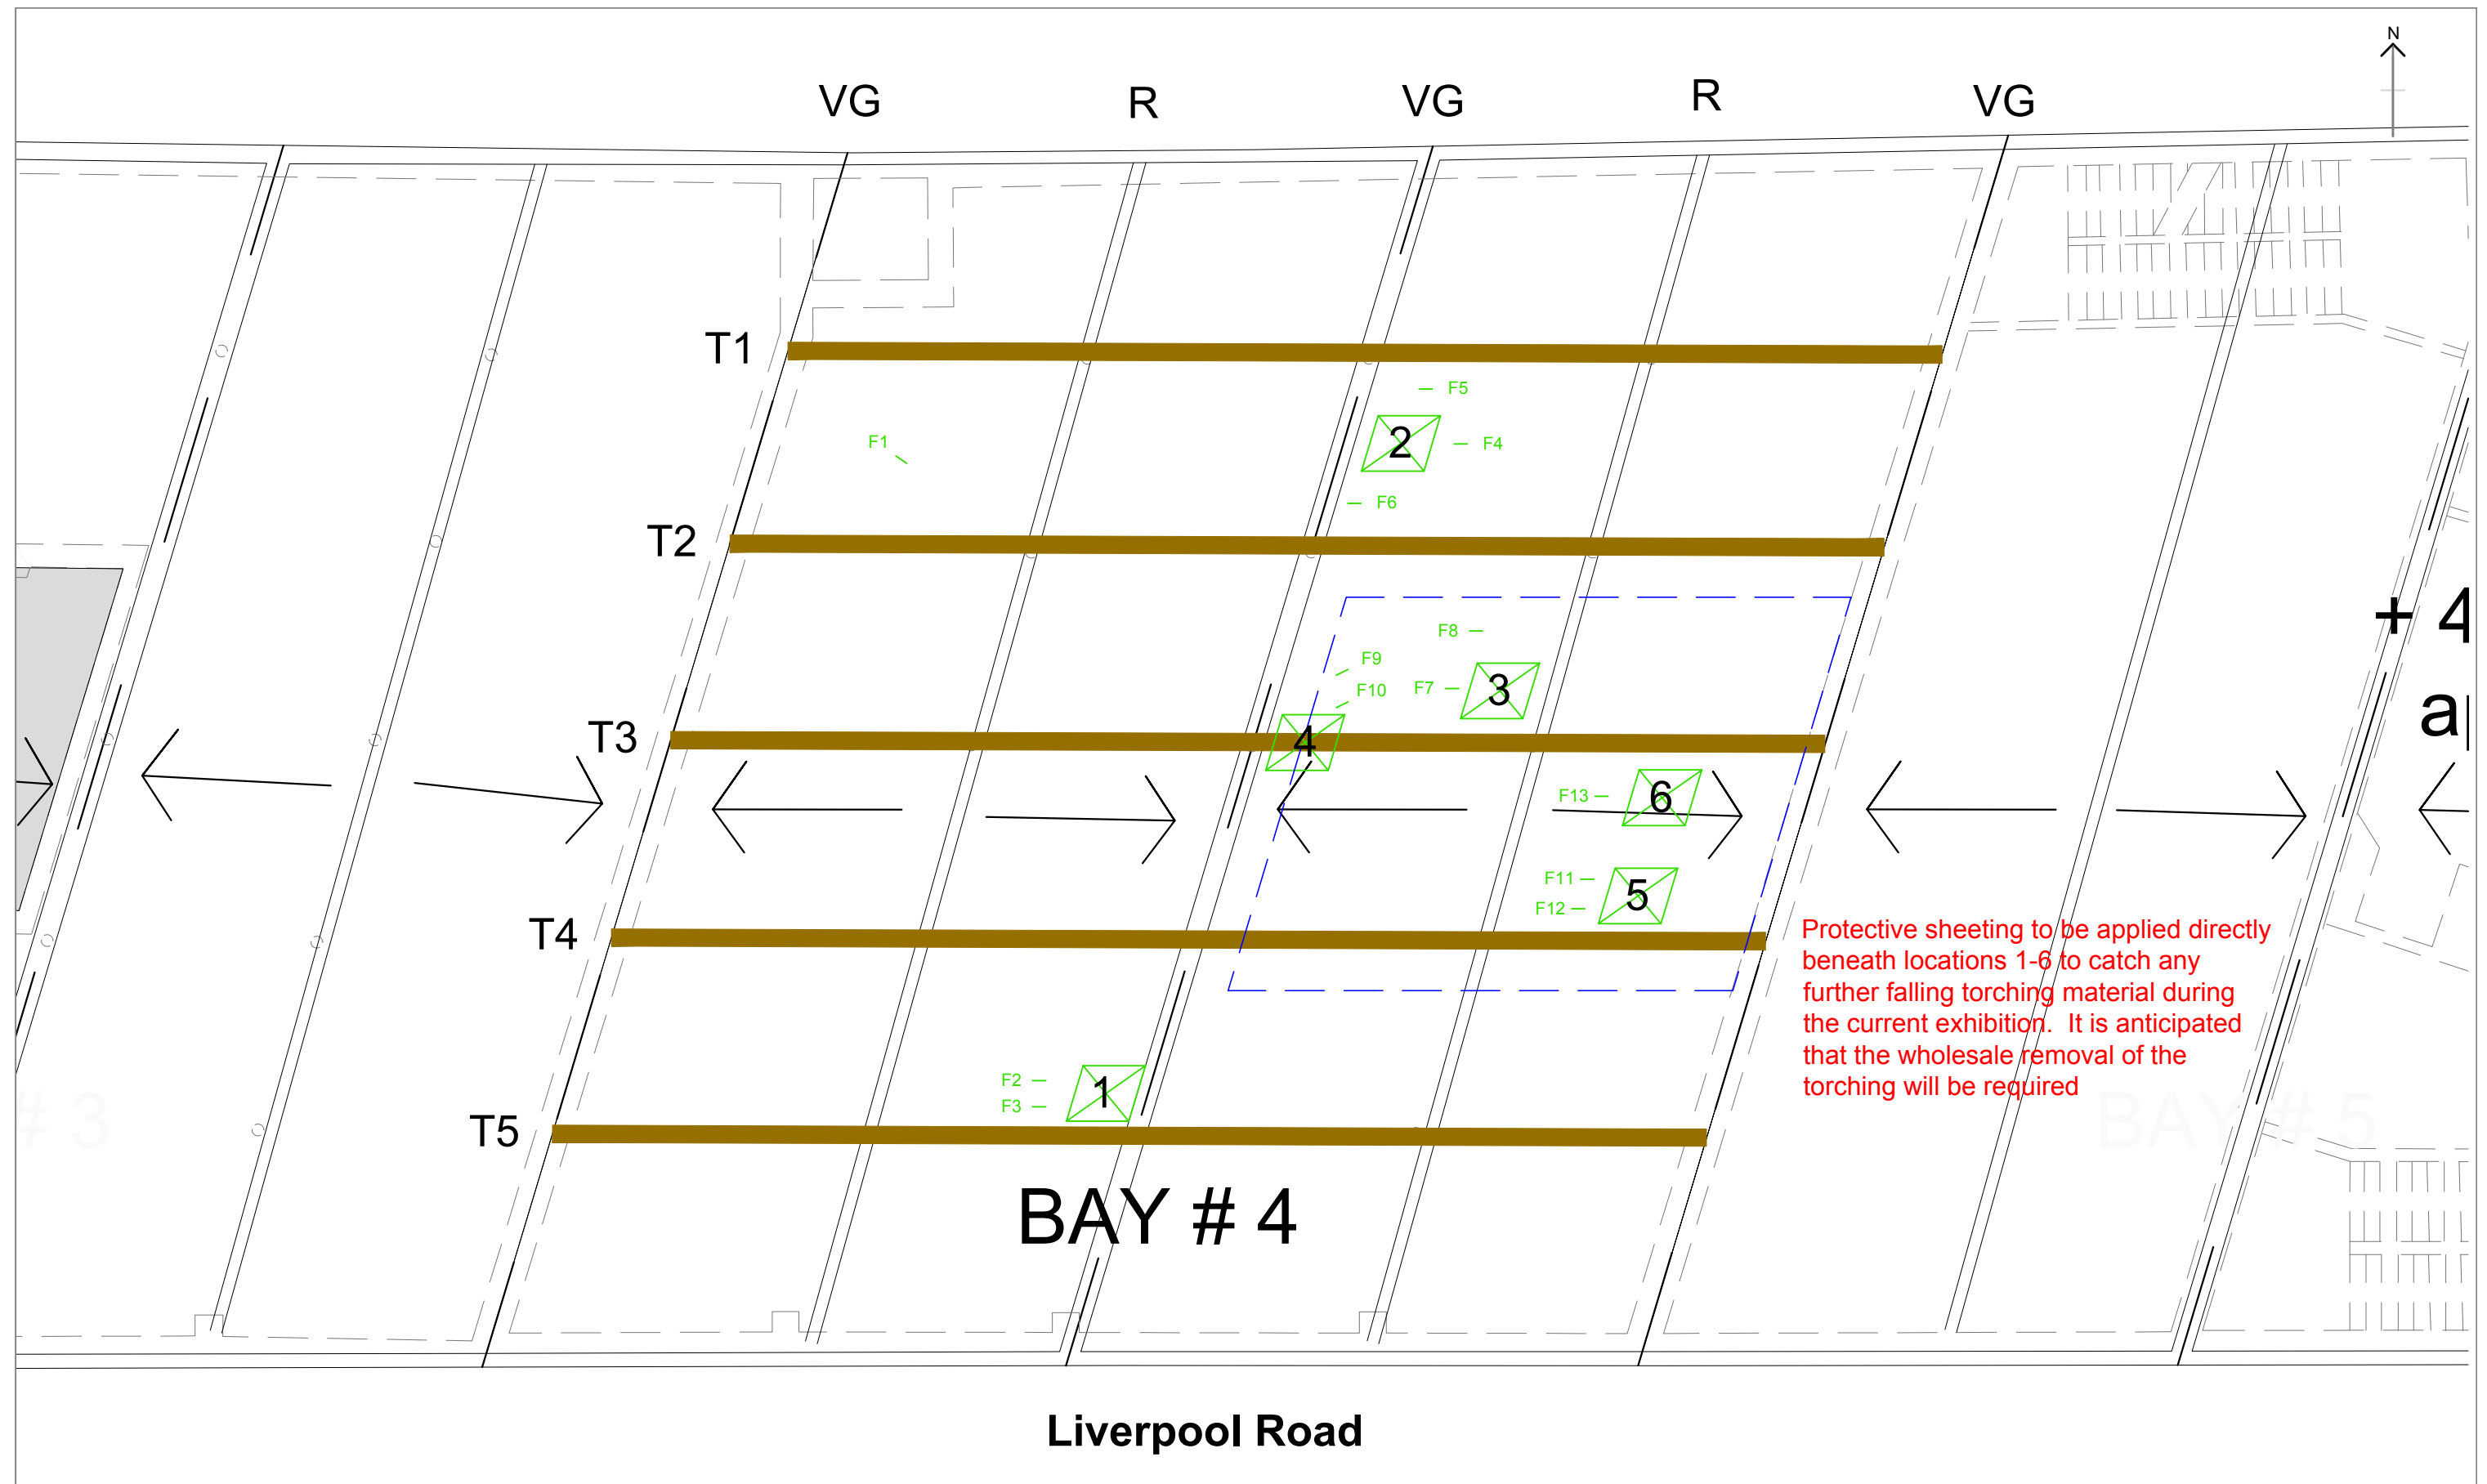
**Science and Industry Museum, Manchester - 1830 Warehouse**  
**BAY NO.4 UNDERSIDE OF ROOF**  
**11 October 2018**

- 1 Purpose of investigation: H+R were called out to inspect the underside of the roof in Bay 04 of the 1830 Warehouse, following falling of debris in the location of an exhibit forming part of the Manchester Science Festival. An inspection from the floor level using torchlight identified 6 no. areas where the 'torching'/'parging' to the underside of the roof finishes appeared to be in relatively poor condition. Following a close tactile inspection from a scaffold tower, loose torching was carefully removed, samples of which were taken for close examination by H+R

- 1 Immediate response: Although the notable areas of loose torching were removed by H+R as a precaution, ahead of the opening of the Manchester Science Festival, protective sheeting should be applied directly beneath the 6 no. locations identified on the attached drawing. The roof over the 'exhibition box' beneath is directly beneath 4 no. of these locations and any falling debris is likely to collect above. However, there is the potential for debris to fall over the sides of the flat roof as it lands on the upper floor and bounces and we would therefore recommend that these areas are also protected
